TWA Flight 800 Missile Impact Analysis

by
Richard Bott
Survivability Division
Systems Engineering Department

DECEMBER 1997

REPORT NUMBER
NAWCWPNS TM 8126

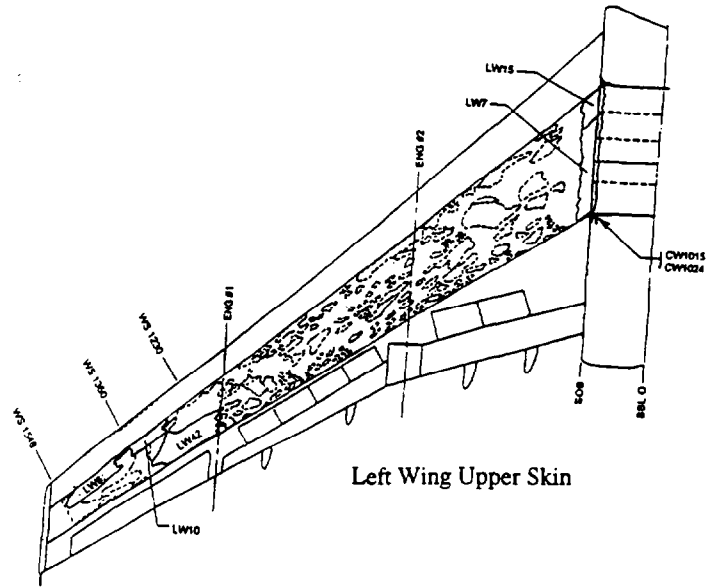
Left Wing Upper Skin

Detailed examinations of the TWA Flight 800 wing fuel tanks were conducted. The left upper wing skin, the left side-of-body rib, and the left leading-edge spar exhibit different and more severe damage from their right wing counterparts. Figures 3, 4, and 5 show comparisons of the damage to the upper wing skins, side-of-body ribs, and inboard leading-edge spars, respectively. Close inspections of the wreckage in these areas revealed no evidence of penetrations by foreign objects and no high-velocity fragment damage consistent with a missile impact. NTSB and FBI documentation support these findings (References 3 and 4).

FIGURE 3. TWA Flight 800 Upper Wing Skin Damage.

Some unexplained damage characteristics on these structures have puzzled investigators, for example, the severe shattering of the left wing upper skin. While the damage mechanisms involved may not be completely understood, the recovery and reconstruction of TWA Flight 800 is the most comprehensive undertaking of its type ever made. This wing damage may be typical for severe water impacts but has gone unnoticed in previous mishaps due to the lack of recovery and reconstruction of debris. Further, the left and right wings of TWA Flight 800 impacted the water in different attitudes, as evidenced by the damage to the engines, which may explain the disparity in damage between the two structures. These damage characteristics are not deemed characteristic of a missile impact, but without validating test data this conclusion cannot be made with 100% certainty.

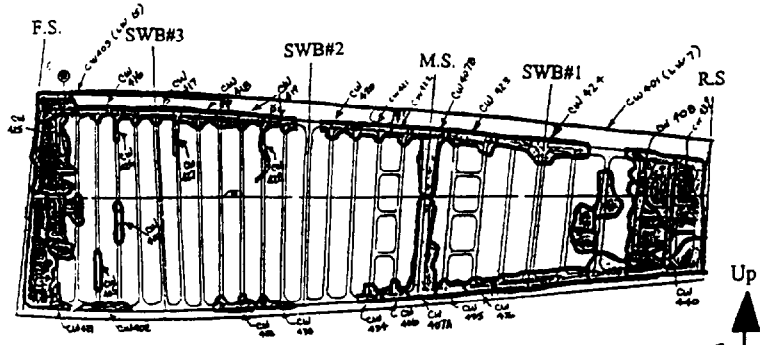
Left Side-of-Body Rib

FIGURE 4. TWA Flight 800 Side-of-Body Rib Damage.

Conceivably, a missile impact in the wing-root fuel tank area could create enough damage to cause the side-of-body rib to collapse into the center wing tank. This collapse could occur without significant release of material from the wing structure, but the preponderance of evidence suggests this did not occur on TWA Flight 800. Most compelling is the fact that both wings remained with the aft fuselage section until they were well downrange. If the severe left wing damage had been caused by a missile impact, the expected result would be an early release of that wing, or at least numerous pieces of it, well uprange in the red recovery zone.

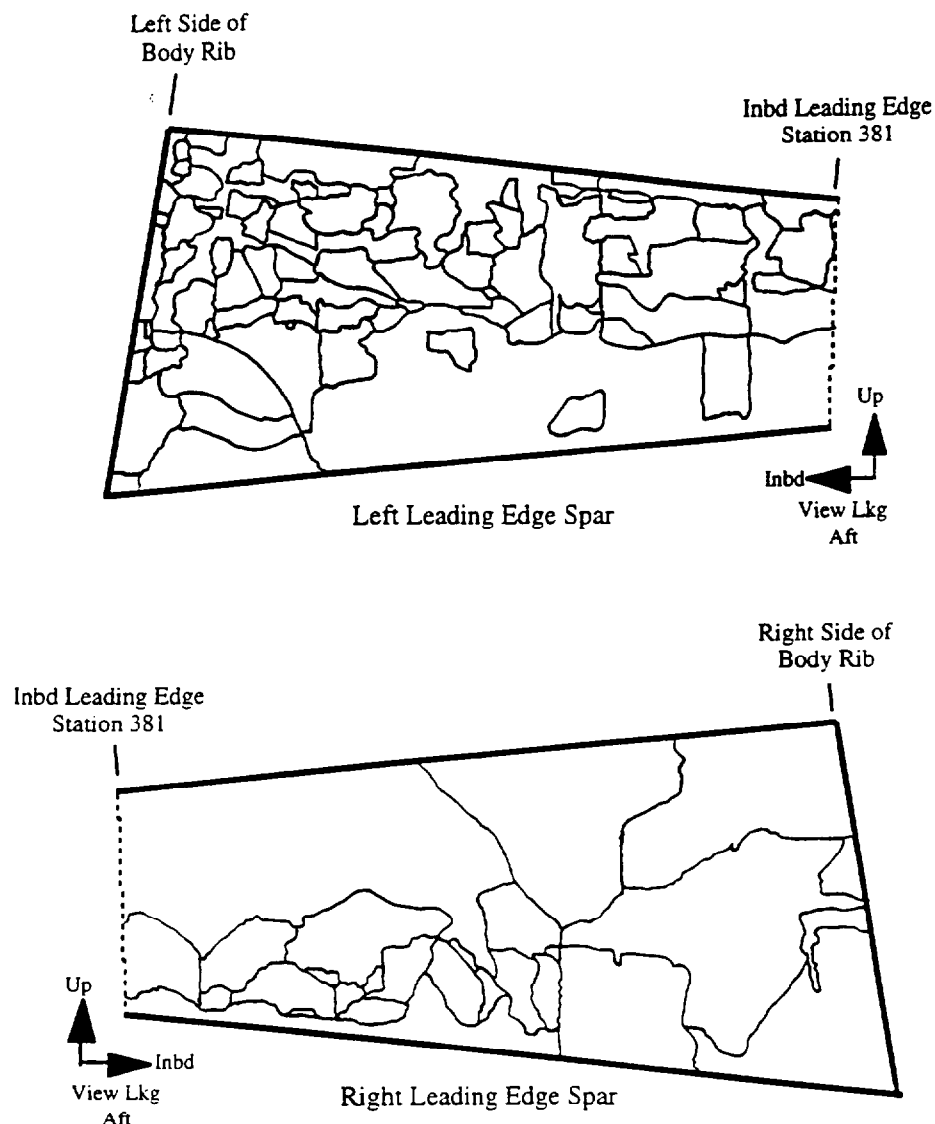
FIGURE 5. TWA Flight 800 Leading-Edge Spar Damage.
