**NATIONAL TRANSPORTATION SAFETY BOARD  
WASHINGTON, D.C**

**GROUP CHAIRMAN'S FACTUAL  
REPORT OF INVESTIGATION  
SOUND SPECTRUM STUDY**

Cockpit Voice Recorder

Aircraft: Trans World Airlines Inc.  
Boeing 747-131 N93119

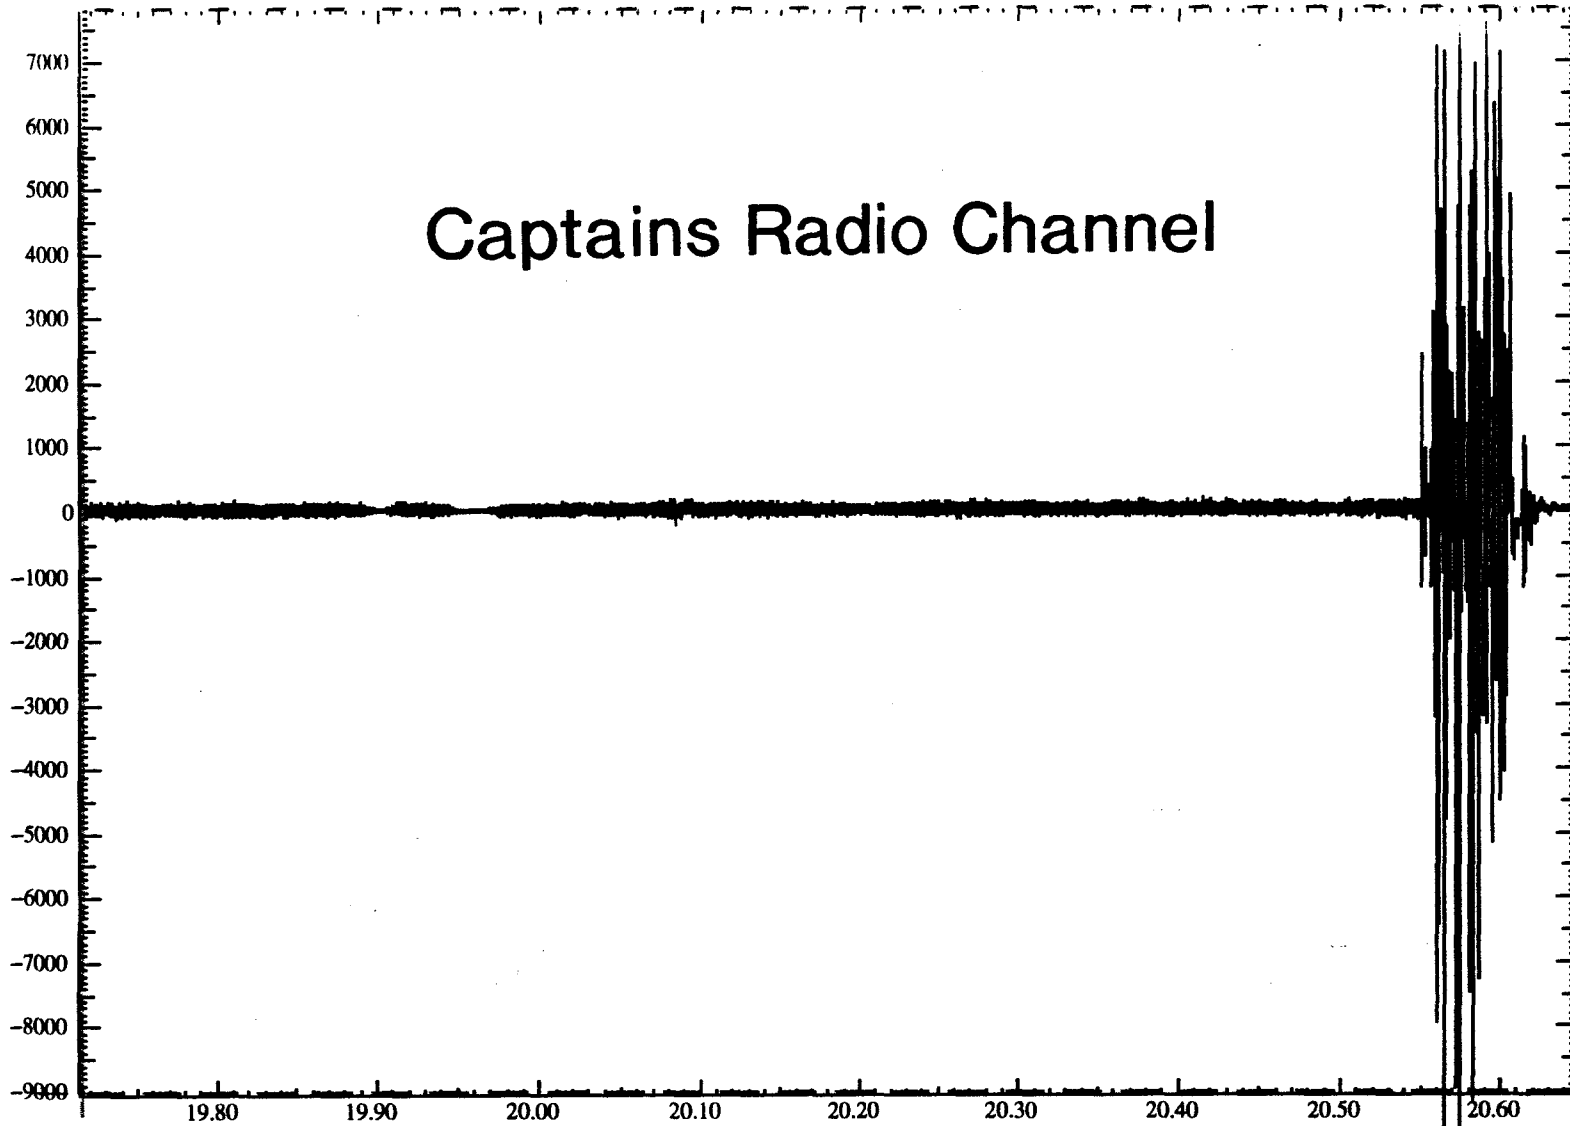
At time 0.73 seconds before the end of the recording and again at 0.68 seconds before the end, the normal 400 Hz signal with its associated harmonics changed. Chart 1 depicts this change in the background signal as observed on the Captain's radio channel. This change consists primarily of a lack of the upper harmonics of the 400 Hz. During these two different areas the signal contains only the 400 Hz component, no added harmonics. Chart 2 depicts the Captain's radio channel and the frequency plots for the regions prior, during and after the disturbance. Chart 3 depicts all of the 3 radio channels in this same area. It can be seen that the disturbance is identifiable only on the Captain's radio track of the CVR.

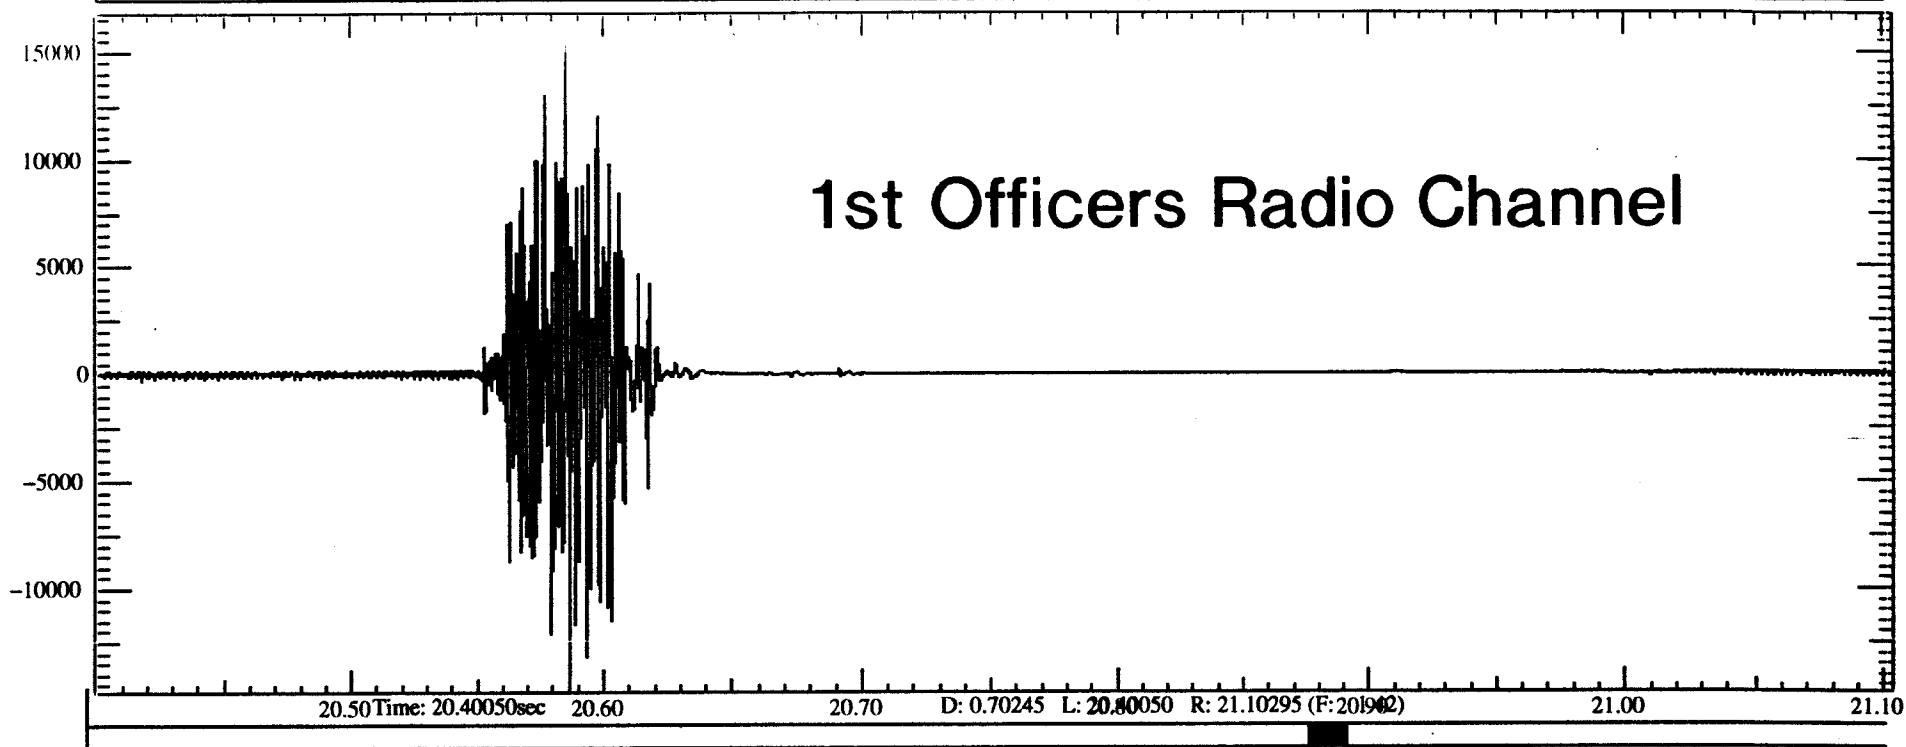
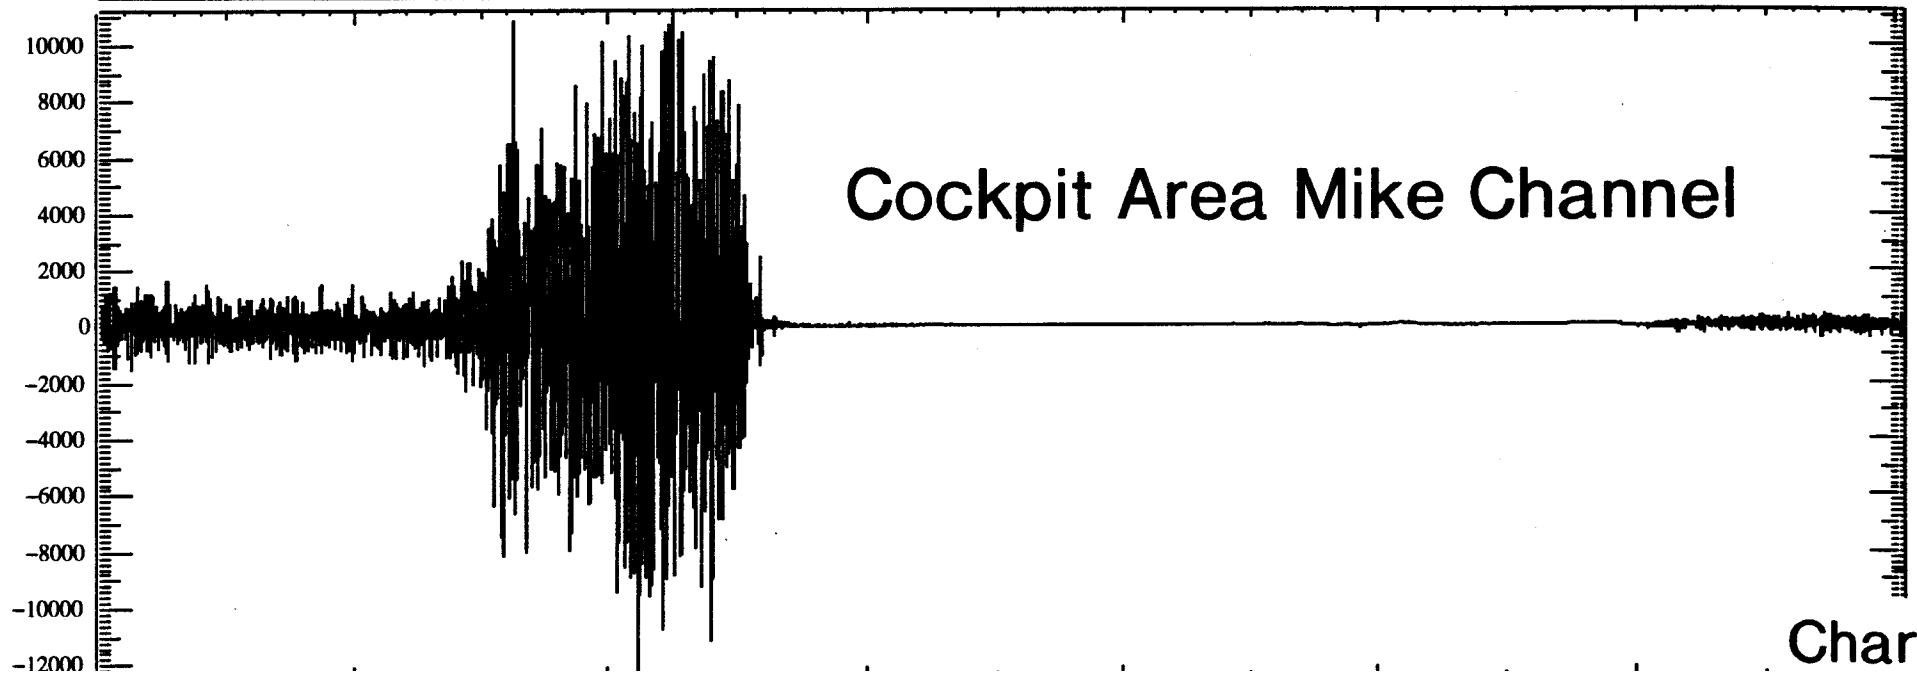
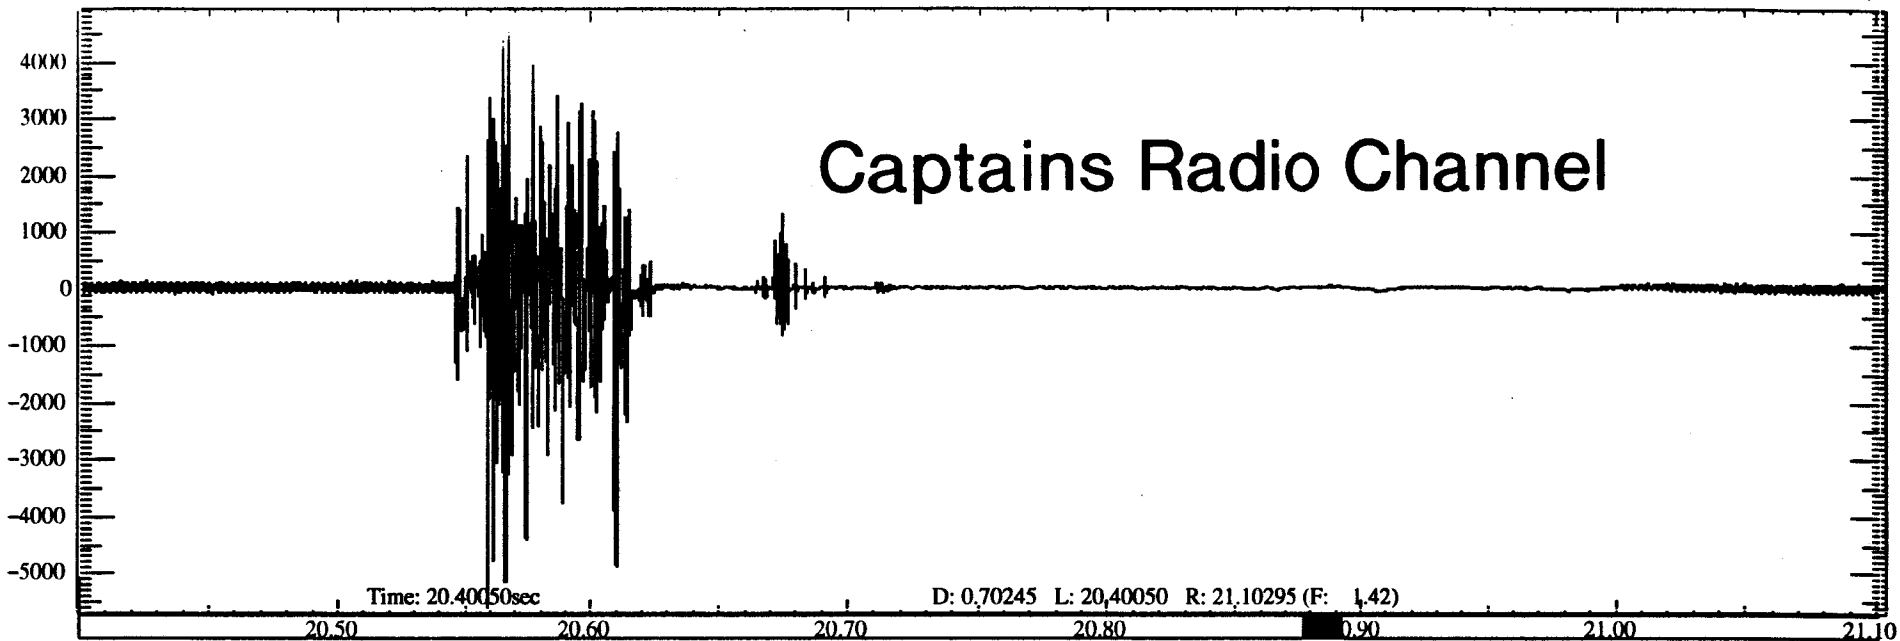
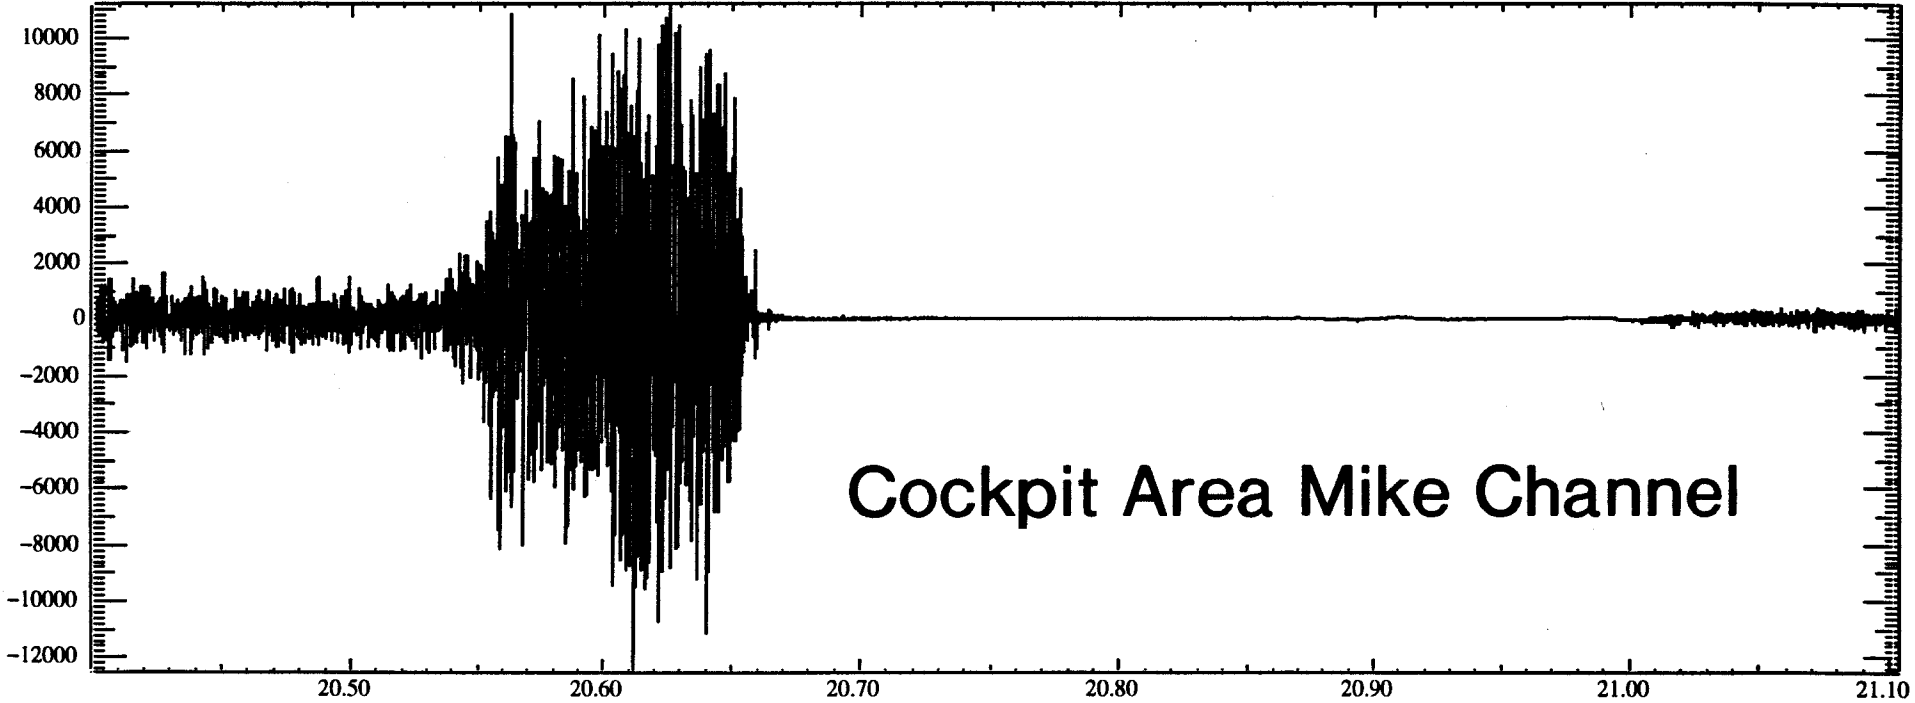
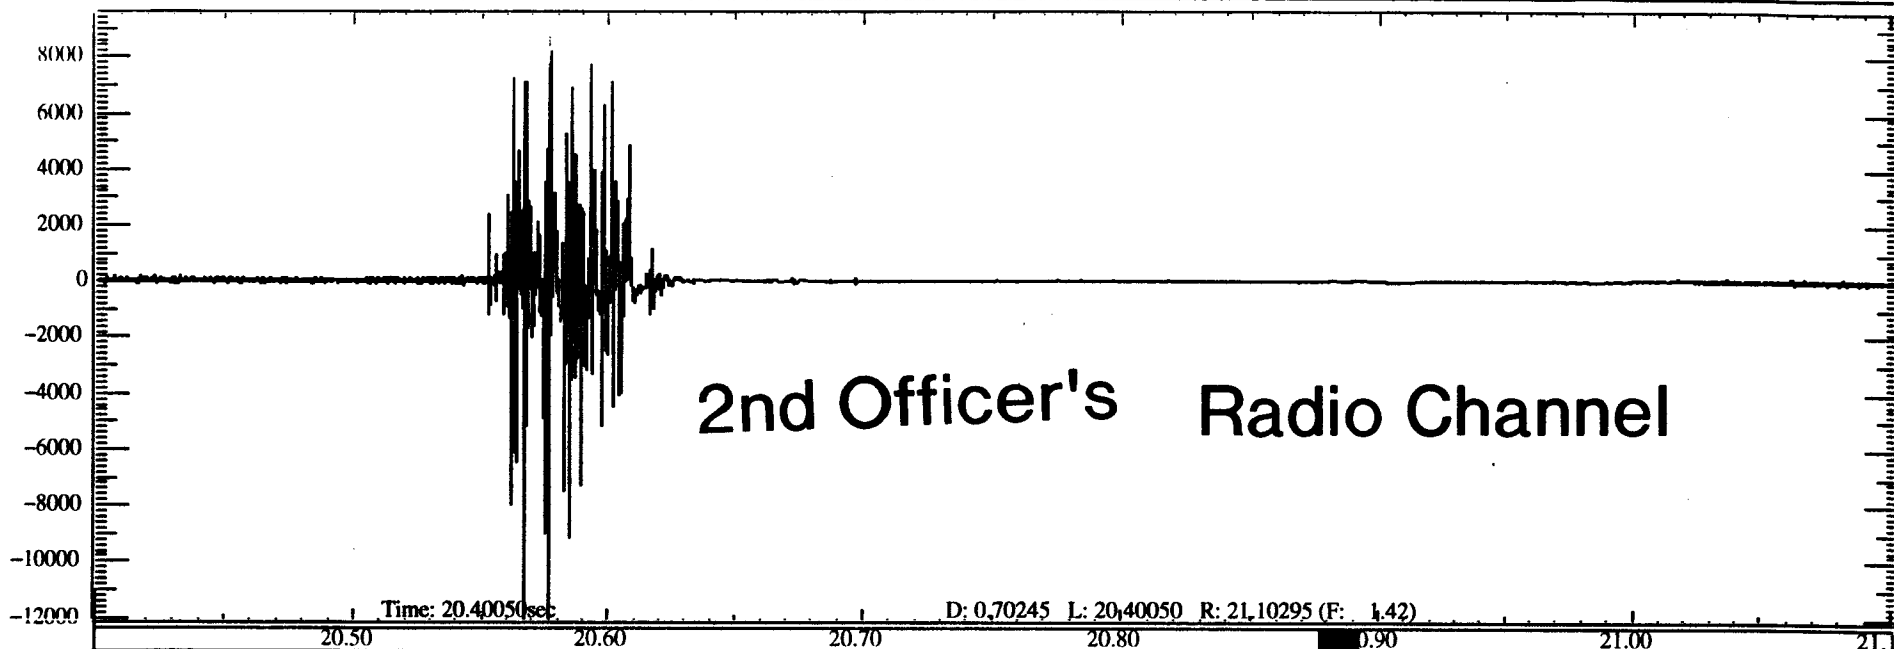
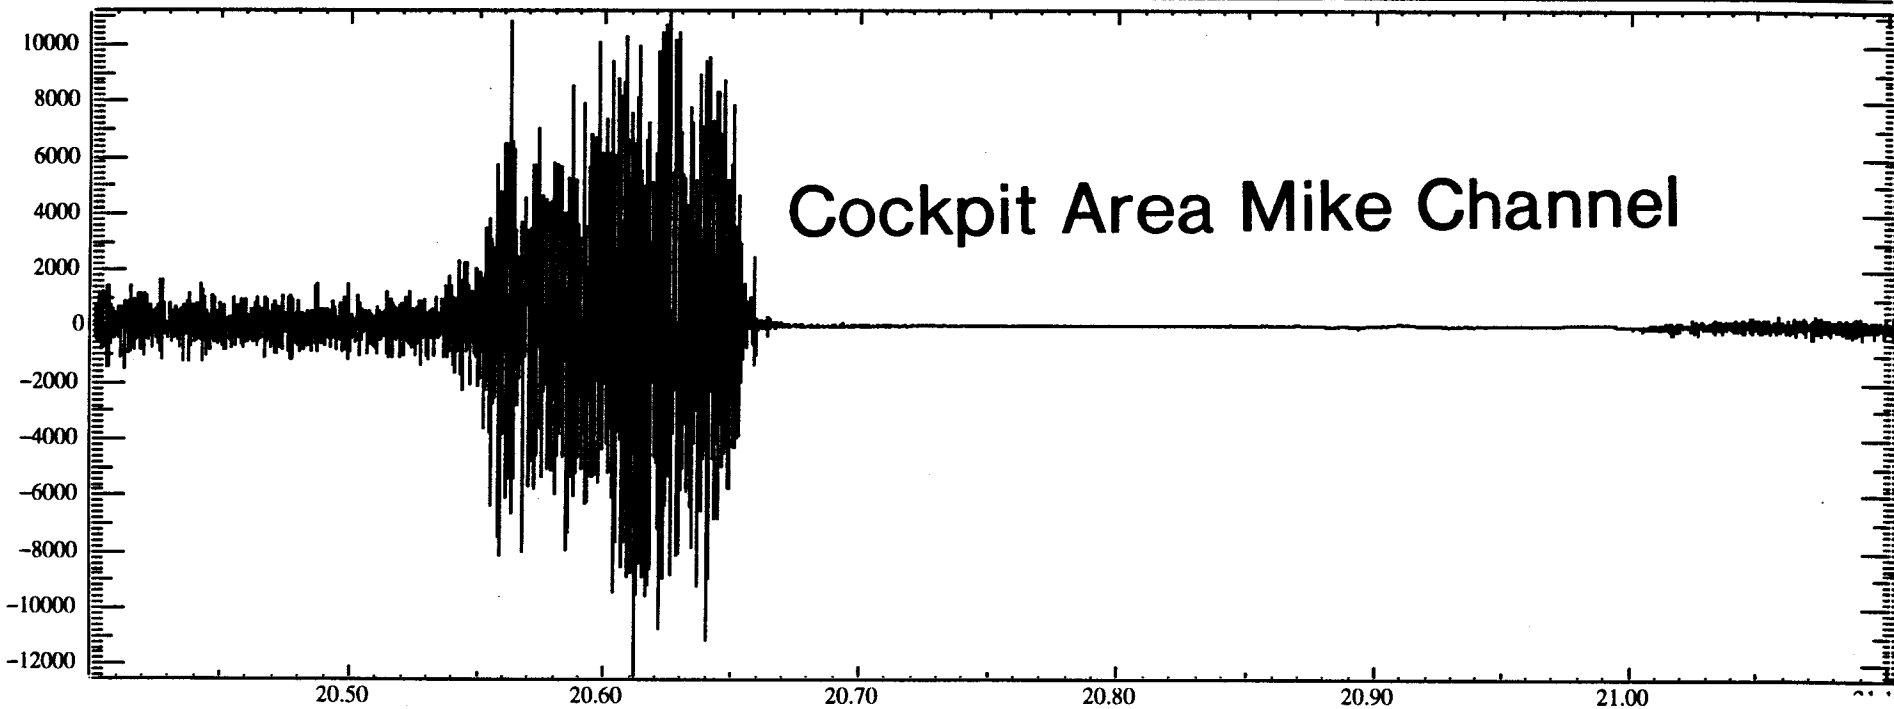
The CVR recording was for the most part very routine and normal until it abruptly ended. This sudden termination of the recording affected all 4 of the CVR channels. Chart 4 depicts the 4 CVR channels for about the last second of CVR data. The top trace displays the data from the 1<sup>st</sup> Officers radio/intercom channel. The 2<sup>nd</sup> trace is the data from cockpit area microphone channel. The 3<sup>rd</sup> trace is the data from the Captain's radio/intercom channel. The 4<sup>th</sup> trace depicts the information from the 2<sup>nd</sup> Officer's radio/intercom channel.

It can be seen from chart 4 that the termination of the recording affected all of the channels slightly differently. It could be assumed that the termination event should look the same on the 3 radio channels. These 3 channels all are identical in their function and they are all being fed information obtained from identical sources. It can be seen on the chart that trace 3 (Captain's radio) is affected 7.25 microseconds

before any disturbance is observed on the other radio channels.

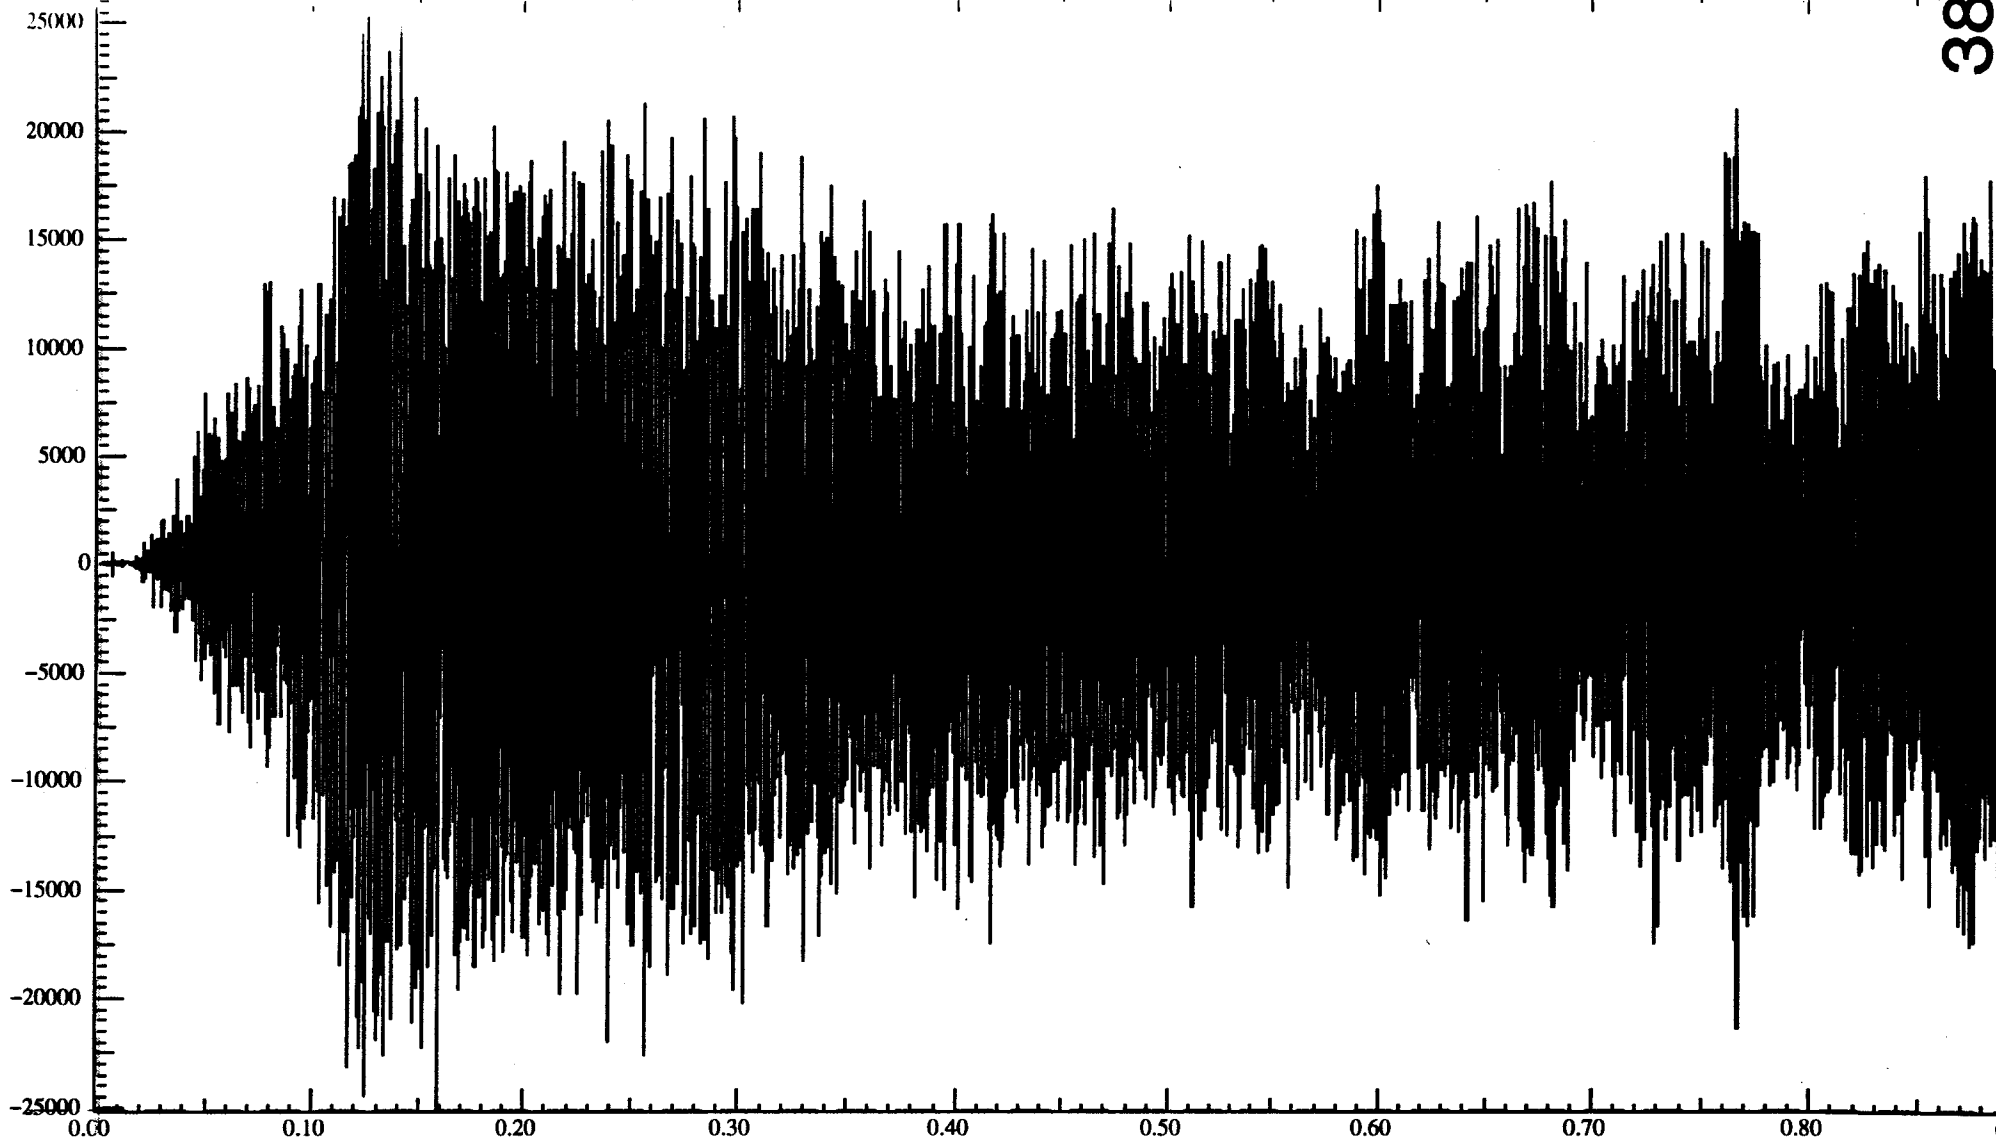
The final test in the trial was to explode a fuel-air mixture in the center wing fuel tank of the Boeing 747 aircraft. This test was conducted by injecting propane into the center wing tank to obtain a 3.2% propane/air mixture. The tank was ignited by placing a small high explosive device on the rear spar of the aircraft. The same CVR recorders and instrumentation were used to document the tank explosion. Chart 28 depicts the same 6 traces which represent the charge initiation ( $T_0$ ), cockpit pressure, cockpit acceleration, cabin acceleration, Fairchild A-100A CVR, Fairchild A-100 CVR. Chart 29 depicts an expanded trace of the Fairchild A-100 CVR record and chart 30 depicts an expanded trace of the Fairchild A-100A CVR. Chart 31 depicts the sound data from the Fairchild A-100 CVR in addition to the power/energy distribution plot similar to what was shown on charts 18-22.
