**NATIONAL TRANSPORTATION SAFETY BOARD
WASHINGTON, D.C**

**RECONSTRUCTION GROUP CHAIRMAN'S FACTUAL
REPORT OF INVESTIGATION**

A. **ACCIDENT:** DCA-96-MA-070

Location: East Moriches, New York
Date: July 17, 1996
Time: 2031 Eastern Daylight Time
Airplane: Boeing 747-131, N93119

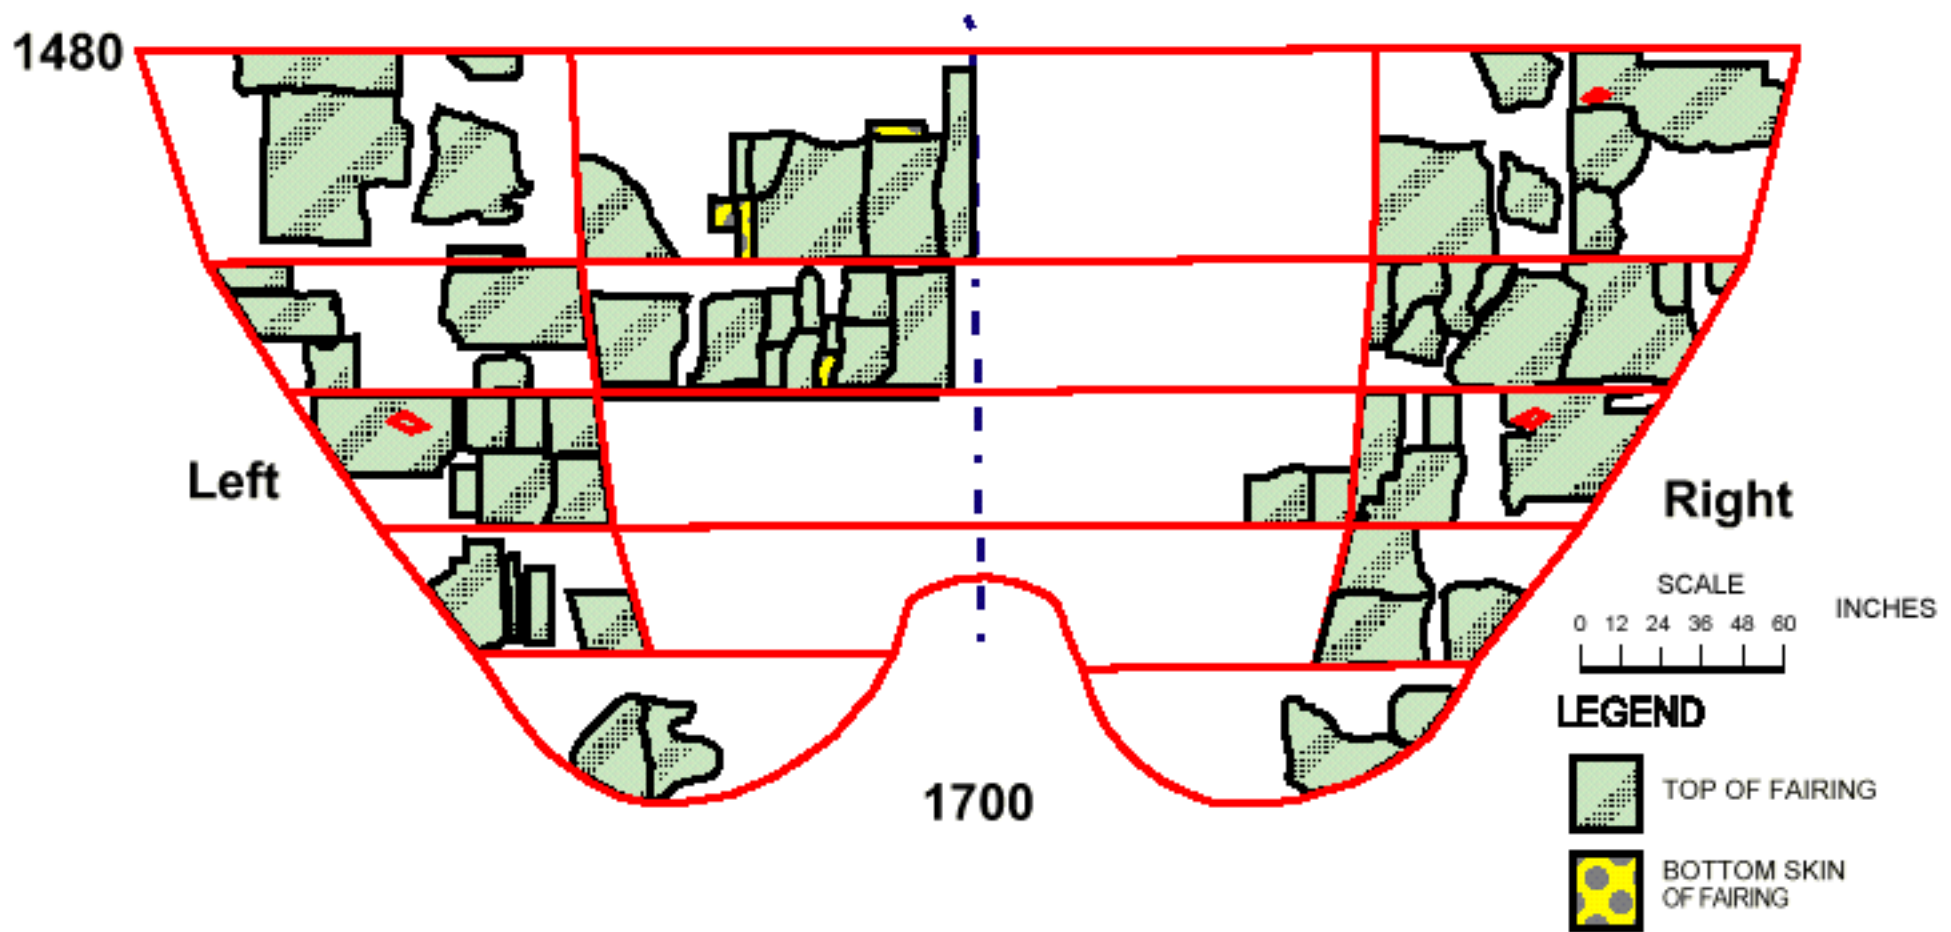
Figure 5 - Fairings from 1480 to 1700

The fairings rearward of the landing gear doors between 1480 and 1700 were placed and documented as shown in figure 5. About 39 percent of these fairings were identified and placed as indicated in spreadsheet 3. The panels between 1480 and 1540 were thicker due to the greater distance

spanned (60 versus 40 inches). Many pieces could be tentatively located into this area, but could not be matched or positively placed as part of the panel. Similarly other thinner parts in the rear compartment areas could not be positively placed.
