**NATIONAL TRANSPORTATION SAFETY BOARD
WASHINGTON, DC.**

**METALLURGY/STRUCTURAL GROUP CHAIRMAN
FACTUAL REPORT
SEQUENCING STUDY
(57 pages)**

METALLURGY / STRUCTURES SEQUENCING STUDY

Place : East Moriches, New York
Date : July 17, 1996
Airplane : Boeing 747-131, N93119
NTSB No. : DCA96-M-A070

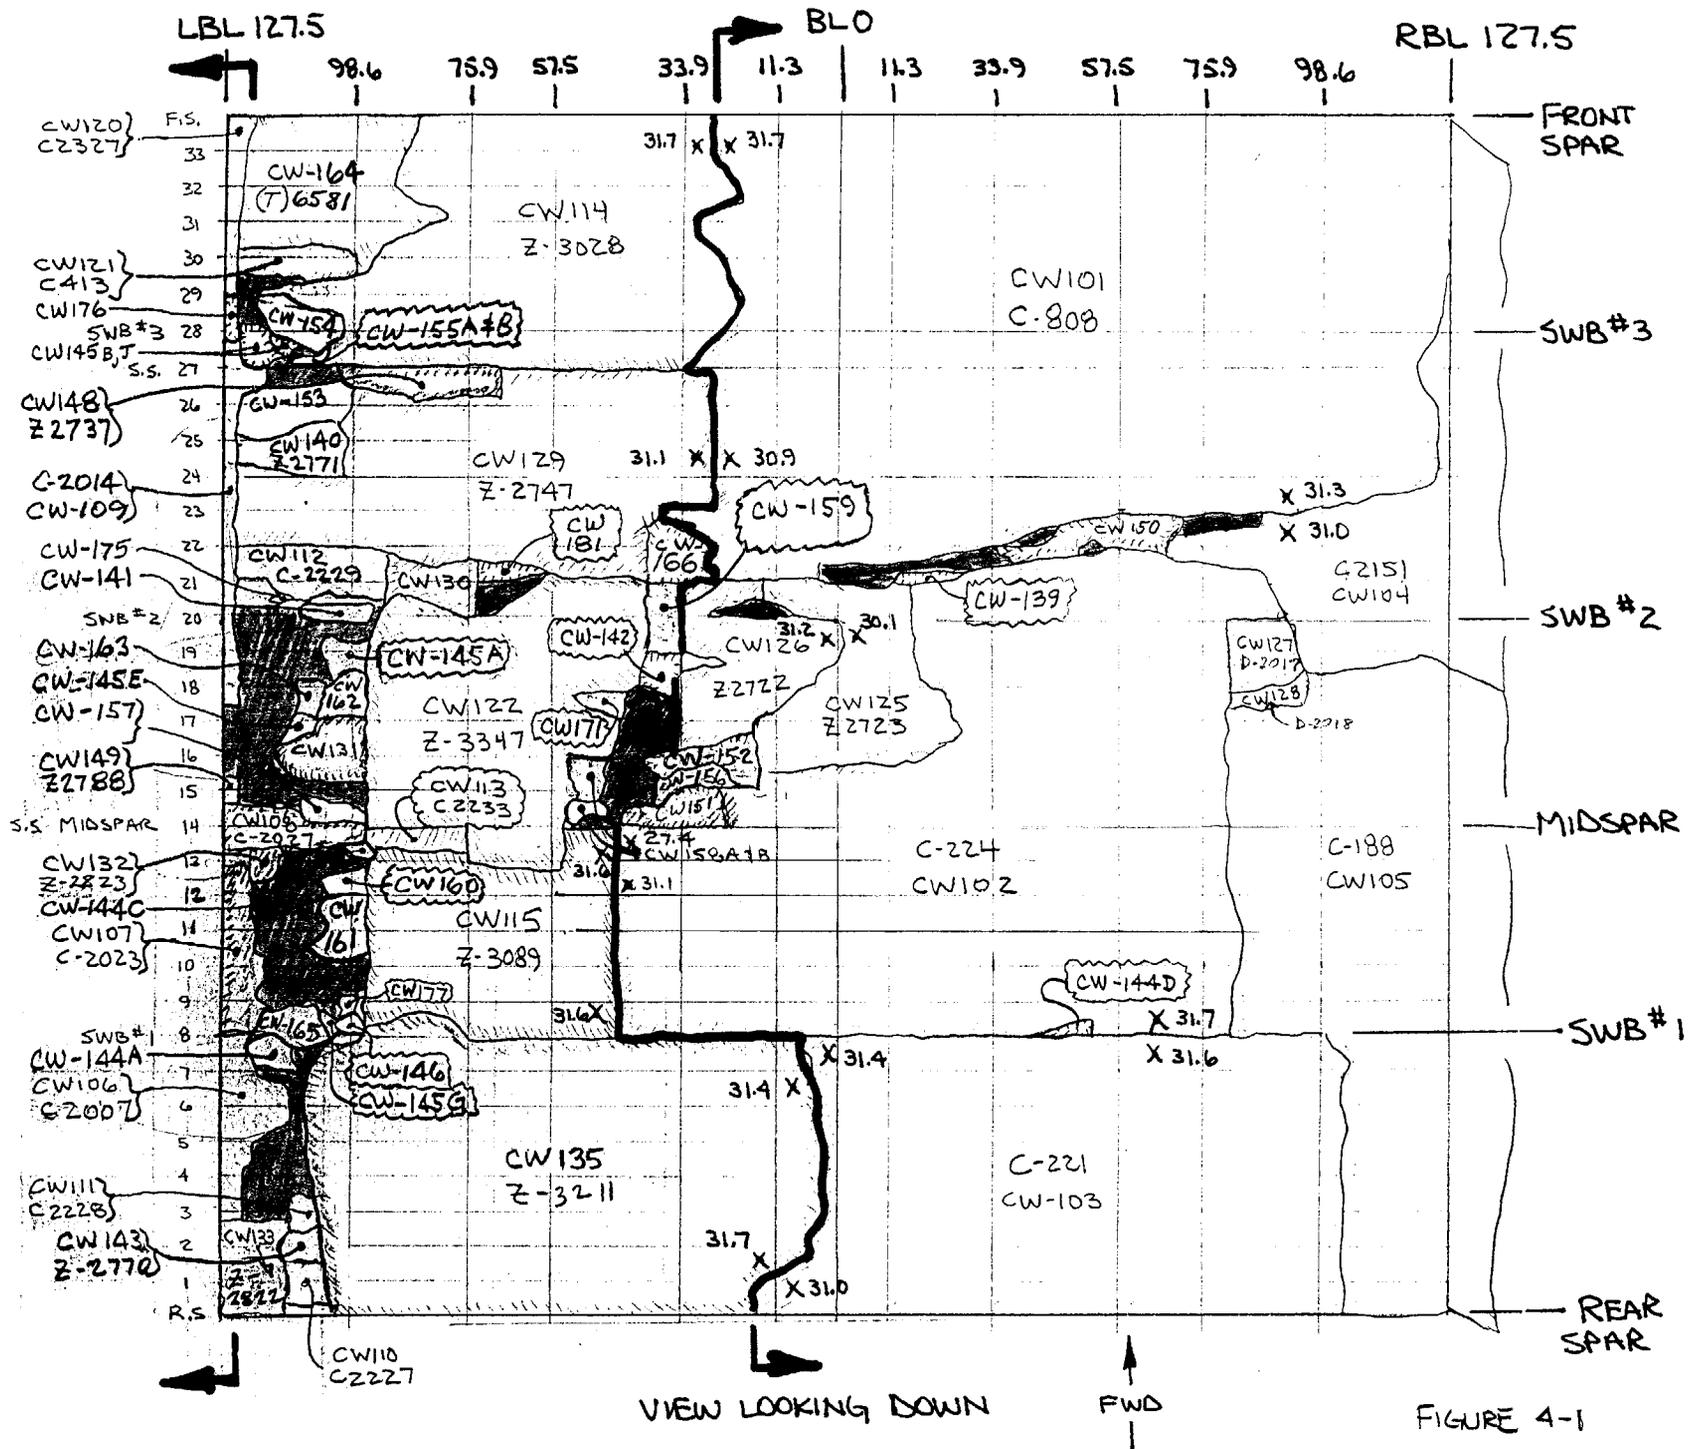
WING CENTER SECTION - UPPER SKIN

The upper skin panel of the WCS is more than 95% recovered and identified with several missing areas on the far left side and two small missing areas in the middle. All identified pieces of the upper panel were found in the green area. However, there are dramatic differences between the left side (clean) and right side (sooted) on both the top and bottom surfaces of this panel. A close examination of sooting on both surfaces and mating fracture faces yields a definition (see figure 4-1) of material departing with the left wing (minimal sooting) versus right wing (fire damage or heavier sooting) at the time of major airplane breakup. Intermediate soot patterns indicate that there is an area of upper panel material between the left side of body and approximately LBL 34 that either separated independently during wing breakup or remained attached to the right wing / aft fuselage for a time after major airplane breakup.

The reconstructed upper panel showed a multiple wave shape, consistent with spanwise compression buckling. In addition, the longitudinal fractures in the upper panel are generally typical of bending (buckling) overstress separations. The longitudinal compression buckling fractures are directly adjacent to the left side of body rib over the aft portion of the upper panel. These fractures and the compression buckling are indications of upward bending loads on the wings at "G" levels beyond the structural capability. Stress analysis (see appendix D) would also indicate that early loss of the front spar and spanwise beam #3 would significantly reduce the ability of the more forward upper panel to carry compression loads but would not initiate overall panel collapse under nominal flight loads.

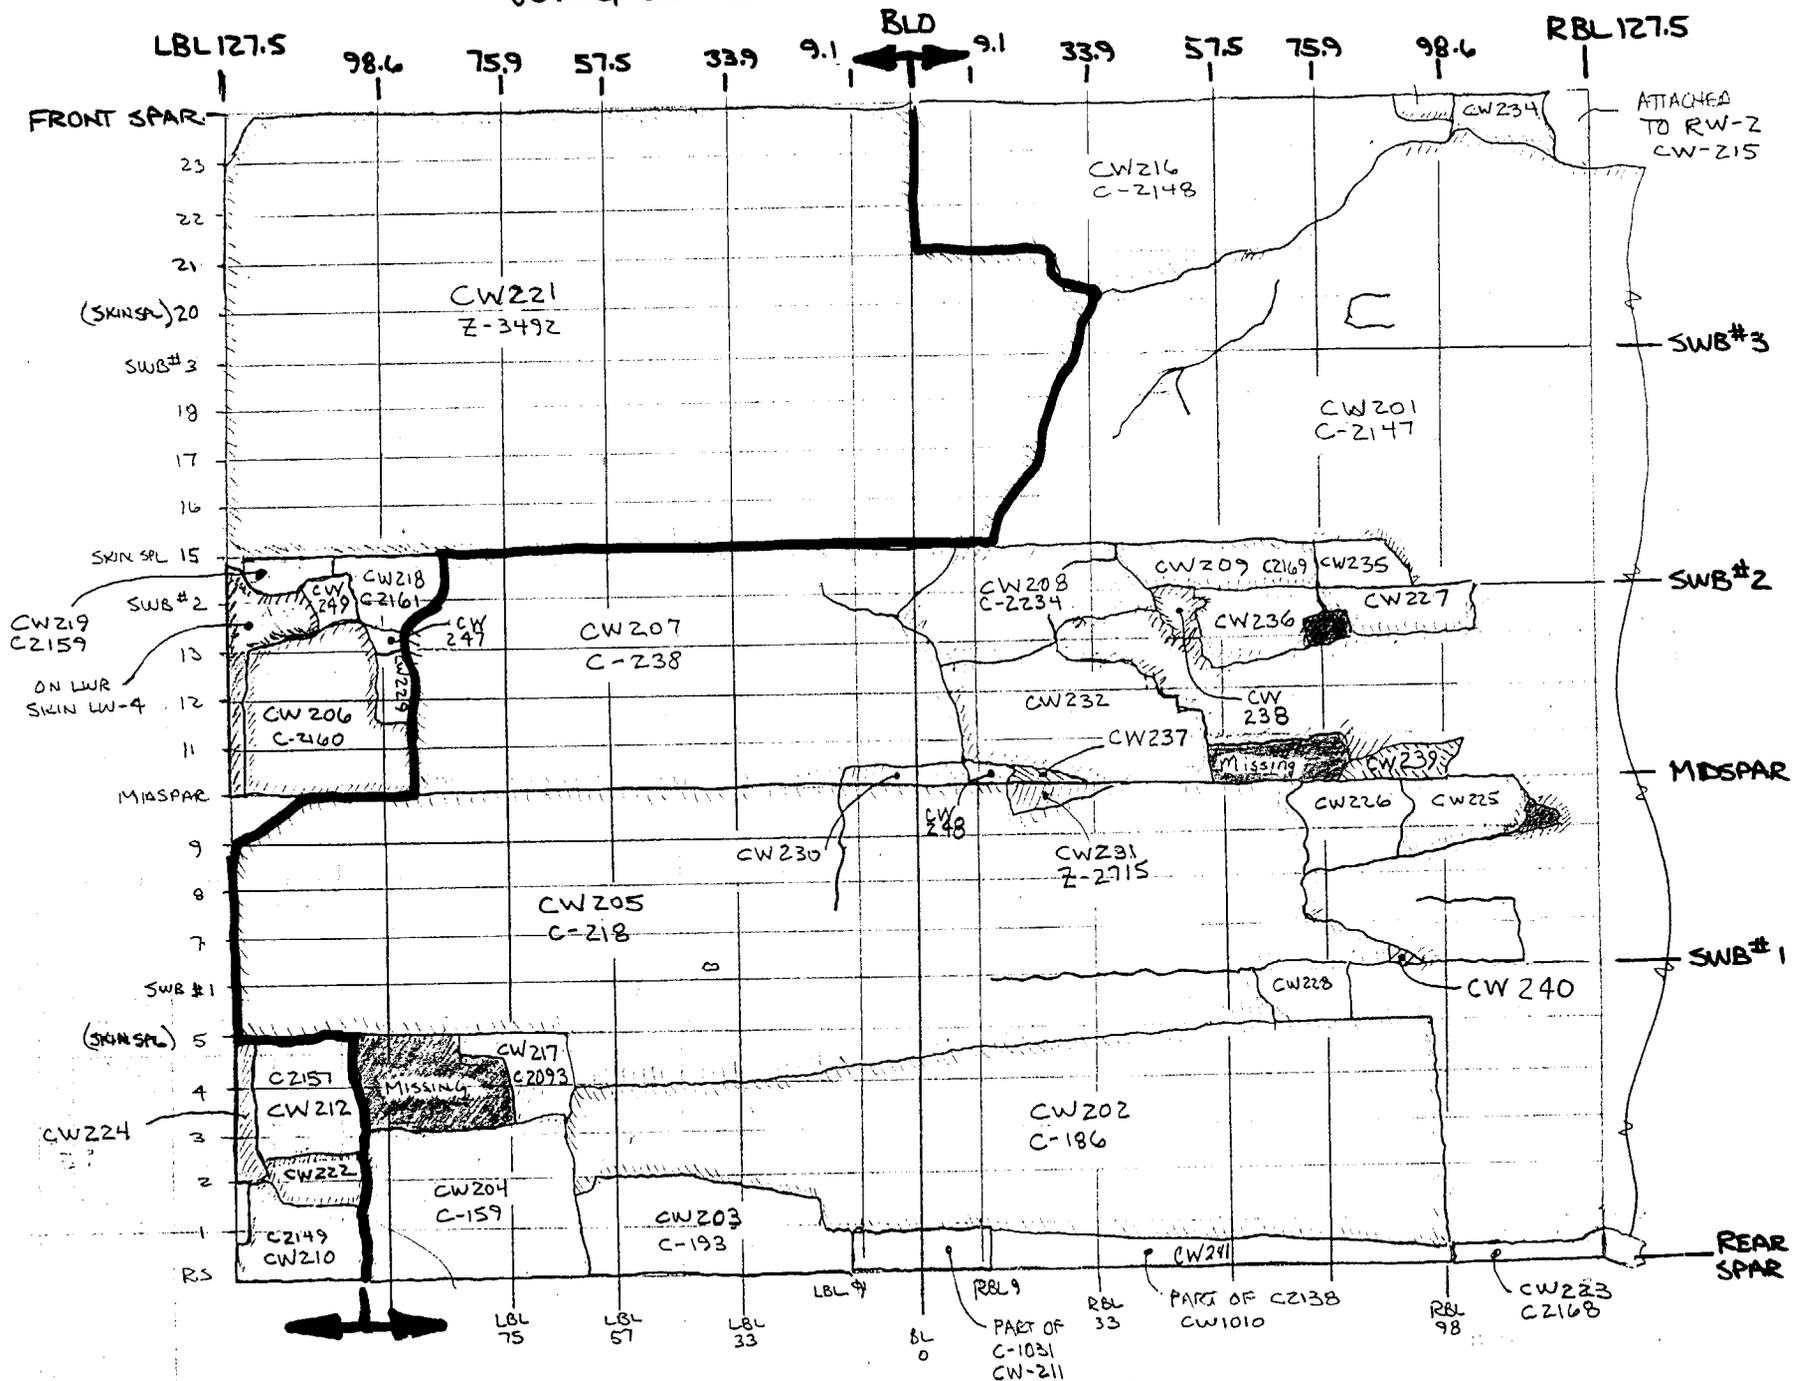
WING CENTER SECTION - LOWER SKIN

The lower skin panel is more than 95% recovered and identified with small missing pieces on the left side and right middle area. The sooting patterns on the lower surface of this panel varies from light to heavy in different areas over essentially the entire lower surface, but with the heaviest accumulation of soot on the right side of the lower surface. The upper surface shows more localized areas of heavy sooting with some areas clean. The soot patterns on the upper and lower surfaces and on the fracture faces also indicate a delineation between material separating with the left wing versus the right wing as shown in figure 4-2. Fracture features along this line of delineation are typical of a tensile and/or bending overstress, also consistent with wing up bending.

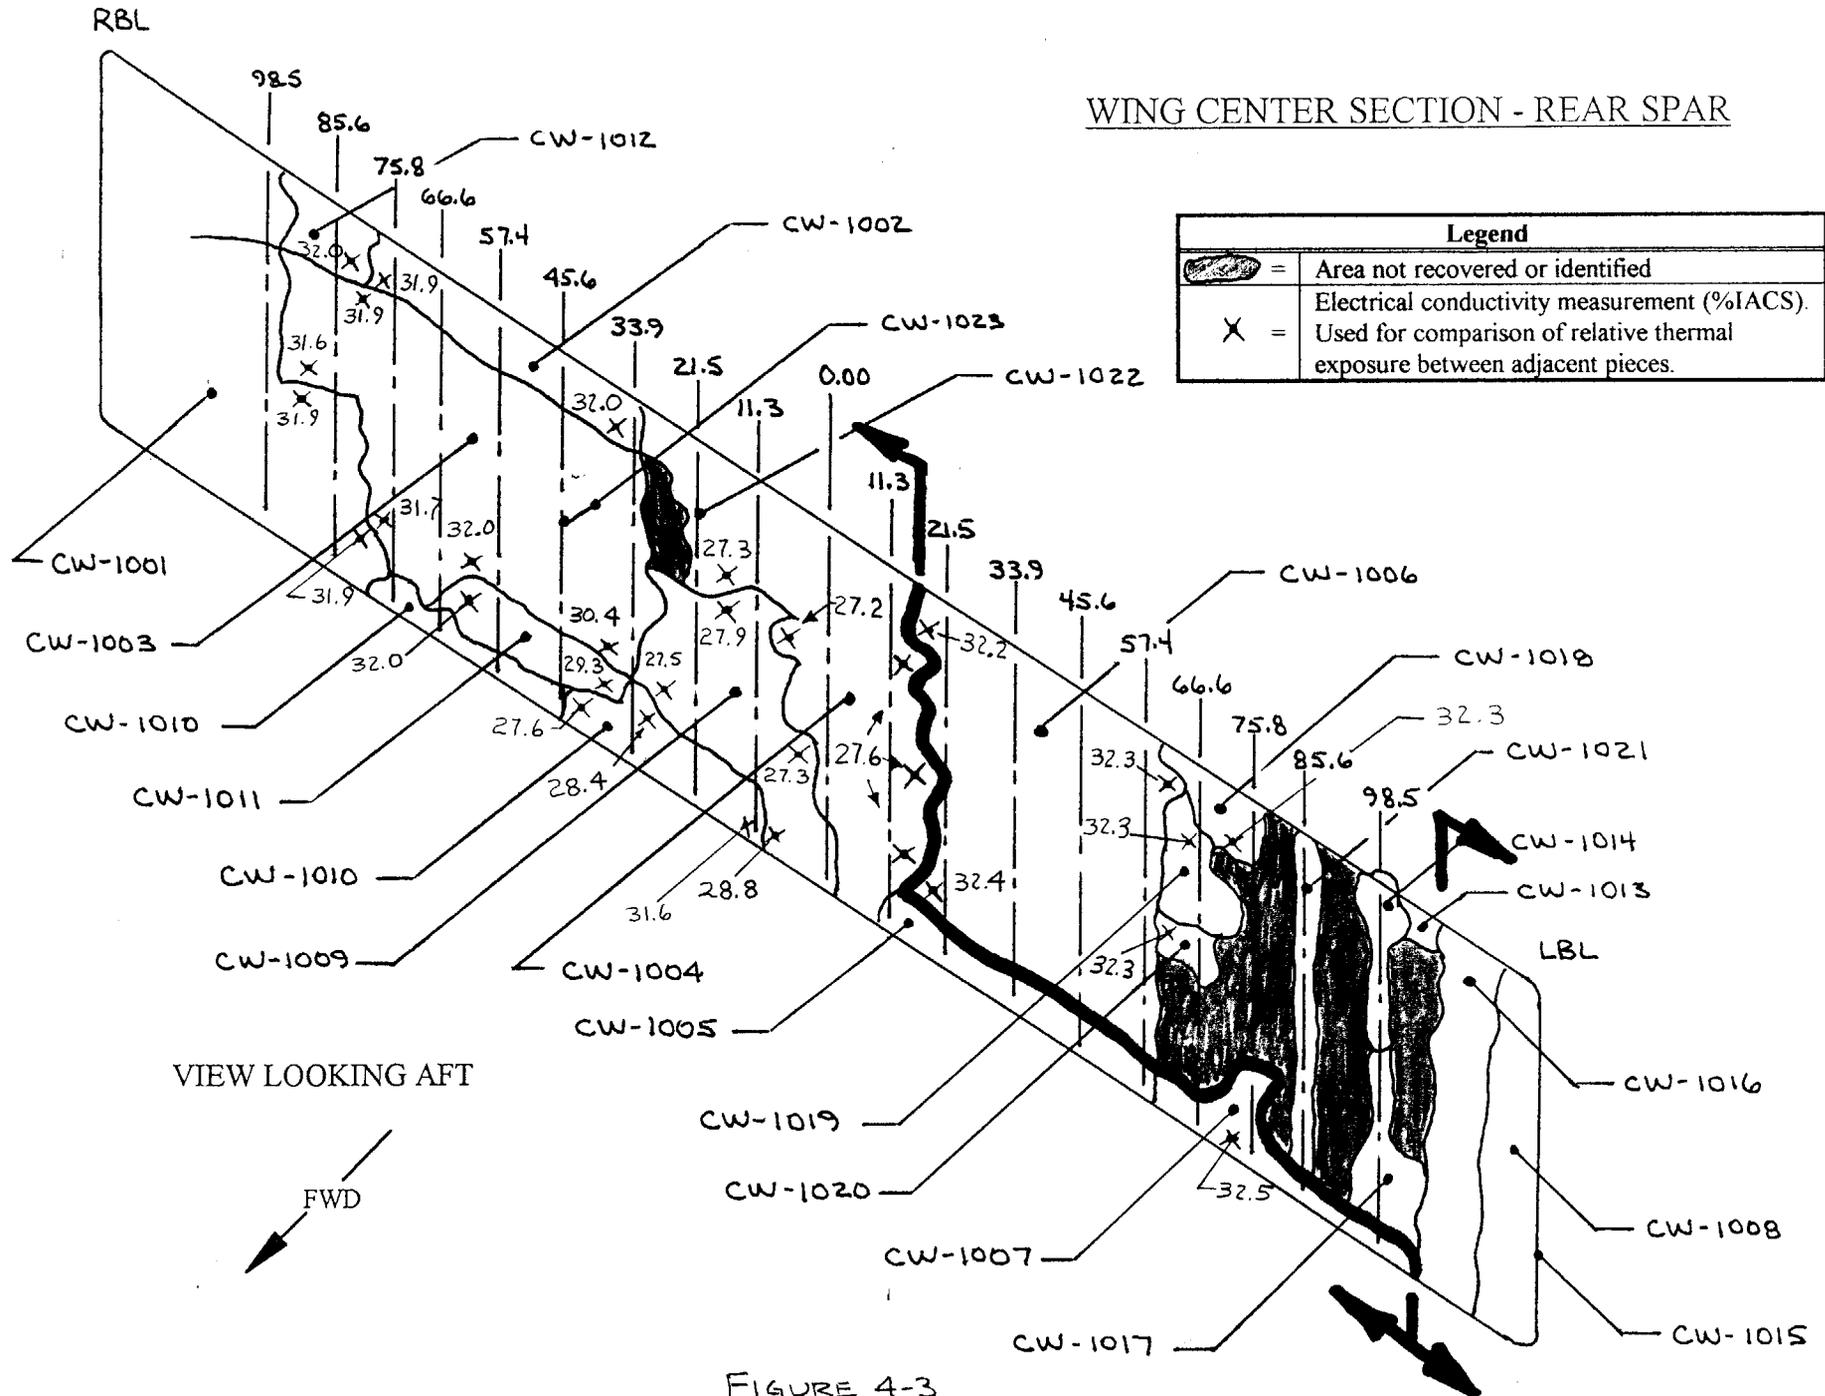
WING CENTER SECTION - REAR SPAR

The rear spar is approximately 90% recovered and identified with missing pieces mostly on the left side (LBL 57 to LBL 98) and a small area on the right (RBL 22 to RBL 33). Both the forward and aft surfaces of the rear spar are sooted to the right of LBL 21 (very heavily between LBL 21 and RBL 63). A review of sooting, fracture morphology, and interface with upper and lower panels indicates that at major airplane breakup, the pickle fork fitting on the left side of the spar remained attached to the left wing, the lower chord and that the spar generally to the right of LBL 21.5 departed with the right wing (see figure 4-3). A portion of the spar between the left side pickle fork fitting and LBL 21.5 either separated independently or remained attached to the right wing/aft fuselage for a period of time. No identifiable indications of damage or sooting prior to major airplane breakup could be documented.

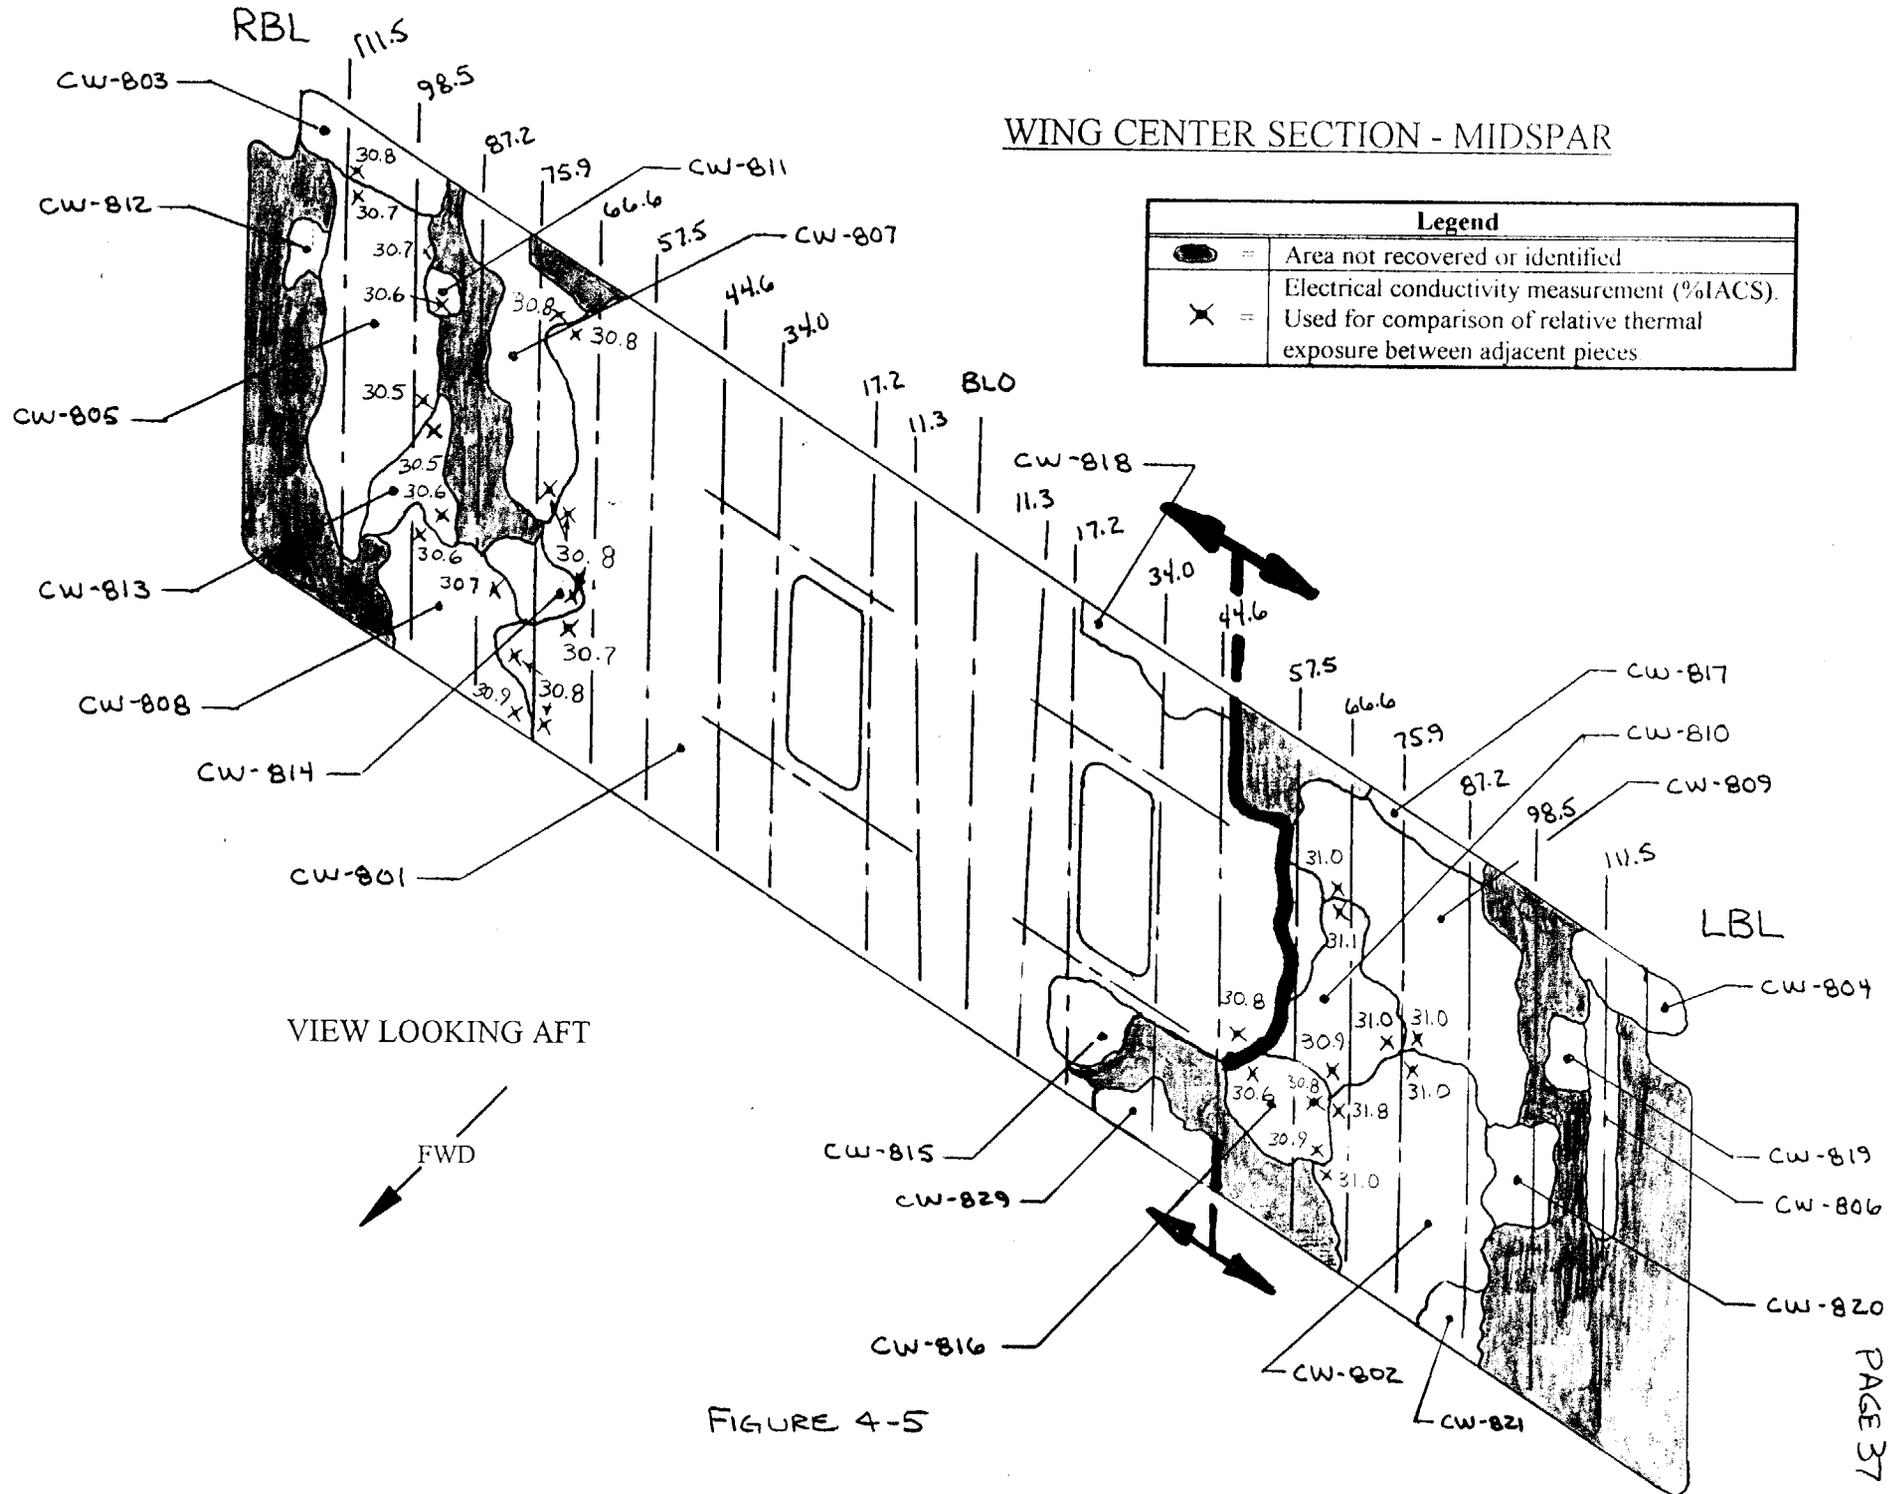
WING CENTER SECTION - MIDSPAR

The midspar is approximately 75% recovered and identified with areas missing on both left and right sides. Sooting (light to heavy) is generally present on the forward surface (RBL 67 to LBL 44) and aft surface (RBL 67 to LBL 98). Sooting of mating fracture faces, crack morphology, and deformation patterns indicate that the midspar failed at LBL 44 consistent with compression buckling during major airplane breakup, with the area to right going with right wing and remainder with the left wing (see figure 4-5). Relatively minor sooting outboard of LBL 44 on the aft surface is another indication of an earlier event involving fire/soot between SWB#1 and midspar (see discussion on SWB#1, section 4.6). The midspar did not contain indications of differential pressure between the forward and aft sides.

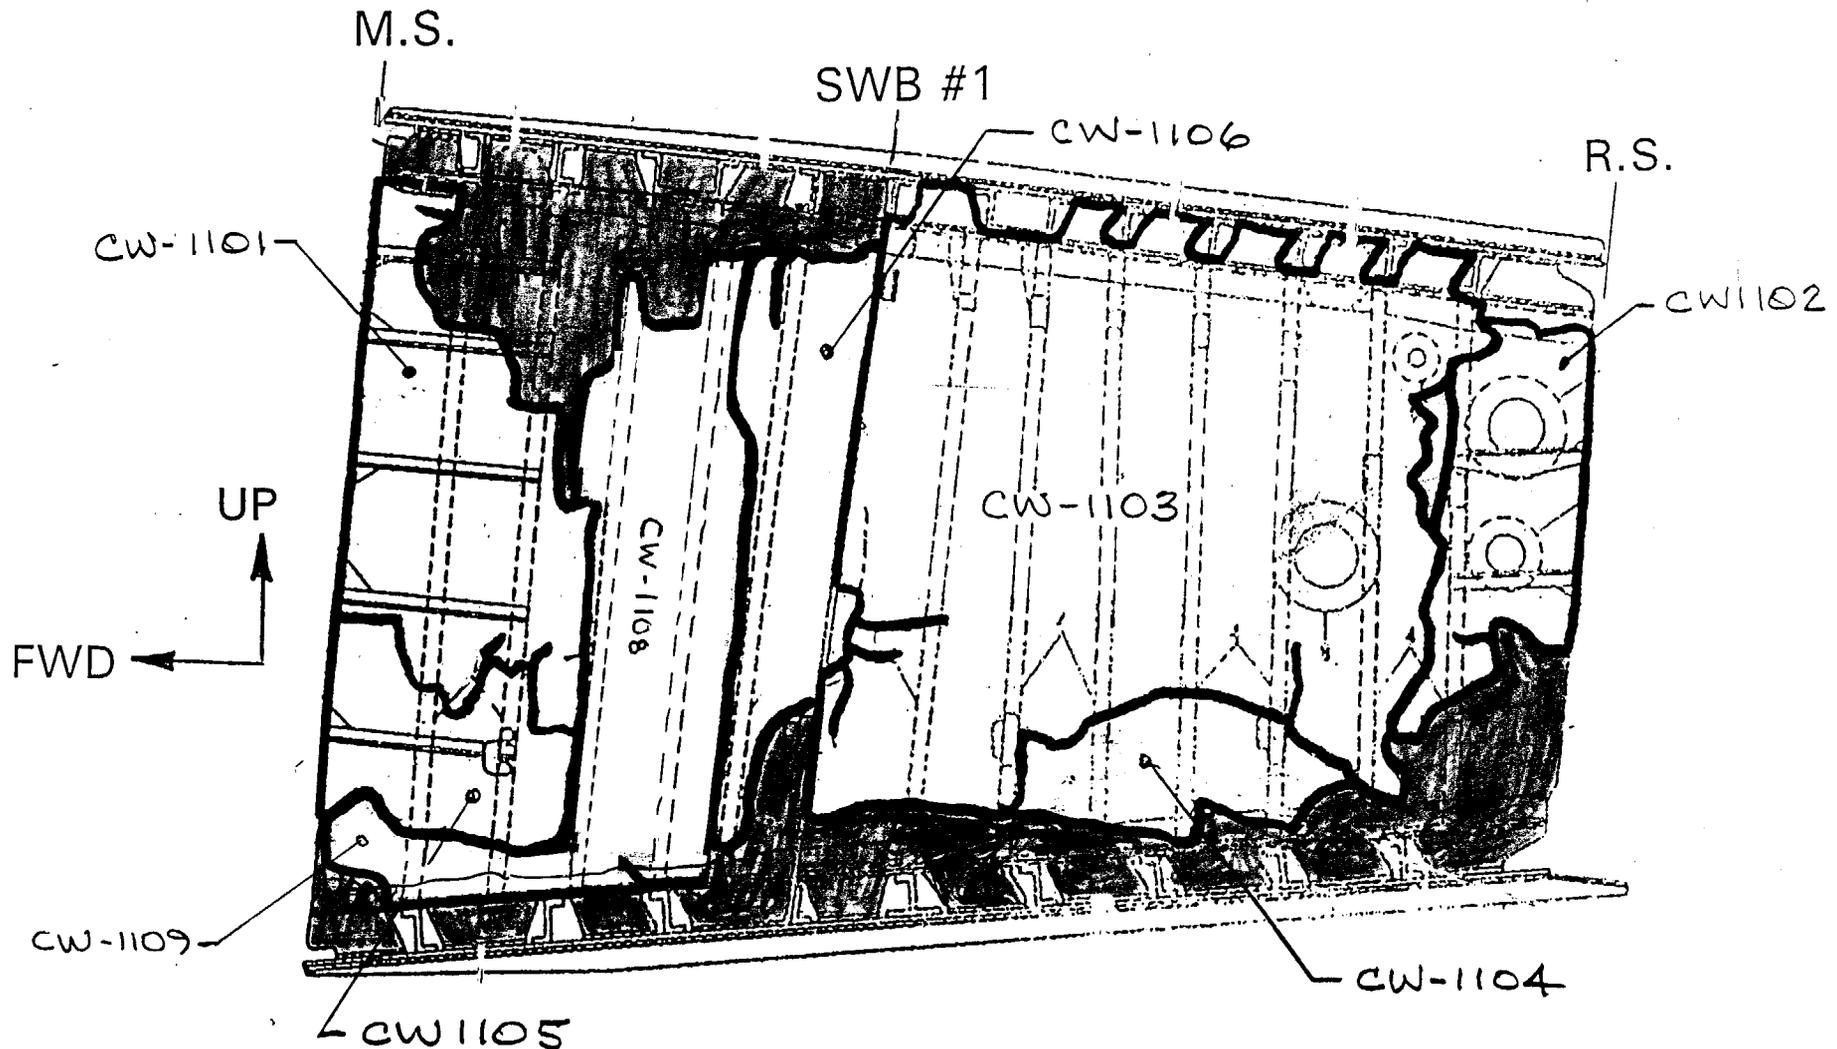
WING CENTER SECTION - BL 0.00 RIB

Approximately 90% of the centerline rib between the rear spar and SWB#1 has been recovered and identified but only 40% of the rib between SWB#1 and midspar (see figure 4-6). The section between rear spar and SWB#1 is heavily sooted on forward, aft, and upper fracture faces. The pieces between SWB#1 and midspar are equally heavily sooted on both the left and right surfaces and most fracture faces. Sooting and the location and features of fractures indicate the centerline rib remained with the right wing at major airplane breakup. Definitive damage or sooting prior to major airplane breakup could not be identified, however see the sections on SWB#1 (section 4.6) and the midspar (section 4.7) for discussion of indications of earlier damage on these components, which may have also related to the centerline rib. There were indications described of an overpressure acting aft on SWB#1 and early presence of fire or soot ahead of SWB#1, either of which might have affected the centerline rib.

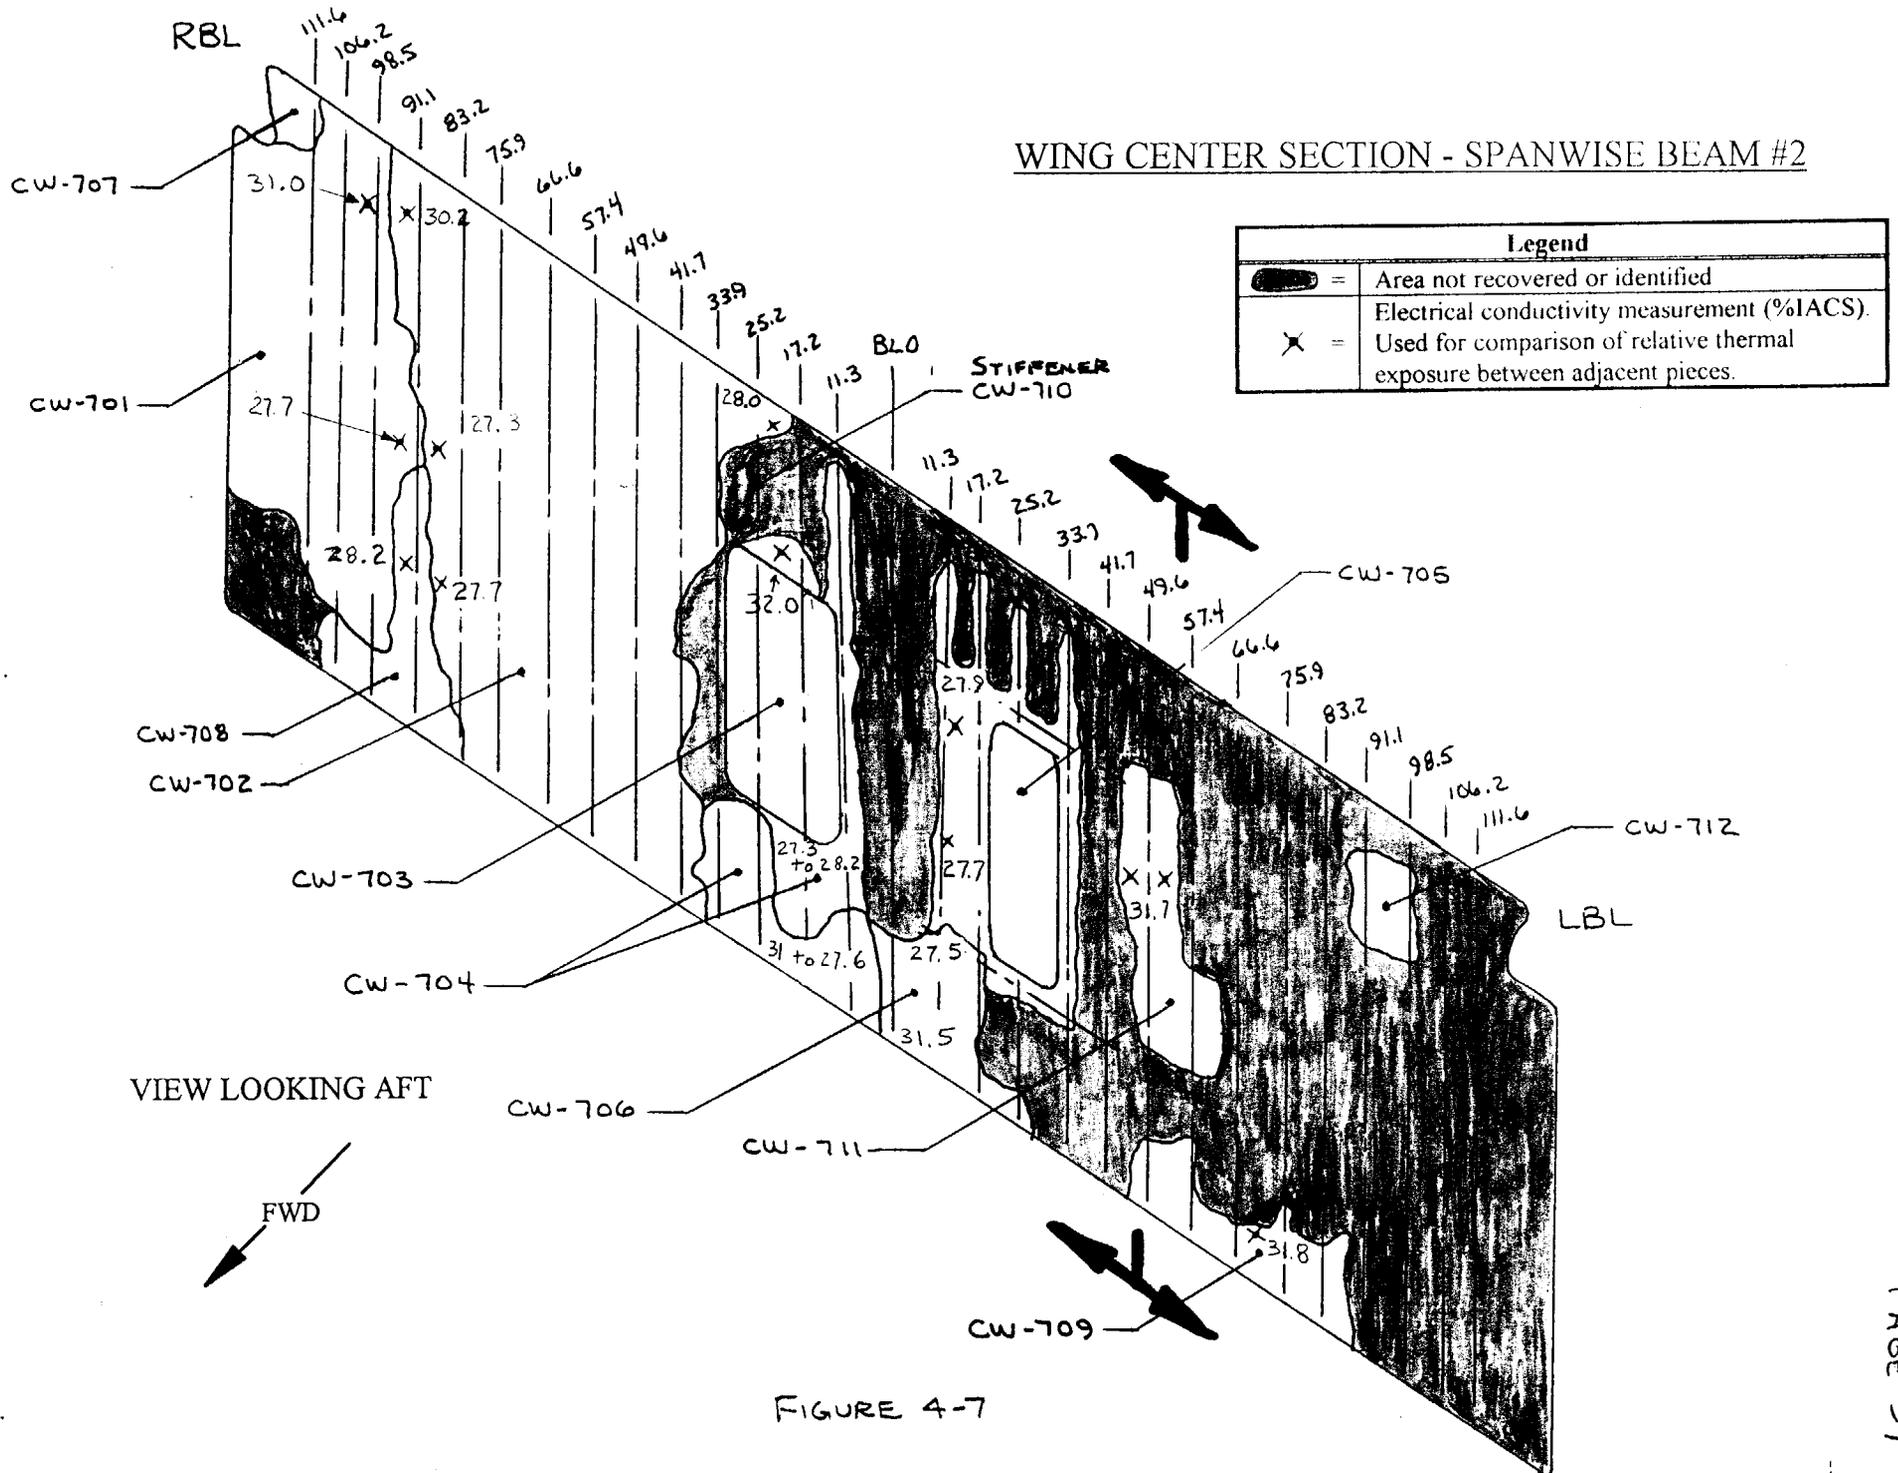
WING CENTER SECTION - SPANWISE BEAM #2

Spanwise beam #2 (SWB#2) is approximately 65% recovered and identified with most of the left side still missing (see figure 4-7). The manufacturing access door and a small attached portion of web above the door were recovered from the red area indicating early departure from the airplane. The door fasteners on the bottom and left (inboard) sides of the door were separated mostly in vertical shear (door along with upper and outboard surround structure moving up and the remaining surround structure moving down relative to each other). The remainder of the door fasteners were fractured in tension by the door peeling forward and

upward, finally tearing out a small portion of the upper web above the door. Witness marks found on the upper panel corresponded to deformation in the lower inboard corner of the door, indicating that the door separated upward with enough velocity to create this damage. Final separation of the door (peeling upward in the forward direction) indicated that the pressure on the aft surface of the door was significantly greater than the pressure on the forward surface of the door at that time. The access door is only lightly sooted, while sooting is moderate to heavy over most of the other pieces of the beam, consistent with much more substantial fire exposure after separation of the access door. The soot patterns indicated that most of the identified pieces of SWB#2 (with the significant exception of the access door) remained attached to the right wing at major airplane breakup.

A large portion of the right side of SWB#2 remained attached to the upper skin panel. Soot patterns indicate that the lower chord remained attached to the web until water impact but was separated from the lower skin panel before major fire exposure. In general, the features on the right side of the beam indicated that this entire portion of the beam remained largely intact but had separated from the lower panel before fire exposure. Recontact damage and separation of the web from the lower chord occurred after fire exposure.

The right side of SWB#2 also contained “accordion” damage (folding directly inboard) from forces acting in the inboard direction on the outboard end of the beam. No soot accumulation occurred after the deformation was created (see appendix B).
