**NATIONAL TRANSPORTATION SAFETY BOARD
WASHINGTON, DC.**

**METALLURGY/STRUCTURAL GROUP CHAIRMAN
FACTUAL REPORT
SEQUENCING STUDY
(57 pages)**

METALLURGY / STRUCTURES SEQUENCING STUDY

Place : East Moriches, New York
Date : July 17, 1996
Airplane : Boeing 747-131, N93119
NTSB No. : DCA96-M-A070

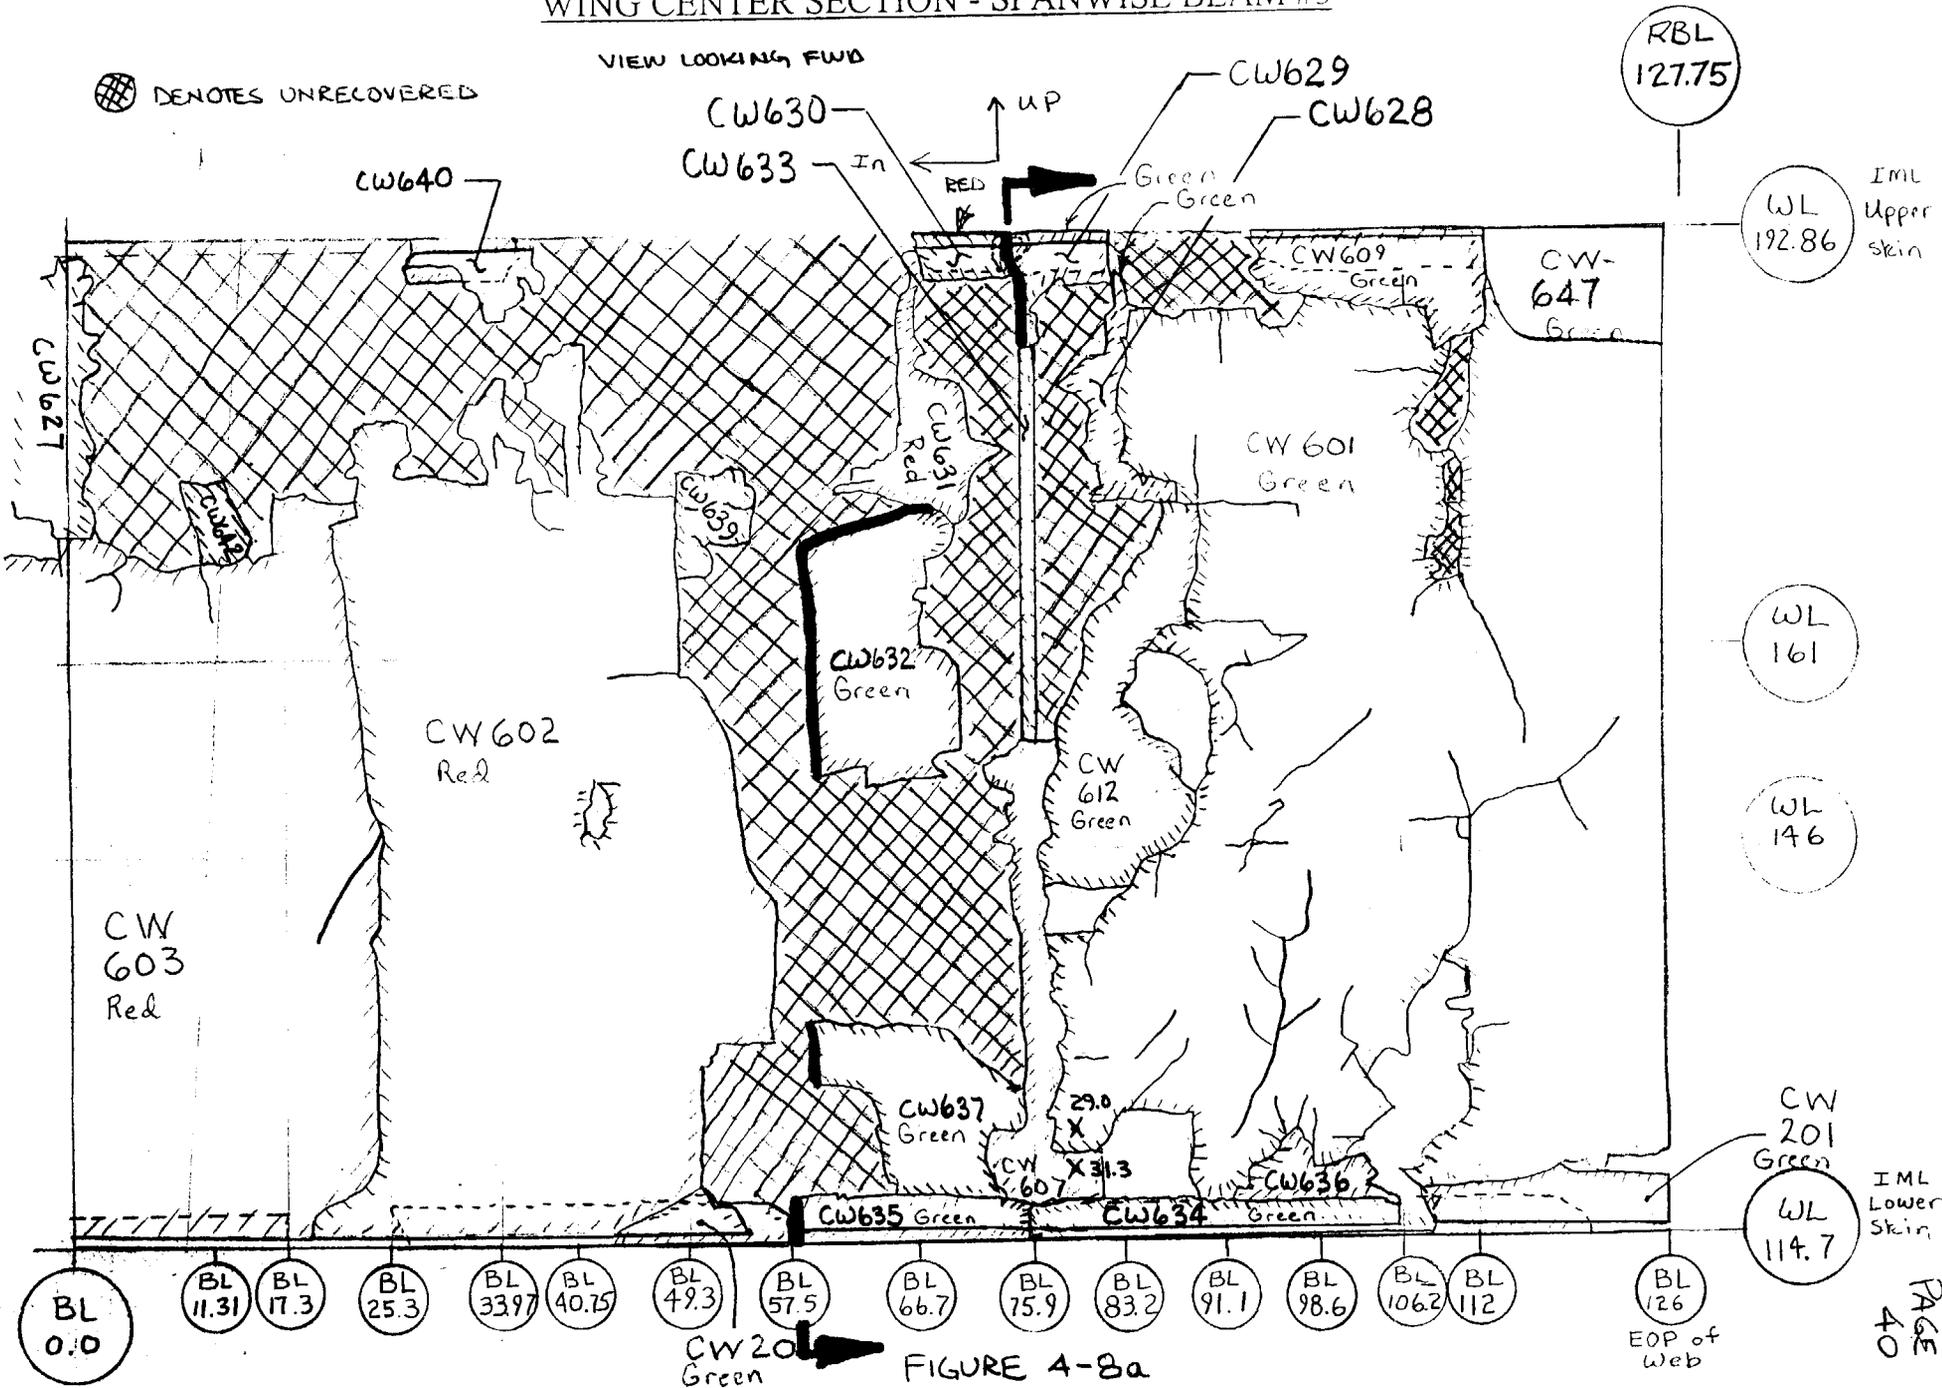
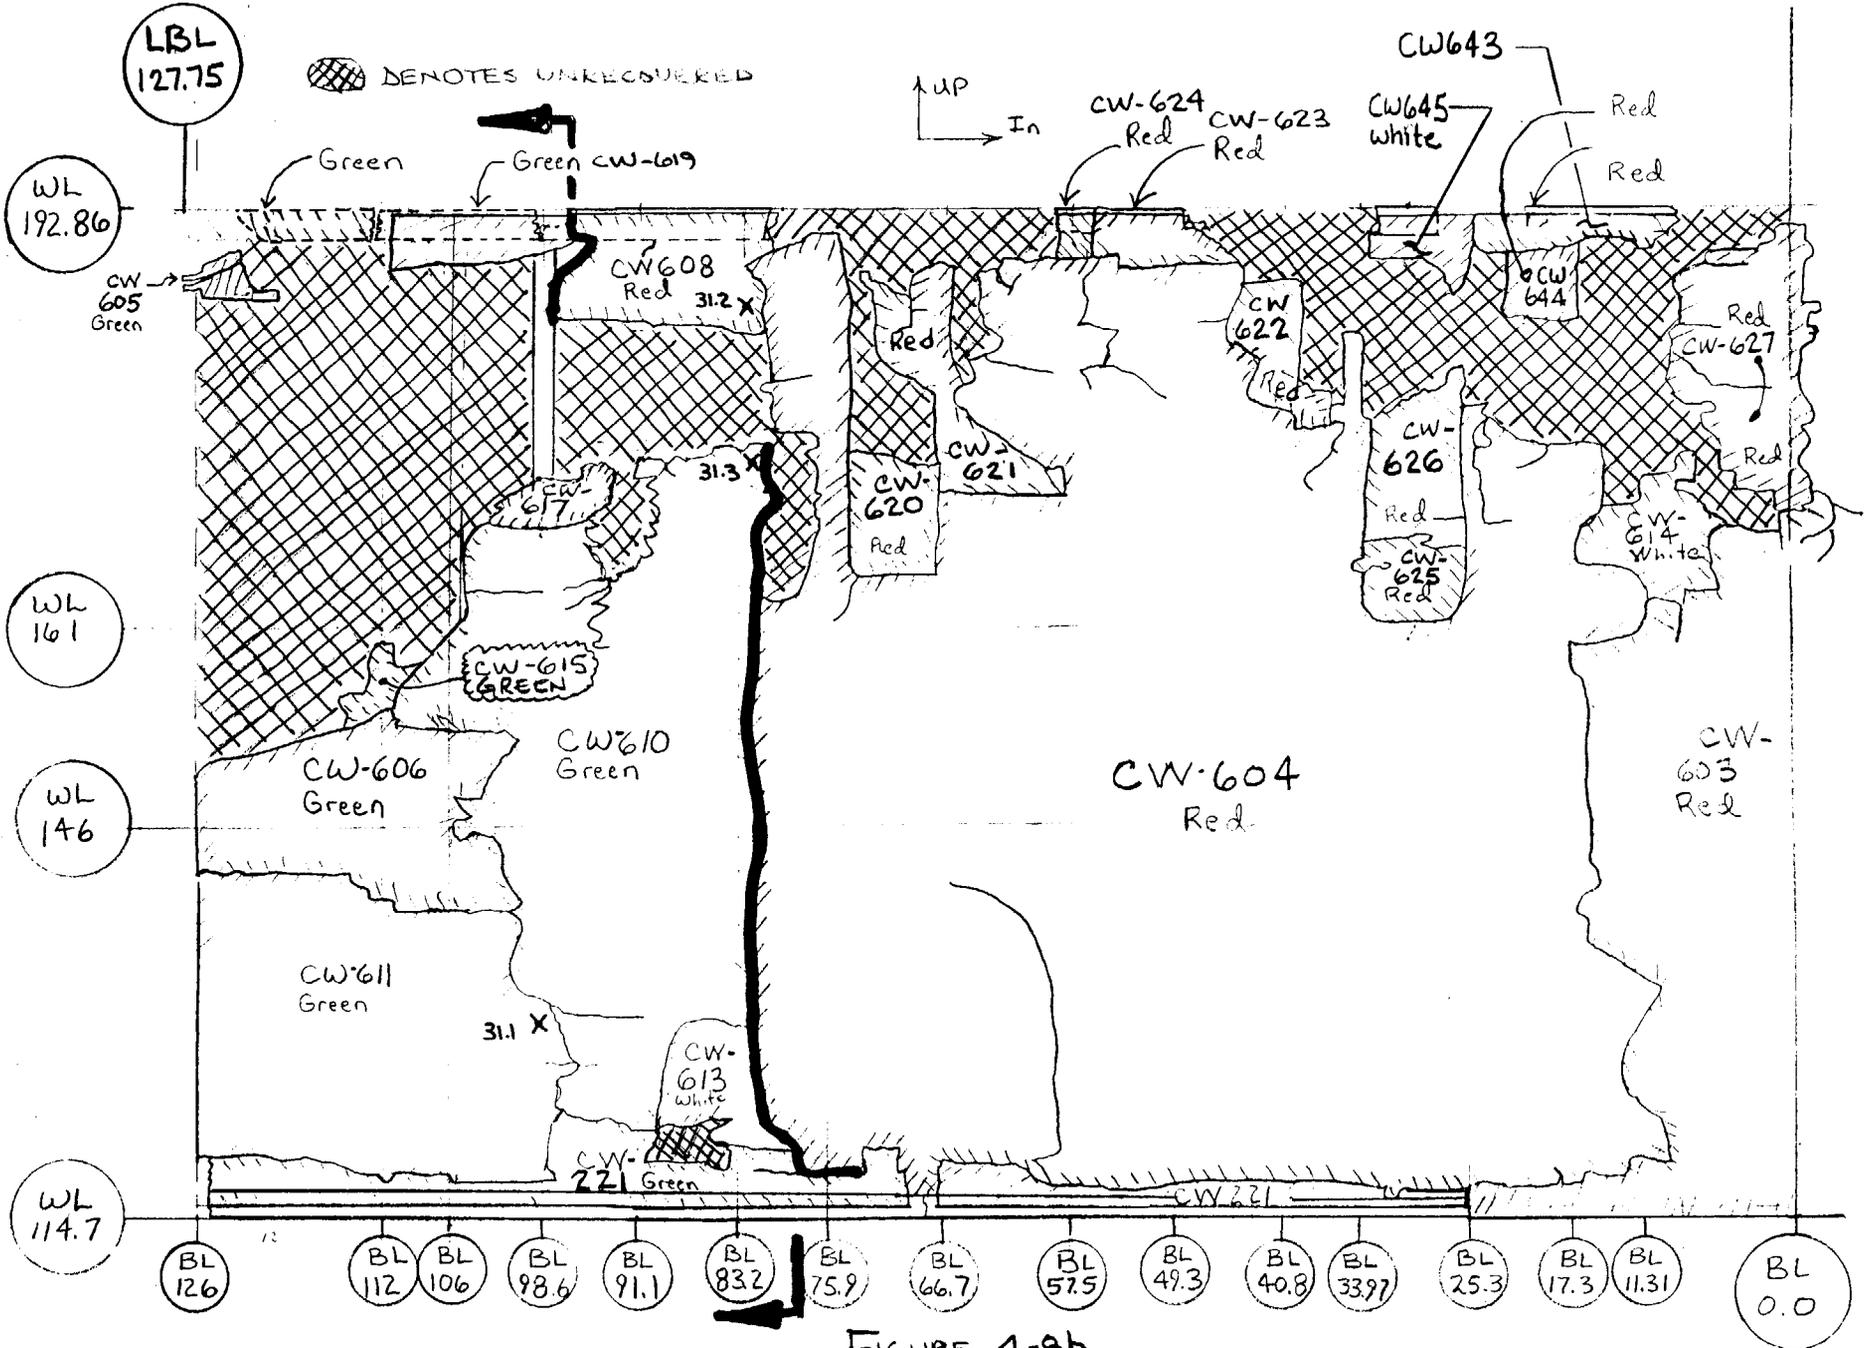
FIGURE 4-8b

Spanwise beam #3 (SWB#3) is approximately 85% recovered with most of the missing area located between RBL 50 and RBL 90 (see figure 4-8). Pieces of the beam between approximately RBL 50 and LBL 80 were recovered from the red area indicating relatively early departure from the airplane. The part of SWB#3 from RBL 87 to right side-of-body is heavily sooted (burn damage) on both surfaces as well as most fracture faces. The pieces recovered from the red area are generally lightly sooted on both faces with occasionally more sooting on the front face. The pieces between LBL 80 and the left side-of-body (green area) are moderately sooted. Piece CW611 (adjacent to the left side-of-body) exhibits soot tails above the protruding fastener heads on the front surface. During major airplane breakup the pieces outboard of LBL 80 went with left wing and the pieces outboard of RBL 75 with right wing. The sooting on the aft surface on the left side and on red area pieces is indicative of an earlier event. Larger amounts of soot accumulation and fire damage on the right wing pieces indicate that this portion of the structure

was involved in a later major fire. The soot and fire damage associated with the later major fire masked any possible features that may have been associated with a possible earlier fire affecting the pieces of SWB#3 to the right of RBL 57.5.

The upper chord for SWB#3 was fractured through the fillet radius between the vertical leg and the upper horizontal leg of the chord. The upper chord fracture initiated at multiple locations and progressed essentially the full width of the beam.

Initial forward rotation of the upper portion of SWB#3 caused the upper chord of this beam to impact the aft face of the vertical portion of stringer 29, located 6 inches in front of SWB#3. This stringer also has a “Z” shape, with the upper horizontal leg pointing aft and the lower horizontal leg pointing forward. The upper horizontal leg of stringer 29 remained attached to the upper skin over most of the width of the WCS. The vertical leg had separated from the upper horizontal leg at the fillet radius. Only three pieces of the vertical leg of stringer 29 have been identified to date. These pieces extended from LBL 50 to RBL 36 and from RBL 55 to RBL 104. Except for small pieces attached to the vertical portion, no pieces of the lower horizontal leg were identified.

Vertical fractures through SWB#3 were found at various locations including near the respective sides-of-body. These fractures are also consistent with a forward acting overpressure on the aft surface of SWB#3. Separation of the top of the SWB#3 allowed the segments to rotate forward about the lower intercostals (or, in the case of the center segment, about the beam's lower chord) until the top of the beam impacted the stiffeners on the aft surface of the front spar approximately 12" below the upper skin panel. The impact broke off parts of the upper web and stiffeners of SWB#3. The remaining lower portion of SWB#3 continued rotating forward and down with upper stiffener ends tearing vertical holes in the front spar web at various locations down to about 1 to 2 feet from the lower panel.

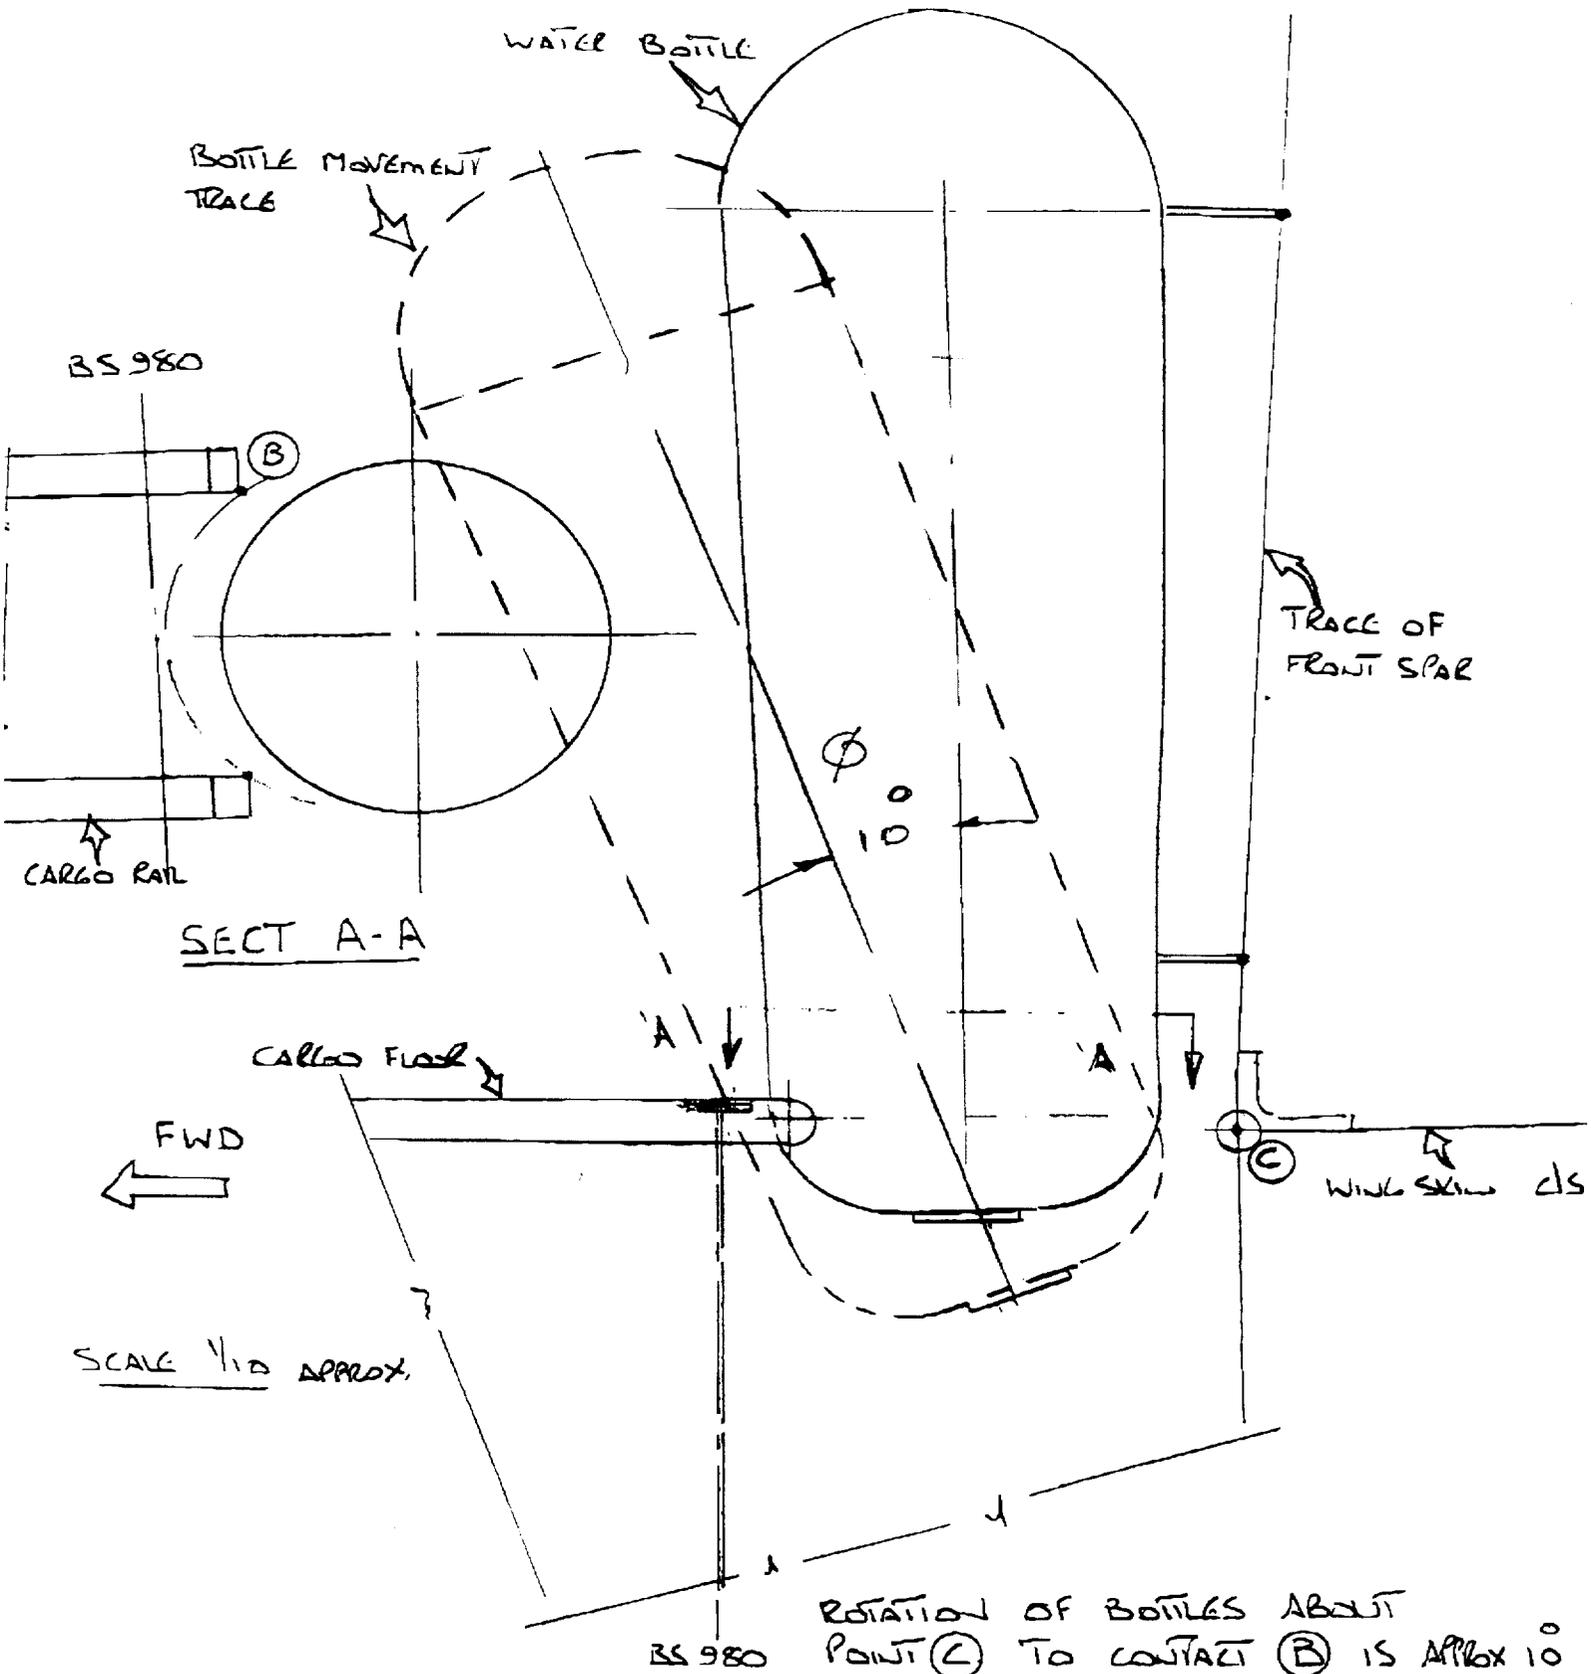
FIGURE 4-10

As discussed in section 4.10, SWB#3 rotated forward impacting the vertical stiffeners on the aft surface of the front spar. The impact, along with possible overpressure from behind SWB#3 fractured the front spar upper chord in the radius between the horizontal and vertical legs of the chord. The horizontal leg of the chord remained attached to the upper skin panel, and the vertical leg remained attached to the web of the front spar. Continued forward and downward rotation of SWB#3 tore holes in the front spar web, at various locations down to about 1 to 2 feet from the lower panel. Geometric layouts (see Appendix B) indicate that SWB#3 probably rotated almost fully forward and down prior to full rotation of the front spar about its connection to the WCS lower panel. The potable water bottles (centered on the front surface of the front spar) sustained relatively minor damage on their aft sides from impact with pieces of SWB#3. The forward side of the right bottle contained impact marks and fractures roughly corresponding to cargo floor structure. A geometric layout indicates that only about 10 degrees of rotation of the front spar would be needed to force contact between the bottles and the cargo floor structure (see figure 4-10).

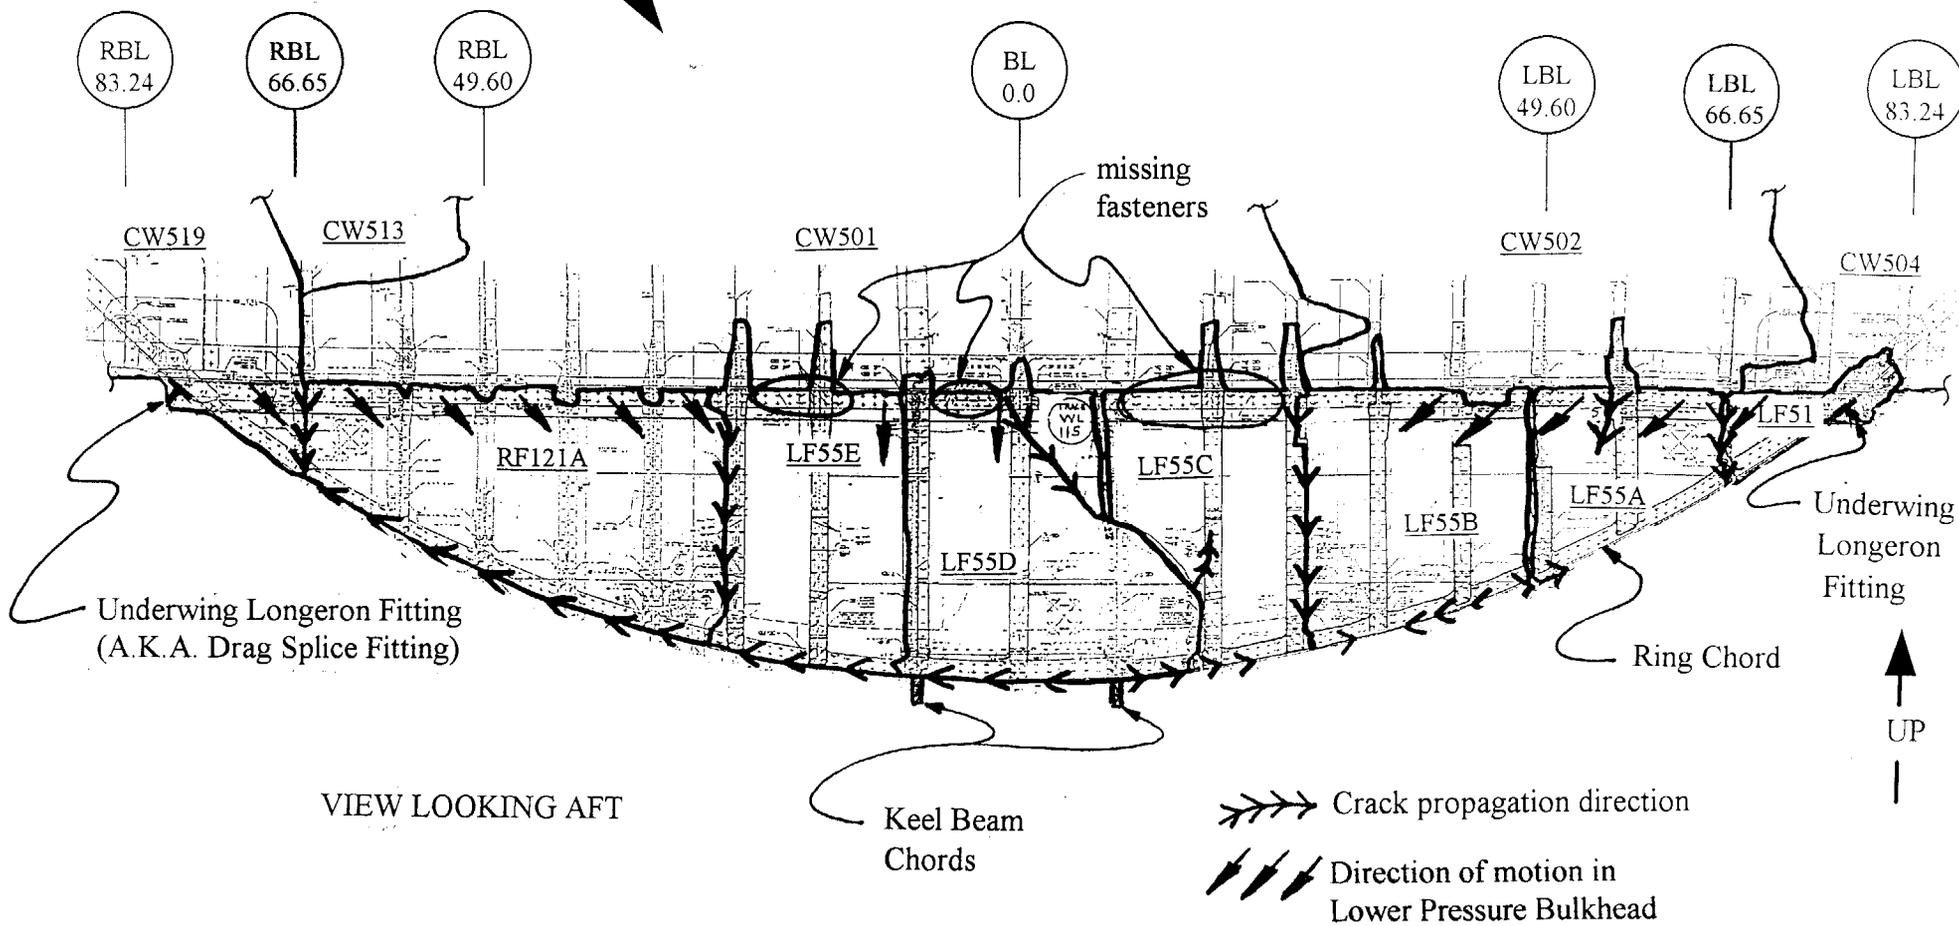
FIGURE 4-11

adjacent fittings stayed with the airplane and were recovered from the green area. The aft surface of the lower pressure bulkhead pieces to the left of the keel beam had soot deposits, especially on the upper edges of protruding head fasteners and on other protruding objects. Some soot was also noted on the aft surface of the bulkhead to the right of the keel beam. Crack propagation directions have been identified and documented on Figure 4-11.

At RBL 66, LBL 26, and LBL 66 web cracks propagated down from the front spar web and reinitiated downward in the lower pressure bulkhead with eventual associated axial fracture of the ring chord. There are additional lower bulkhead fractures at RBL 9 and LBL 9 which are close to the keel beam interface. There is an additional vertical web crack at LBL 49 which is associated with the separation of piece LF55A. The stiffeners “splicing” webs of the front spar and lower bulkhead are uniformly buckled in the free flange consistent with the motion of the front spar rotating forward. The stiffener at LBL18 is not bent forward as far as the others indicating limited forward rotation of the front spar in this area prior to ring chord separation at the bottom of the stiffener. The fasteners common to the splice between the webs of the front spar and lower pressure bulkhead are consistently (left and right sides, BL26 to BL75) separated in shear with the lower web being pulled downward and somewhat inboard.

There are two bathtub fittings nested in the ring chord above the underwing longeron. These joints have fractured in a tension/bending mode consistent with the fuselage skin panels forward of the fittings rotating outward about the ring chord, applying a bending moment which is reacted between these fittings (tension) and the longeron fitting. The bathtub fittings appear to have separated first then the longeron joint in a manner consistent with being overloaded by the same bending moment.

The keel beam lower chords are spliced just ahead of the lower pressure bulkhead to the keel beam runout in the forward body. Each keel chord extension tang is fractured identically in a down bending mode (i.e. body panel with keel runouts rotating downward relative to the main keel beam aft of the front spar).

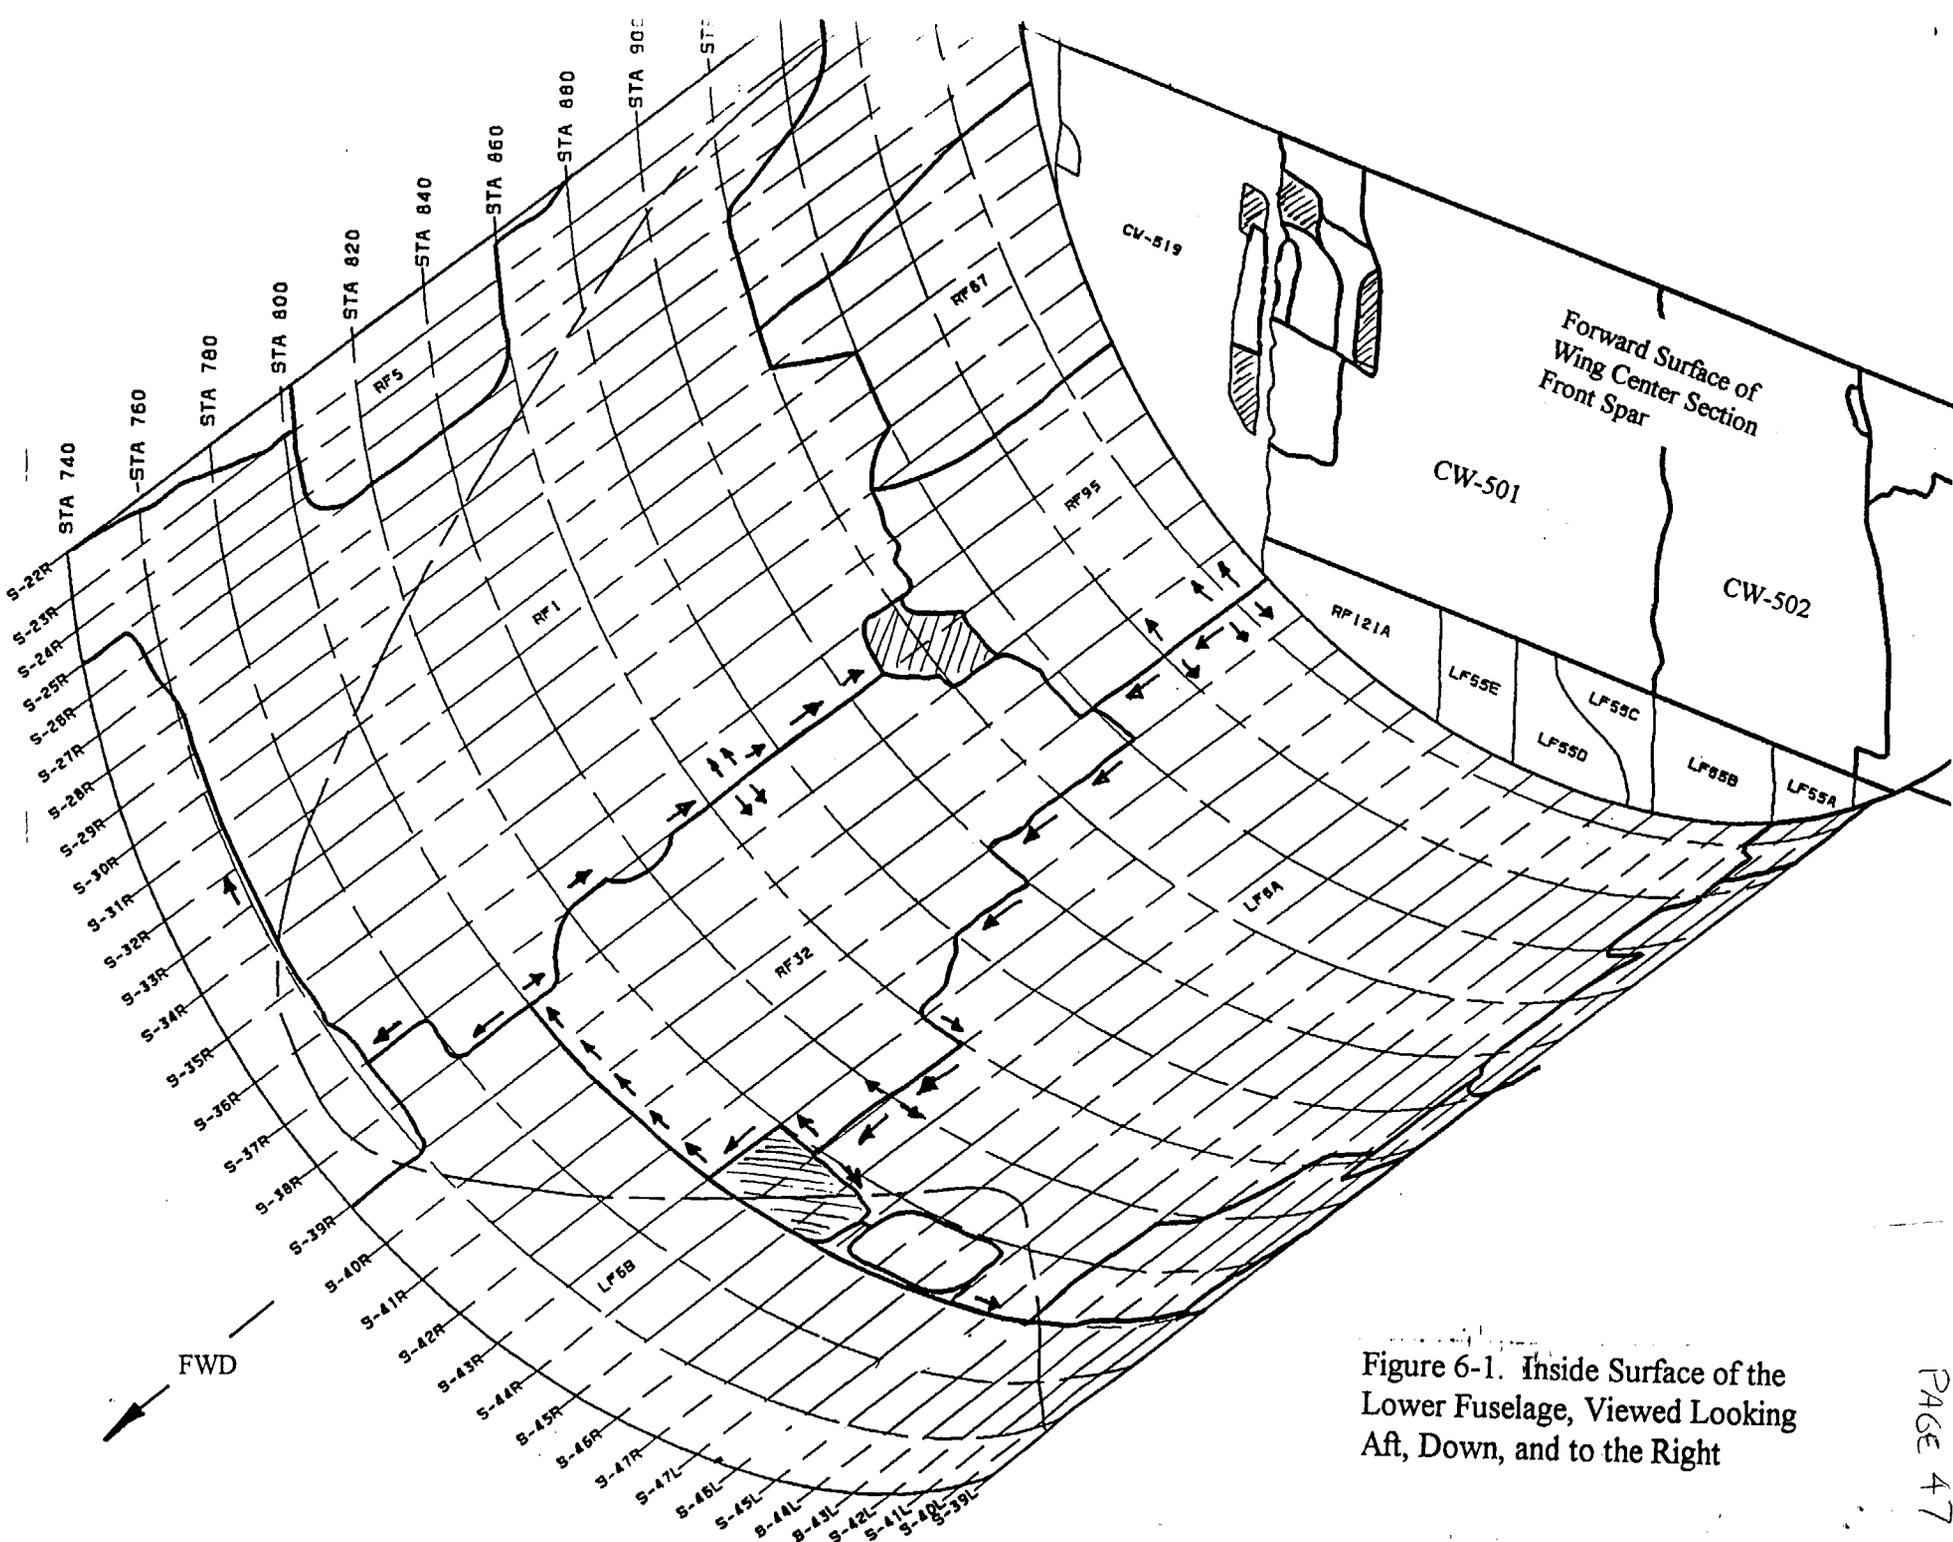
Figure 6-1. Inside Surface of the Lower Fuselage, Viewed Looking Aft, Down, and to the Right

Figures 6-1 and 6-2 are two drawings of oblique views looking aft and either left or right at the internal surface of the aft end of the forward cargo compartment and the forward surface of the front spar of the wing center section. The stringers and frames are labeled only as linear positions on the drawings. The major pieces are labeled with their investigation data base numbers. Heavier lines on the drawing indicate the locations of fractures in the fuselage skin between the pieces from this area.

The red area pieces on the bottom and right sides of the fuselage structure (pieces LF6A, RF32, and RF1) were relatively undeformed, with most frames and stringers remaining attached to the skin. Between LF6A and LF5 were a series of red area pieces (LF24A, LF24B, and LF95) from which all of the frames and many of the stringers had separated. The stringers and frames were retained on piece LF5, and the frames and stringers on this piece extended downward below the lower edge of the skin on this piece, into the area where the fuselage skin was missing or not identified.

All of the fuselage skin fractures on the pieces from the areas shown in figures 6-1 and 6-2 were examined in detail. No evidence of fractures originating from pre-existing fatigue or corrosion damage was found. Some of the skin fractures progressed along a row of rivets, either longitudinally along a stringer or lap joint, or circumferentially along a frame attachment location. Others were in the skin away from a row of rivets. None of the fuselage pieces from below the window belt in this area contained signs of longitudinal compression buckling. Fractures that were along a row of rivet holes and were consistent with in-plane⁴ loading (hoop or longitudinal tension with the possible presence of in-plane shear) were sequenced as occurring before fractures bending or out-of-plane shear deformation. Three types of earlier fractures were identified:

Unlabeled arrowheads oriented parallel to skin fracture locations in figures 6-1 and 6-2 indicate the location and direction of propagation of the earlier fuselage skin fractures. In places where the earlier longitudinal fractures did not have features indicating a crack propagation direction, arrowheads perpendicular to the separation indicate the tension loading that is consistent with the fracture features. The earlier fuselage skin fractures discussed above separated the right edge, the forward edge, and a portion of the left edge of a combined piece from the bottom of the fuselage (pieces LF6A and LF24A). The earlier fractures also progressed nearly completely around the circumference of piece RF32 and circumferentially across the bottom of the fuselage from S33L to S32R.

Additional fuselage skin fractures with features indicative of separation under a combined tension and either bending or out-of-plane shear loads were found on the red area pieces from the left side of the fuselage and are indicated by the arrows labeled with a "1" or "2" in a circle in figure 6-2. These fracture areas stemmed from the earlier cracks or were along the bottom row of rivets at a lap joint. Fracture areas labeled with "1" contained bending deformation and fracture areas labeled with "2" contained out-of-plane shear deformation. These additional fractures nearly completed the separation of a large combined piece from the bottom of the fuselage (combined pieces LF6A, LF24A, LF95, and LF55A).

Fuselage skin fracture areas not indicated by arrowheads in figures 6-1 and 6-2 were classified as later fractures.

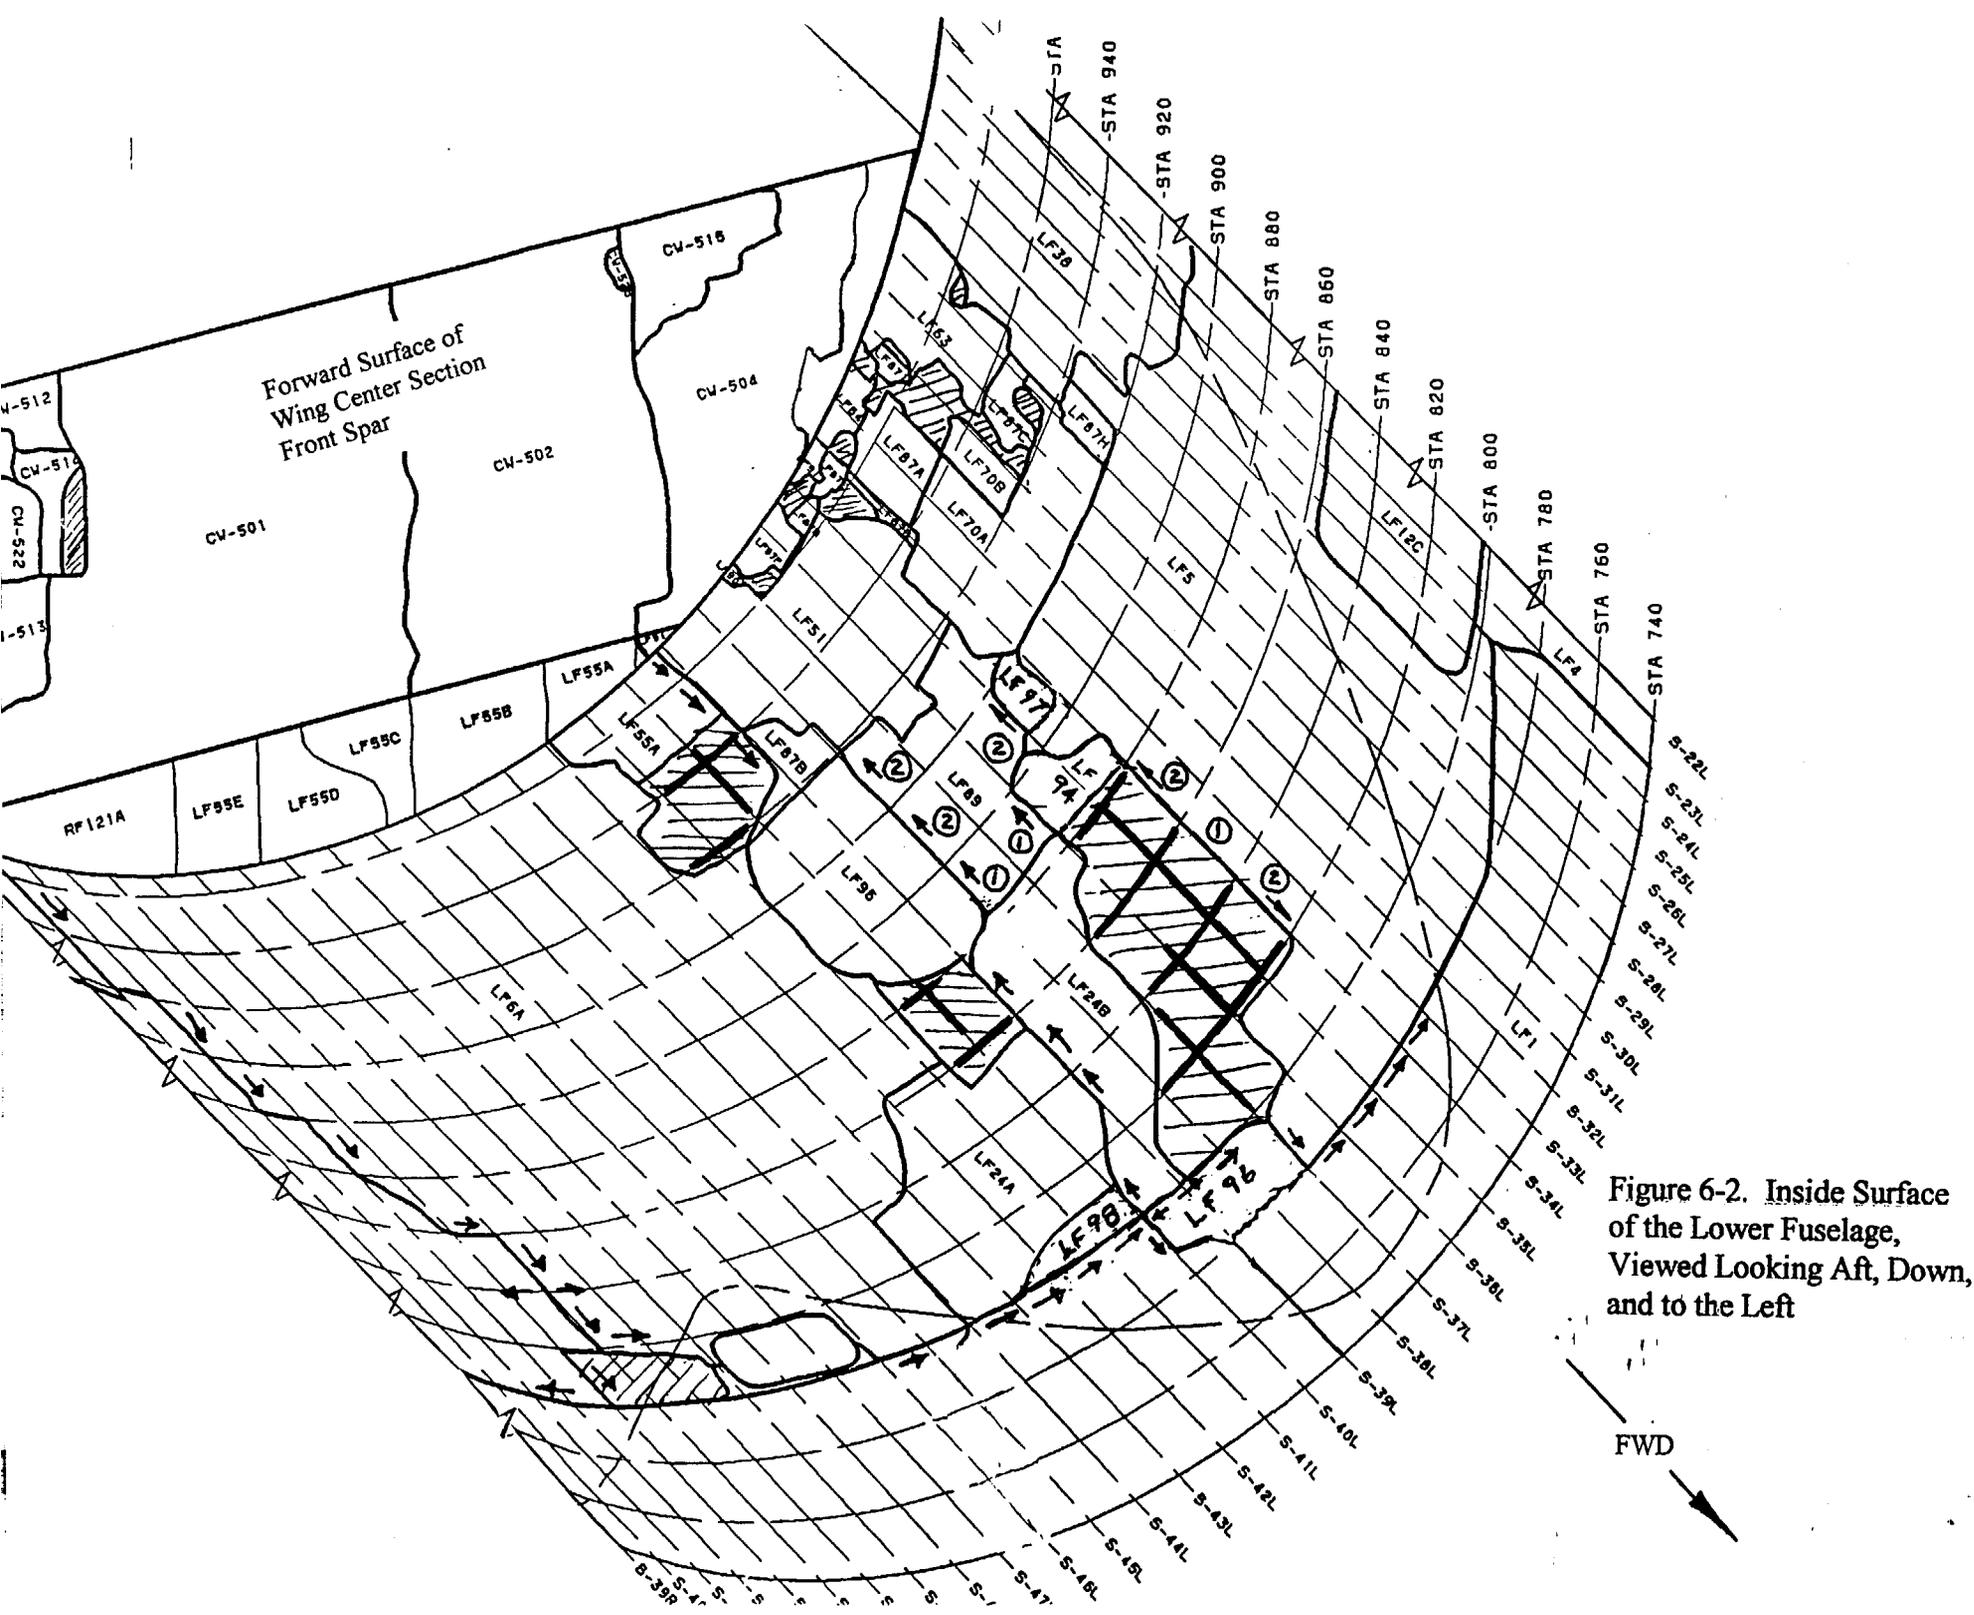
Figure 6-2. Inside Surface of the Lower Fuselage, Viewed Looking Aft, Down, and to the Left

the corresponding pieces on the left side of the fuselage were broken into many small pieces. The skin on most of these smaller pieces contained multiple folds consistent with compression loading in a circumferential direction, with one piece (LF70A) showing crushing in the downward direction. Portions of stringers were trapped within some of these pieces. Damage to these pieces on the left side was consistent with water impact.

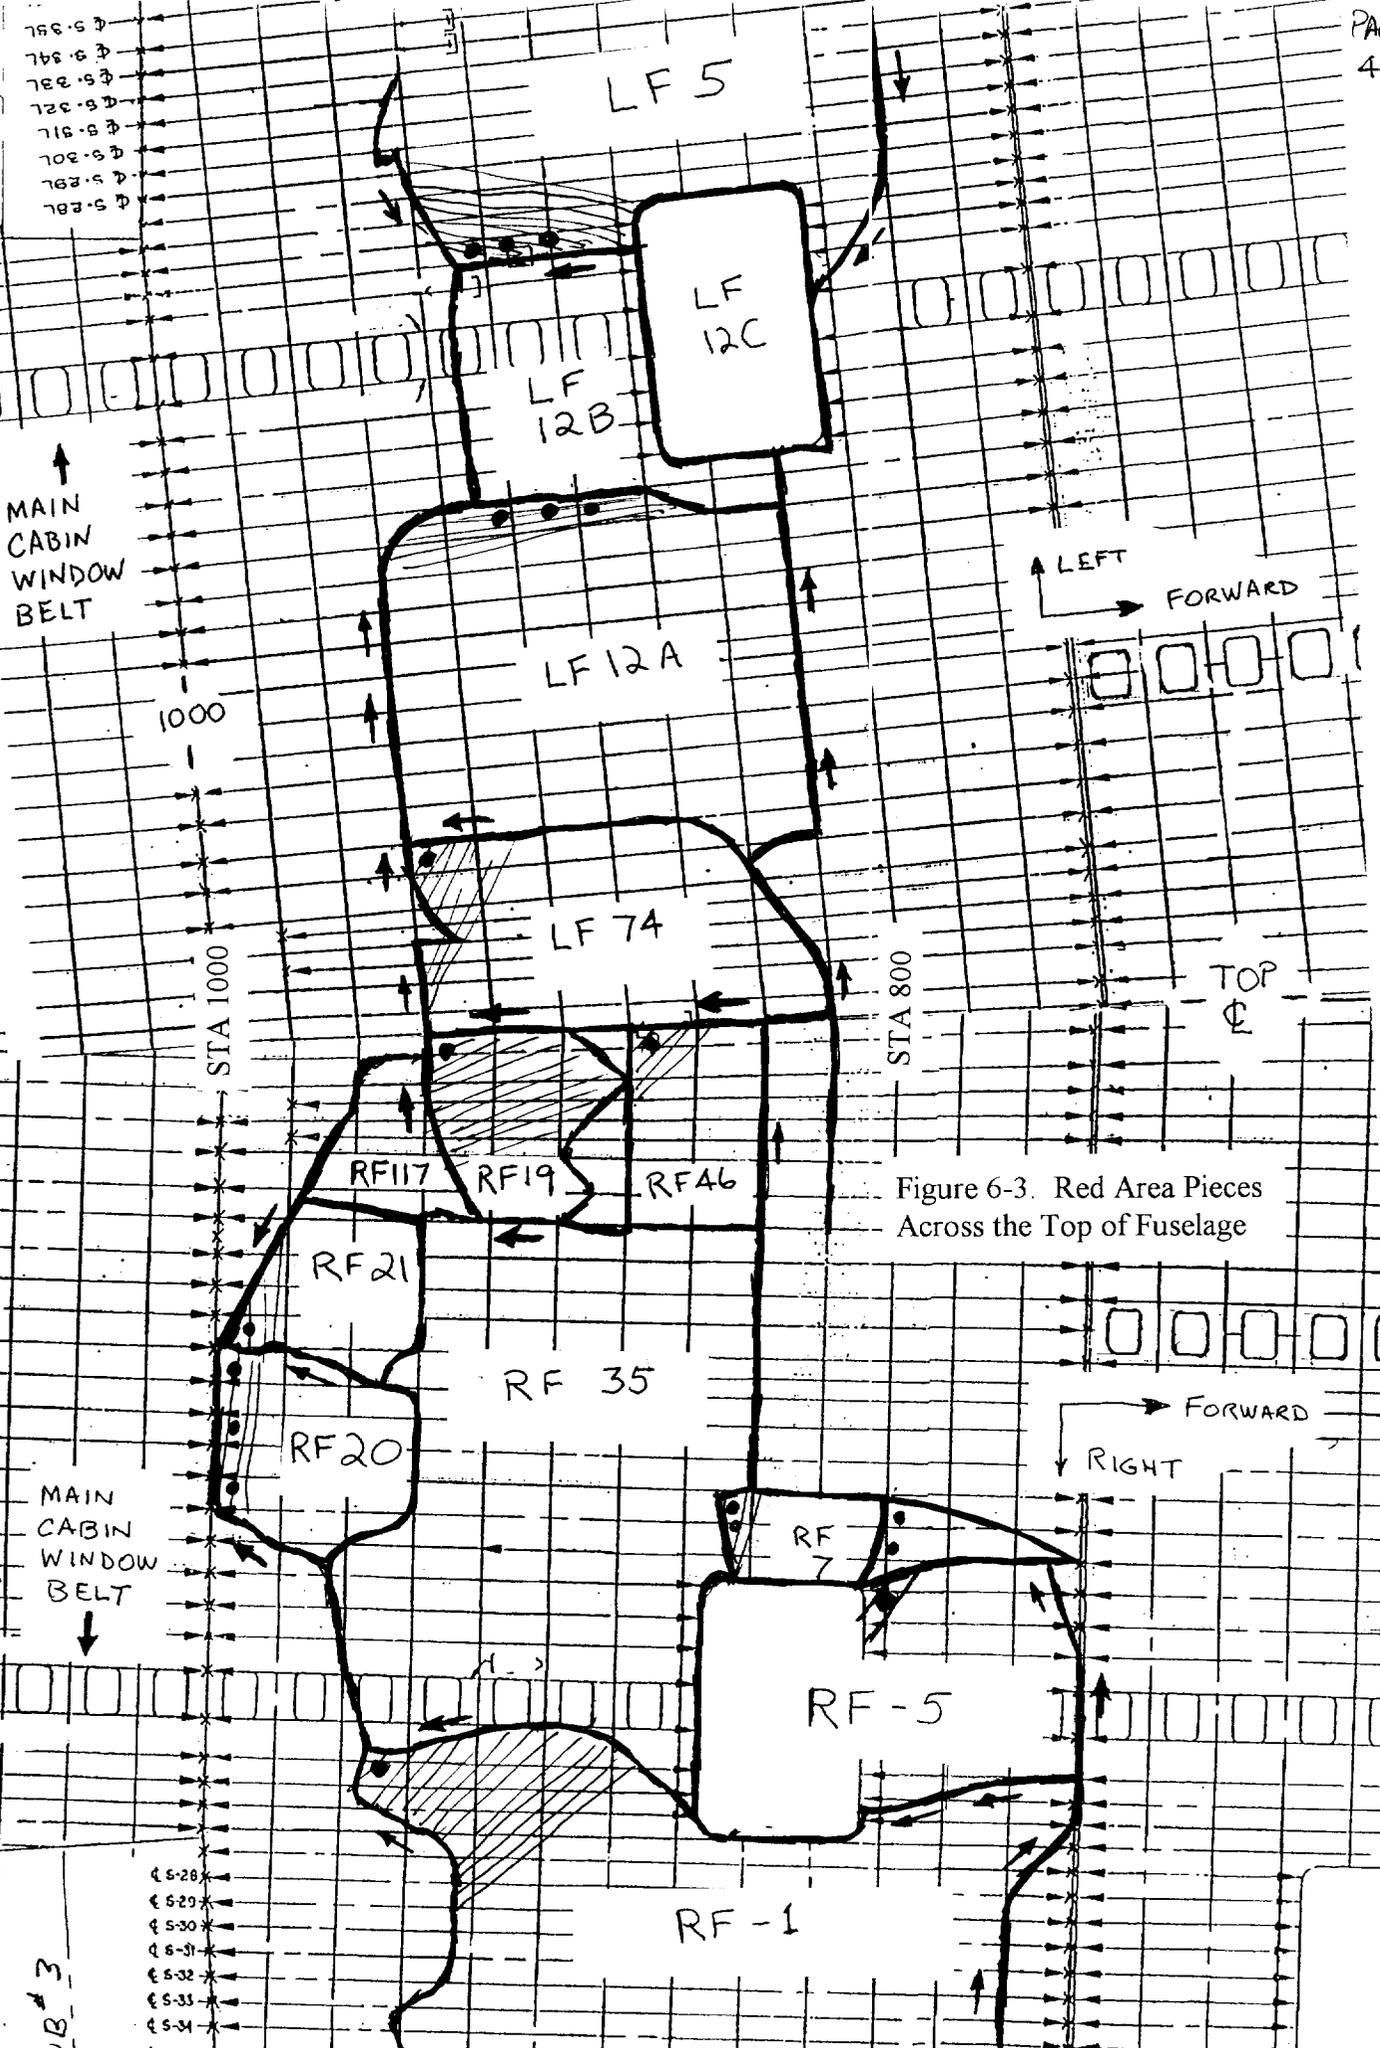
Figure 6-3. Red Area Pieces Across the Top of Fuselage

Figure 6-3 shows a stringer diagram of the fuselage in the area above the main deck window belts. The fracture locations in this diagram are denoted by the dark lines. All fractures in these fuselage skin pieces were "later" fractures, as defined in the section addressing the structure below the main deck window belts. Fracture directions of the fuselage skin structure above the main deck window belts are indicated by the arrowheads adjacent to the fractures in figure 6-3.

Many of the red area fuselage structure pieces from above the window belts contained peeling deformation to the skin, with a decreasing radius of bend toward the end of the peel. Peeled areas were typically not attached to stringers or frames. The peels were created as if the main portion of the piece was moving outboard, away from the fuselage, with the point of the peel being the final point of separation. Both the fracture directions in the skin and the location
