**NATIONAL TRANSPORTATION SAFETY BOARD  
WASHINGTON, D.C.**

**SUPPORTING DOCUMENTATION FOR OVERALL  
BREAKUP SEQUENCE**

# **Metallurgy / Structures Sequencing Group Report**

## **Appendix B: Detailed Rationale**

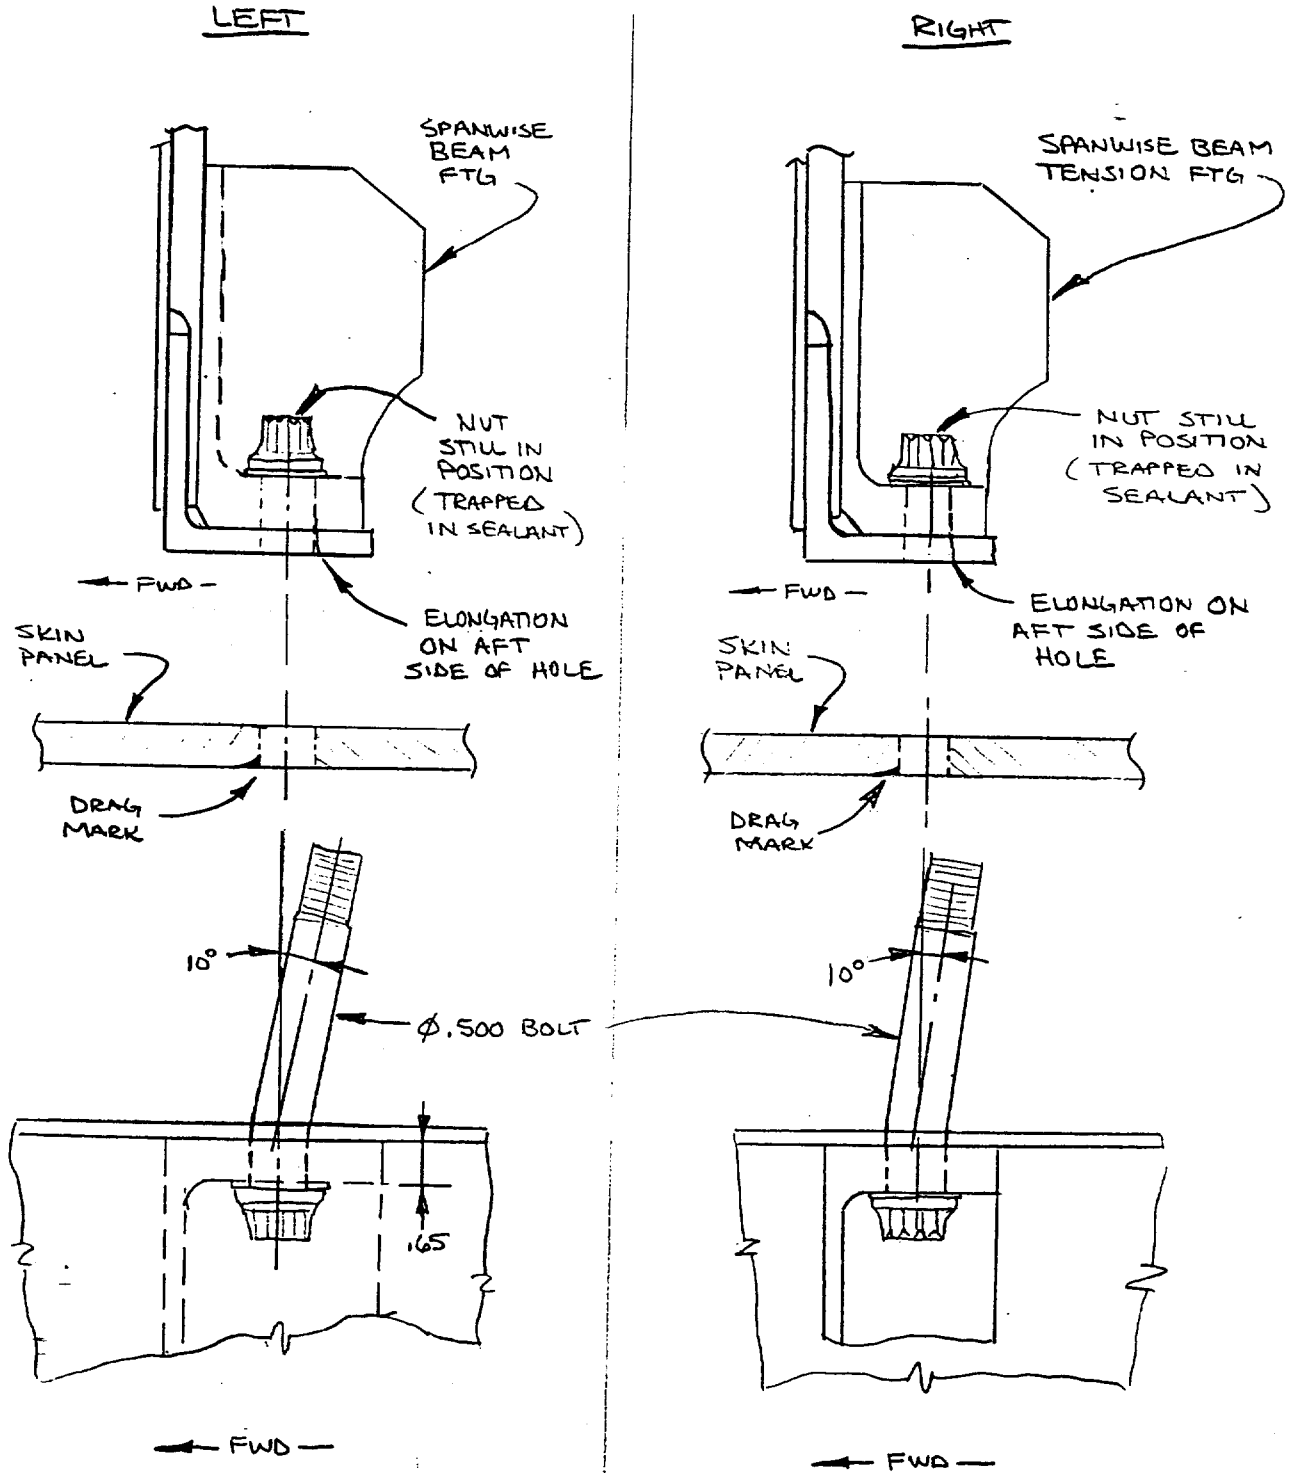
FIGURE B-4

DESCRIPTION OF POSSIBLE SEQUENCE	SUPPORTING OBSERVATIONS	NON-SUPPORTING OBSERVATIONS	Confidence Level
Spanwise beam is possibly intact prior to the keel beam tension bolt fracture. The condition of the related parts is shown in figure B-4.	Keel beam tension fasteners failed by stripping threads out of the nut indicating relatively pure tension loading with low bending forces.	Structure from left side of SWB#2 not recovered or identified	Medium
Resultant web shear from the keel beam loads induced while fracturing the keel beam tension bolts is consistent with initiating shear failure of the access door fasteners common to stiffeners and surround structure shown in zone A on figure B-5. This could also be as a result of overpressure in the WCS.	<ol style="list-style-type: none"> <li>1. Shear failure of fasteners common to the stiffeners, surround structure, and the manufacturing access door. Examination of the sheared rivets in the stiffener shows the door attach structure moving down relative to the access door.</li> <li>2. Indication of early shear tie failure at the upper panel attachment of stiffener at RBL 17.2 due to partially sooted fracture on skin flange of the upper chord.</li> </ol>		Medium

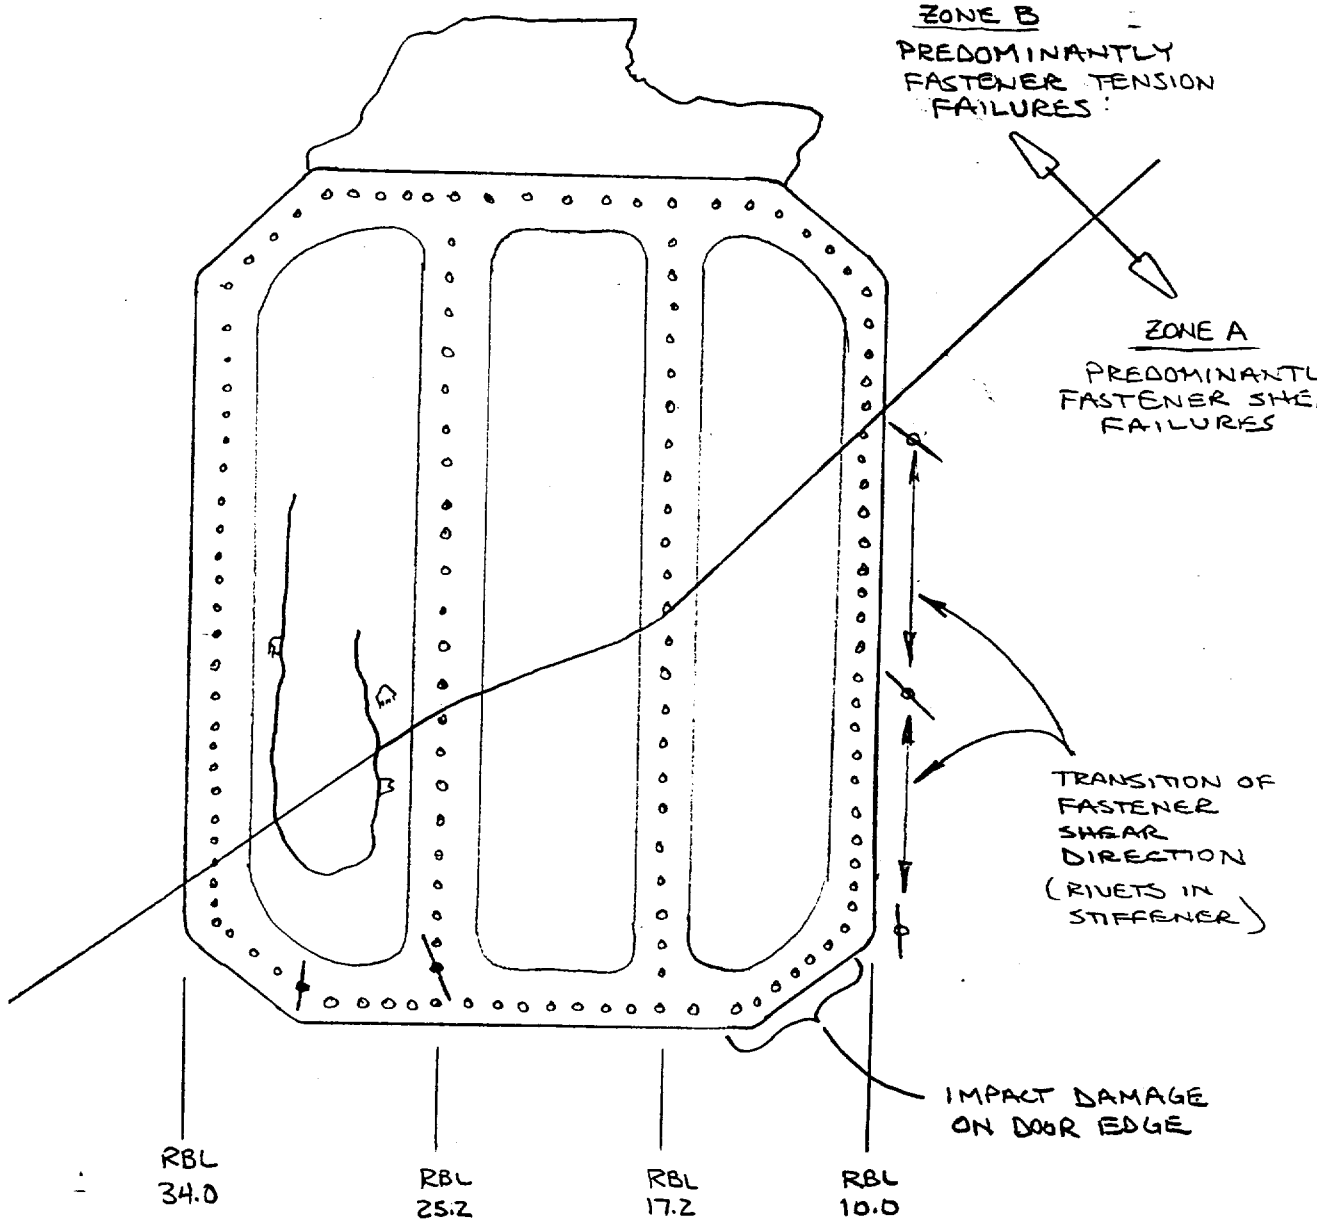
SPANWISE BEAM # 2  
MANUFACTURING  
ACCESS  
DOOR  
(CW703)

Additional out of plane forces (pressure on aft surface of door) results in tension separation of the remainder of the fasteners holding the manufacturing access door to the adjacent web and stiffeners shown in zone B on figure B-3.	<ol style="list-style-type: none"> <li>1. Zone B fastener failures are as a result of tension (prying).</li> <li>2. Impact damage on lower inboard edge of door matches closely with two sets of witness marks on the underside of the upper skin panel and stringer.</li> </ol>		Medium
Access door exits Wing Center Section after breakup of SpanWise Beam #3 and the Front Spar and exits fuselage (after breakup of fuselage red zone pieces). Access door exits prior to fire damage	<ol style="list-style-type: none"> <li>1. Access door recovered from red debris field.</li> <li>2. Access door has only apparent light sooting,</li> <li>3. Front spar, spanwise beam #3, and fuselage must fail for door to exit.</li> <li>4. Unsooted web fracture face on the web remaining attached to the access door with sooted fracture faces on the web remaining on CW-702.</li> </ol>		High

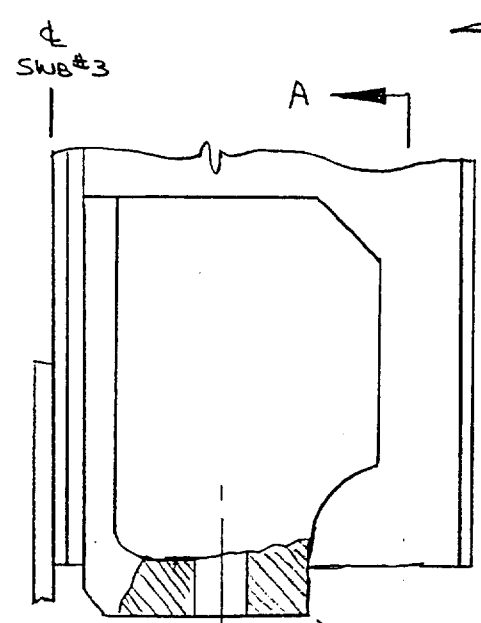
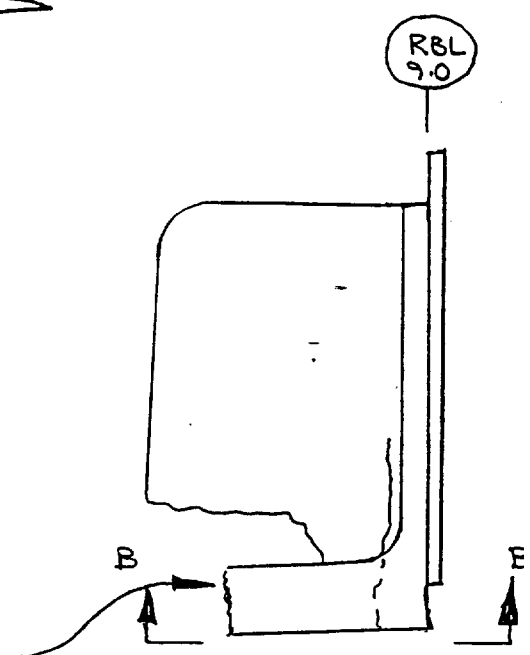
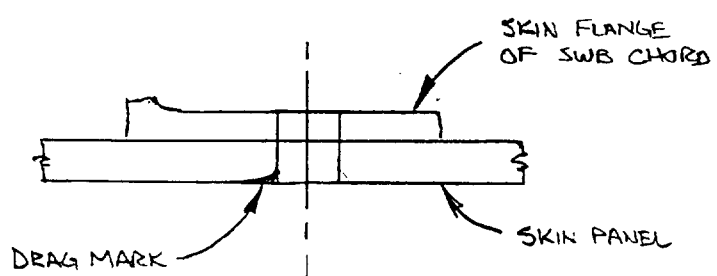
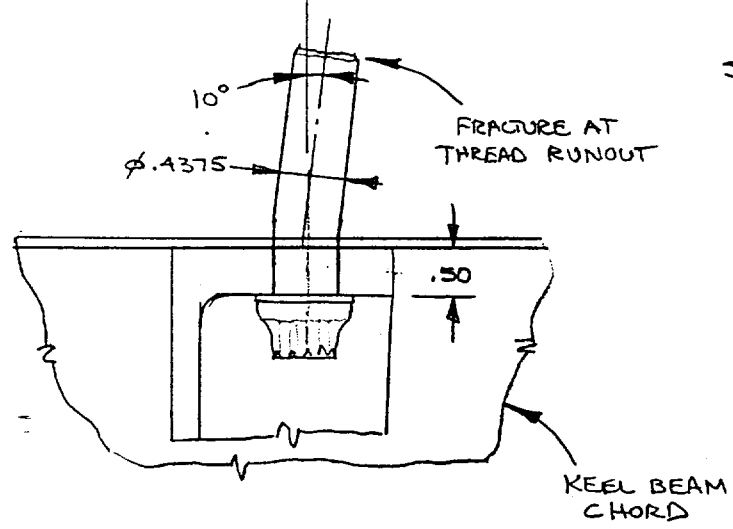
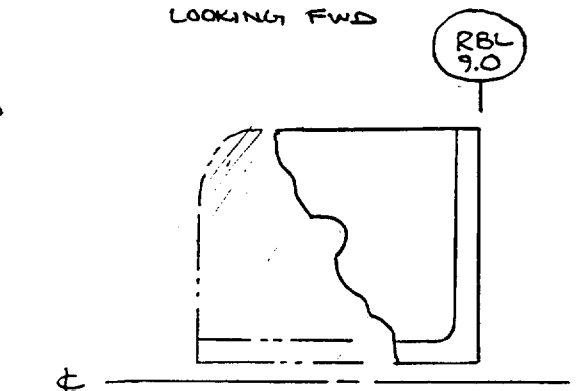
### SWB#3 - RIGHT FTG

BOTTOM OF TENSION FITTING BROKEN OUT

FRACTURE AT THREAD RUNOUT

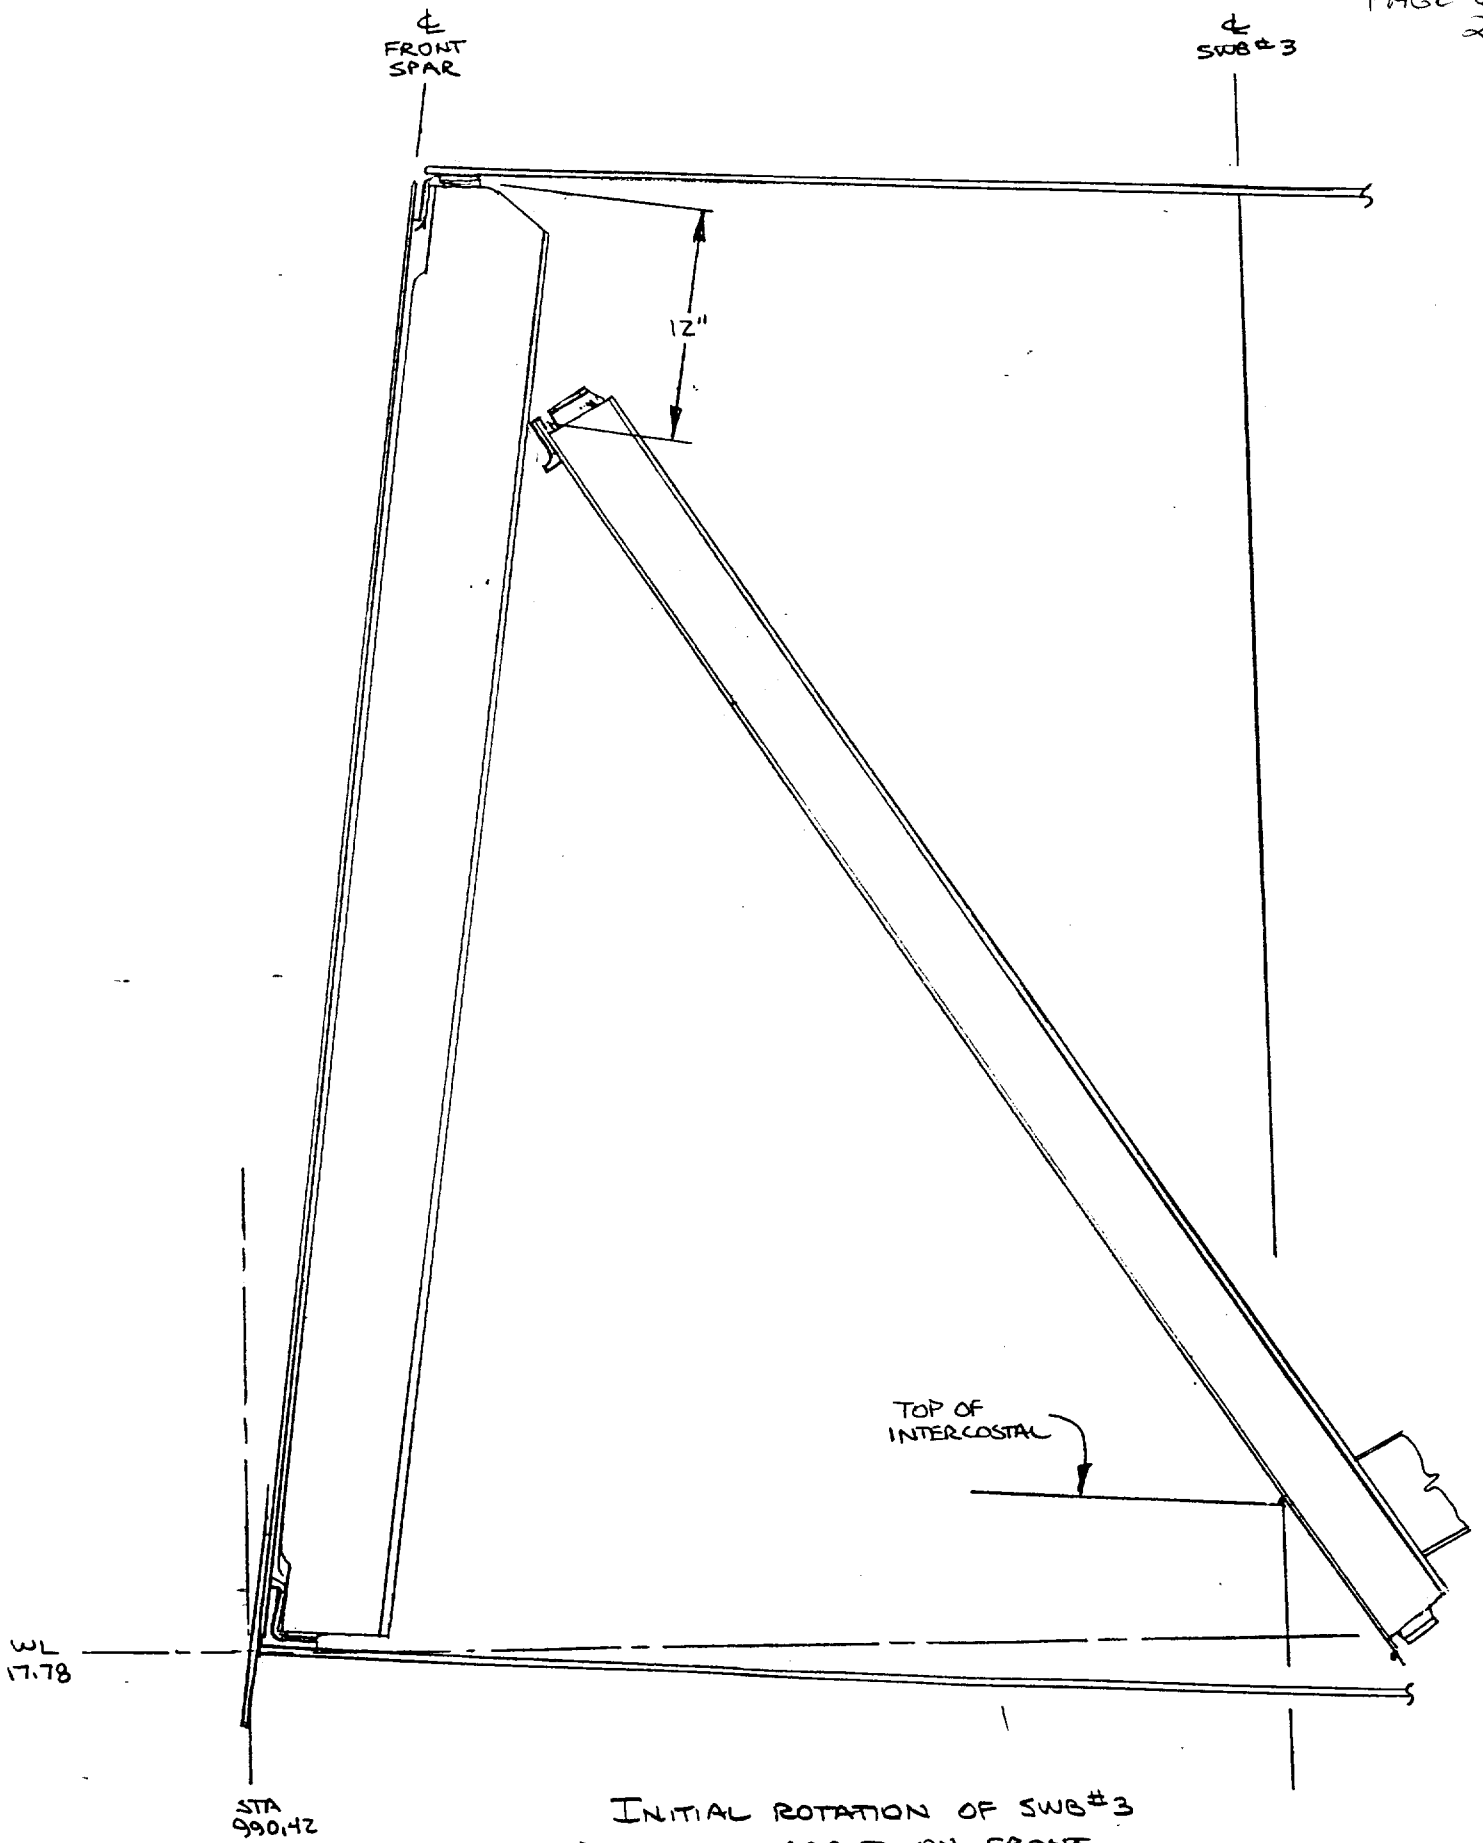
FIGURE B-8

INITIAL ROTATION OF SWB#3  
PRODUCES IMPACT ON FRONT  
SPAR IN A ZONE 12' BELOW  
THE UPPER SPAR CHORD.

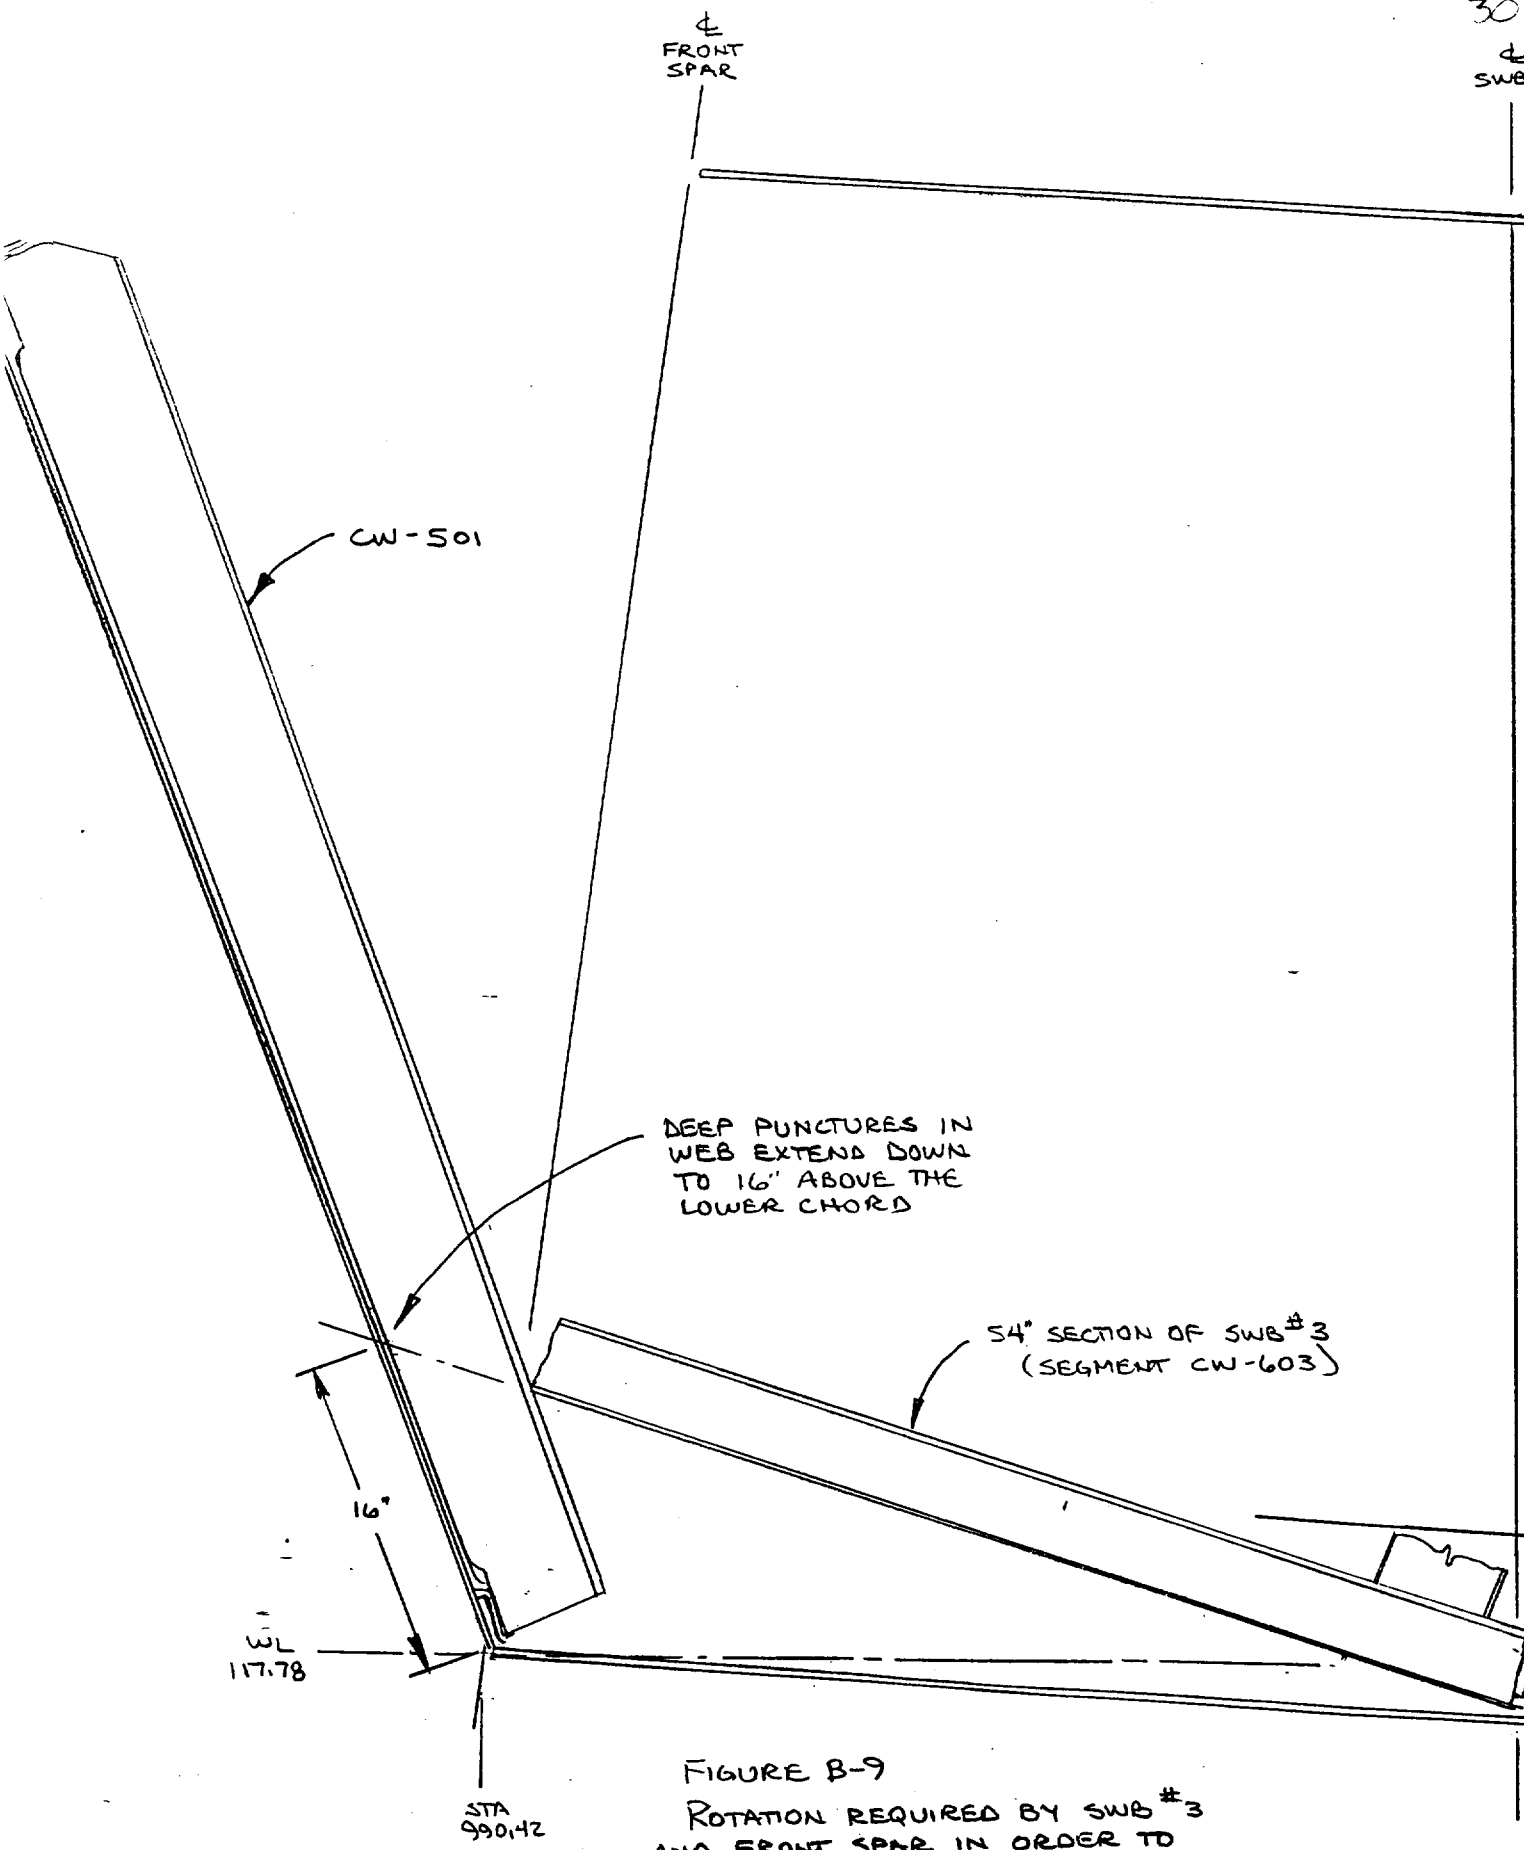
FIGURE B-9  
ROTATION REQUIRED BY SWB #3 AND FRONT SPAR IN ORDER TO PRODUCE DEEP SPLITS IN THE FRONT SPAR WEB AT RBL AND LBL 6.0 (ROTATION ABOUT LWR CHORD)

DEEP PUNCTURES IN WEB EXTEND DOWN TO 16" ABOVE THE LOWER CHORD

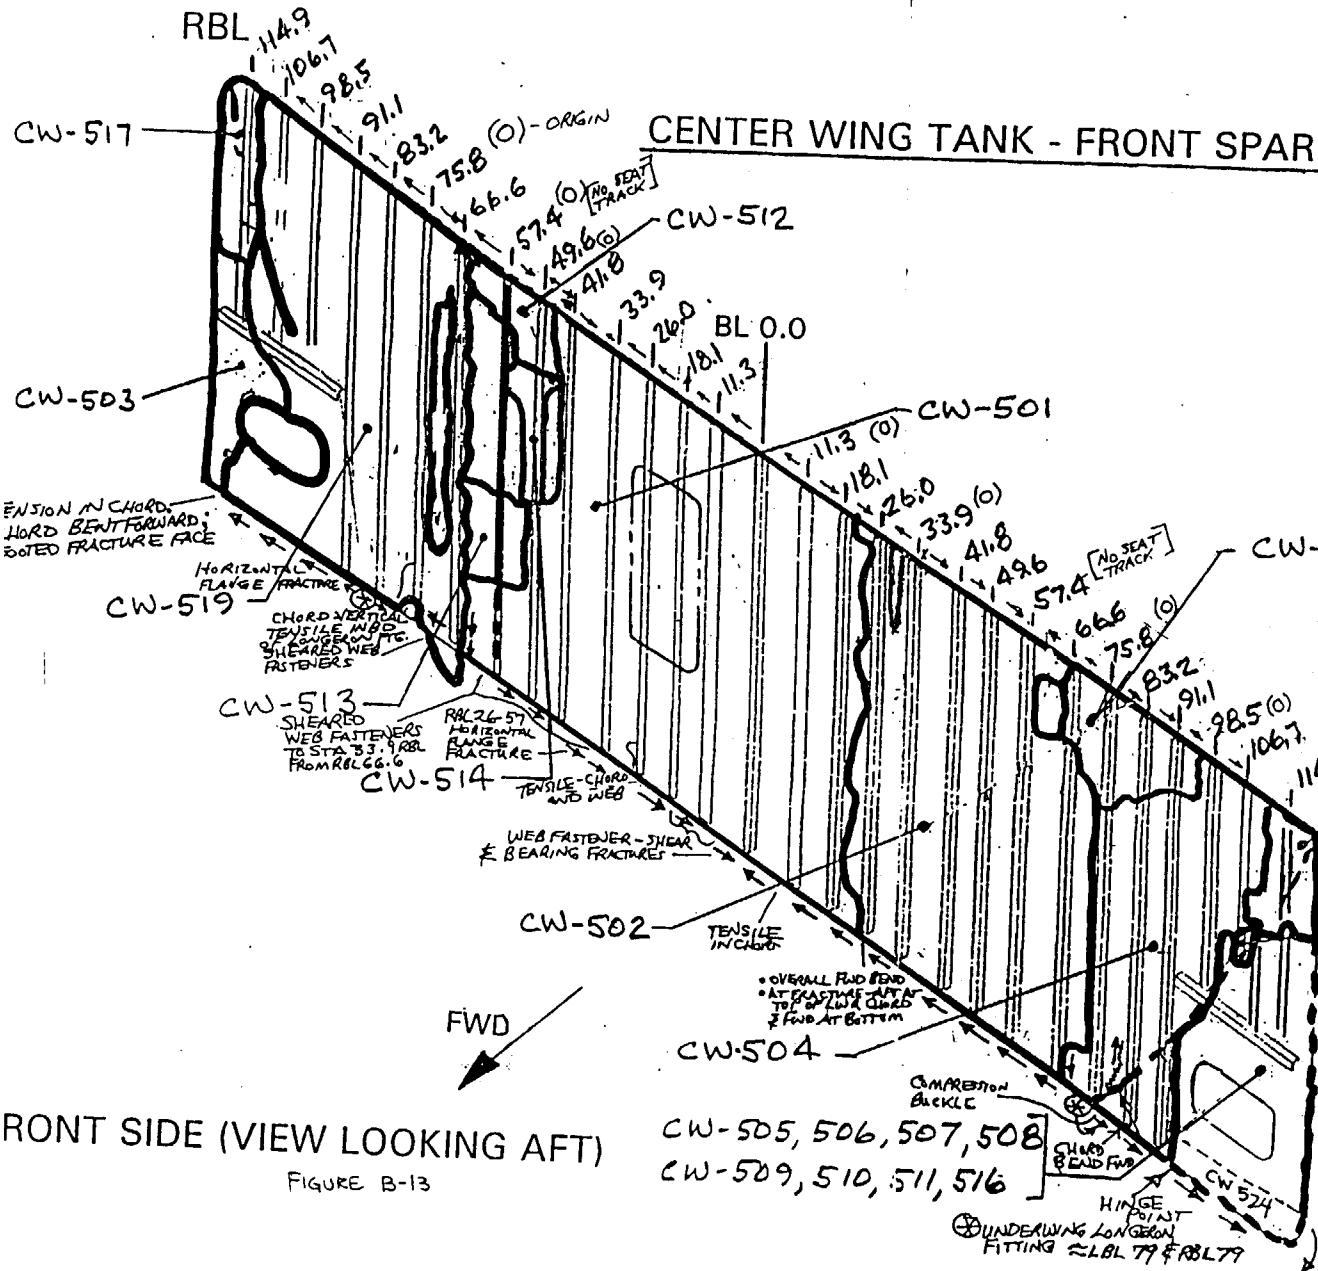
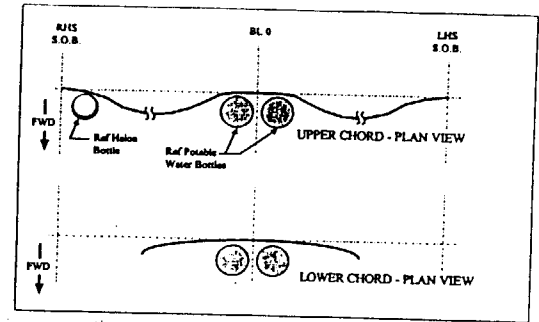
FRONT SIDE (VIEW LOOKING AFT)  
FIGURE B-13

DESCRIPTION OF POSSIBLE SEQUENCE	SUPPORTING OBSERVATIONS	NON-SUPPORTING OBSERVATIONS	Confidence Level
<p>As a result of spanwise beam #3 rotating fwd, the upper chord of the spanwise beam impacts the aft side of the front spar stiffeners, This results in crushing of the aft side of the stiffeners at a location shown in figure B-8.</p>	<p>Impact marks and damage on the aft side of the front spar stiffeners at a distance of approx. 12" below the upper stiffener shear ties. The damage on the aft side of some of the stiffeners shows two distinct impact marks with 3" vertical separation that equals the chord height of the spanwise beam upper chord.</p>		High
<p>The applied impact force on the aft side of the stiffeners and local buckling of the stiffeners at the impact zone results in bending of the upper spar chord between the vertical and horizontal flange. Overpressure loads may also contribute, This bending moment results in a fracture in the fillet radius of the upper spar chord.</p>	<p>Multiple initiation sites of the upper spar chord fracture coincident with the floor beam locations at RBL 75 and 57.5, and LBL 11, 33, 75, and 98. These fractures are bending type fracture with the lower edge of the chord moving fwd relative to the skin flange of the chord. At all of these locations, the chord has a slight residual deformation indicative of an inbd/outbd bowing of the vertical flange of the chord. See figure B-13.</p>		High

SLIGHT BOWING & FWD NOTED AT ORIGIN SITES ASSOCIATED WITH FLOOR BEAMS AT RBL 98, RBL 75, RBL 57, LBL 11, LBL 33, LBL 57, LBL 75 AND LBL 98. INITIATION SITES IN UPPER CHORD CO-LOCATED AT FLOOR BEAM AT RBL 75, RBL 57, LBL 11, LBL 33, LBL 75, AND LBL 98. ONE ADD'L INITIATION SITE BETWEEN RBL 41 AND RBL 45 WAS ASSOCIATED WITH WHERE THE FRACTURE DROVE DOWN IN THE VERTICAL FLANGE OF FRONT SPAR UPPER CHORD.

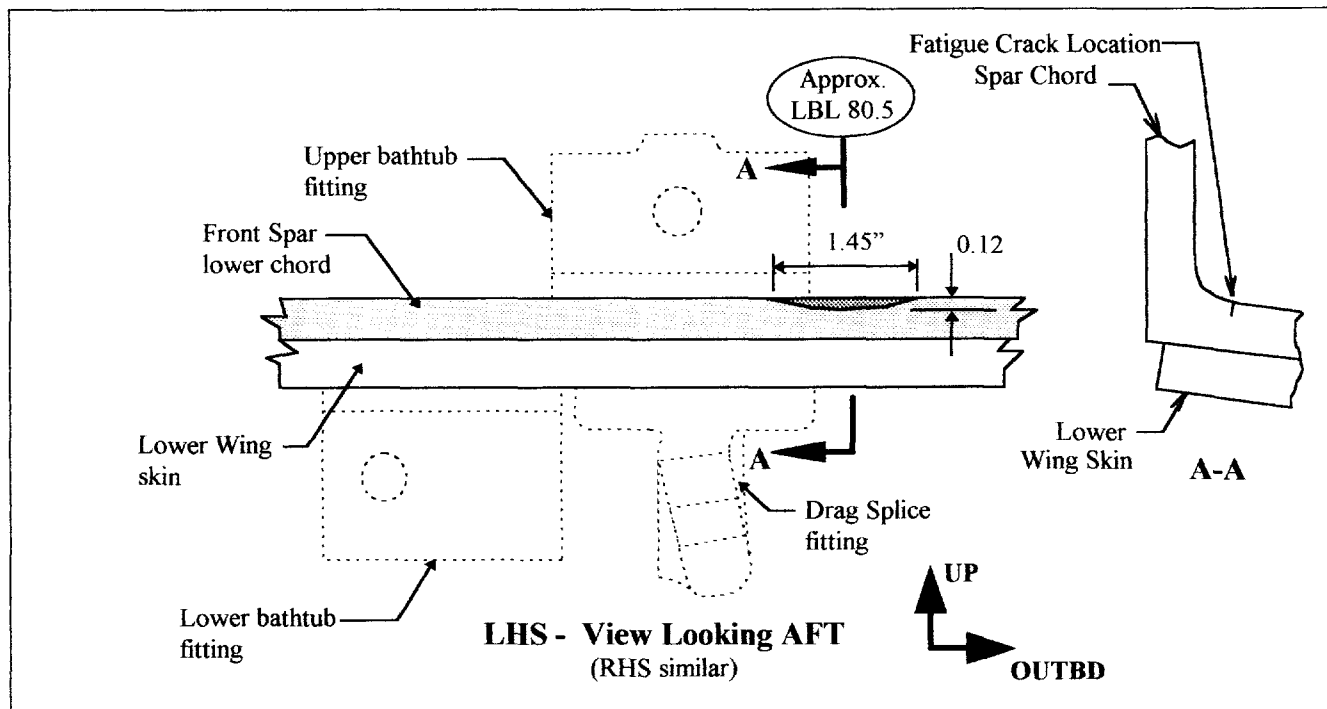
C.1 Front Spar lower horizontal chord - existing fatigue cracking (continued)

Fatigue cracks were found in the Front Spar lower horizontal chord in the fillet radius just outboard of the underwing longeron splice fittings at both RBL and LBL 80. The existing cracks were approximately 1.2 inch and 1.45 inch on the RHS and LHS, respectively. The cracks originated at the inside fillet radius and were part through cracks, progressing approximately one third through the chord thickness (approximately 0.10 inch deep and 0.125 inch deep on the RHS and LHS, respectively). A schematic illustration of the fatigue cracking is shown on the top of the following page.

The Front Spar lower horizontal chord in the vicinity of the fatigue cracking is subjected to inspection under the Supplemental Structural Inspection Document (SSID) program. A previous instance of cracking at this location was found on a different 747-100. Those cracks were larger than the ones identified on TWA800 but also did not extend through the thickness of the chord. Cracking between the horizontal and vertical legs of the chord is initiated by secondary deflections acting to open and close the angle between the lower chord legs as a function of body pressure and underwing longeron loads. The orientation and configuration of the cracking does not degrade the capability of the front spar lower chord in performing its primary function of reacting wing bending loads as part of the basic wing box structure. This region is affected by SB 747-53-2064 for adjacent ring chord cracking. The modification per SB 747-53-2064 had been installed on N93119 in 1982, incorporating two bathtub fittings on the Wing Center Section lower skin panel and a double bathtub fitting on the fuselage skin. These fittings are immediately adjacent to the underwing longeron splice fitting and serve to provide an alternate load path for the longeron forward/aft loads. It is apparent from the bathtub fitting arrangement that the post-modification configuration is very stiff and the deflection that would have initiated and propagated the fatigue cracking has been significantly limited. Without continued deflection, the fatigue growth cannot continue, indicating that the minor fatigue cracking existed prior to the installation of the bathtub fittings.

Examination of the area of fatigue cracking and adjacent material on the fracture face indicates an abrupt transition from slow crack growth to a sudden ductile fracture. This provides further confirmation that the cracking did not propagate to failure due to fatigue but rather was the result of a one time static overload associated with structural breakup. The NTSB Materials Laboratory has examined the larger of the two cracks and will issue a separate report. A more complete description of the fatigue cracking may also be found in the Metallurgical Field Notes.

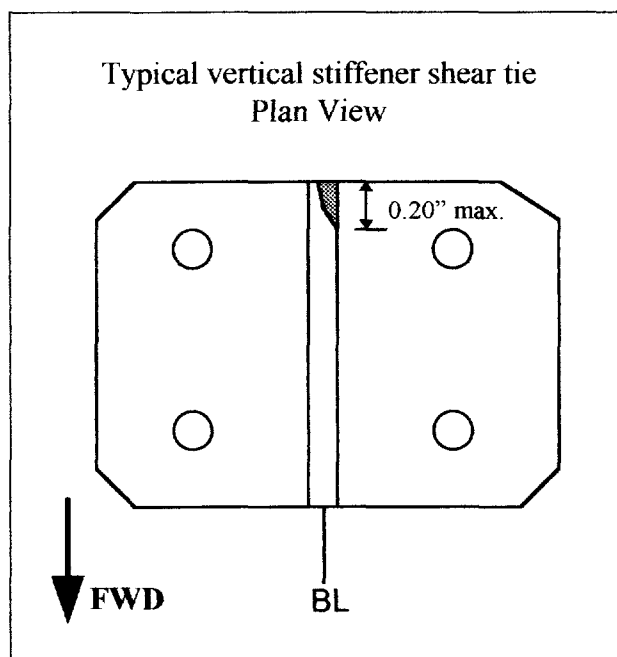
Small existing fatigue cracks were found in the vertical stiffener shear ties at RBL 83.24 (lower), RBL 75.92 (upper and lower), LBL 75.92 (upper and lower), and LBL 83.24 (lower).

The cracks were all in the shear tie radius near the base of the leg that attaches to the vertical stiffener at the aft edge. This cracking is the subject of SB 747-57-2249. The Service Bulletin was issued in 1989 after reports of in-service cracking. The maximum crack length on the subject airplane was 0.20 inch long. In service, operators have reported cracks ranging from 0.50 inch to 1.5 inch long without complete part fracture, demonstrating the capability of these shear ties to withstand cracking well in excess of the 0.20 inch detected cracking under normal operating conditions. Furthermore examination of the area of fatigue cracking and adjacent material on the fracture face indicates an abrupt transition from slow crack growth to a sudden ductile fracture. This provides further confirmation that the cracking did not propagate to failure due to fatigue but rather was the result of a one time static overload associated with structural breakup.

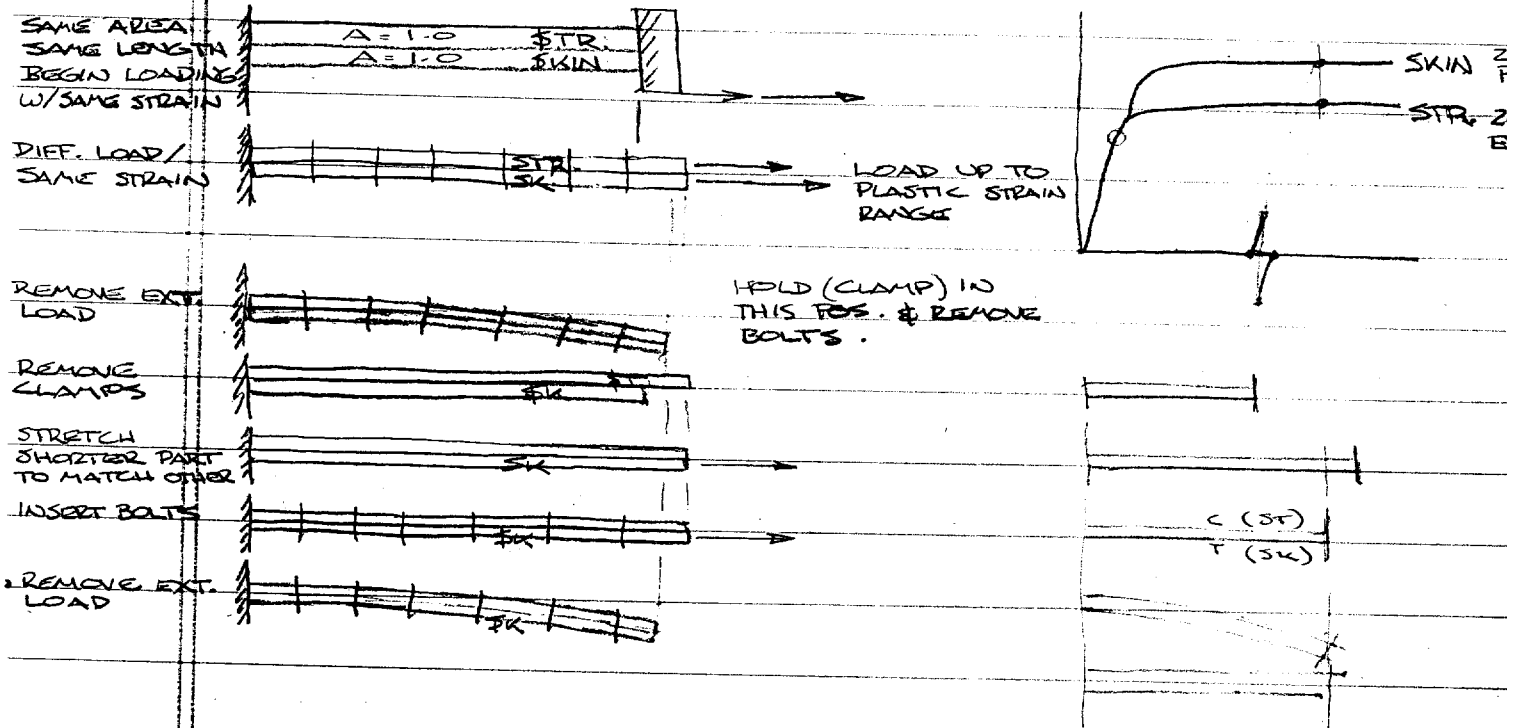
THE ABOVE OBSERVATIONS DESCRIBE THE EXPECTED CONDITION OF A BOLTED COMBINATION OF 2024 PLATE (SKIN) & 2024 ALUMINUM (STRINGER) AFTER EXPOSURE TO UNIFORM TENSION STRESS INTO THE PLASTIC RANGE WHILE RESTRAINED TO FORCE EQUAL STRAINS IN BOTH PARTS.

THE CONDITION FOUND @ THE RHS LOWER SKIN (WS 382 OF) WAS AS SHOWN ABOVE WITH THE STRINGER SEPARATED OVER A LENGTH OF 155 IN. THE SKIN ELEMENT WAS LONGER THAN THE STRINGER, INDICATING THAT THESE PARTS DID NOT ARRIVE AT THE OBSERVED STATE AS A RESULT OF UNIFORM TENSION INTO THE PLASTIC RANGE WHILE ACTING AS PART OF THE INTACT WING WITH APPLIED WING BENDING LOADS. [FOR THIS LOCATION]. OTHER LOCATIONS EXHIBIT DIFFERENT CONDITIONS OF THE SKIN/STRINGERS WHICH COULD SUPPORT THE BOEING VIEW THAT THE WING WAS HELDED BY BENDING INTO THE DIAGONAL POSITION.

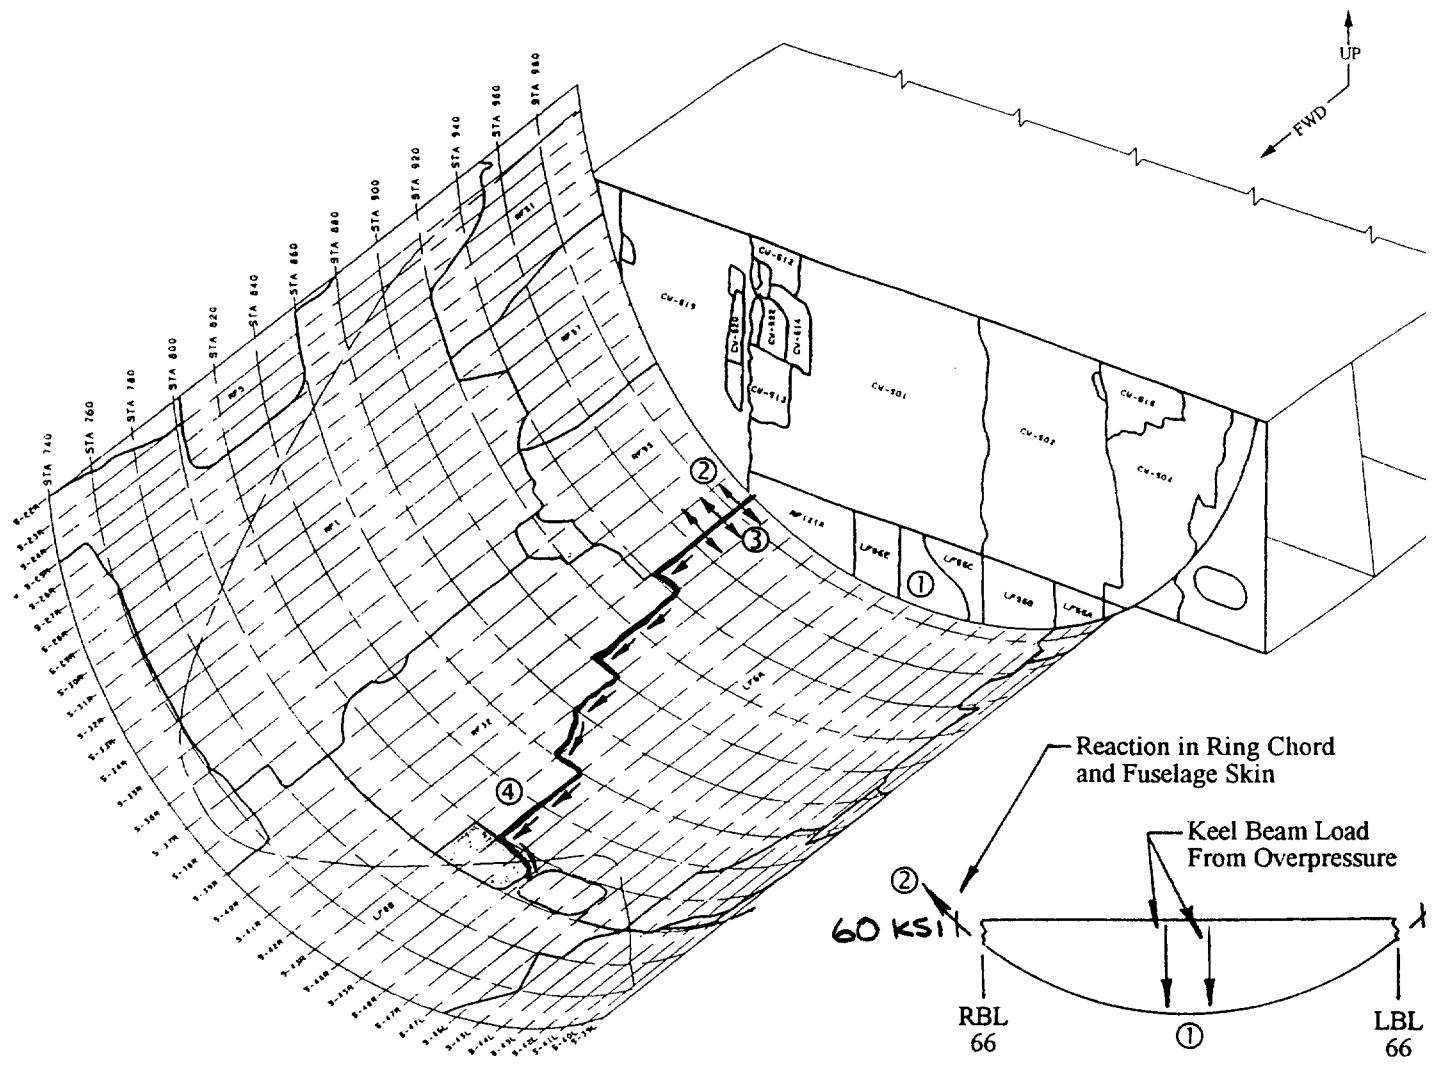
## Failure Initiation; Fuselage Lower Lobe

- ① Keel Beam overpressure related loading still present in lower pressure bulkhead (RELATED TO ASSUMED 25 PSI)
- ② Load reaction is concentrated in ring chord and adjacent fuselage skin at RBL 66 and LBL 66 where web has failed
- ③ Ring chord and adjacent fuselage fail in net tension at RBL 66 (S-40R) 60 KSI PREDICTED 55 KSI ALLOWABLE
- ④ Fuselage crack propagates forward to access door opening at STA 810
