**NATIONAL TRANSPORTATION SAFETY BOARD
WASHINGTON, D.C.**

**FIRE AND EXPLOSION GROUP FACTUAL REPORT
Appendix II
(Sooting/Fracture Diagrams)
(35 pages)**

TWA FLIGHT 800 ACCIDENT INVESTIGATION

**APPENDIX II
SOOTING/FRACTURE DIAGRAMS**

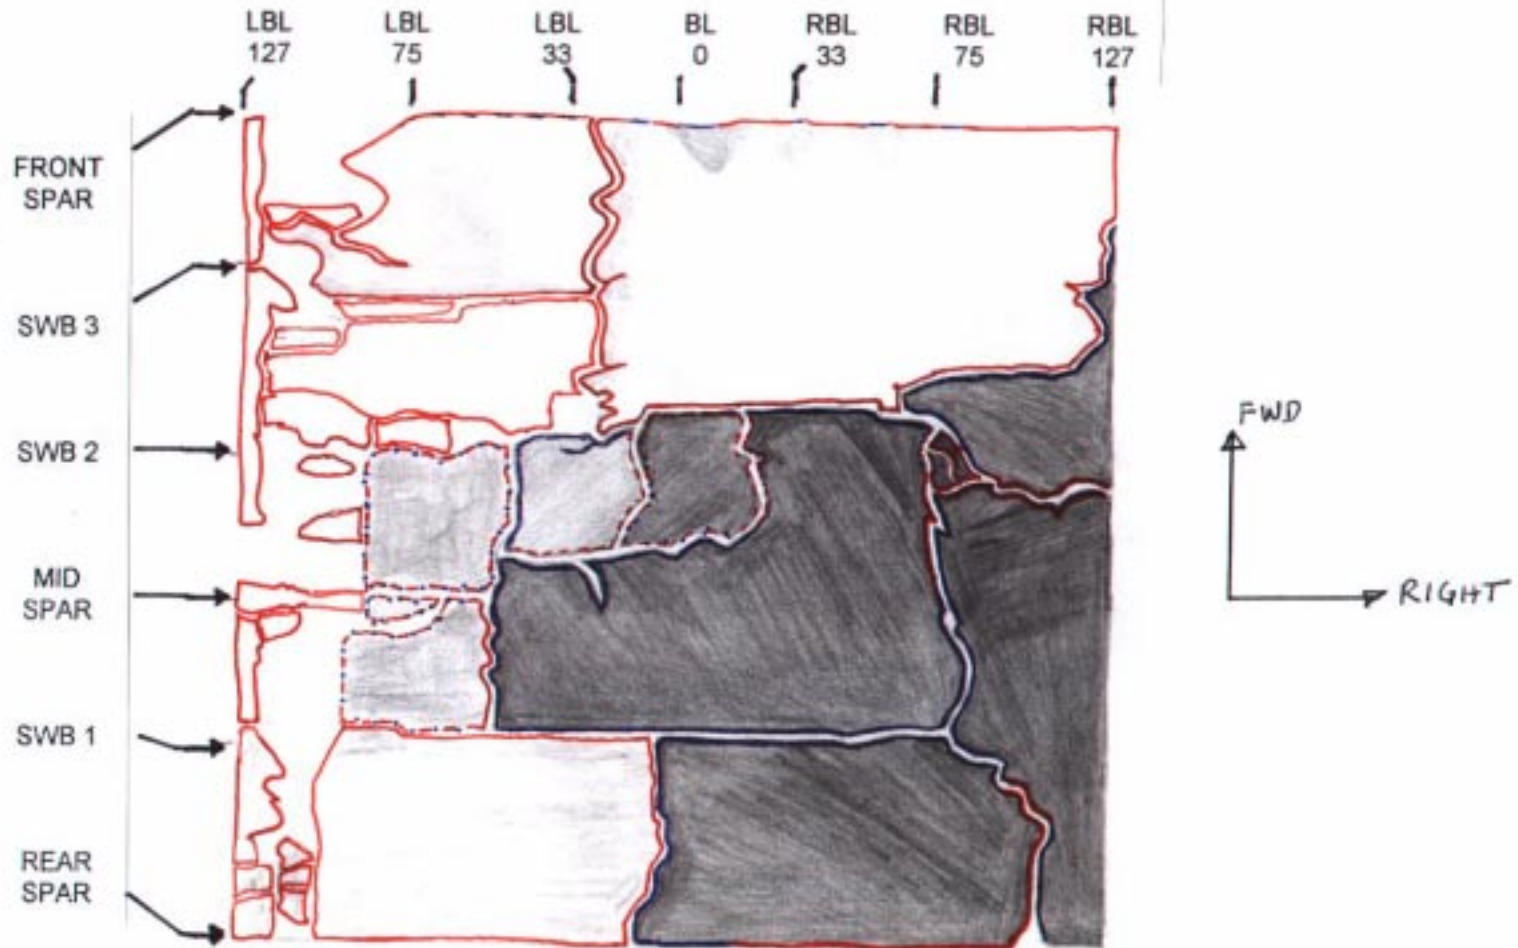
Diagram 1.

CENTER WING TANK SOOTING PATTERN DIAGRAM

UPPER SKIN - UPPER SURFACE

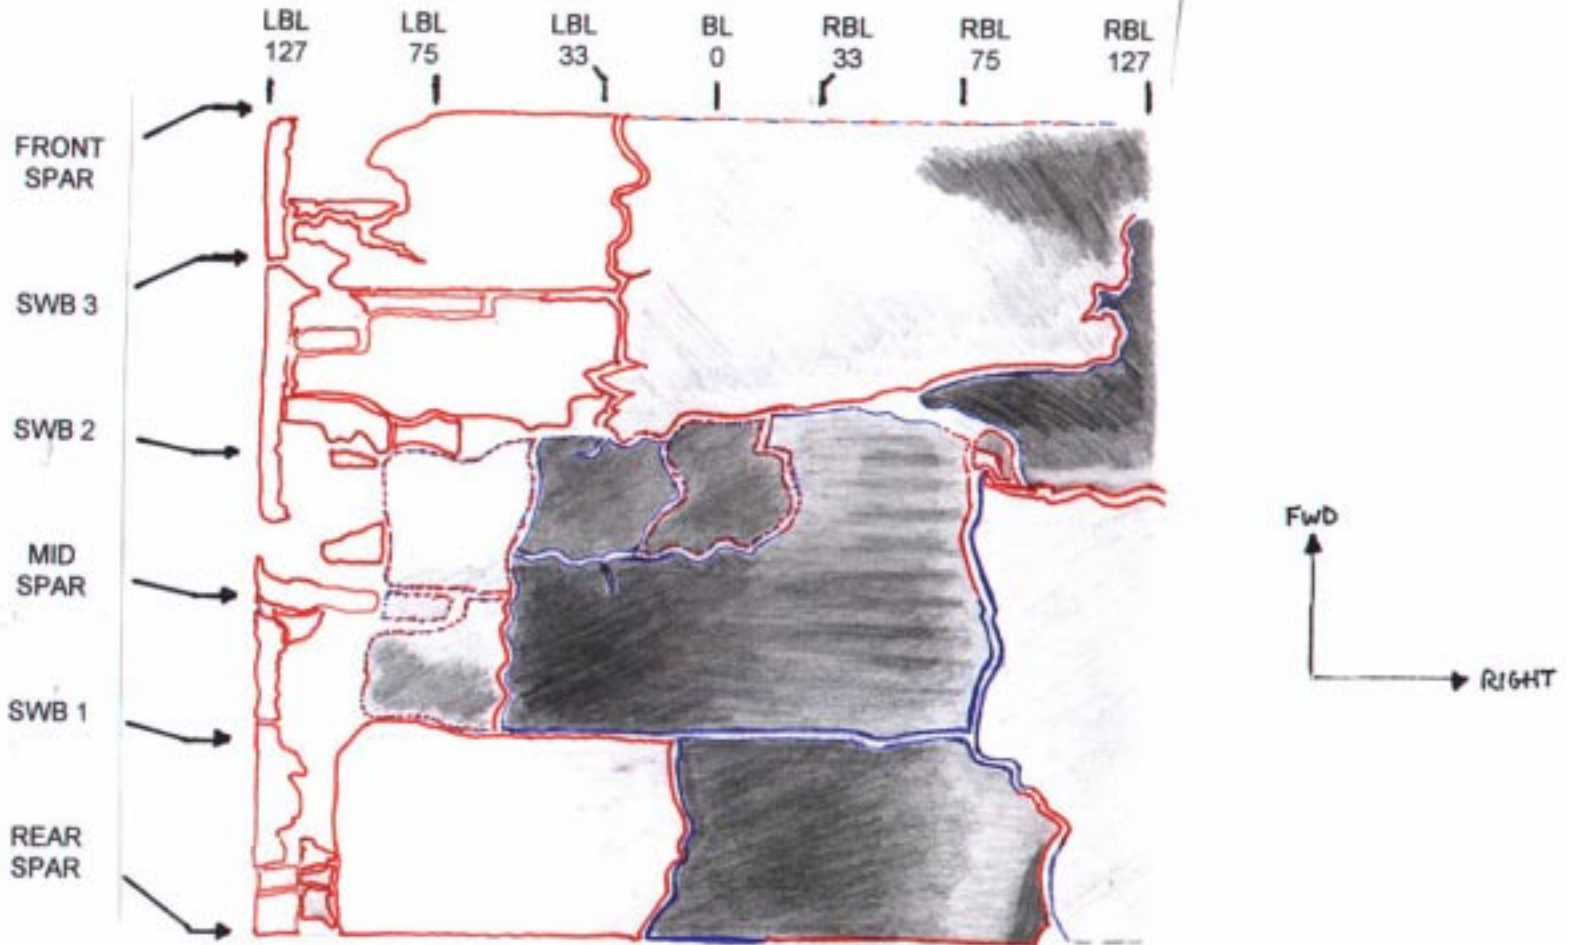
Diagram 2.

CENTER WING TANK SOOTING PATTERN DIAGRAM

UPPER SKIN - LOWER SURFACE

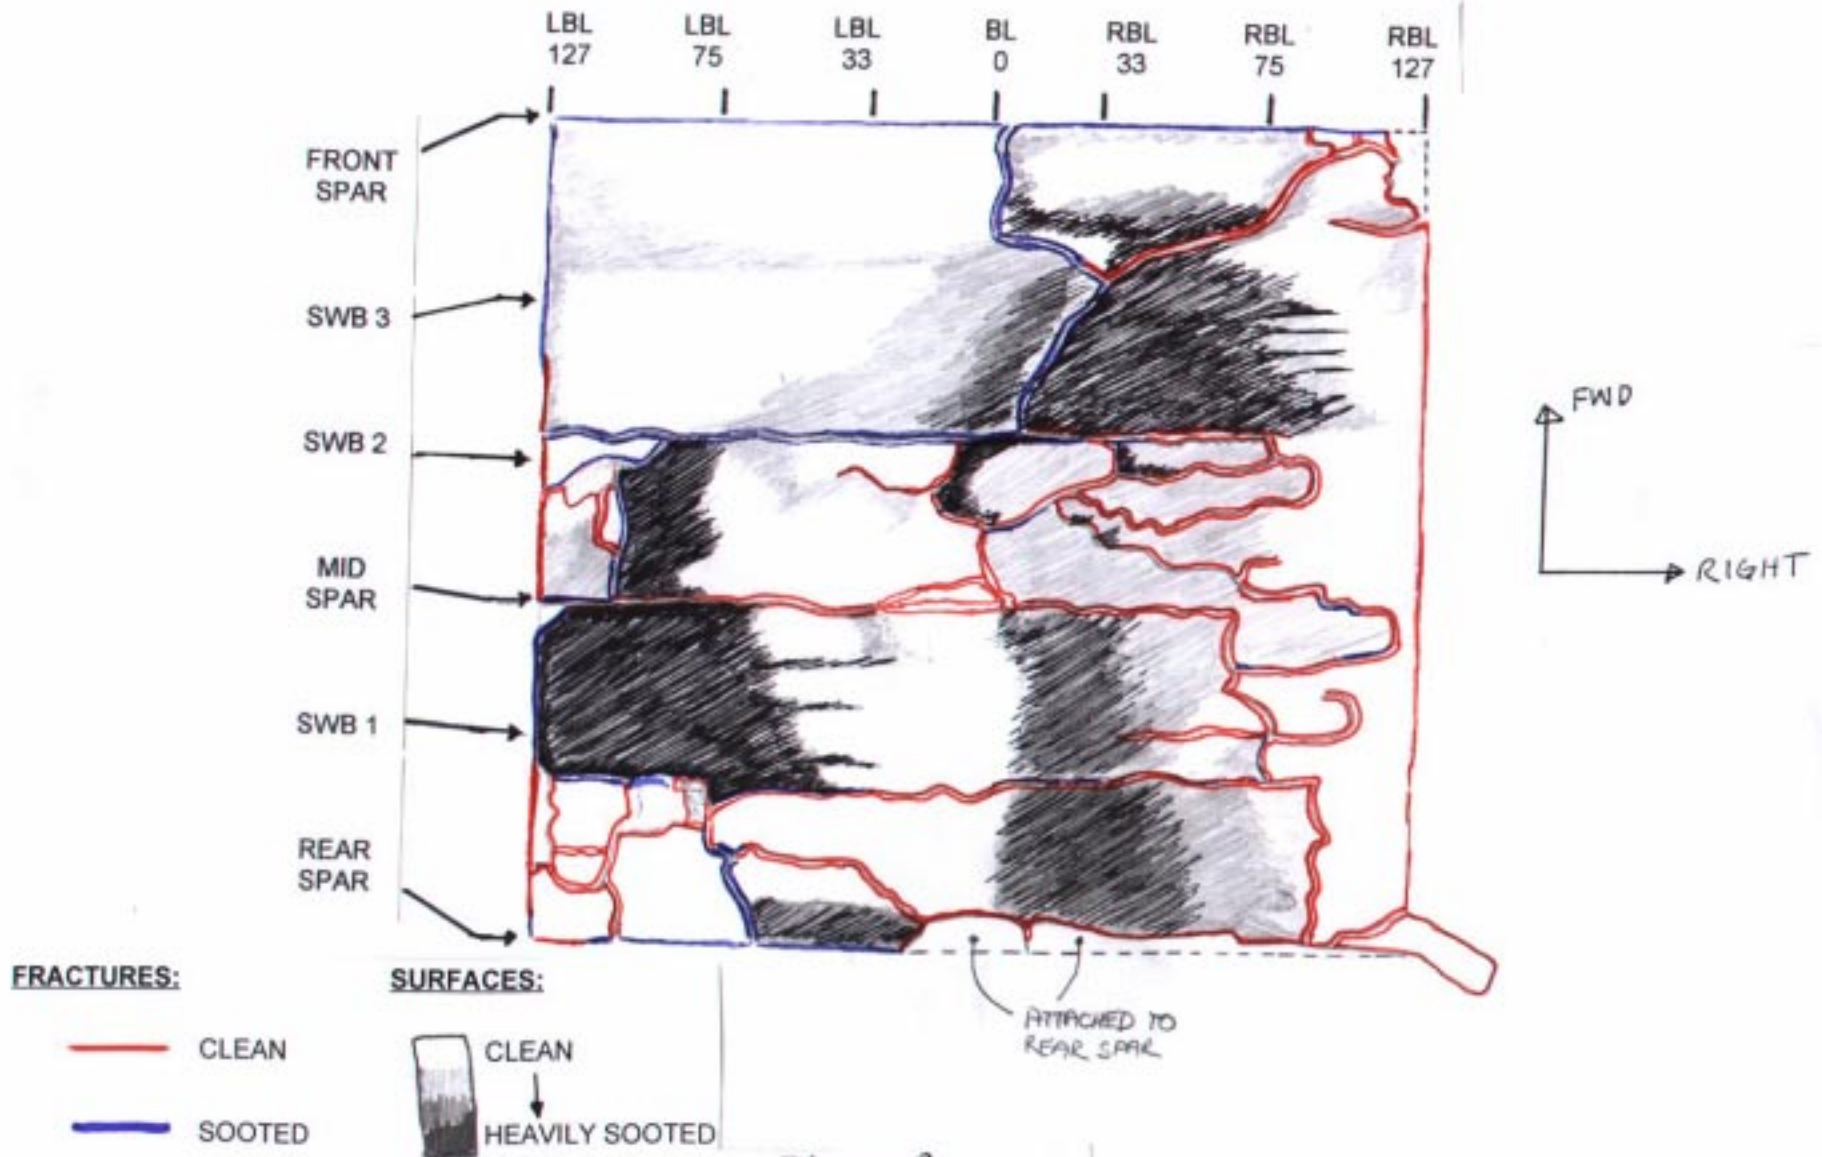
Diagram 3.

CENTER WING TANK SOOTING PATTERN DIAGRAM

LOWER SKIN - UPPER SURFACE

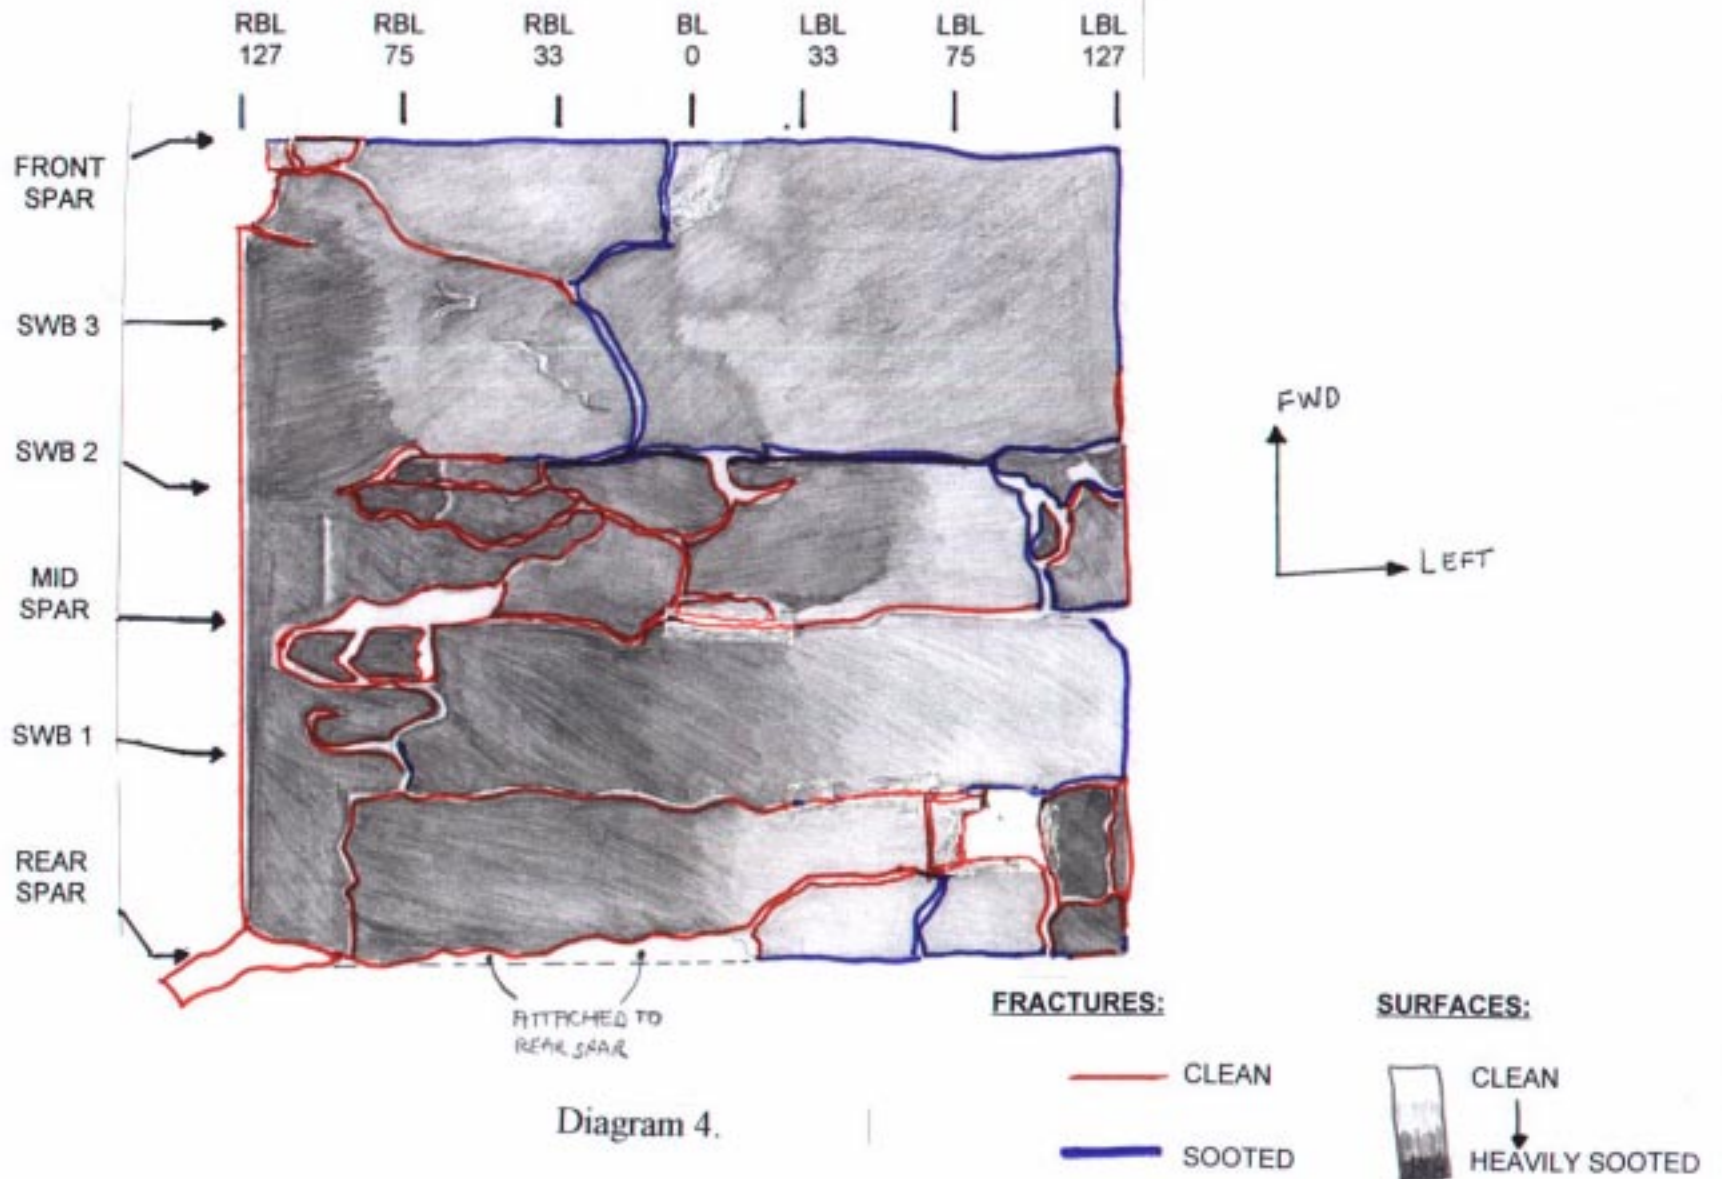
Diagram 4.

CENTER WING TANK SOOTING PATTERN DIAGRAM

LOWER SKIN - LOWER SURFACE

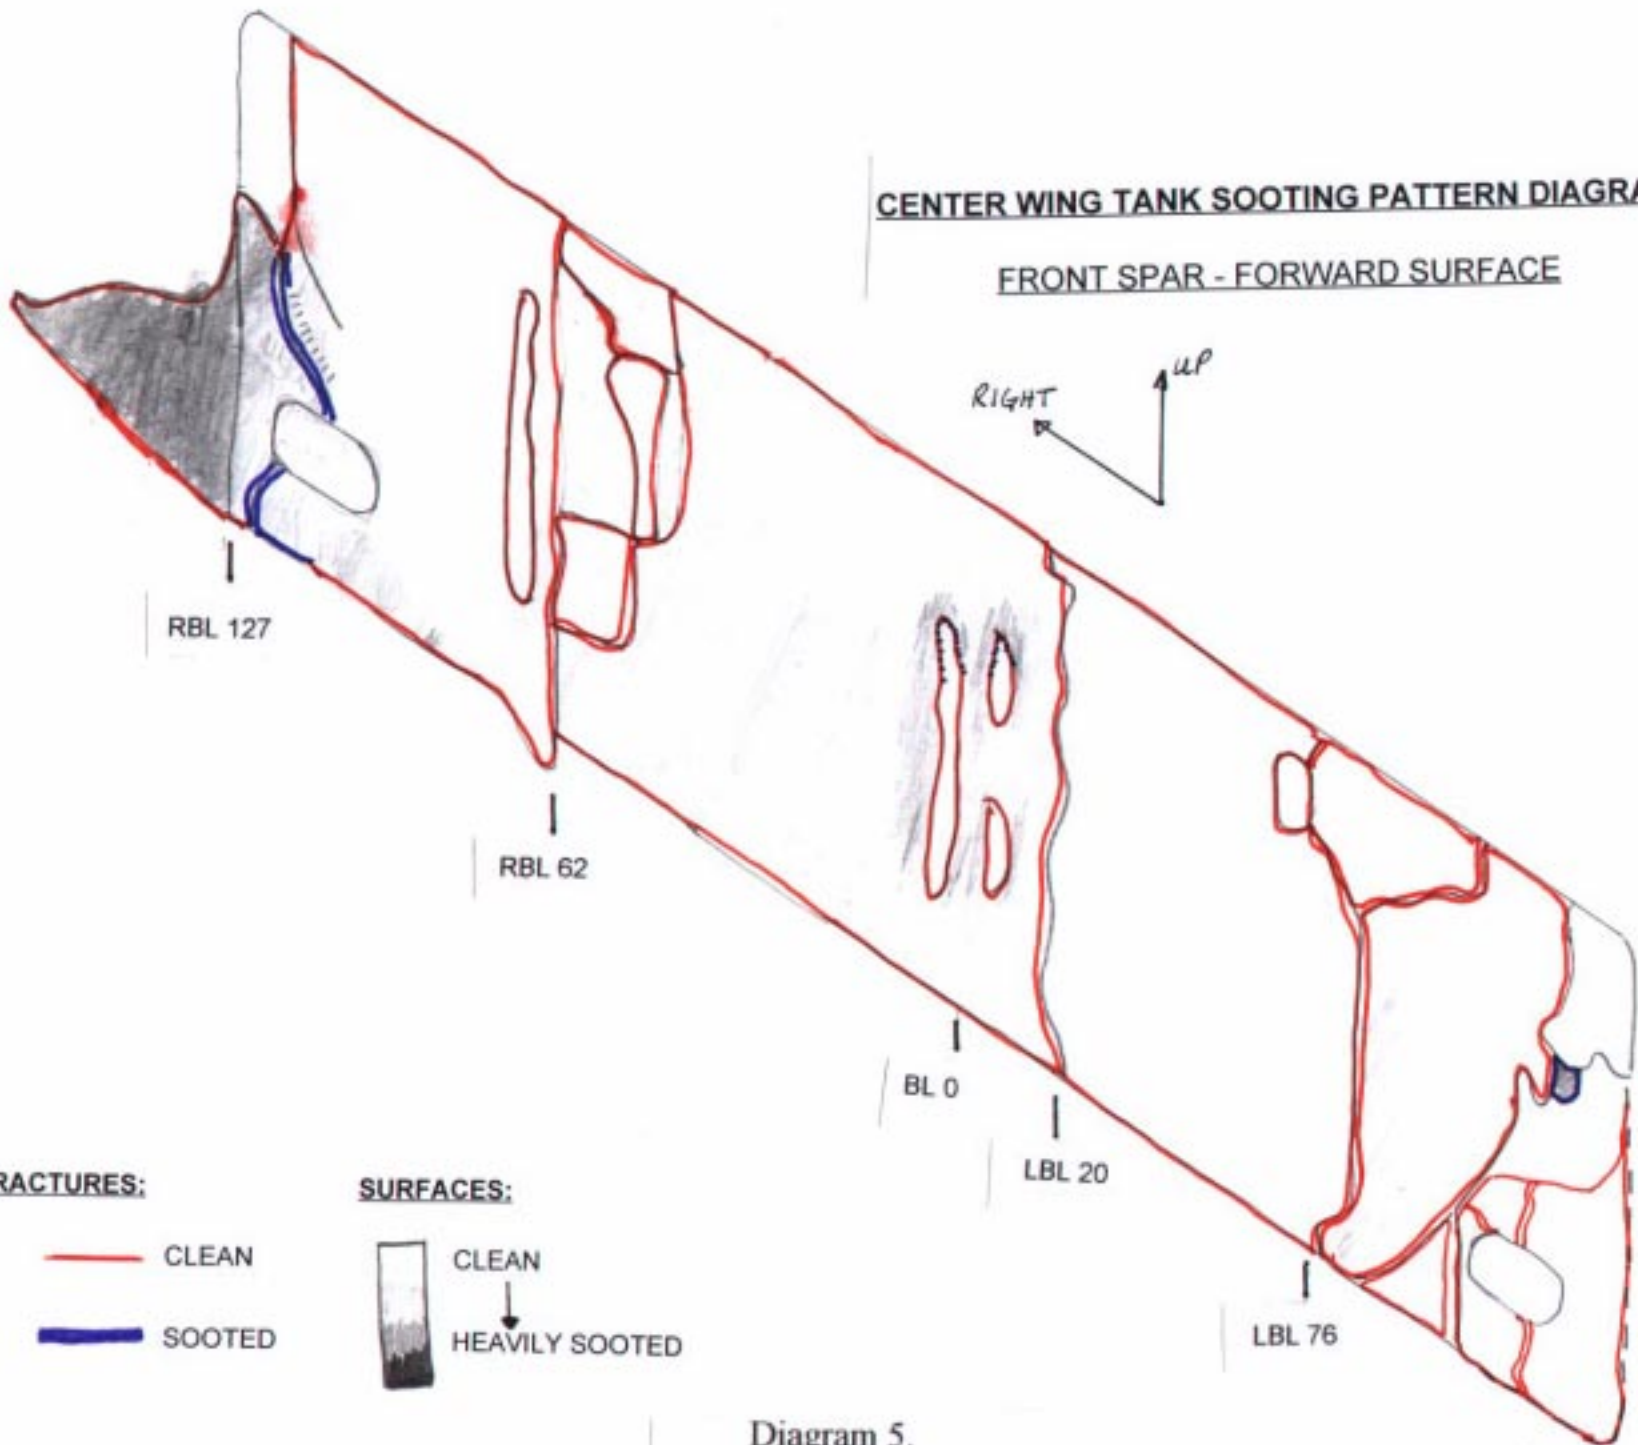
Diagram 5.

CENTER WING TANK SOOTING PATTERN DIAGRAM

FRONT SPAR - FORWARD SURFACE

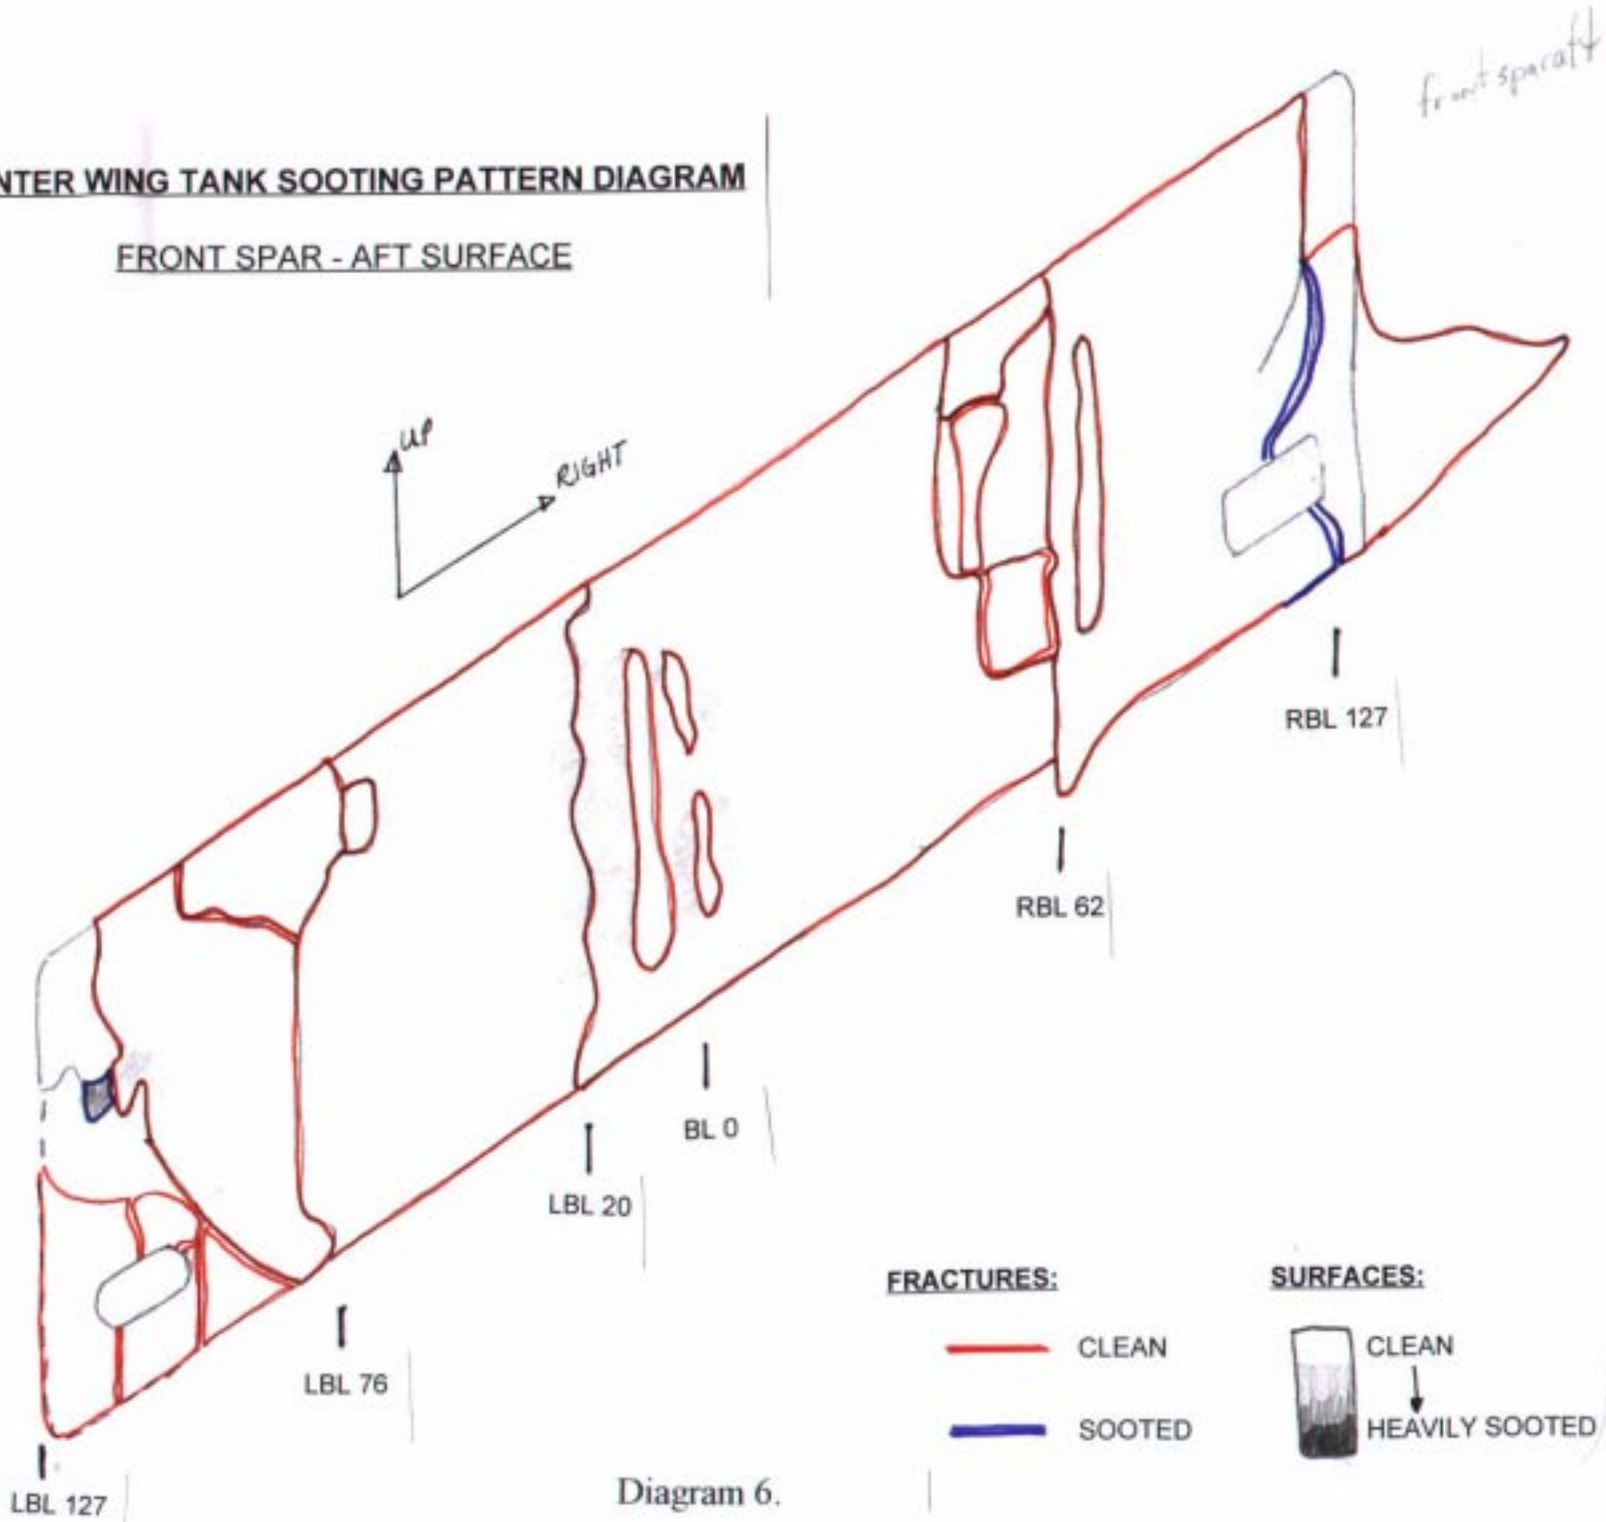
CENTER WING TANK SOOTING PATTERN DIAGRAM

FRONT SPAR - AFT SURFACE

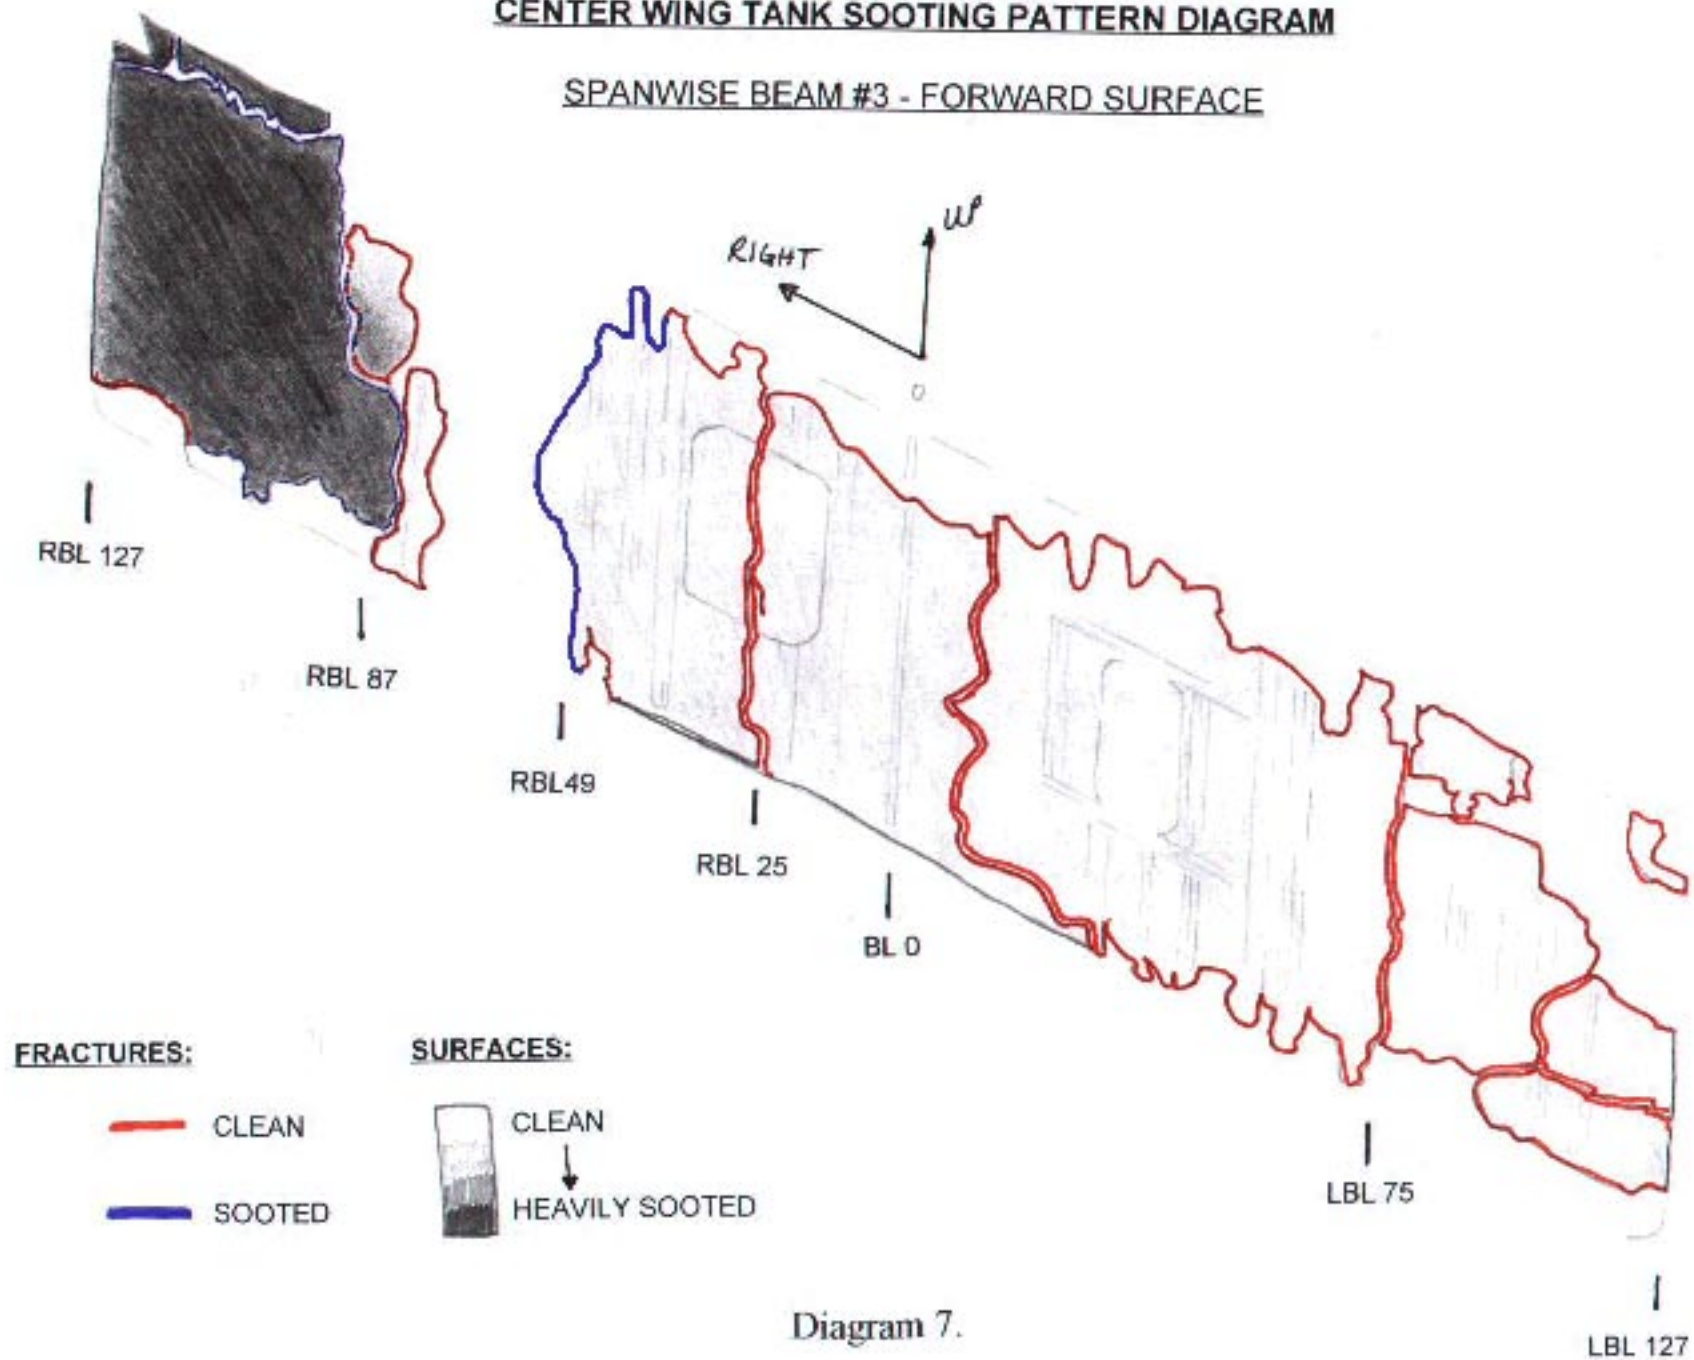
Diagram 7.

CENTER WING TANK SOOTING PATTERN DIAGRAM

SPANWISE BEAM #3 - FORWARD SURFACE

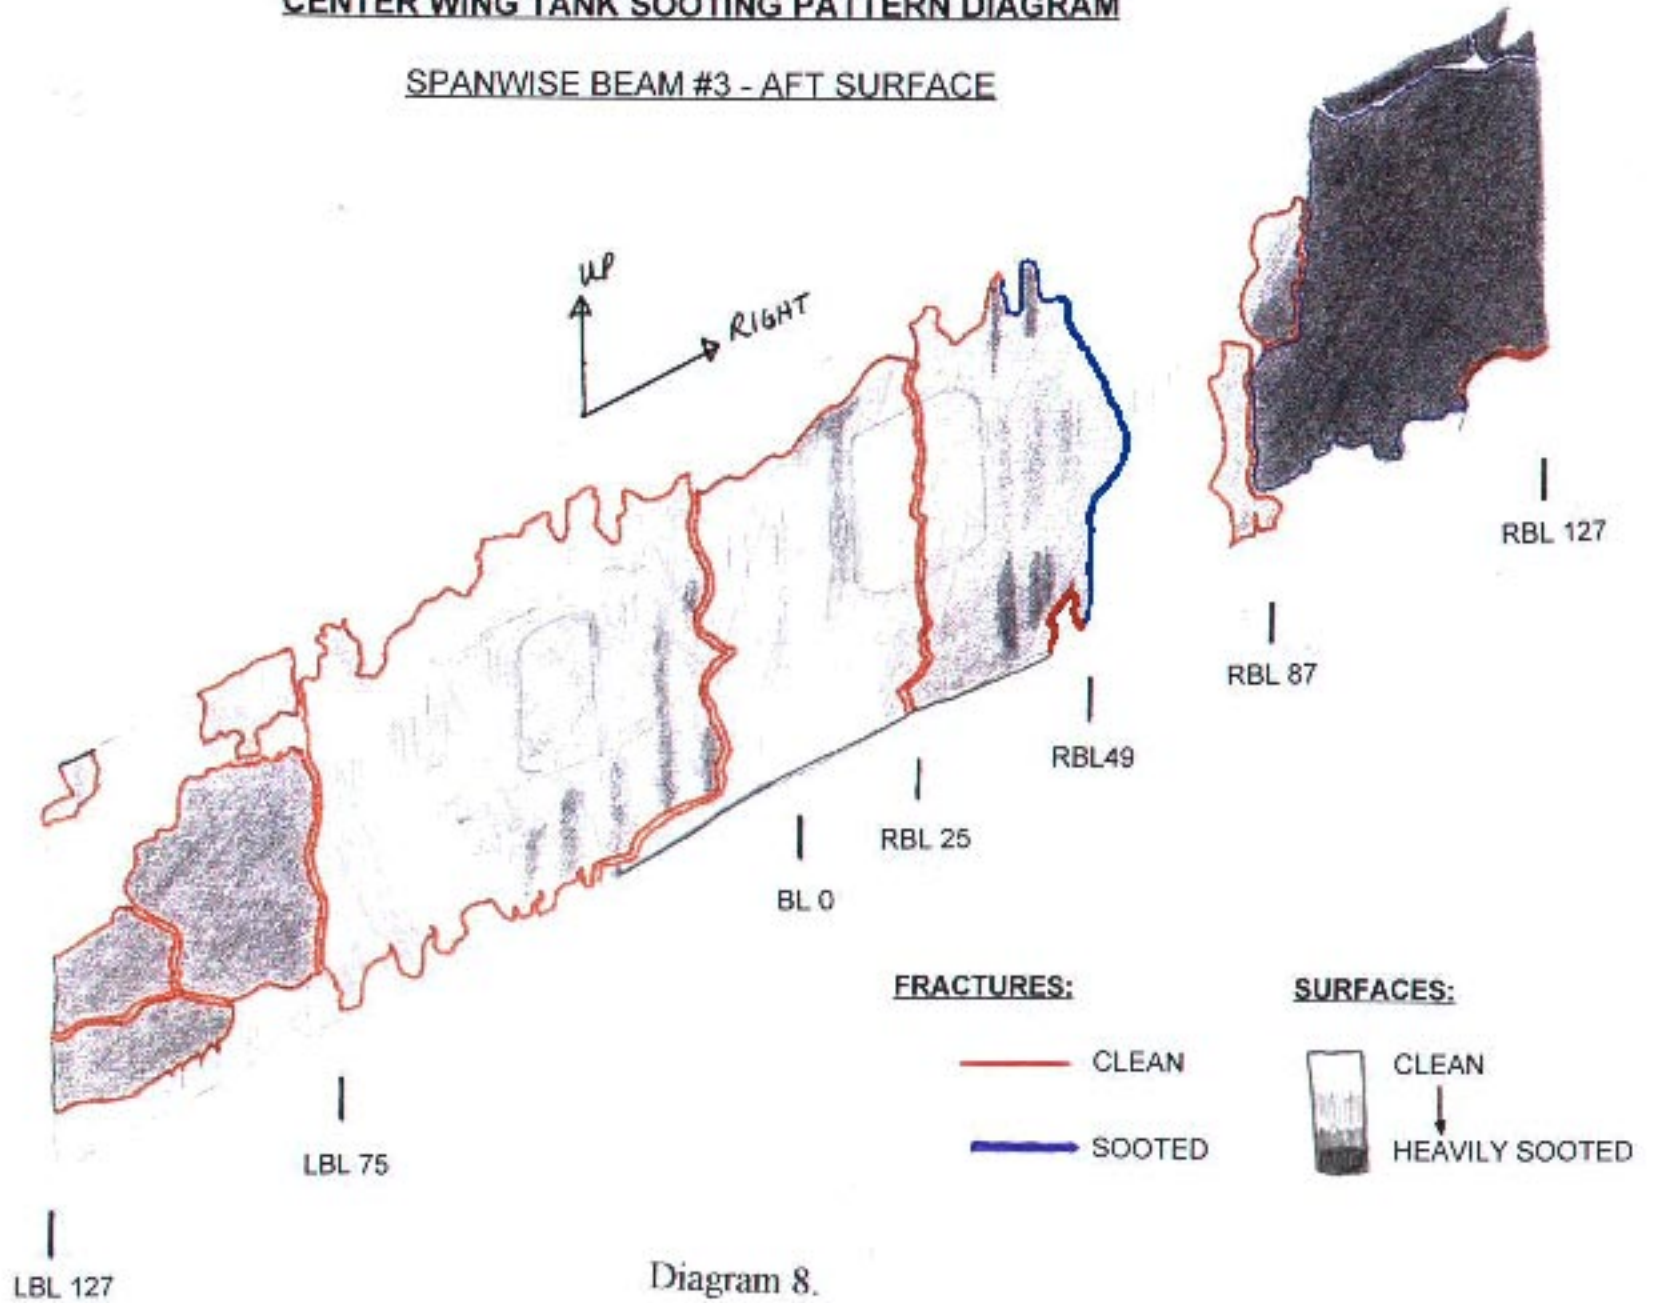
CENTER WING TANK SOOTING PATTERN DIAGRAM

SPANWISE BEAM #3 - AFT SURFACE

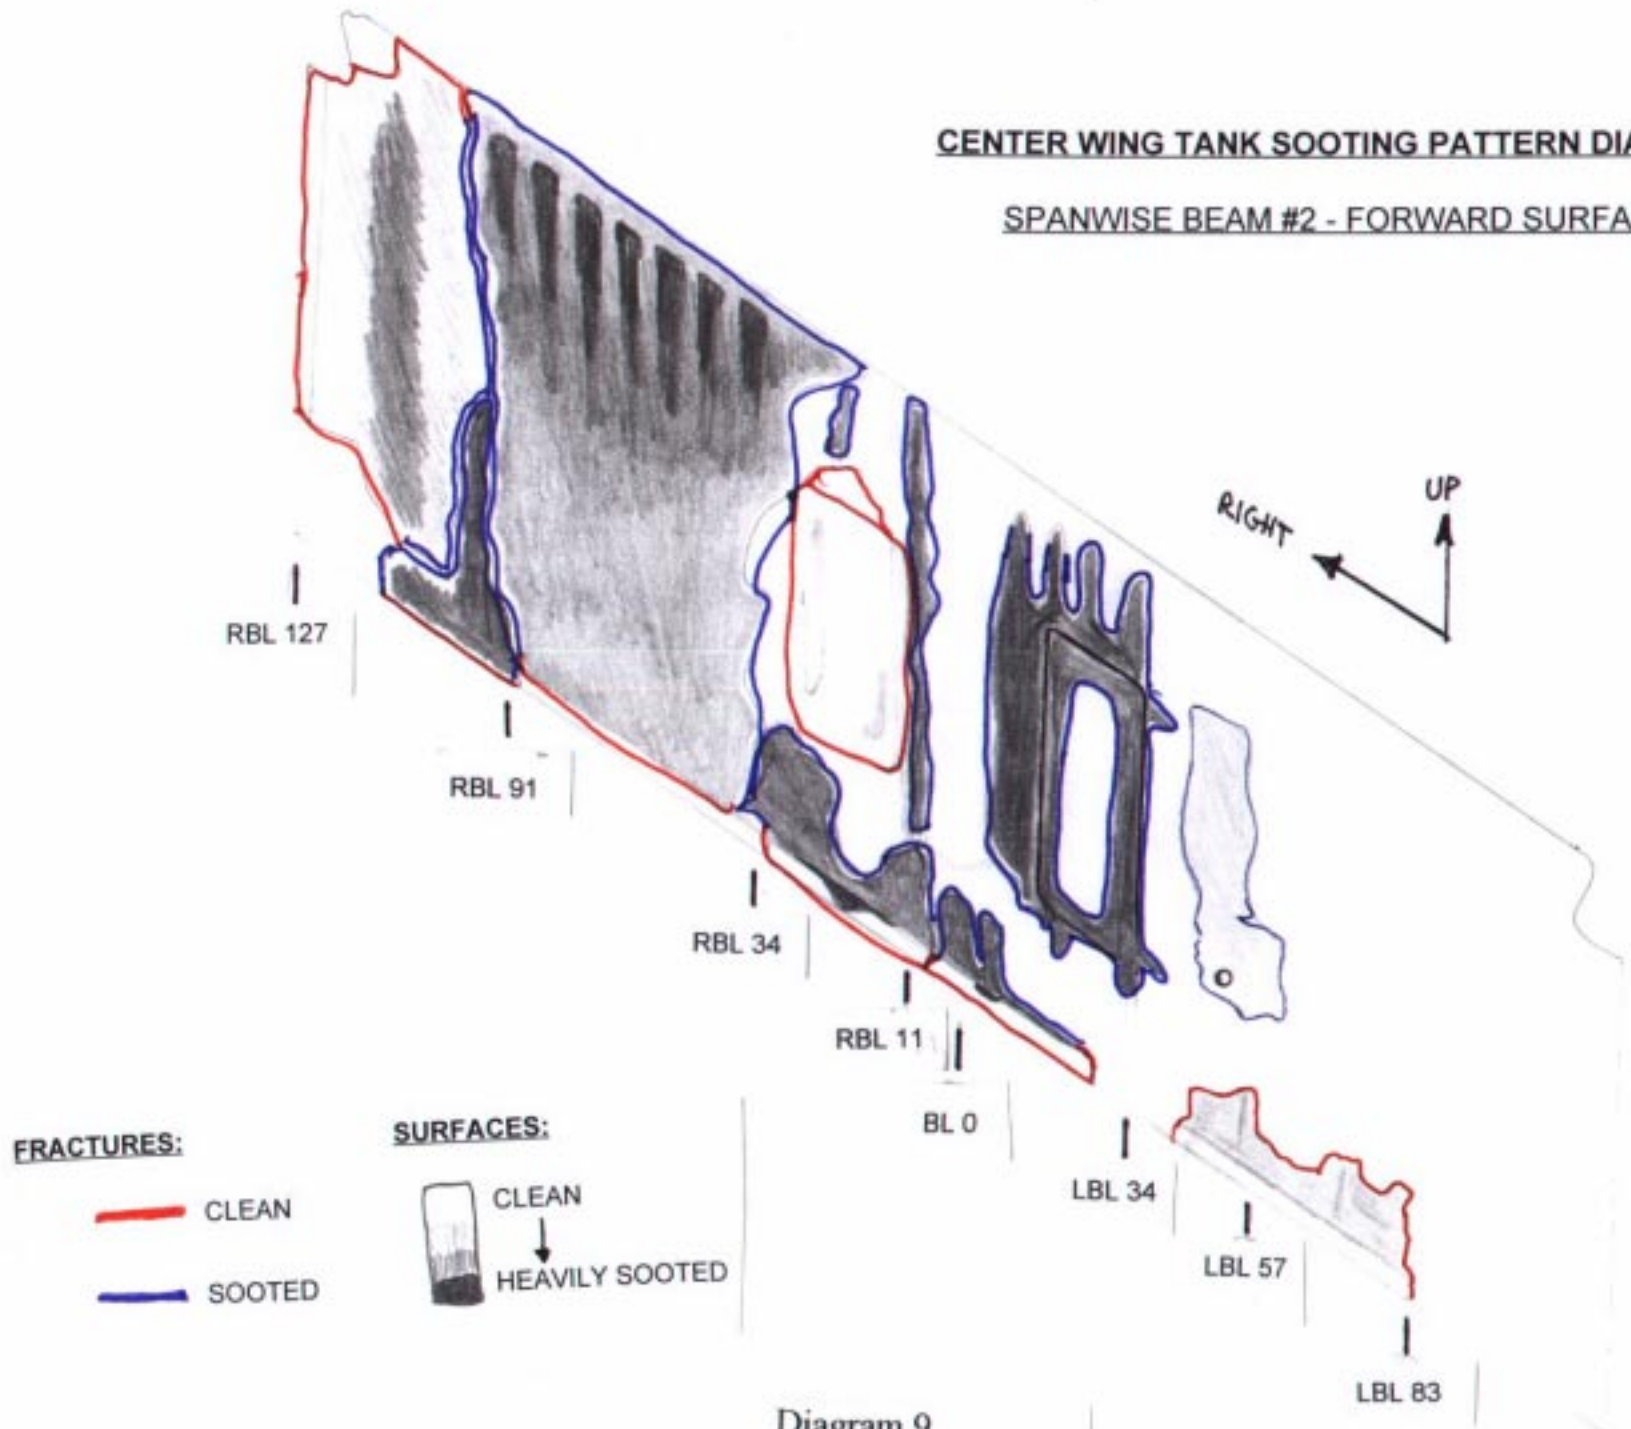
Diagram 9.

CENTER WING TANK SOOTING PATTERN DIAGRAM

SPANWISE BEAM #2 - FORWARD SURFACE

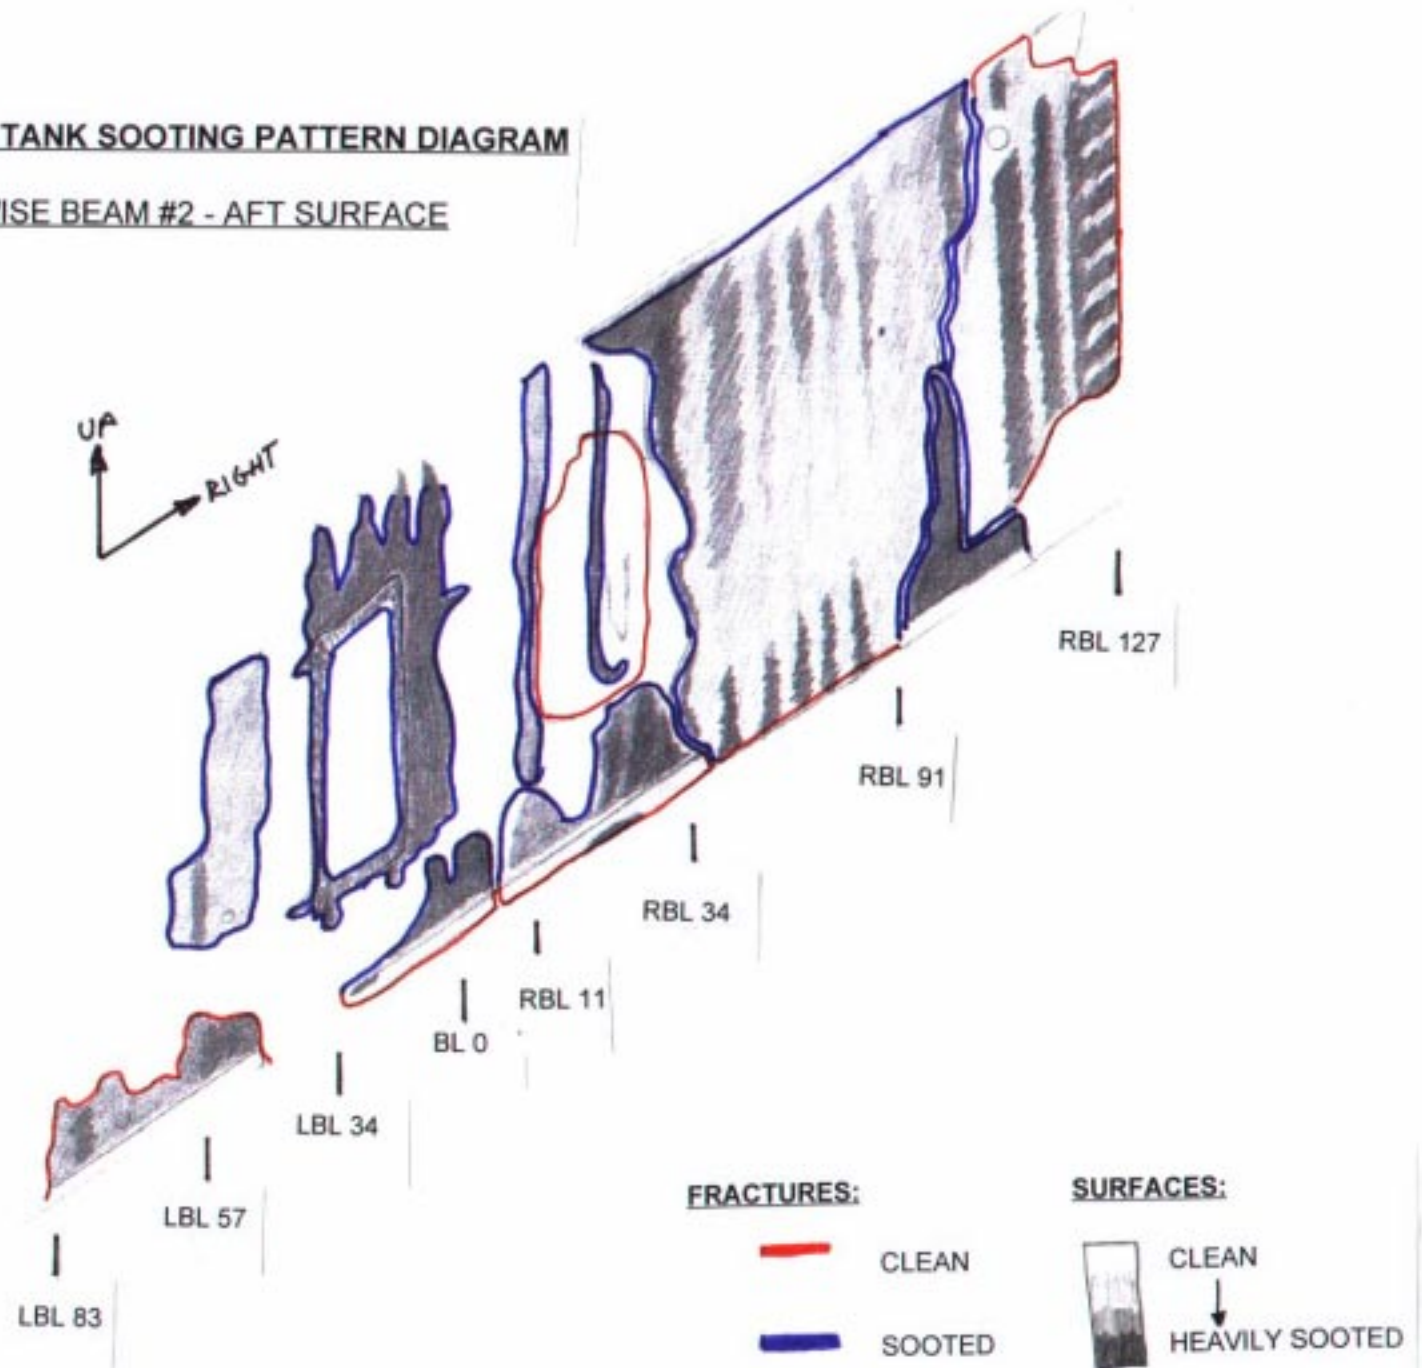
Diagram 10.

CENTER WING TANK SOOTING PATTERN DIAGRAM

SPANWISE BEAM #2 - AFT SURFACE

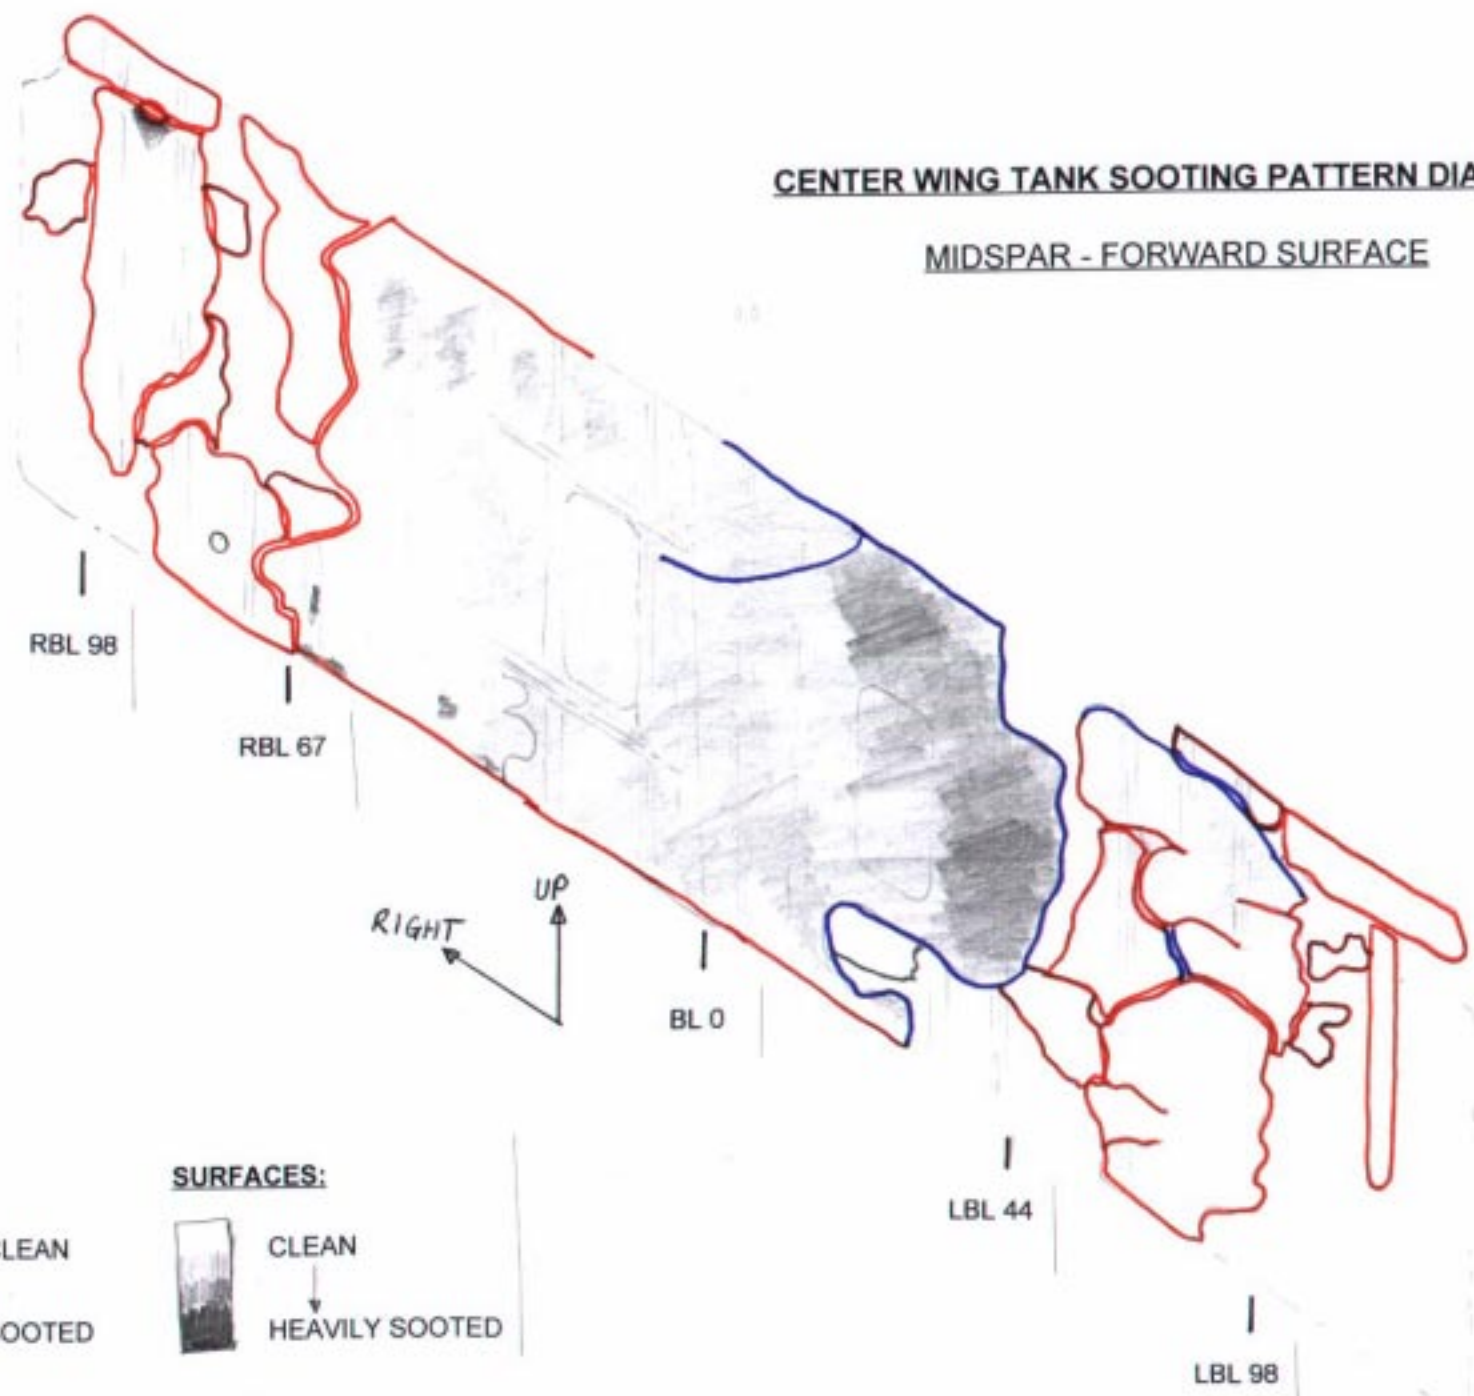
Diagram 11.

CENTER WING TANK SOOTING PATTERN DIAGRAM

MIDSPAR - FORWARD SURFACE
