**NATIONAL TRANSPORTATION SAFETY BOARD
WASHINGTON, D.C.**

**FIRE AND EXPLOSION GROUP FACTUAL REPORT
Appendix II
(Sooting/Fracture Diagrams)
(35 pages)**

TWA FLIGHT 800 ACCIDENT INVESTIGATION

**APPENDIX II
SOOTING/FRACTURE DIAGRAMS**

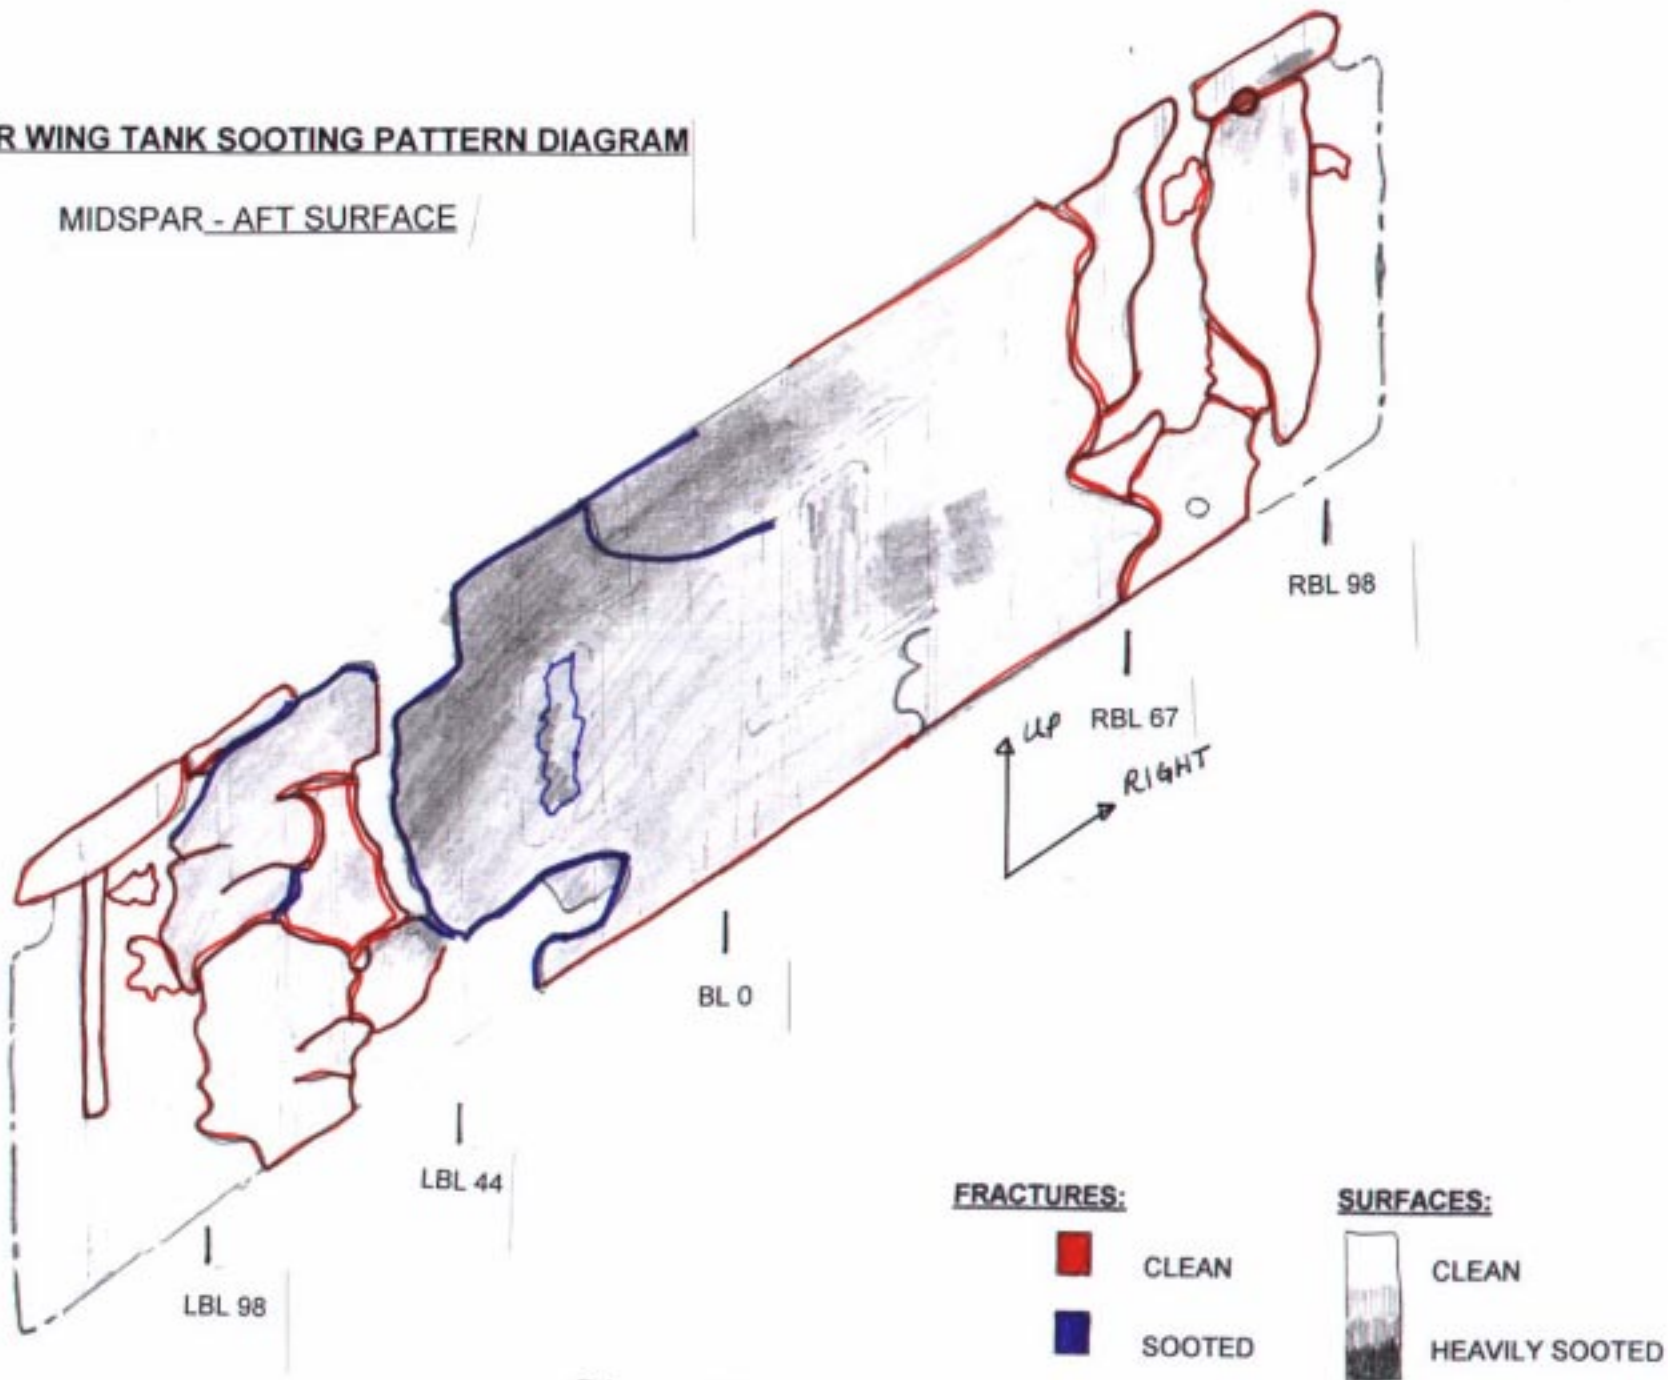
Diagram 12.

CENTER WING TANK SOOTING PATTERN DIAGRAM

MIDSPAR - AFT SURFACE

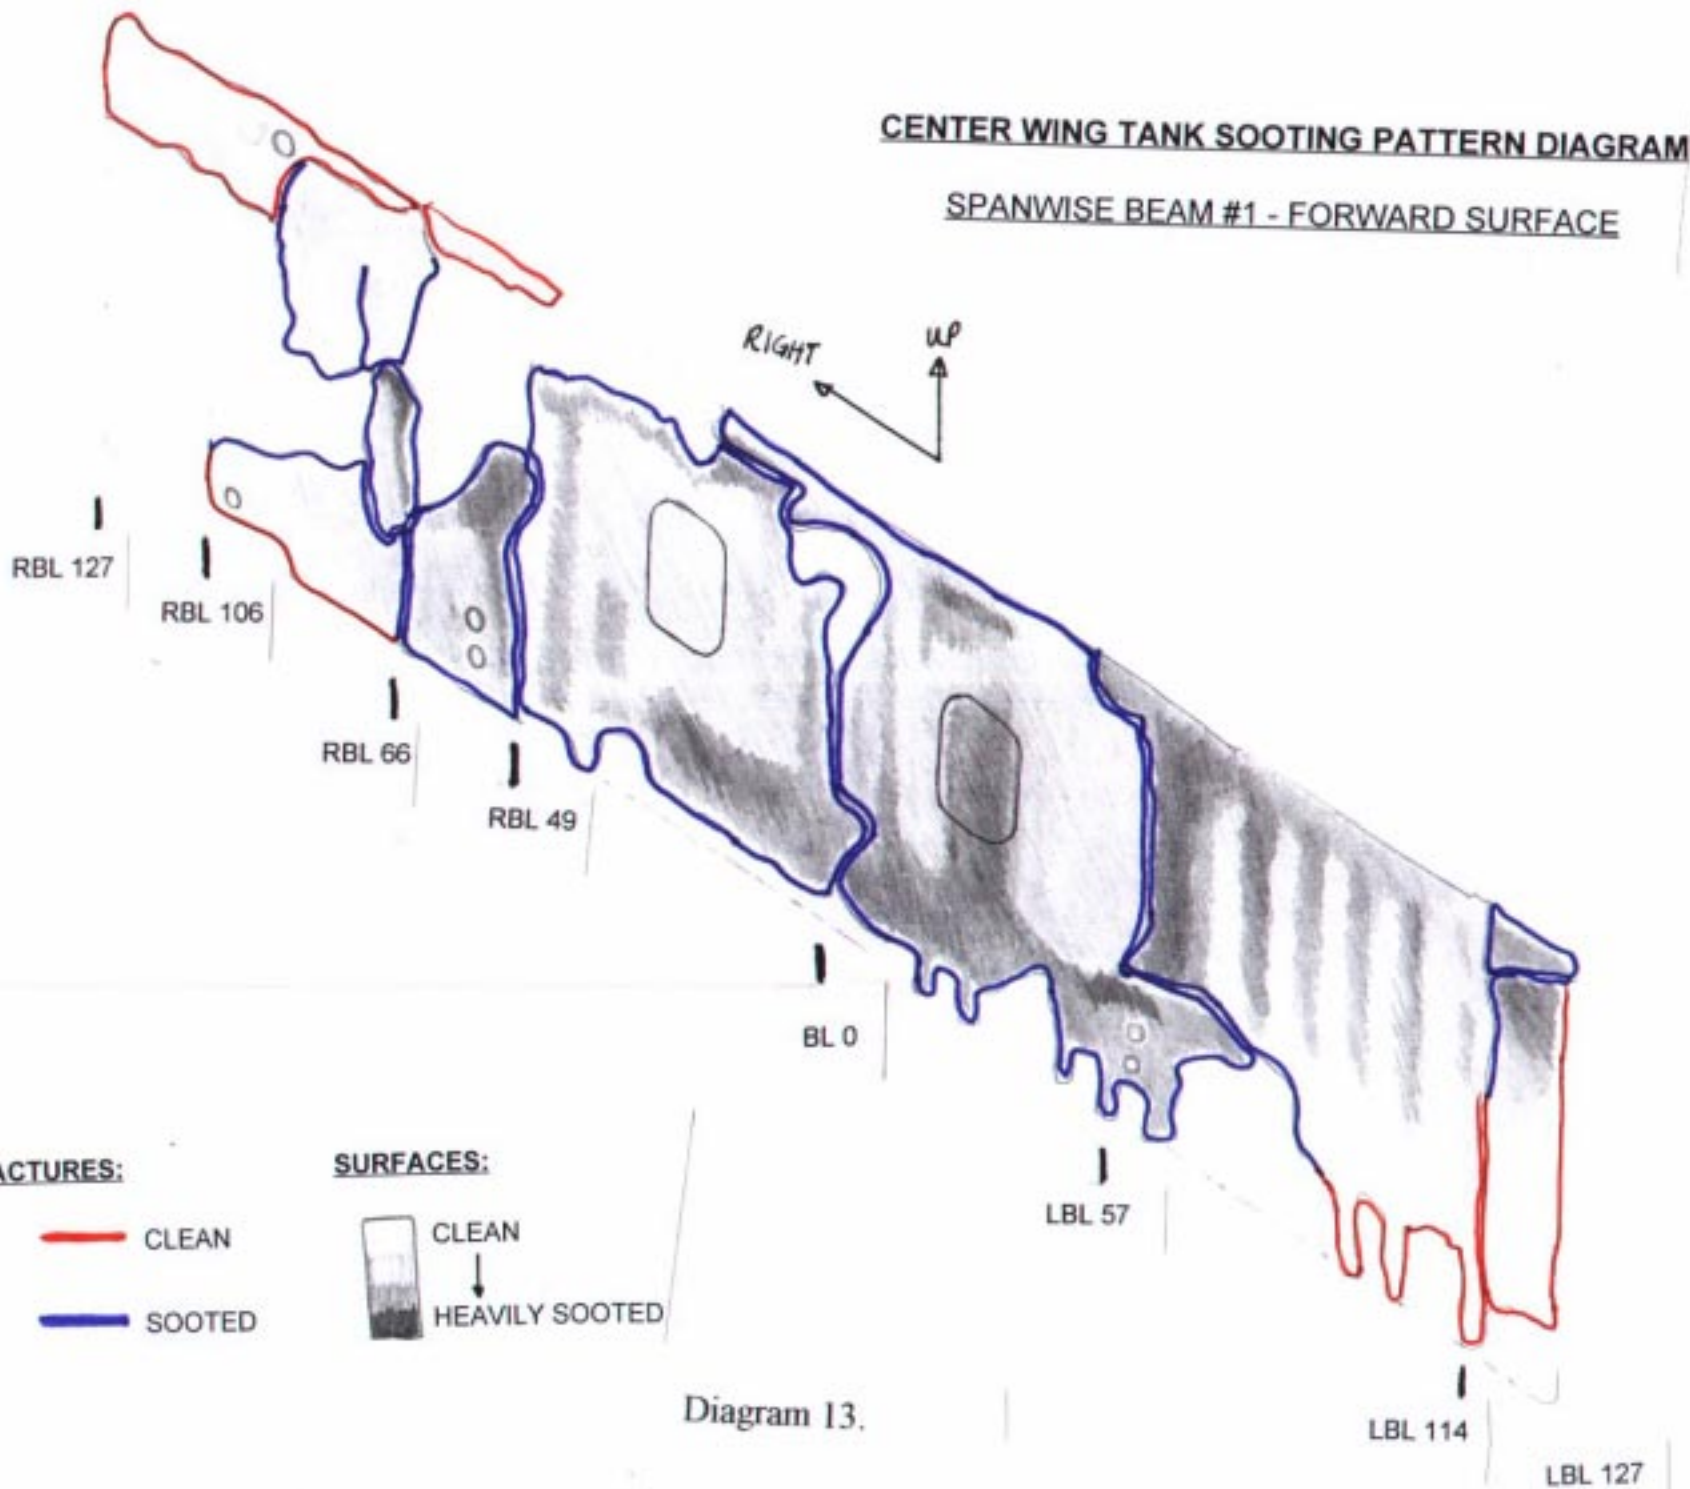
Diagram 13.

CENTER WING TANK SOOTING PATTERN DIAGRAM

SPANWISE BEAM #1 - FORWARD SURFACE

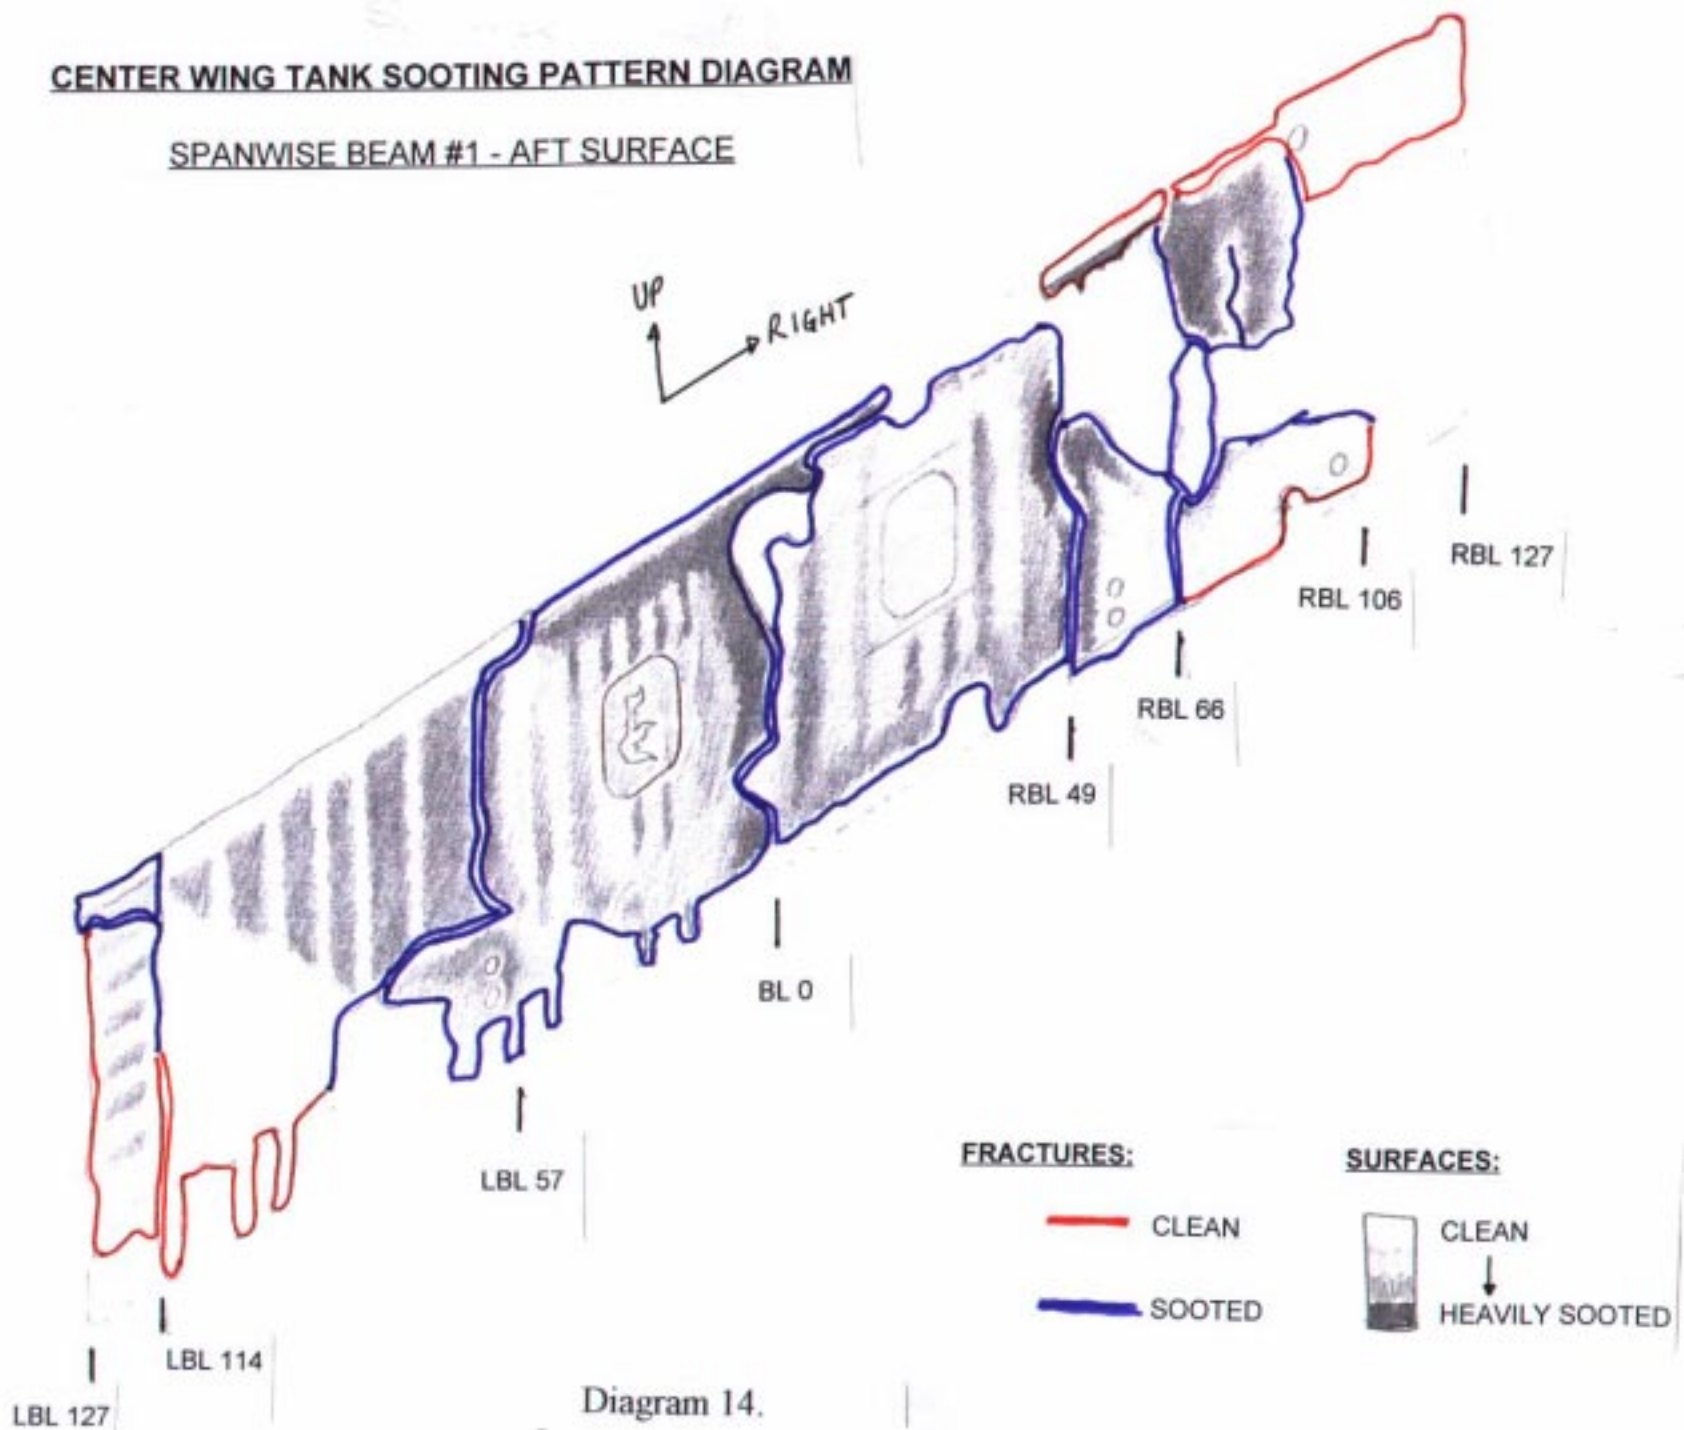
Diagram 14.

CENTER WING TANK SOOTING PATTERN DIAGRAM

SPANWISE BEAM #1 - AFT SURFACE

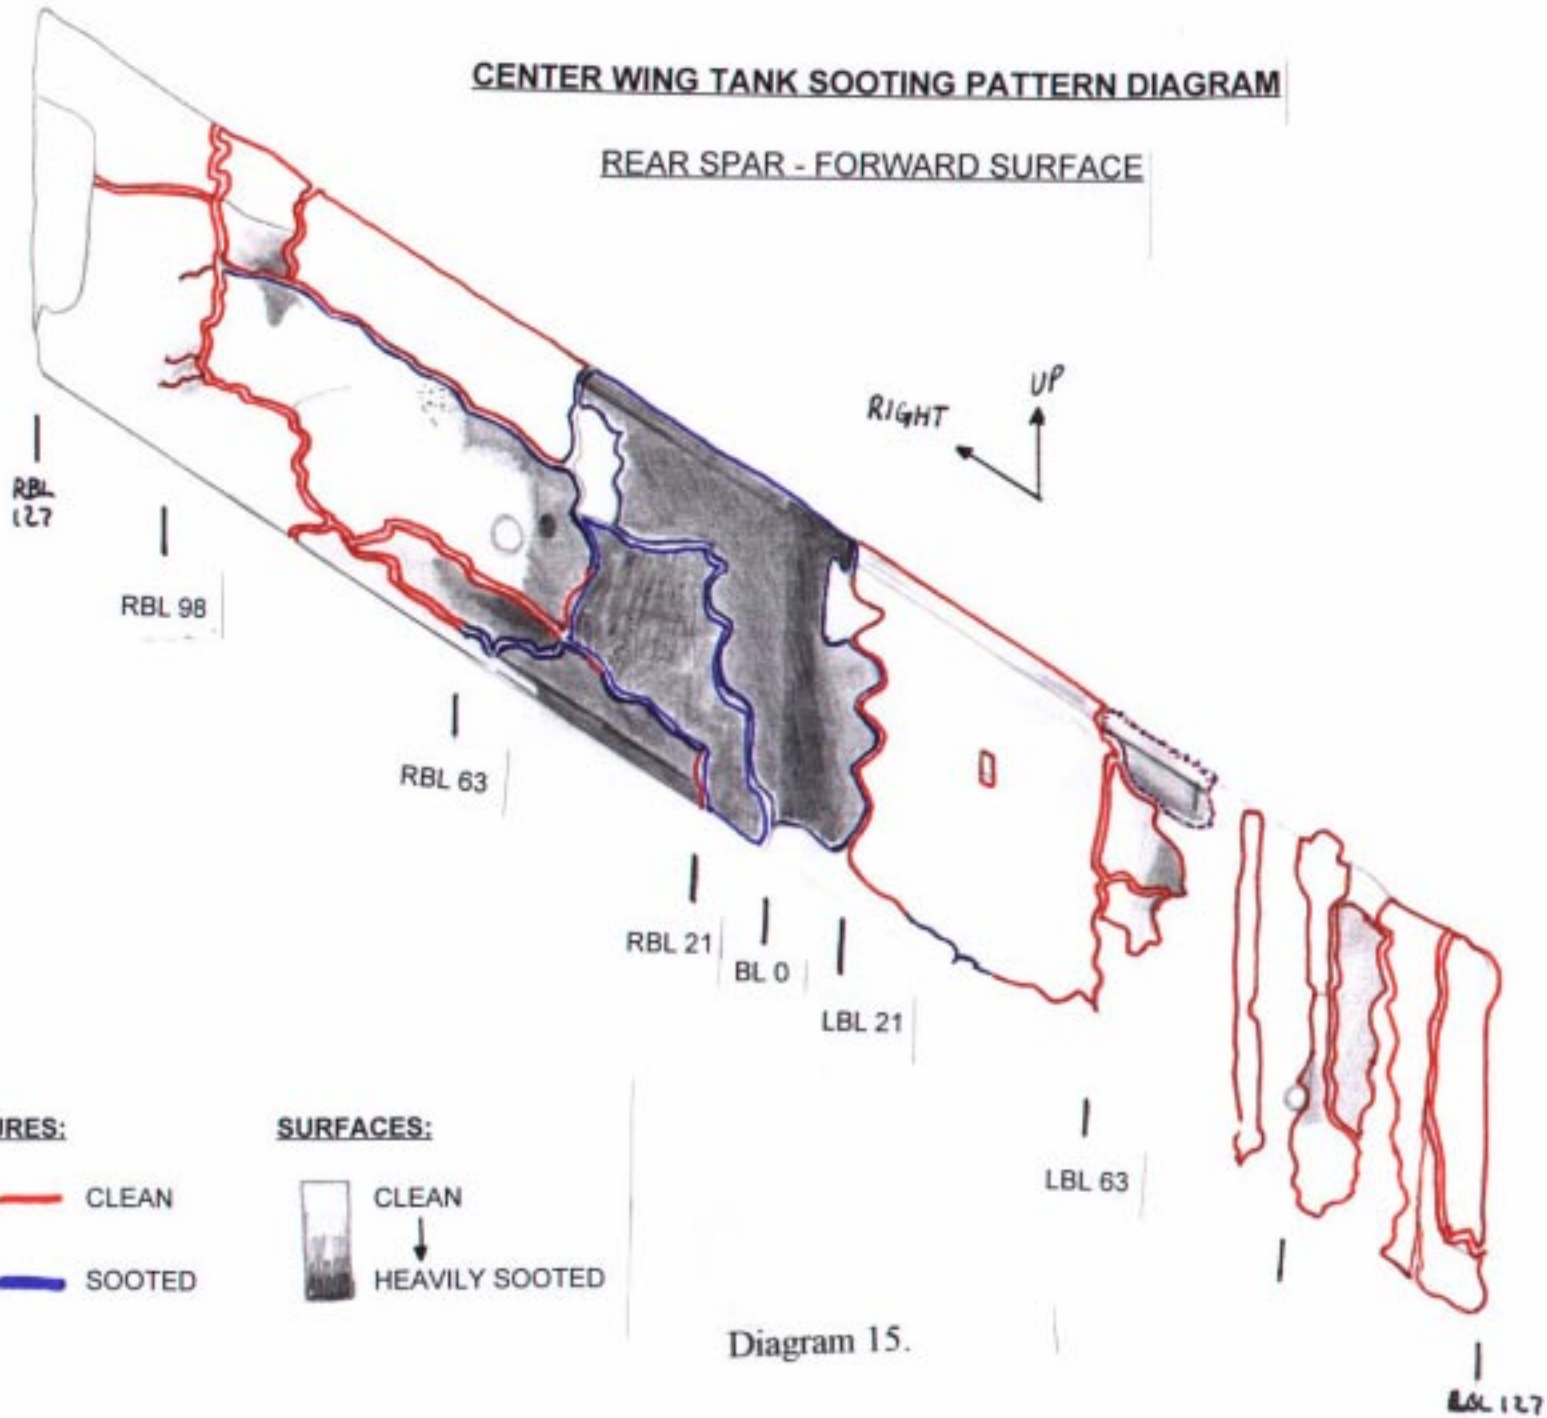
Diagram 15.

CENTER WING TANK SOOTING PATTERN DIAGRAM

REAR SPAR - FORWARD SURFACE

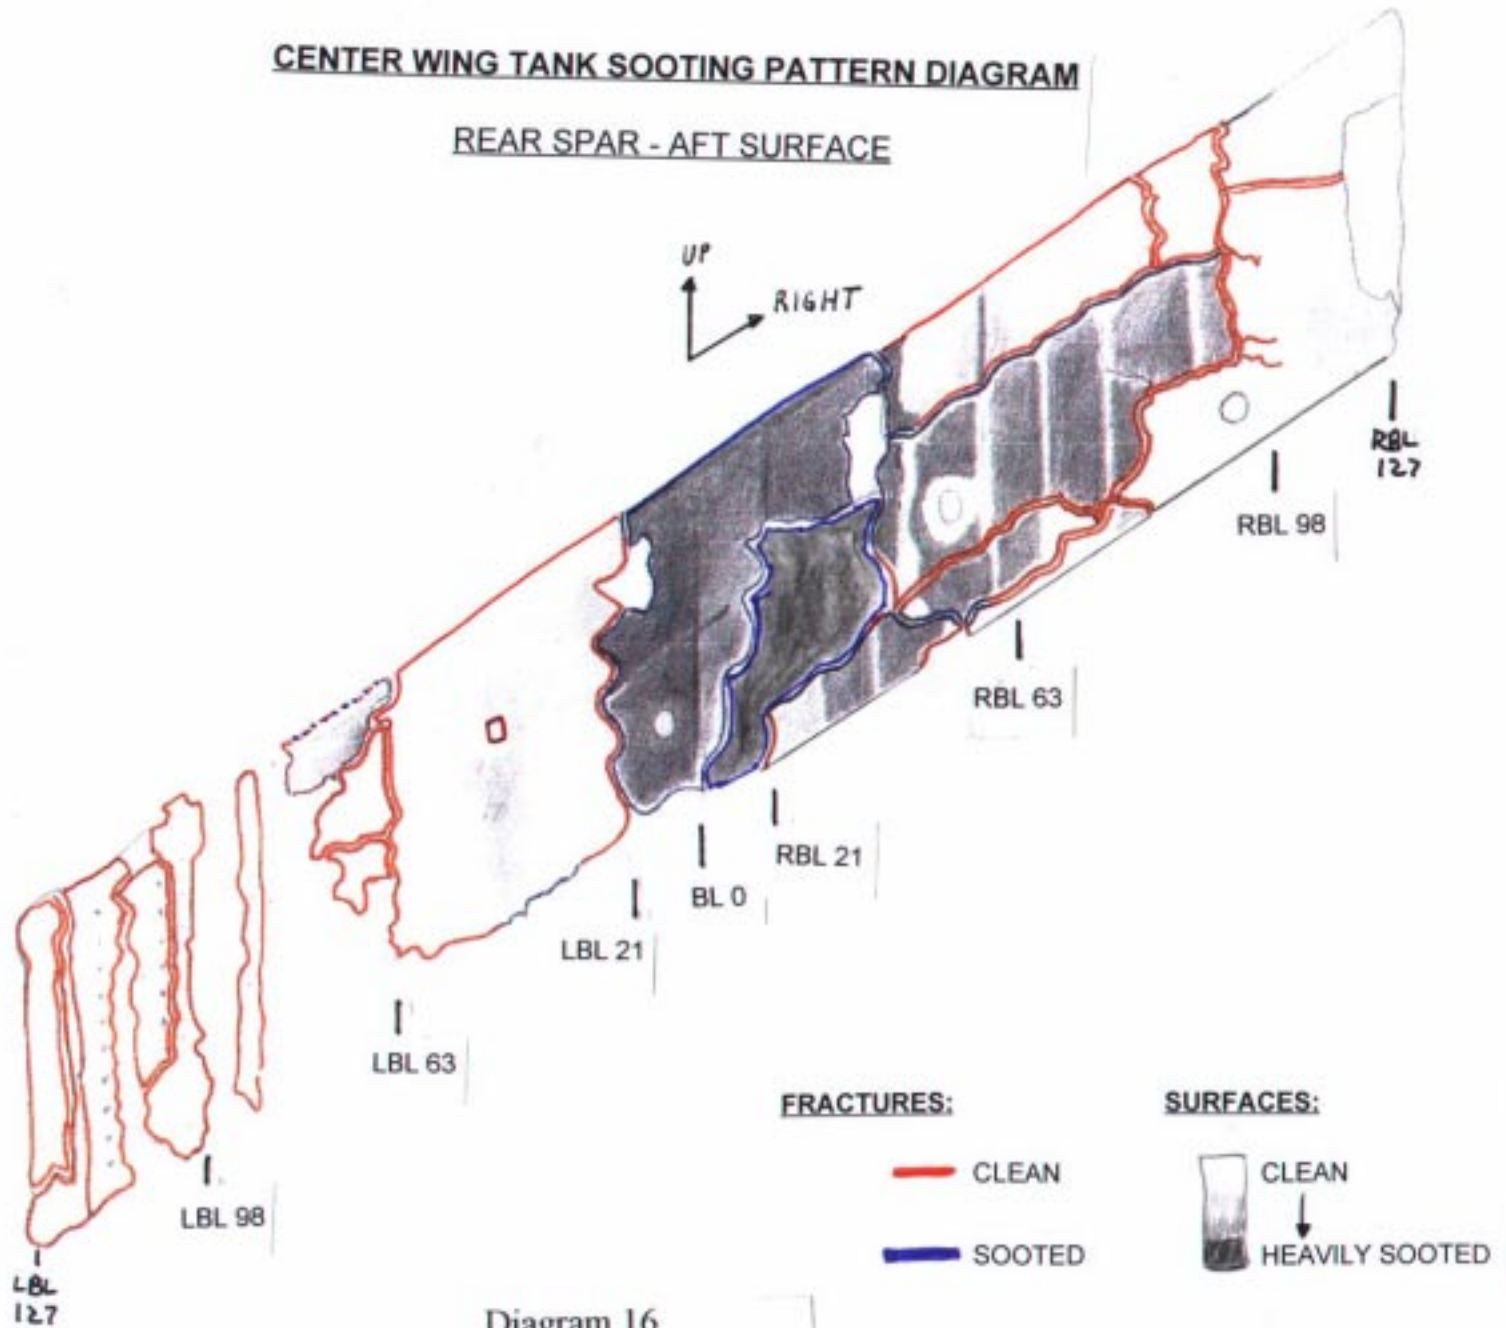
Diagram 16.

CENTER WING TANK SOOTING PATTERN DIAGRAM

REAR SPAR - AFT SURFACE

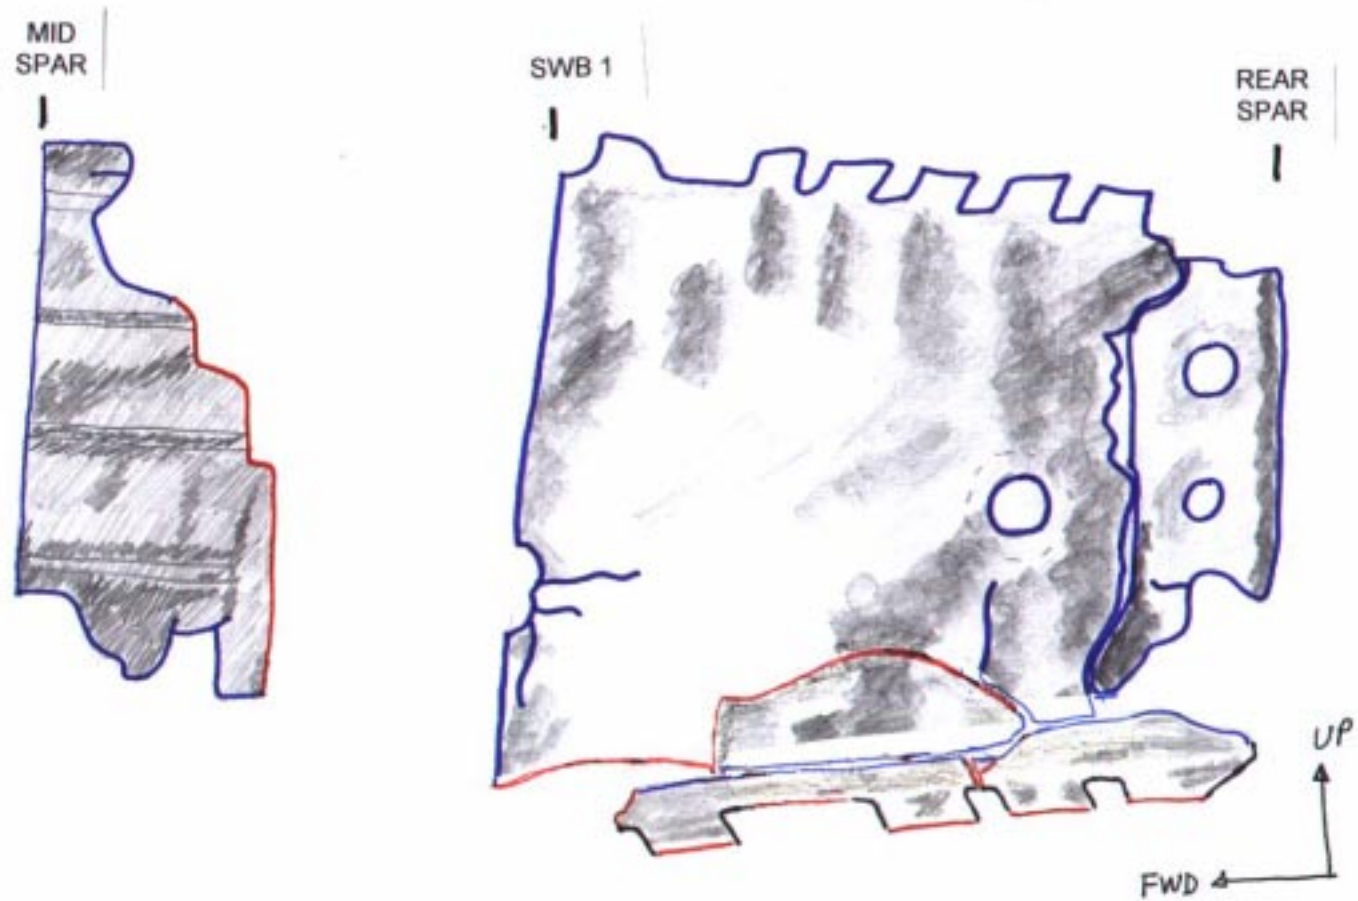
Diagram 17.

CENTER WING TANK SOOTING PATTERN DIAGRAM

BL 0 RIB - LEFT SURFACE

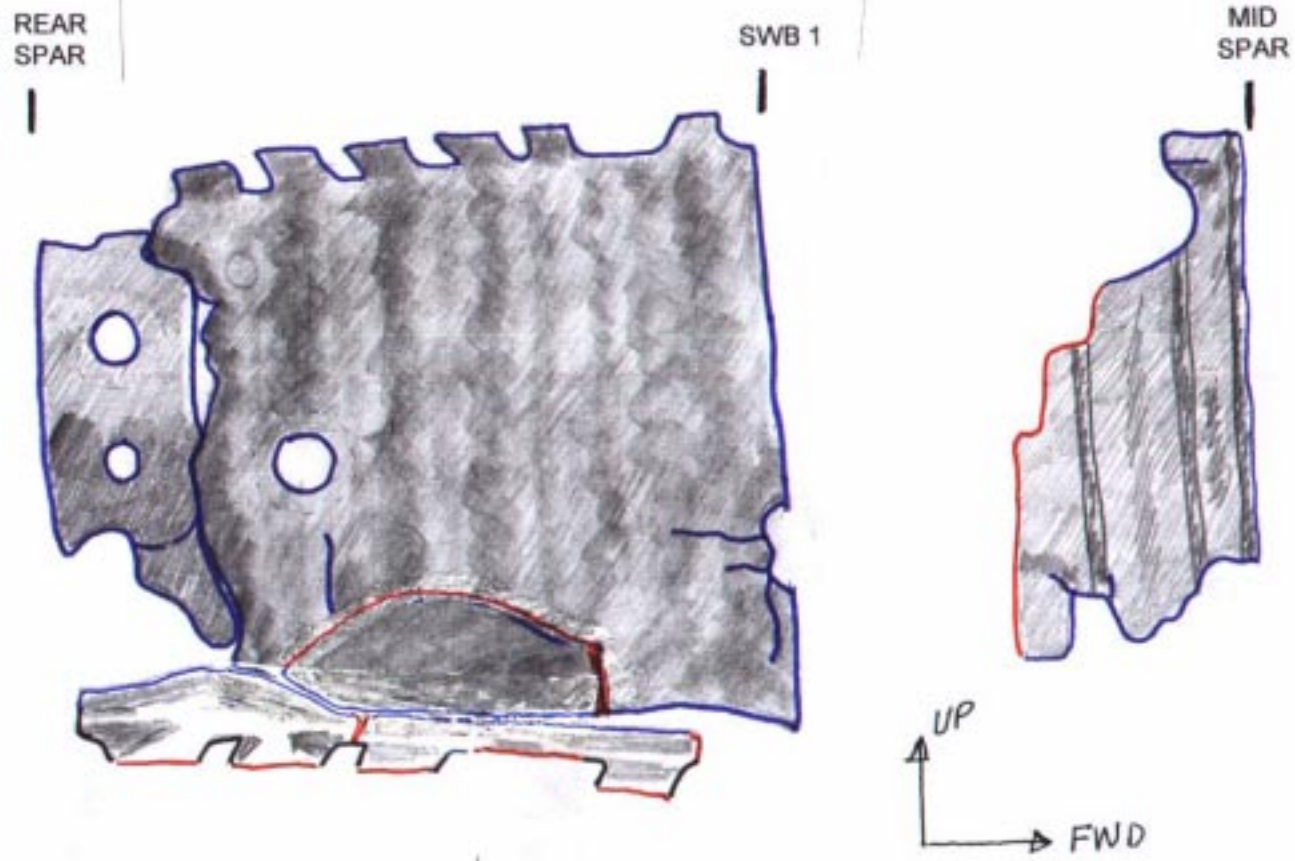
Diagram 18.

CENTER WING TANK SOOTING PATTERN DIAGRAM

BL 0 RIB - RIGHT SURFACE

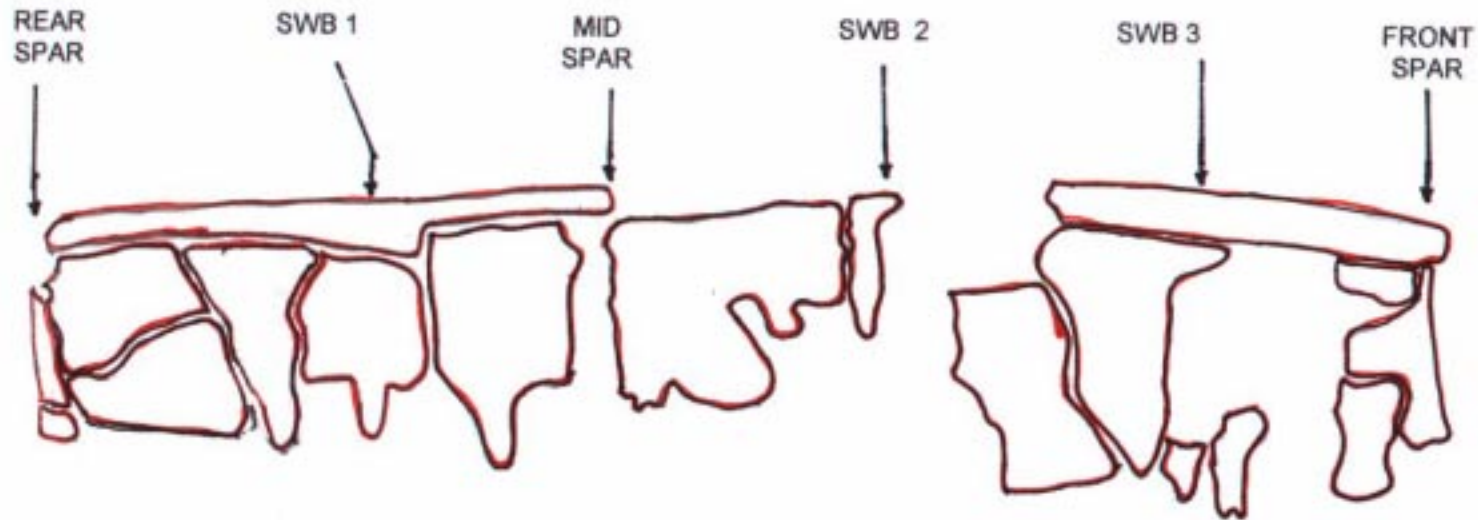
Diagram 19.

CENTER WING TANK SOOTING PATTERN DIAGRAM

RIGHTHAND SIDE OF BODY RIB - OUTBOARD SURFACE

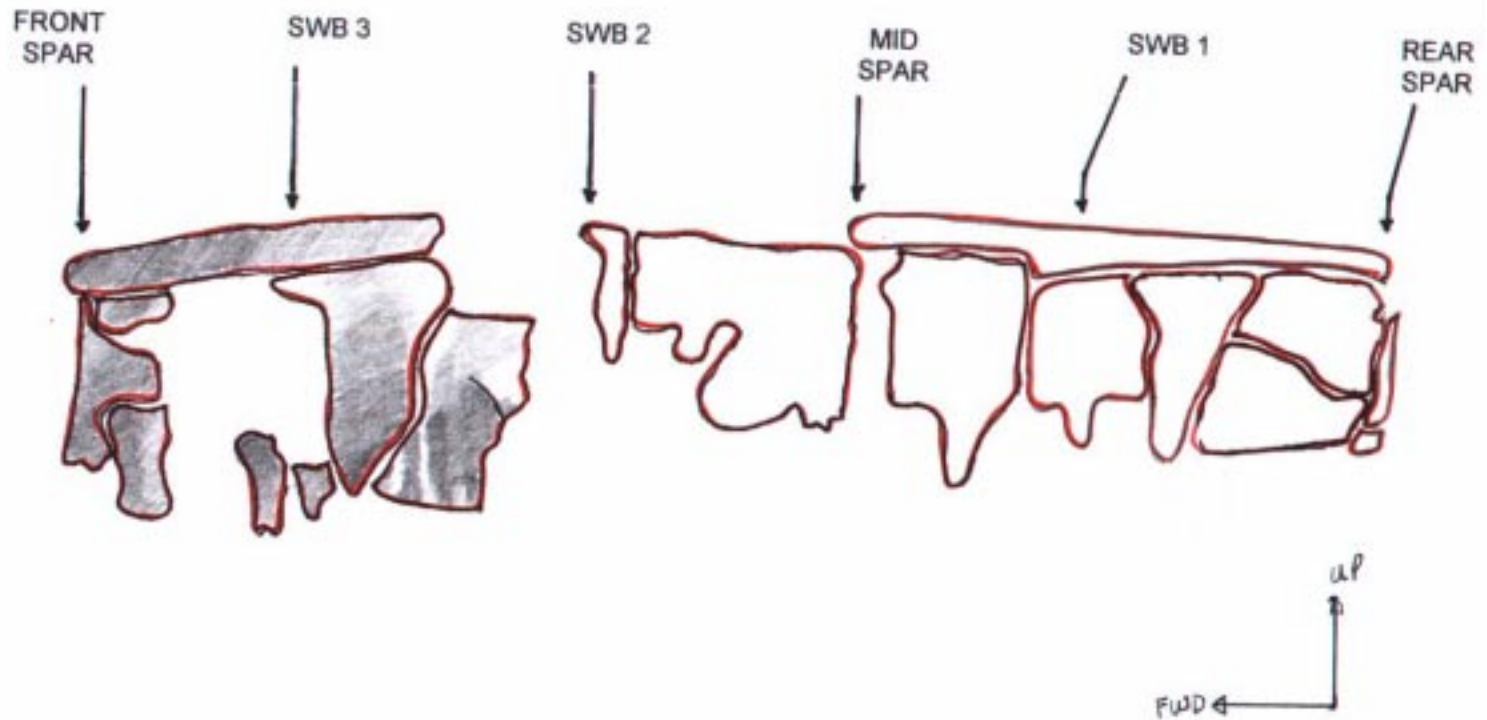
Diagram 20.

CENTER WING TANK SOOTING PATTERN DIAGRAM
RIGHTHAND SIDE OF BODY RIB - INBOARD SURFACE

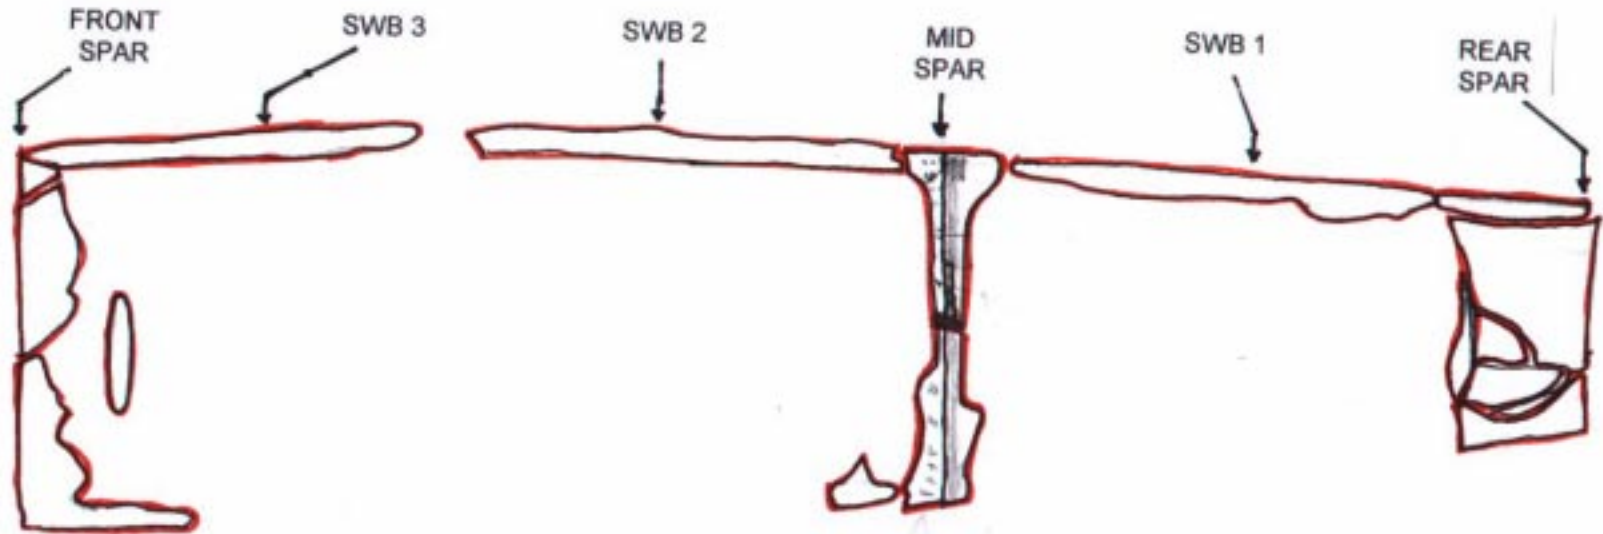
Diagram 21.

CENTER WING TANK SOOTING PATTERN DIAGRAM

LEFTHAND SIDE OF BODY RIB - OUTBOARD SURFACE

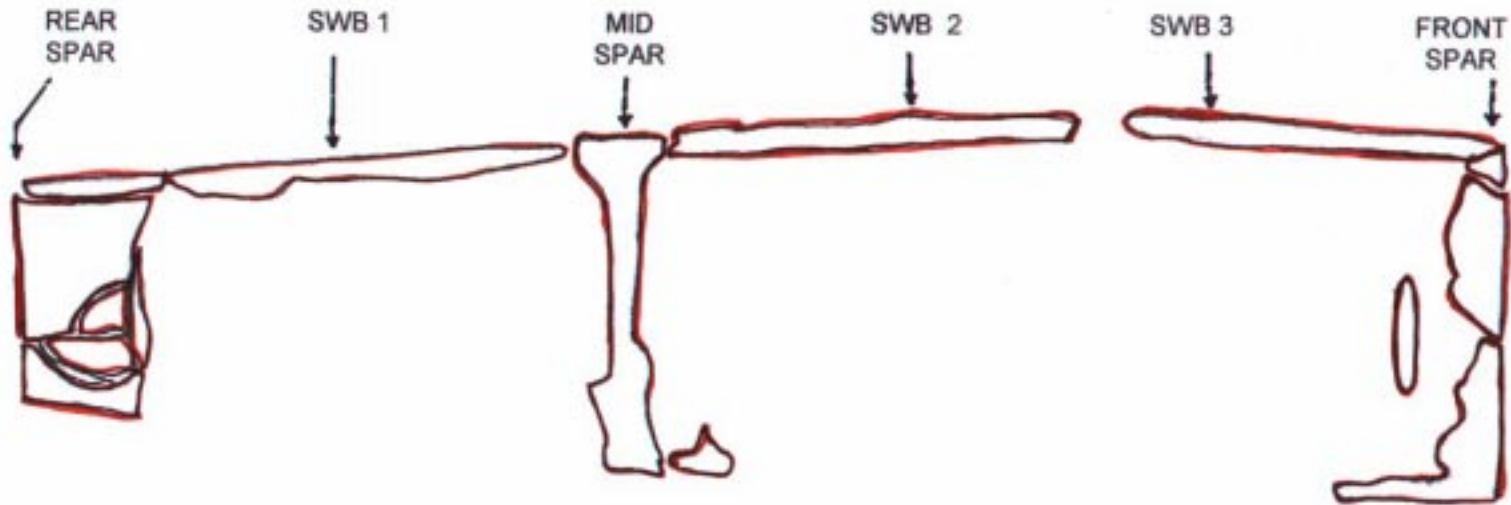
Diagram 22.

CENTER WING TANK SOOTING PATTERN DIAGRAM

LEFTHAND SIDE OF BODY RIB - INBOARD SURFACE

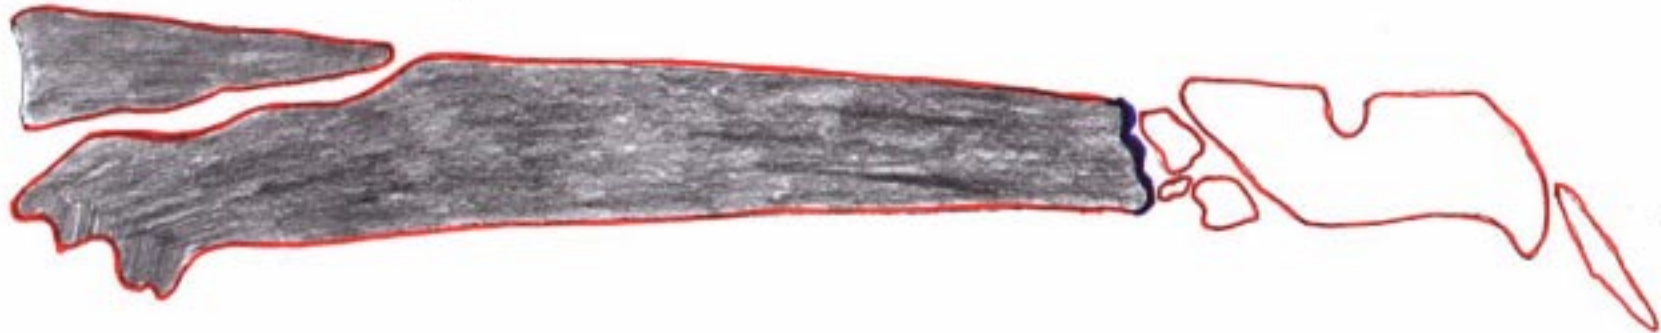
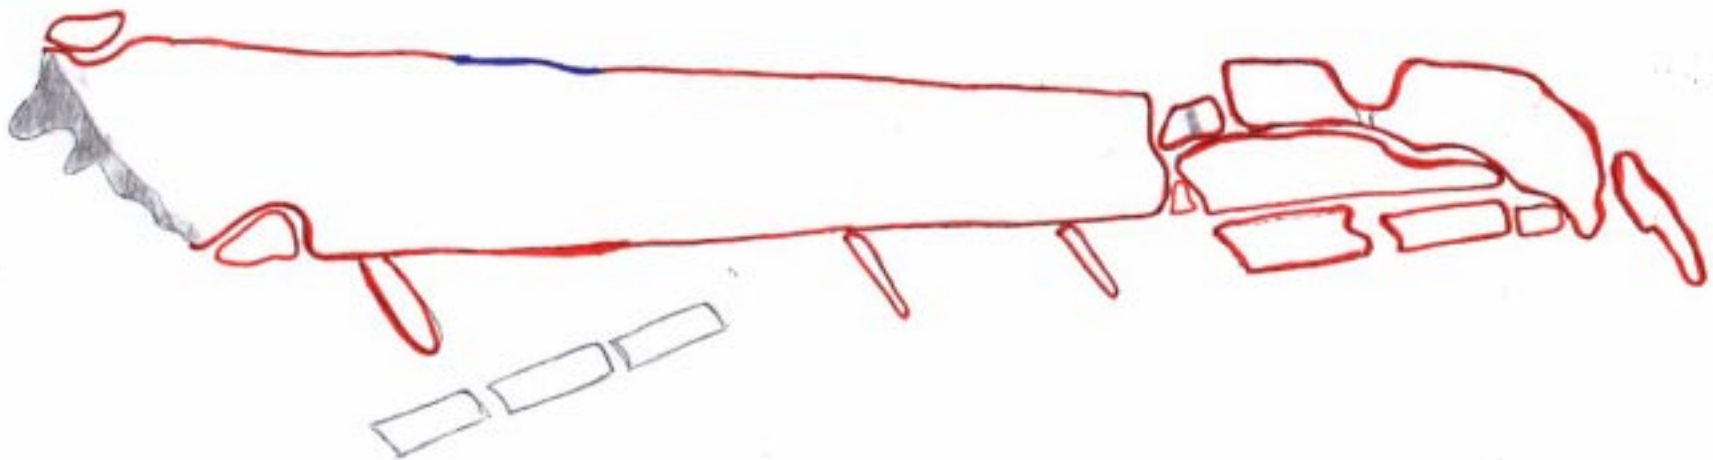
Diagram 23.

RIGHT WING SOOTING PATTERN DIAGRAM

UPPER SKIN - EXTERNAL SURFACE

LOWER SKIN - EXTERNAL SURFACE

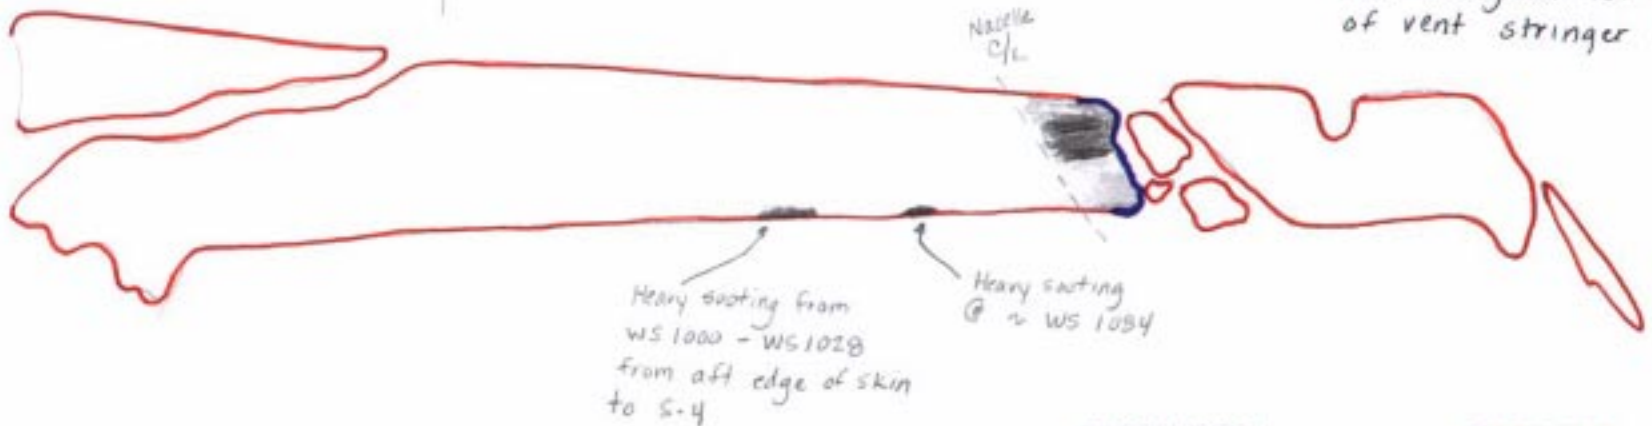
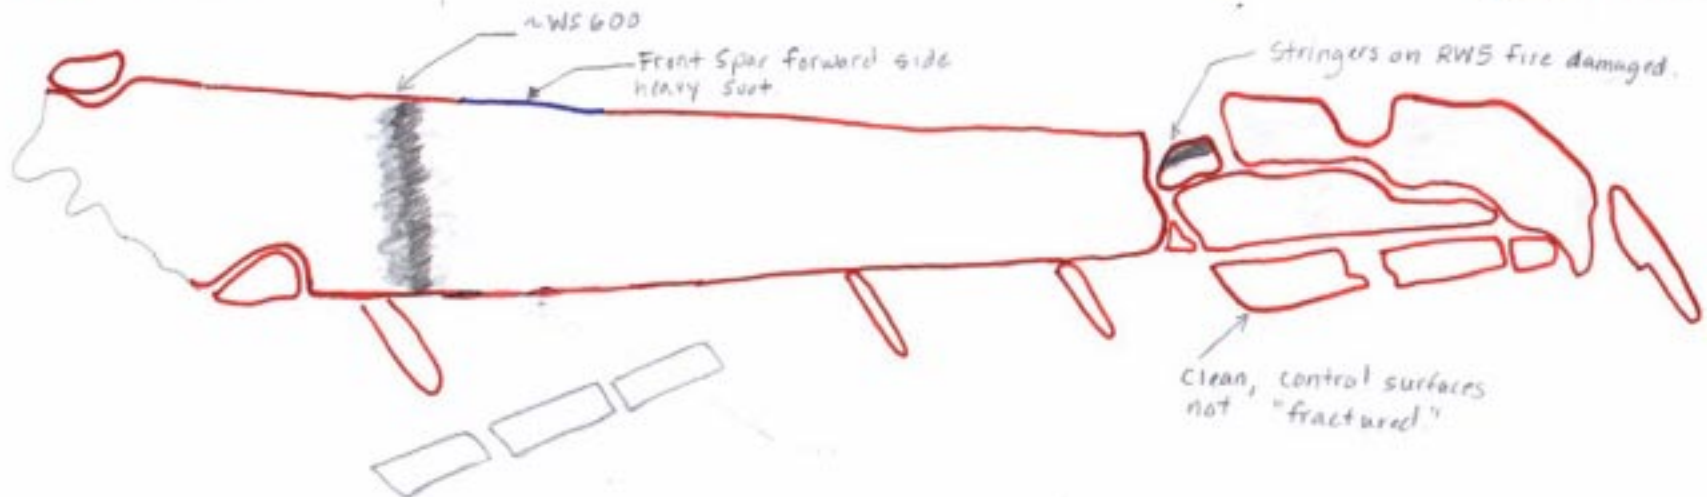
Diagram 24.

RIGHT WING SOOTING PATTERN DIAGRAM

UPPER SKIN - INTERNAL SURFACE

NOTE: See Vent Stringer soot diagram for details of vent stringer sooting.

LOWER SKIN - INTERNAL SURFACE

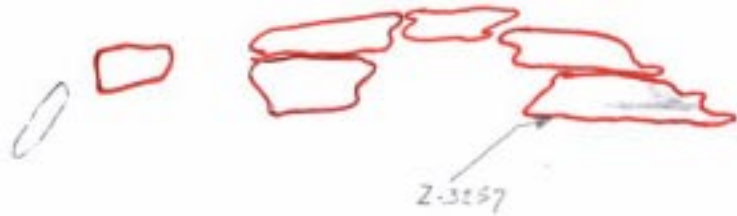
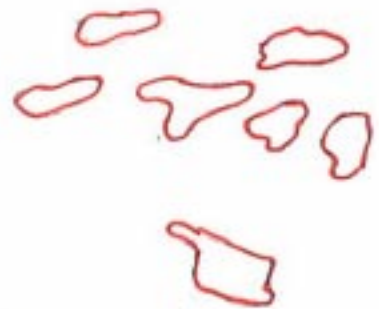
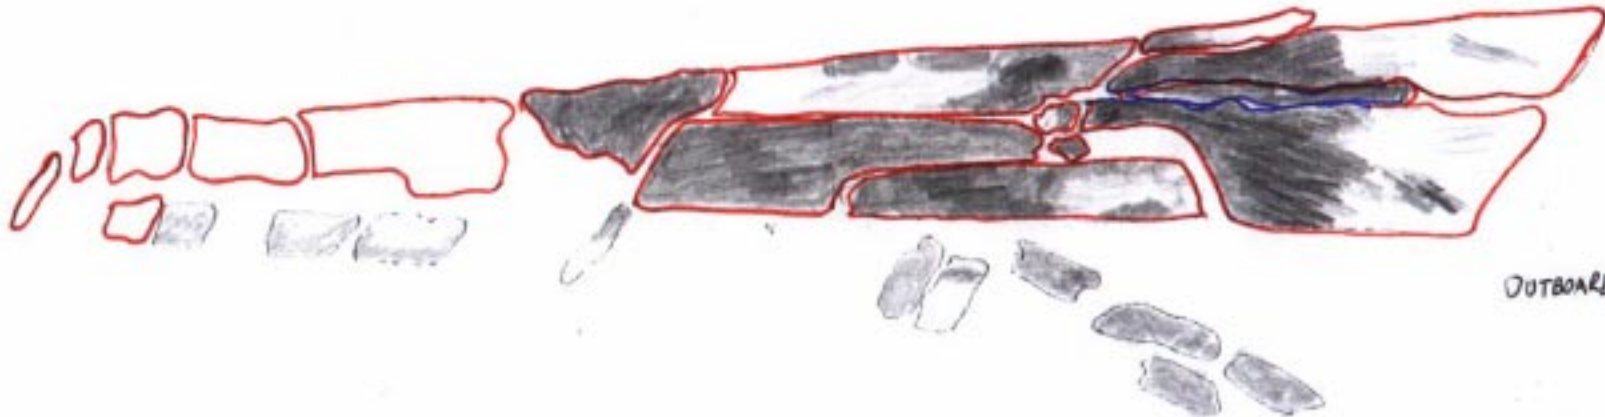
Diagram 25.

LEFT WING SOOTING PATTERN DIAGRAM

UPPER SKIN - EXTERNAL SURFACE

NOTE: Many small pieces of the upper skin are not shown on the diagram.

NOTE: With the exception of the piece noted, the external surface of the upper skin is clean. The control surfaces do show sooting and fire damage to the composite parts.

LOWER SKIN - EXTERNAL SURFACE

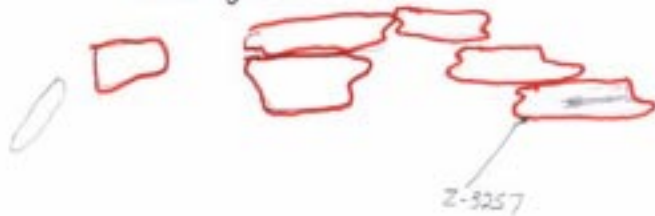
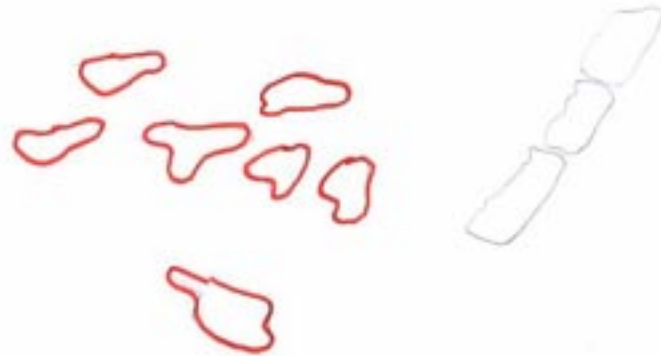
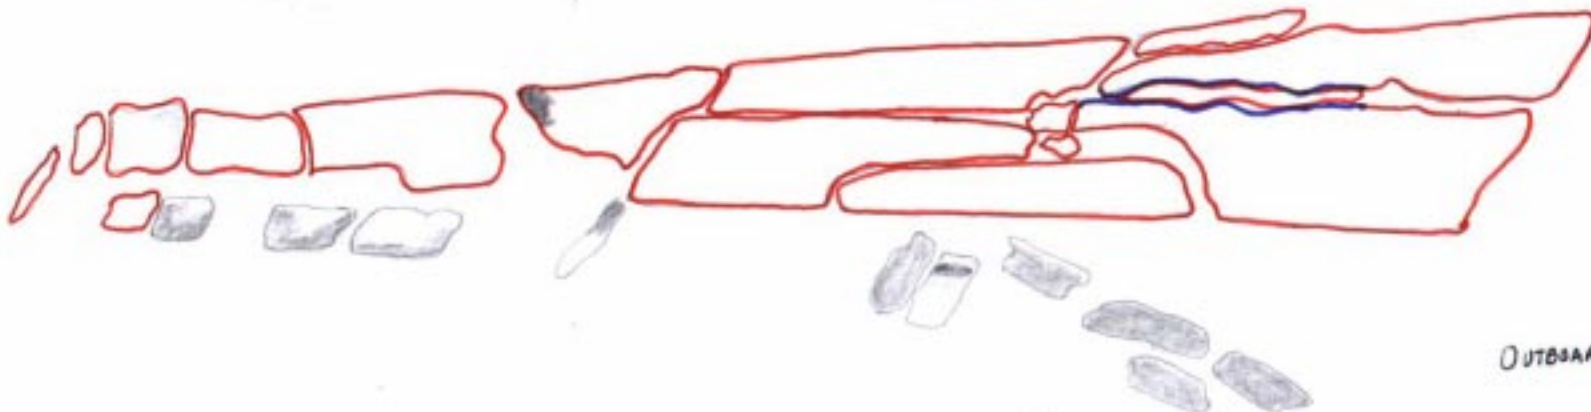
Diagram 26.

LEFT WING SOOTING PATTERN DIAGRAM

UPPER SKIN - INTERNAL SURFACE

NOTE: Many small pieces of the upper skin are not shown on the diagram.

NOTE: With the exception of the piece noted, the internal surface of the upper skin is clean. The control surfaces do show sooting and fire damage to the composite parts.

NOTE: SEE vent stringer soot diagram for details of vent stringer sooting.

LOWER SKIN - INTERNAL SURFACE
