**NATIONAL TRANSPORTATION SAFETY BOARD
WASHINGTON, D.C.**

**FIRE AND EXPLOSION GROUP FACTUAL REPORT
Appendix II
(Sooting/Fracture Diagrams)
(35 pages)**

TWA FLIGHT 800 ACCIDENT INVESTIGATION

**APPENDIX II
SOOTING/FRACTURE DIAGRAMS**

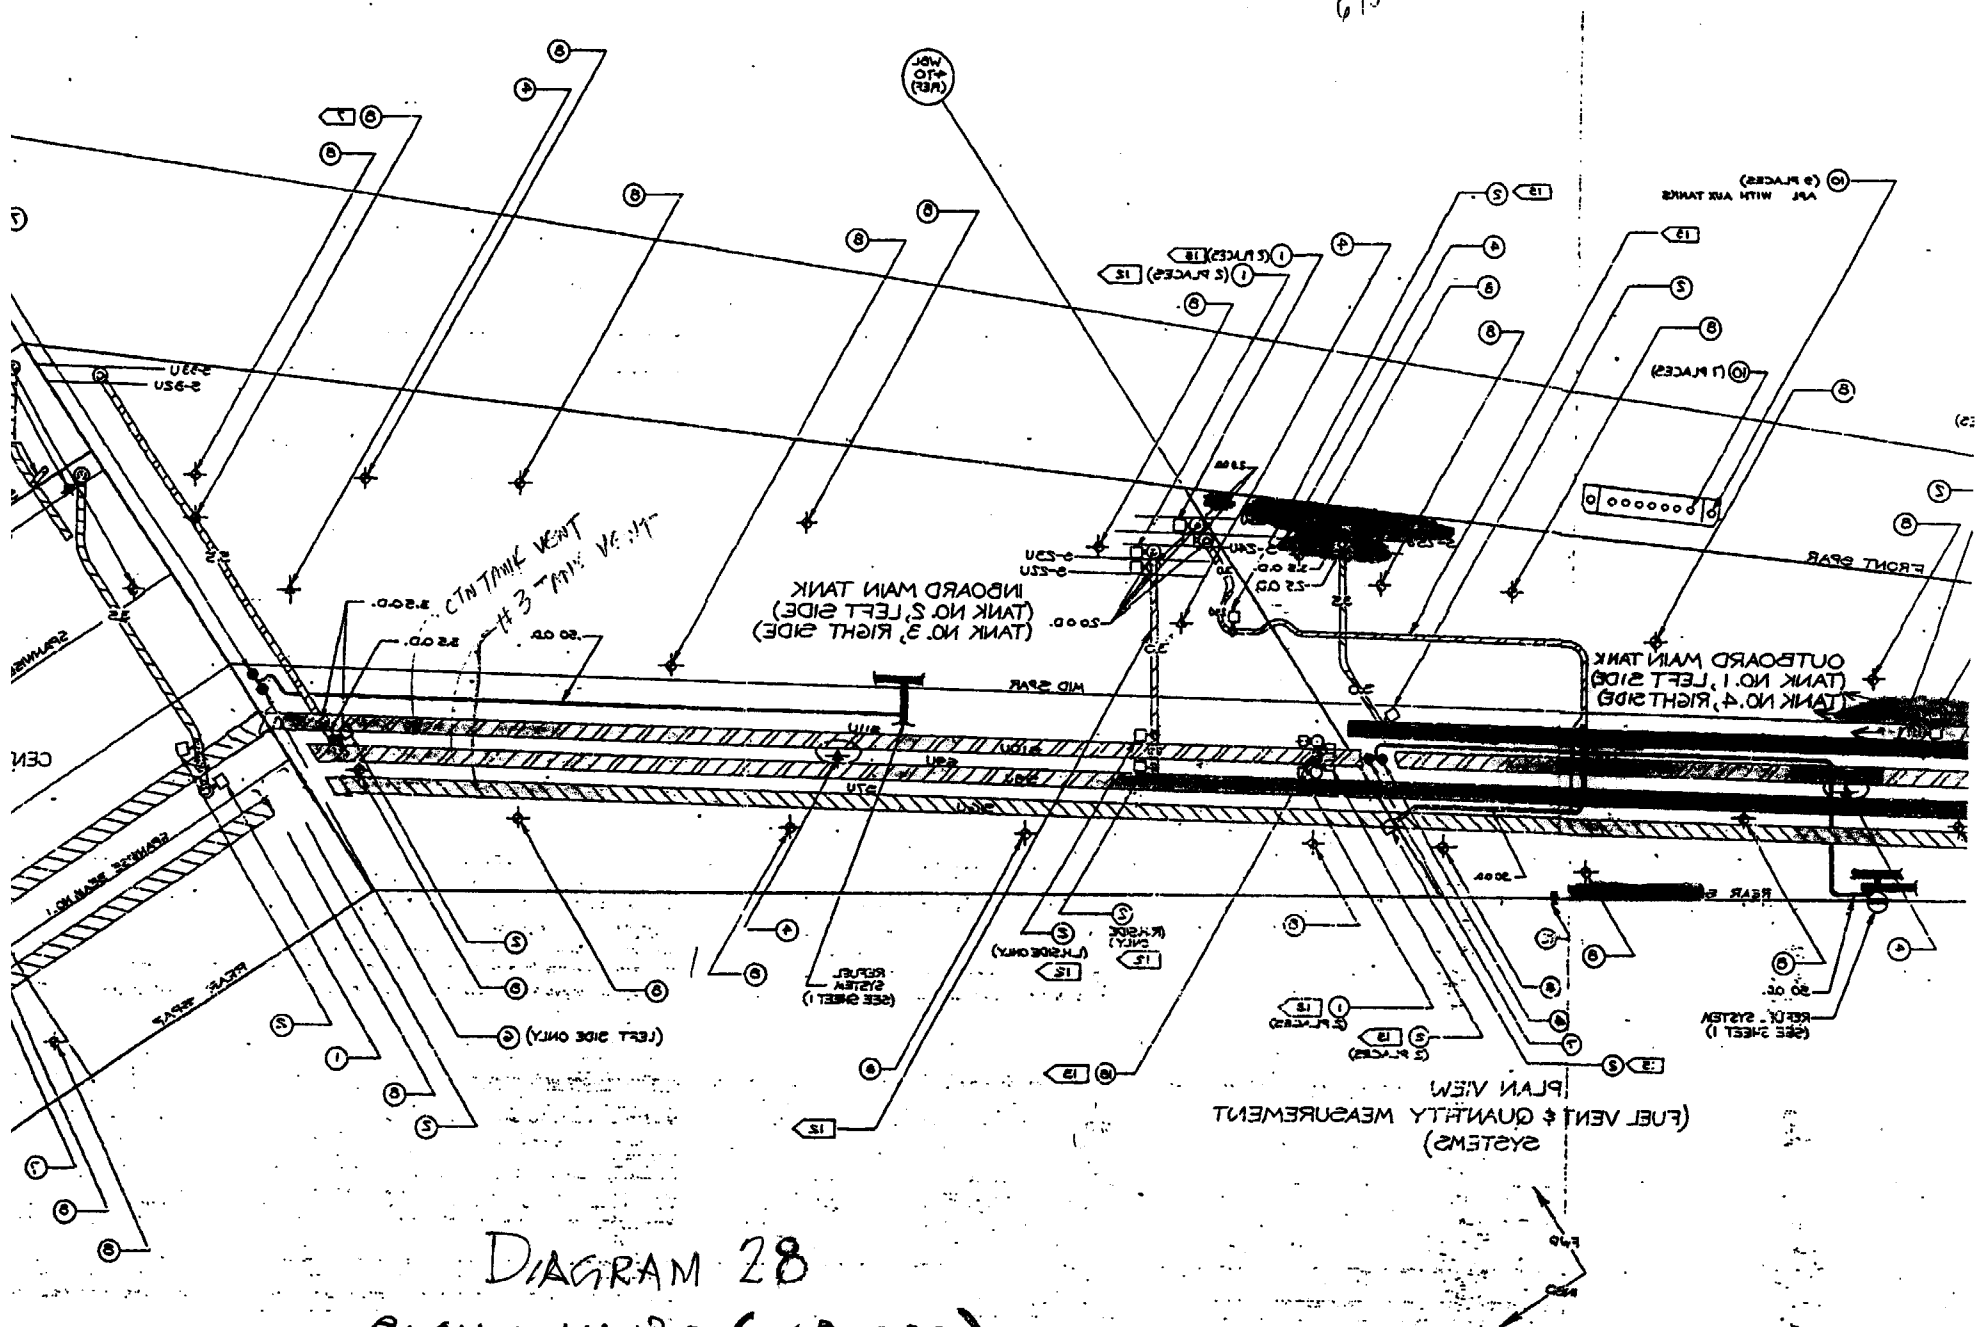
DIAGRAM 28

RIGHT SIDE (INBOARD)

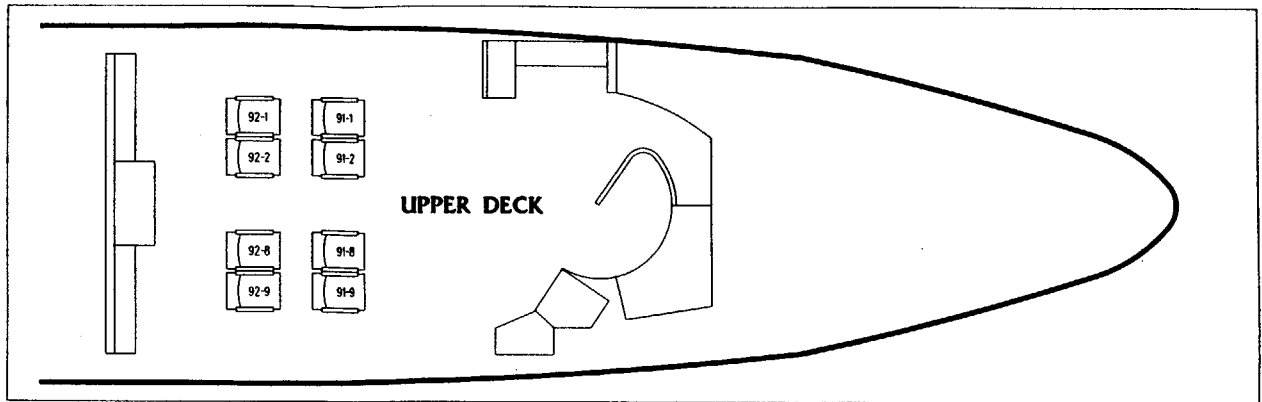
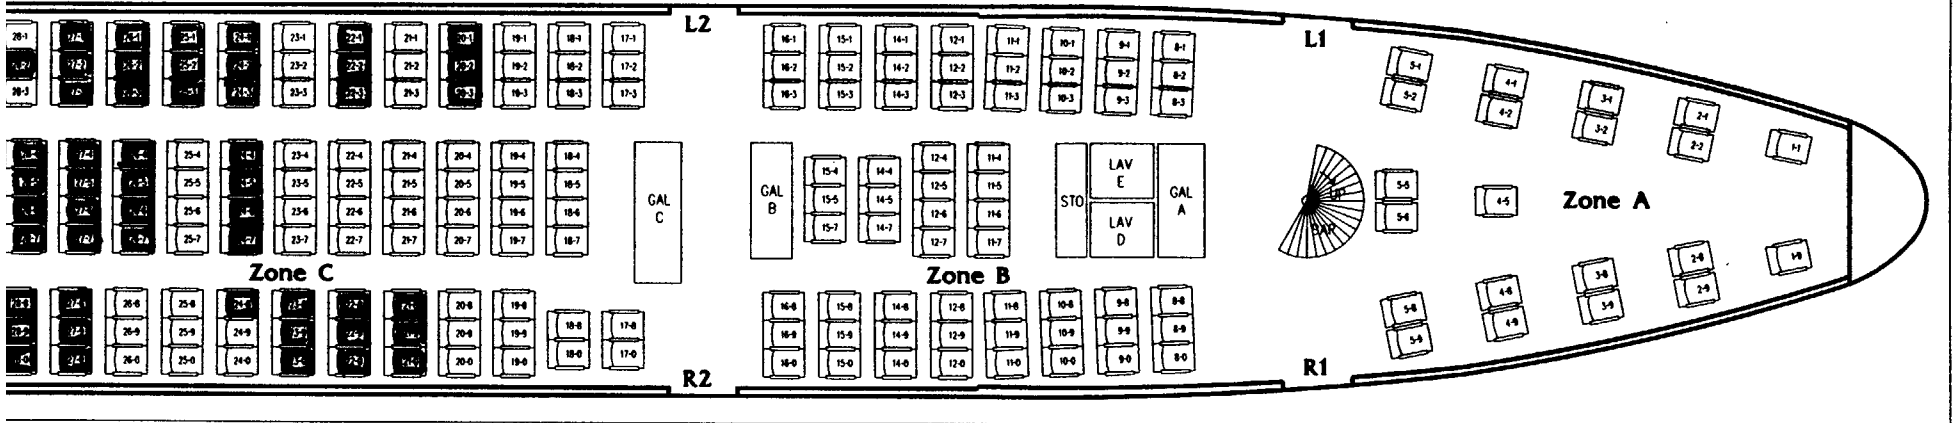
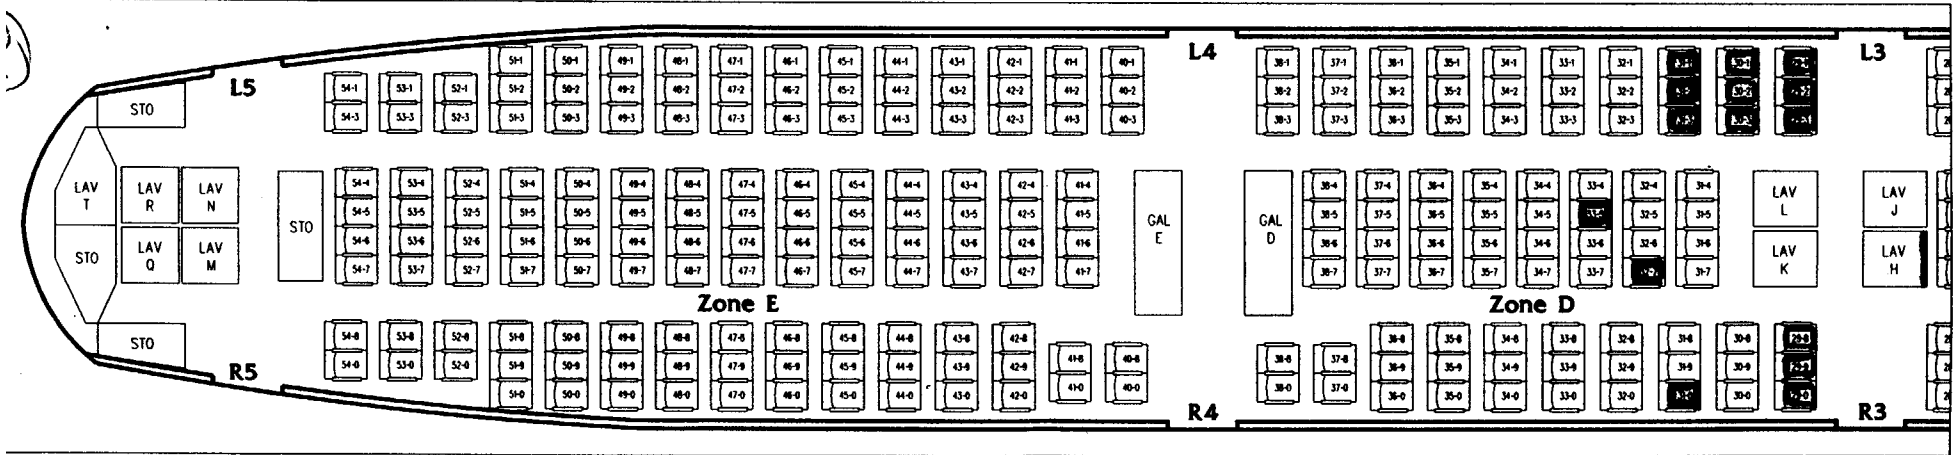
Diagram 29

**Seat Damage
Center Wing Tank Area
Data gathered by Fire and Explosion Group**

Fire Damage and/or Soot

Not Recovered/Identified

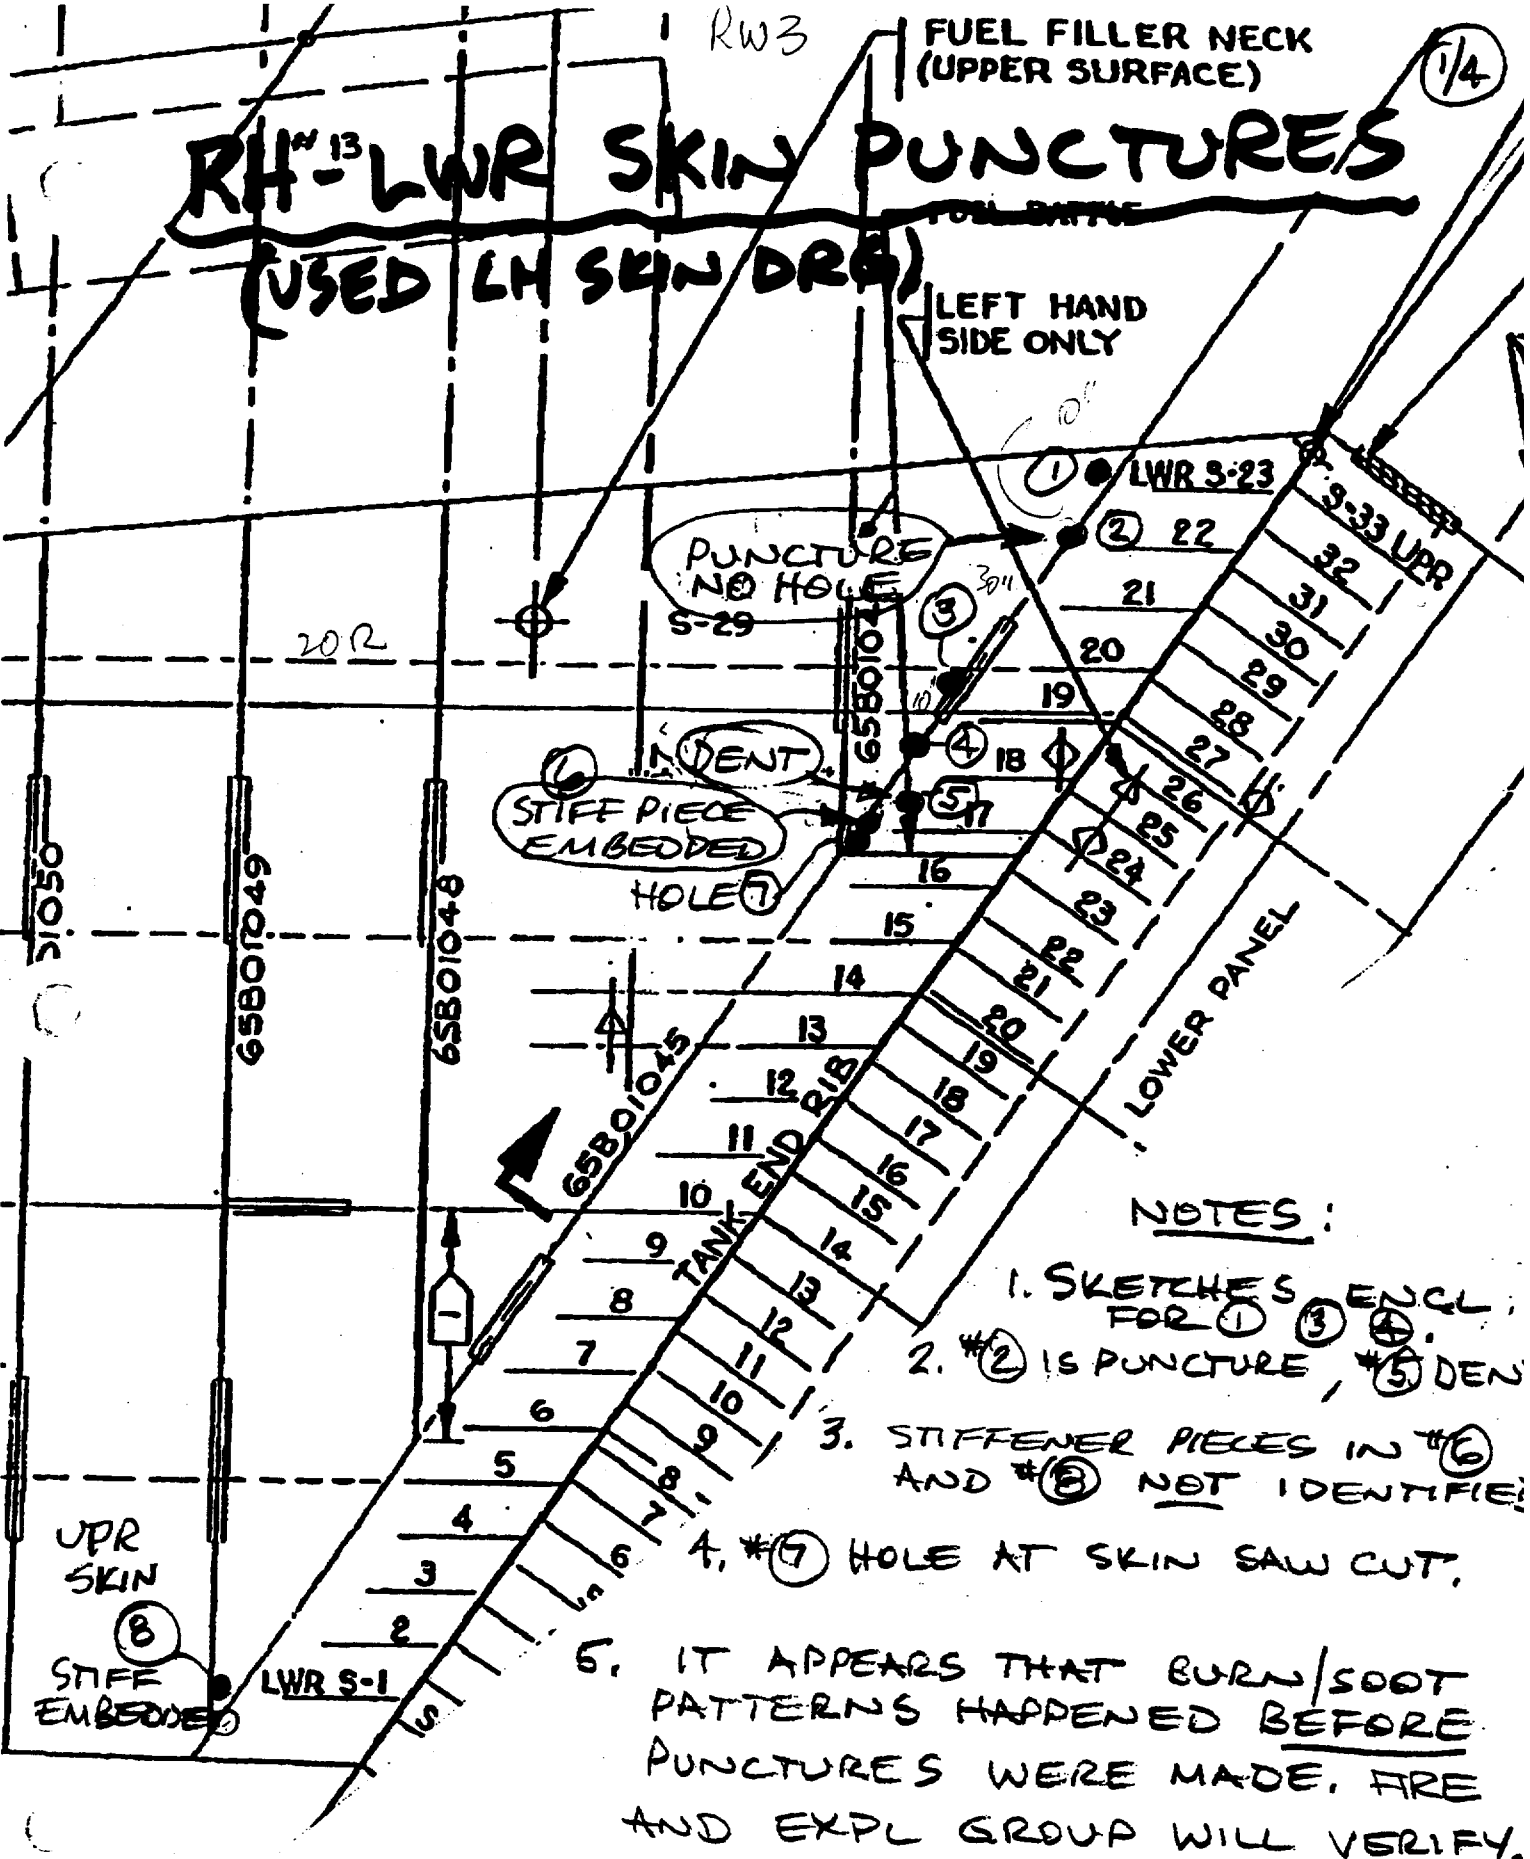
RH^{W13}-LWR SKIN PUNCTURES

1. SKETCHES ENCL. FOR ① ③ ④
2. #② IS PUNCTURE, #⑤ DENT
3. STIFFENER PIECES IN #⑥ AND #⑧ NOT IDENTIFIED
4. #⑦ HOLE AT SKIN SAW CUT.
5. IT APPEARS THAT BURN/SOOT PATTERNS HAPPENED BEFORE PUNCTURES WERE MADE. FIRE AND EXPL GROUP WILL VERIFY.
