DOCKET NO. **SA- 516**

EXHIBIT NO. **9D**

**NATIONAL TRANSPORTATION SAFETY BOARD
WASHINGTON,**

**ACCIDENTS, INCIDENTS,
AND SAFETY RECOMMENDATIONS
REFERRED TO DURING THE INVESTIGATION**

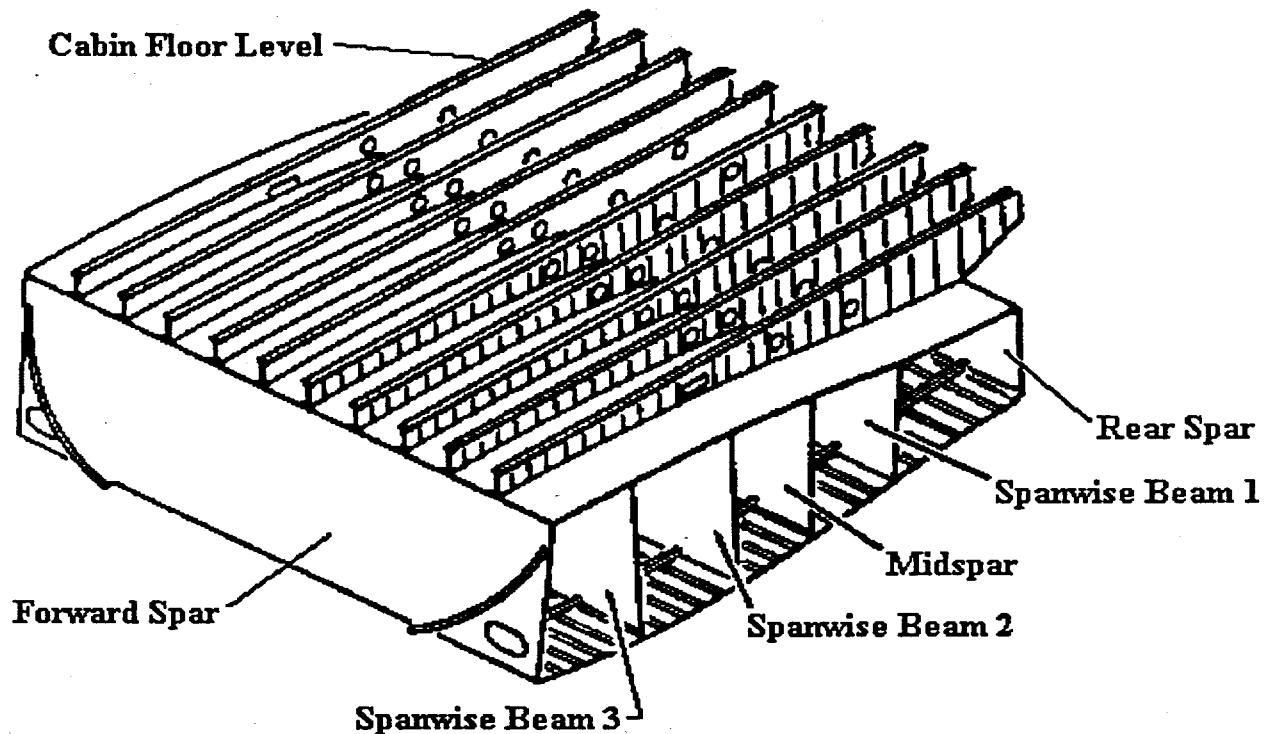
Figure 1. Center Wing Fuel Tank

Portions of the airplane have been reconstructed, including the CWT, the passenger cabin above the CWT, and the air conditioning packs and associated ducting beneath the CWT. The reconstruction thus far shows outward deformation of the CWT walls and deformation of the internal components of the tank that are consistent with an explosion originating within the tank. Airplane parts² from in and around the CWT recovered and identified to date contain no evidence

of bomb or missile damage. The investigation into what might have provided the source of ignition of the fuel-air mixture (including a bomb or missile) in the CWT is continuing.

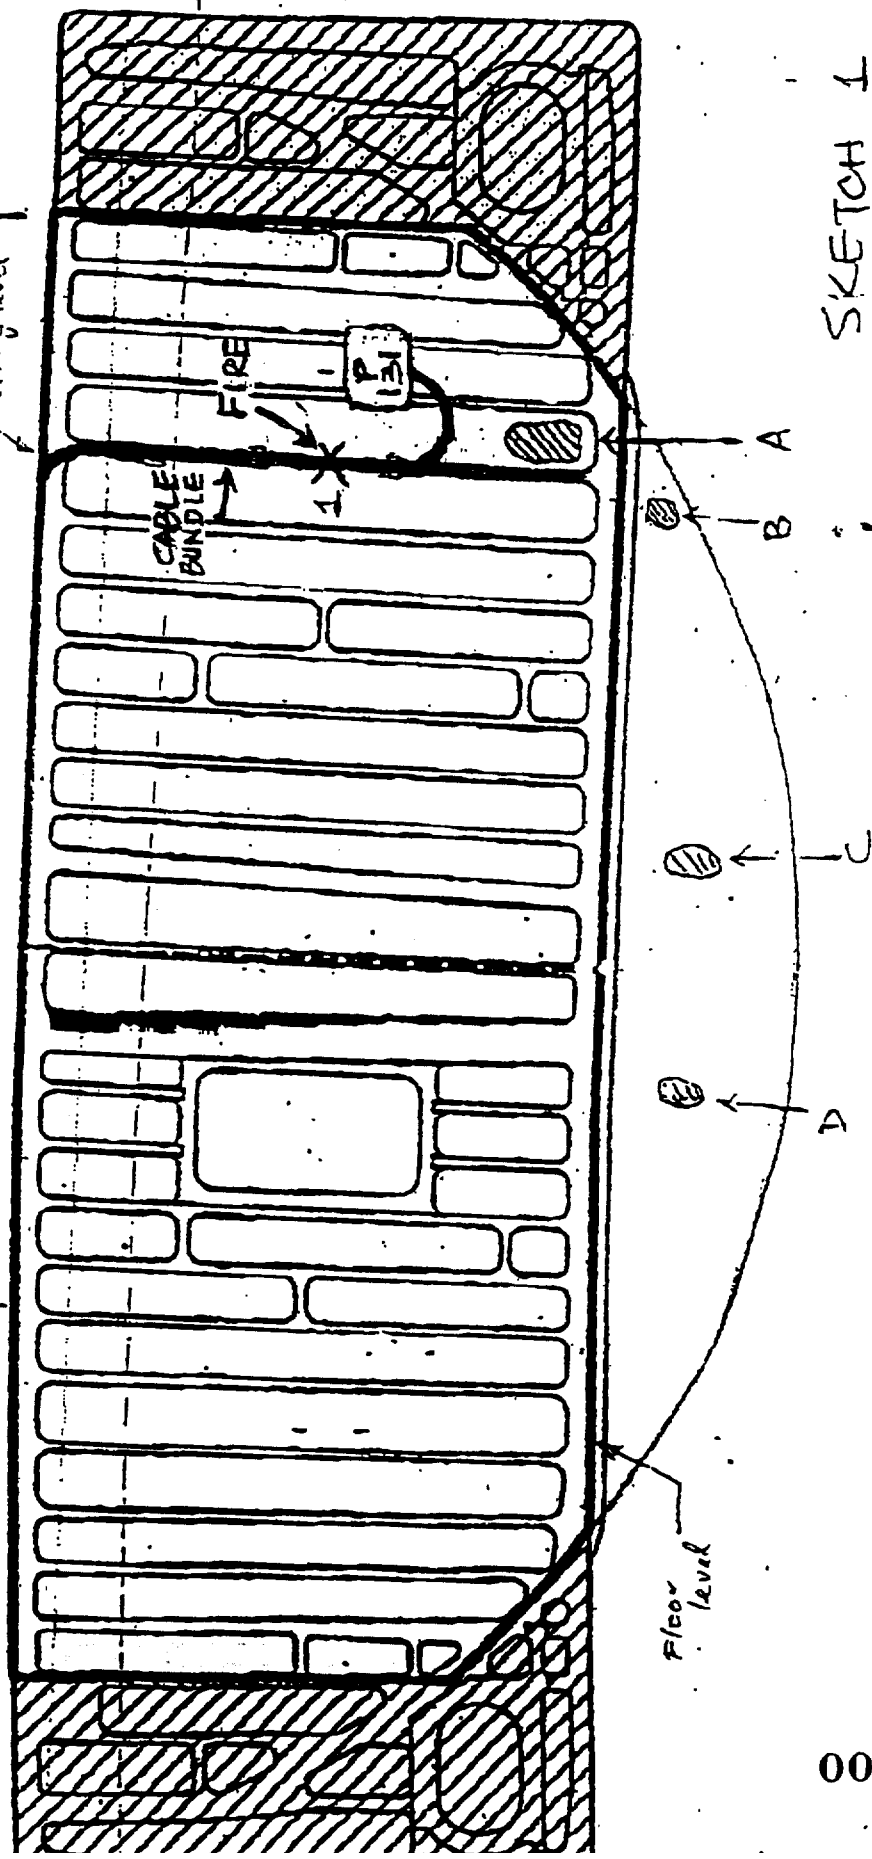
SKETCH 1

5 Please refer to Sketch 1. Imagine you are in the lower forward cargo hold looking aft. The front spar of the centre wing tank is the rectangle in the sketch. Fire had broken out at a bundle of wires (darkened) at location 1, next to junction box P131. The fire could have spreaded down causing the glows seen by the maintenance personnel who fought the fire.

6 The locations shown as A,B,C and D were found to be affected by heat and a conductivity test was carried out in those areas. These areas were found to have been affected beyond the Boeing Structural Repair Manual limits.

8 There was no evidence that the wire bundle had suffered prior damage by cargo. The intact cargo liner is a good 20 odd inches from the insulation blanket and the cables.

- SIA IS ASKING FOR BOEING ASSISTANCE IN THE STRUCTURAL REPAIR OF THE STATION 1000 BULKHEAD.
- SIA IS ASKING FOR BOEING ASSISTANCE IN WHAT TO LOOK FOR INSIDE THE CENTER TANK, IN THE WAY OF POSSIBLE DAMAGE TO THE CENTER TANK SEALANT.
- SIA IS IN THE PROCESS OF REPLACING ALL THE WIRES IN THE BUNDLE IN THE VICINITY OF THE ARCING.
- SIA IS ALSO REPAIRING ALL OF THE WIRING DAMAGED BY THE HEAT FROM THE RESULTANT FIRE (SMALLER WIRE BUNDLES MOSTLY IN THE BILGE AREA NEAR THE STATION 1000 BULKHEAD).

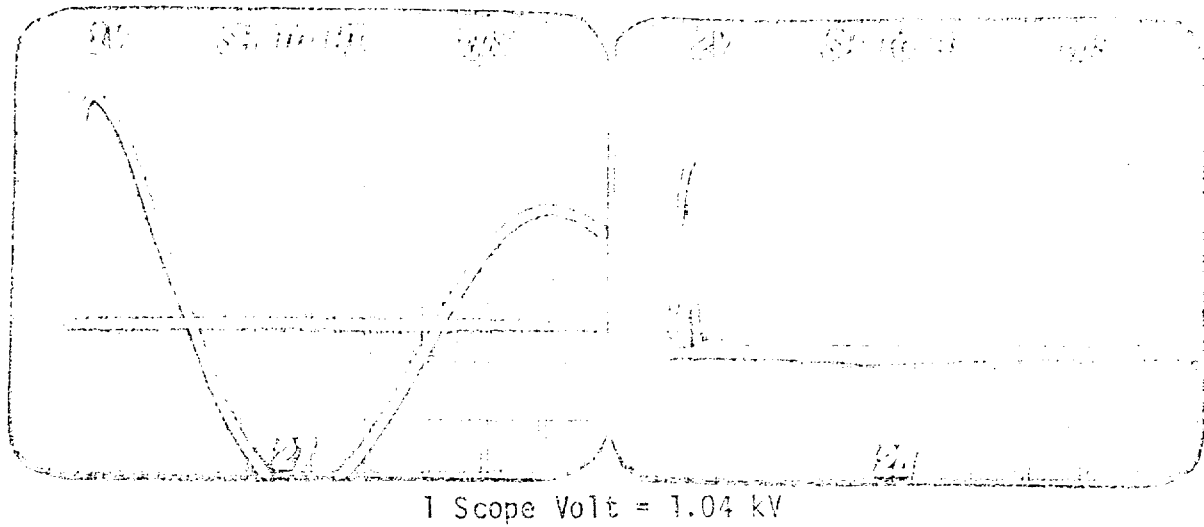
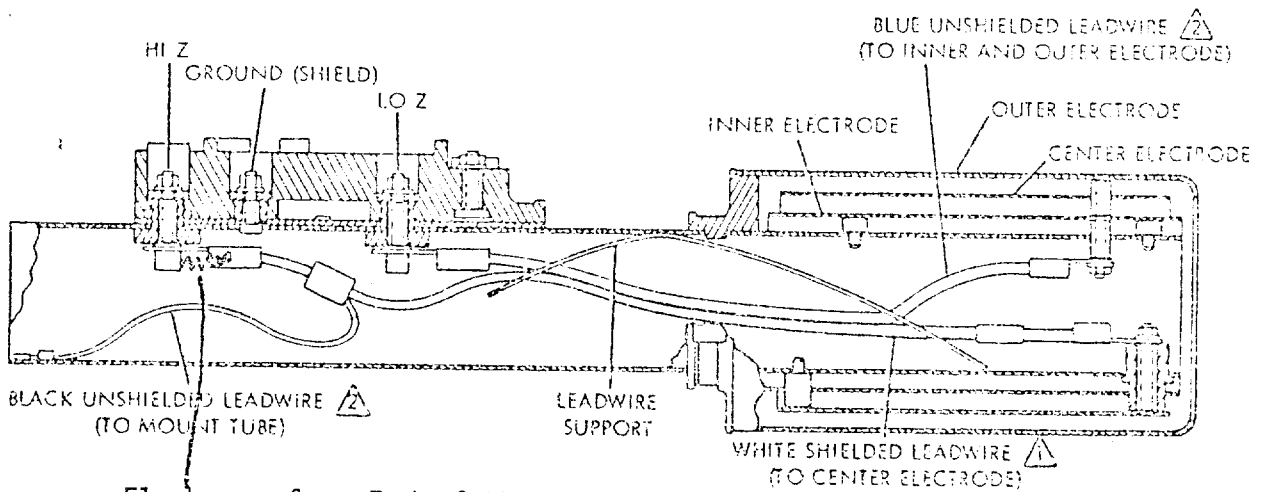
Figure A-6

Flashover from End of Shield
to HI Z Terminal
