SERVICE BULLETIN 747-57-2253

NUMBER: 747-57-2253

DATE: September 21, 1989
REVISION 1: July 5, 1990

SUBJECT: WINGS - CENTER SECTION - SECONDARY FUEL BARRIER INSPECTION AND REPAIR

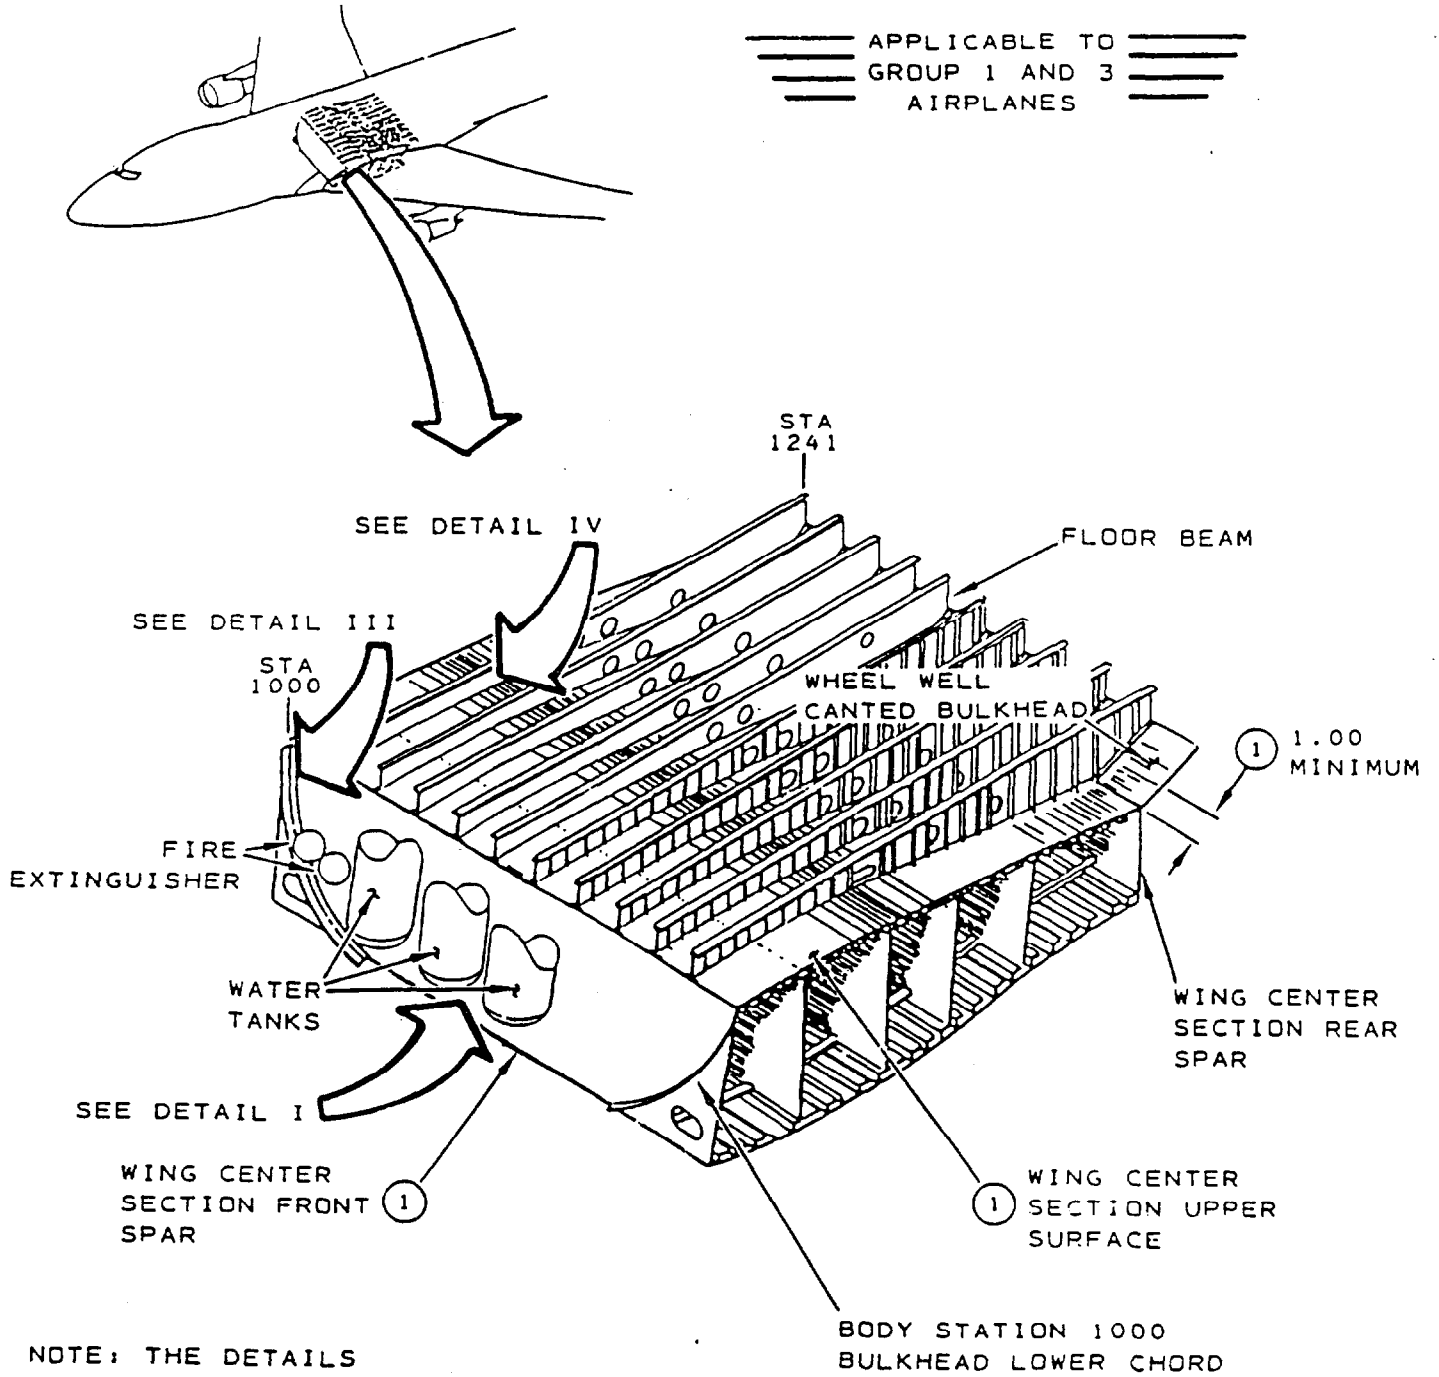
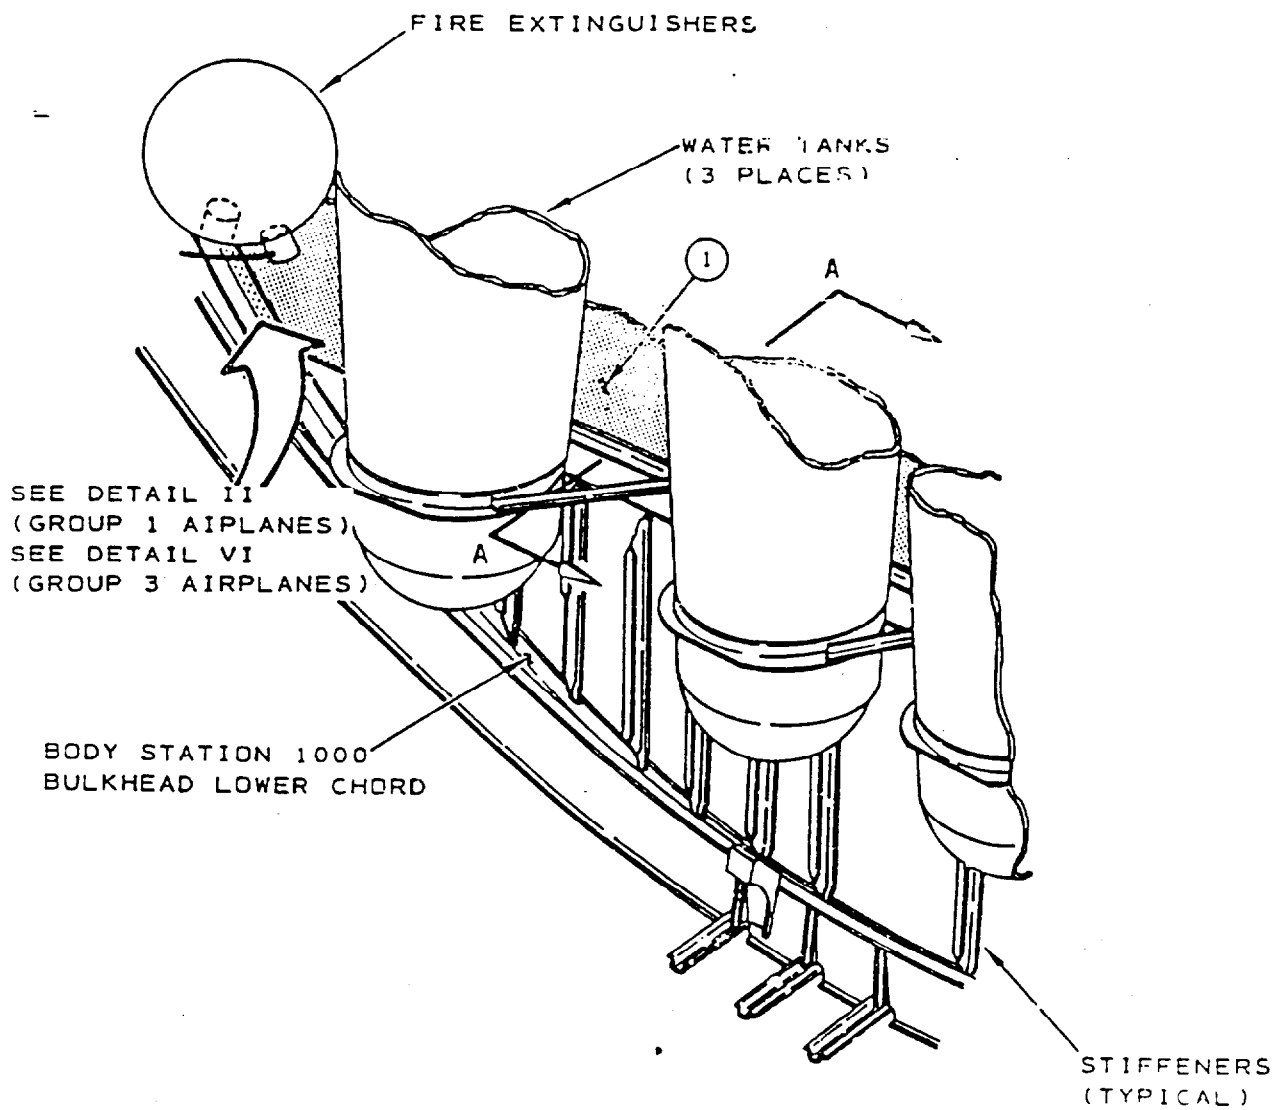
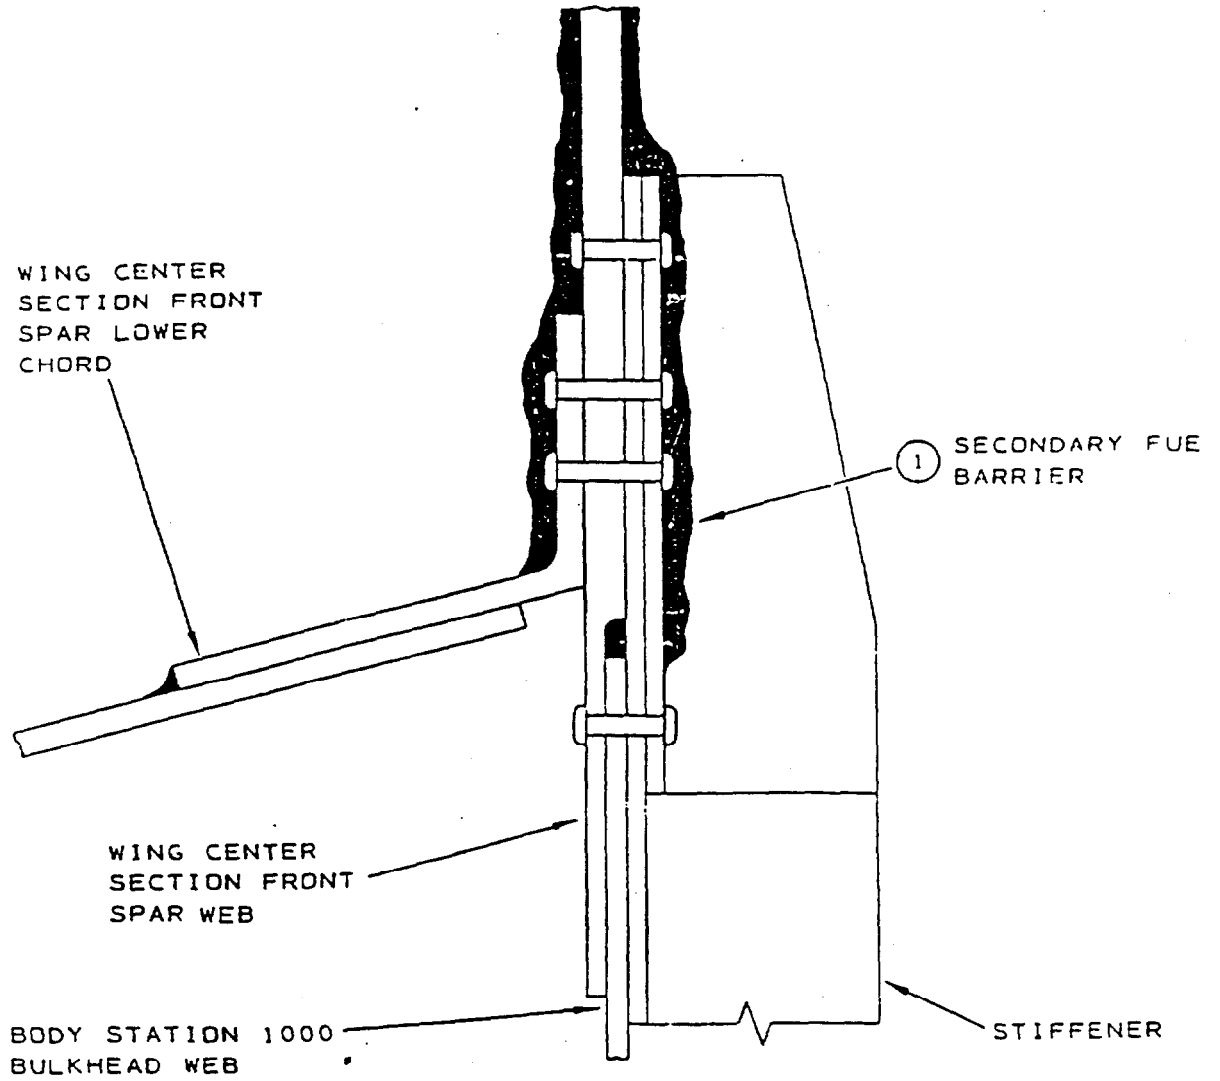
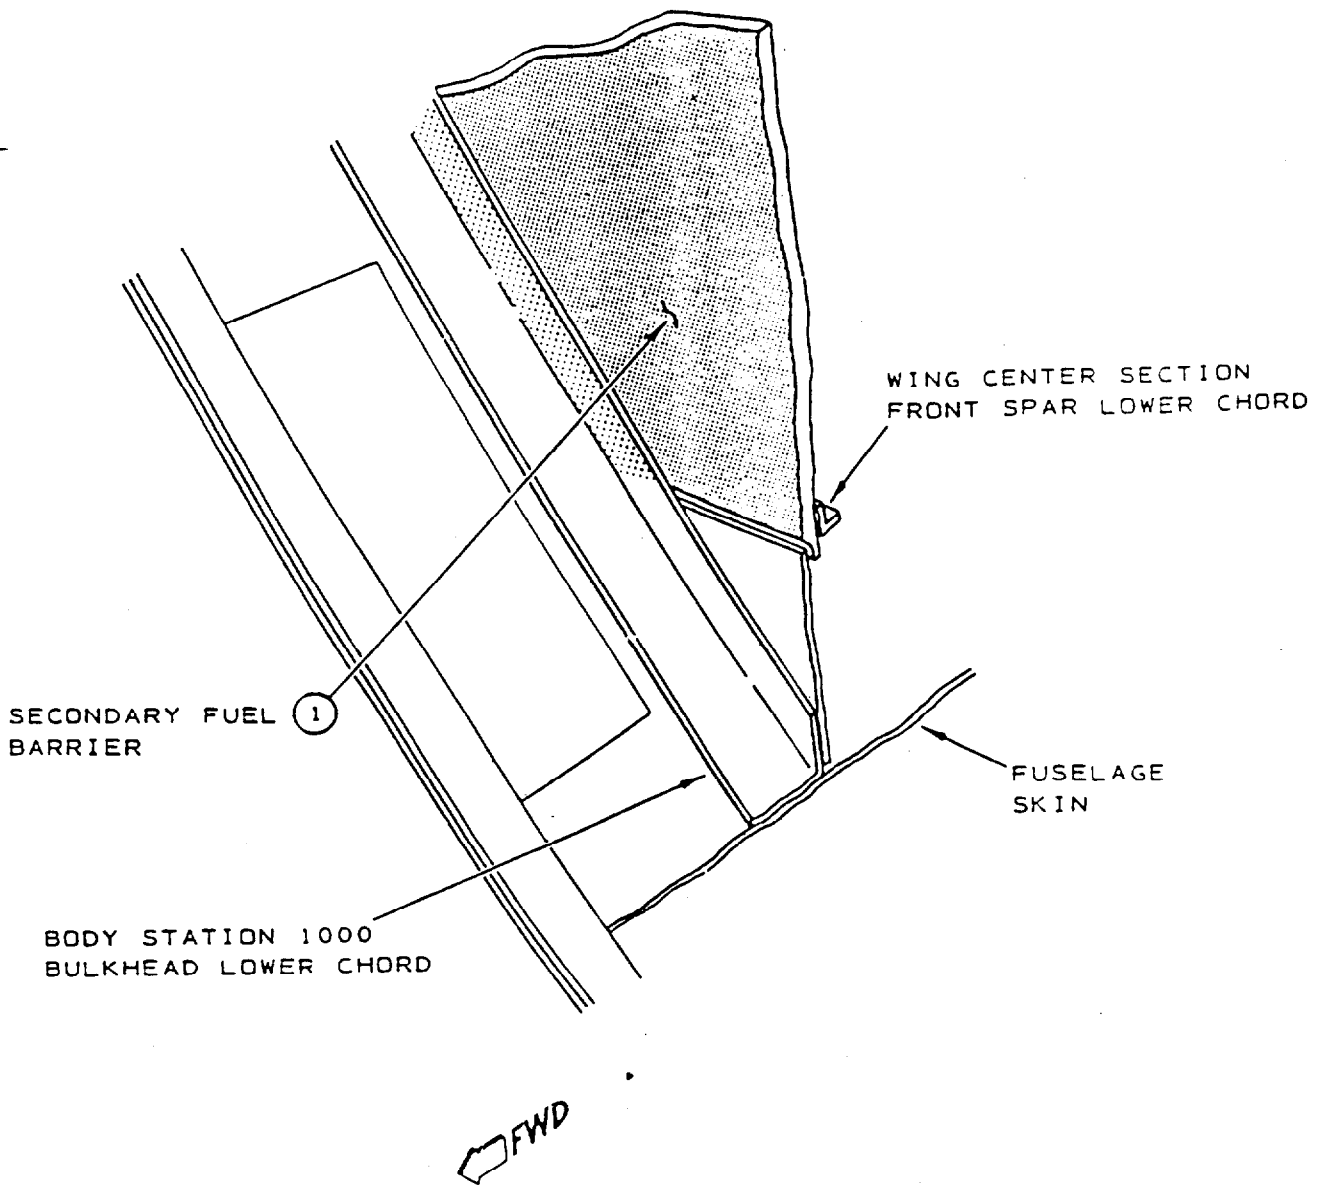
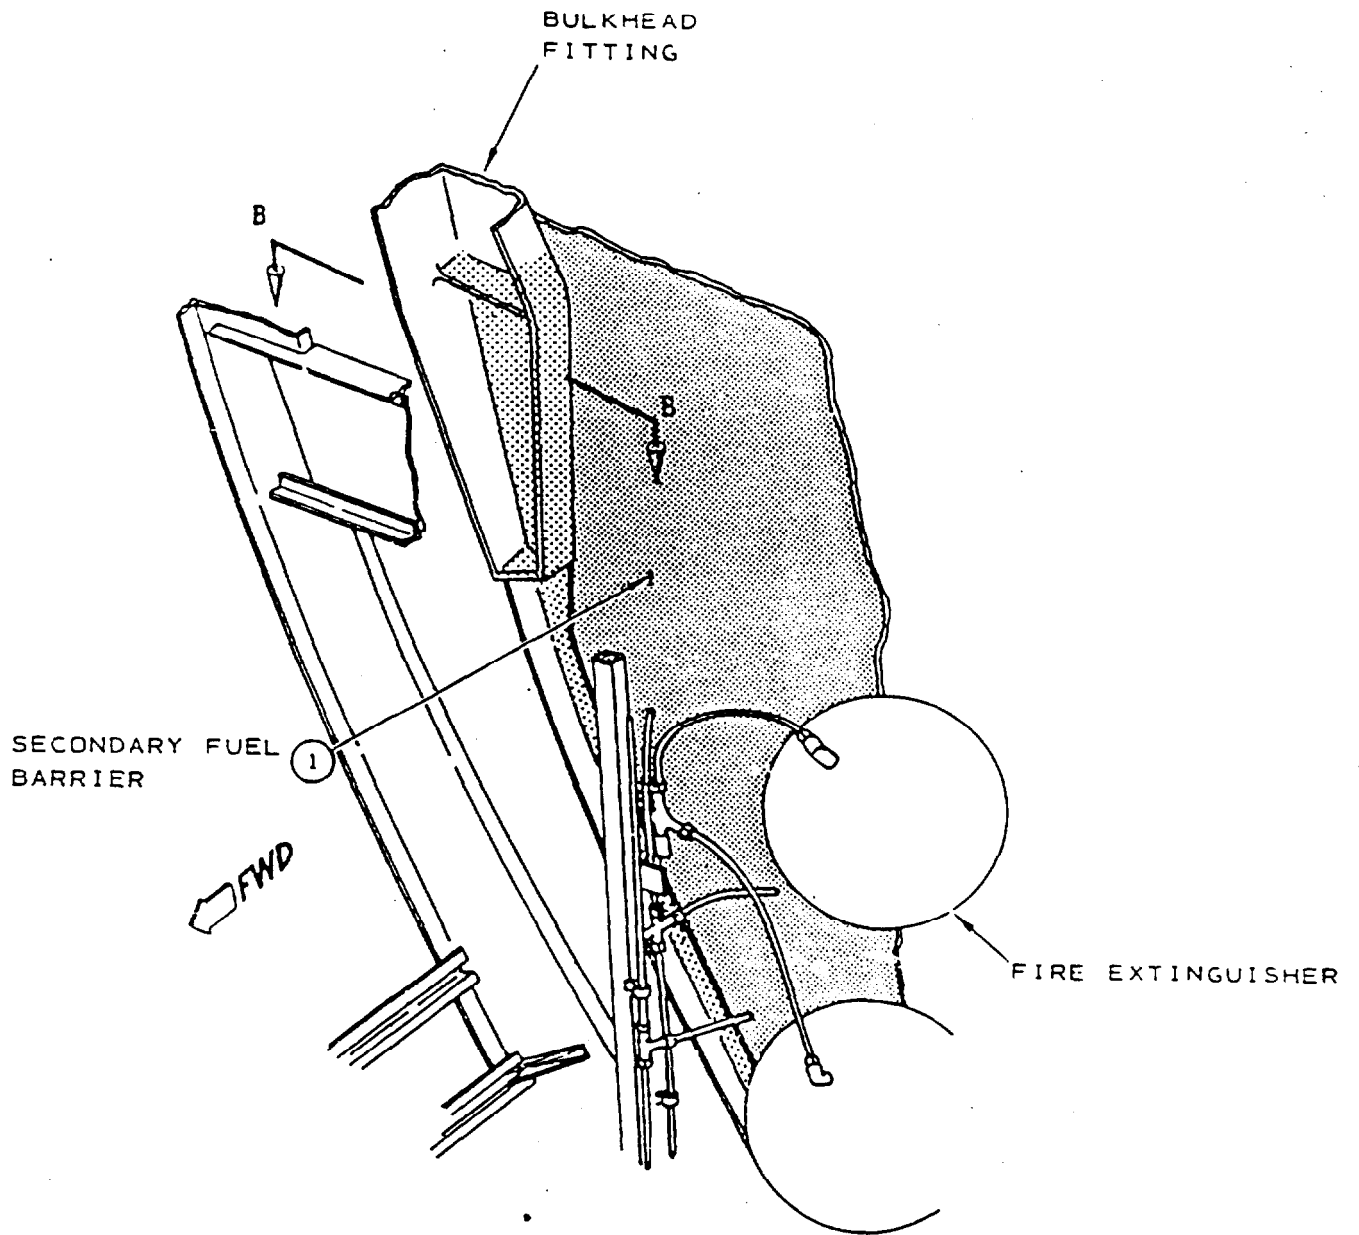
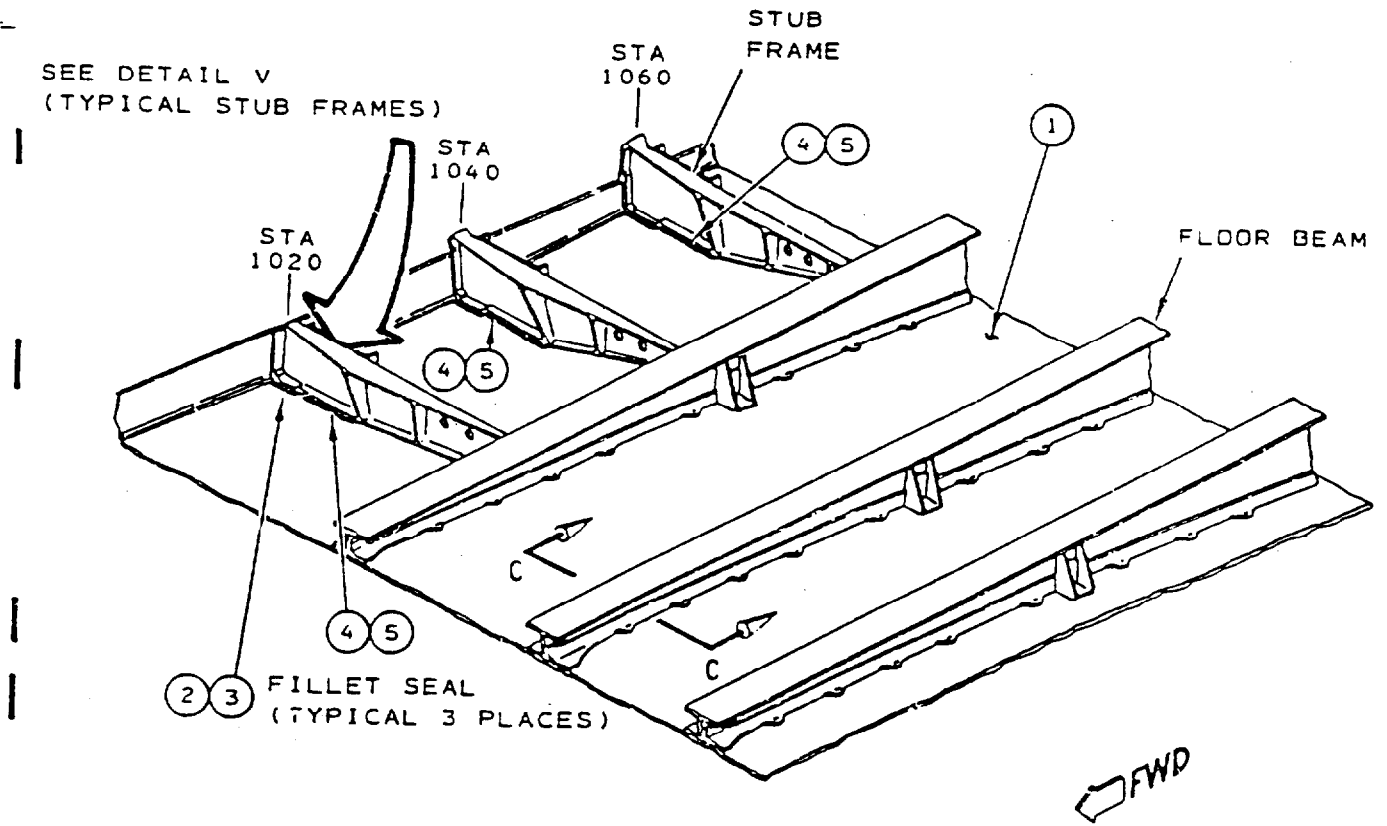
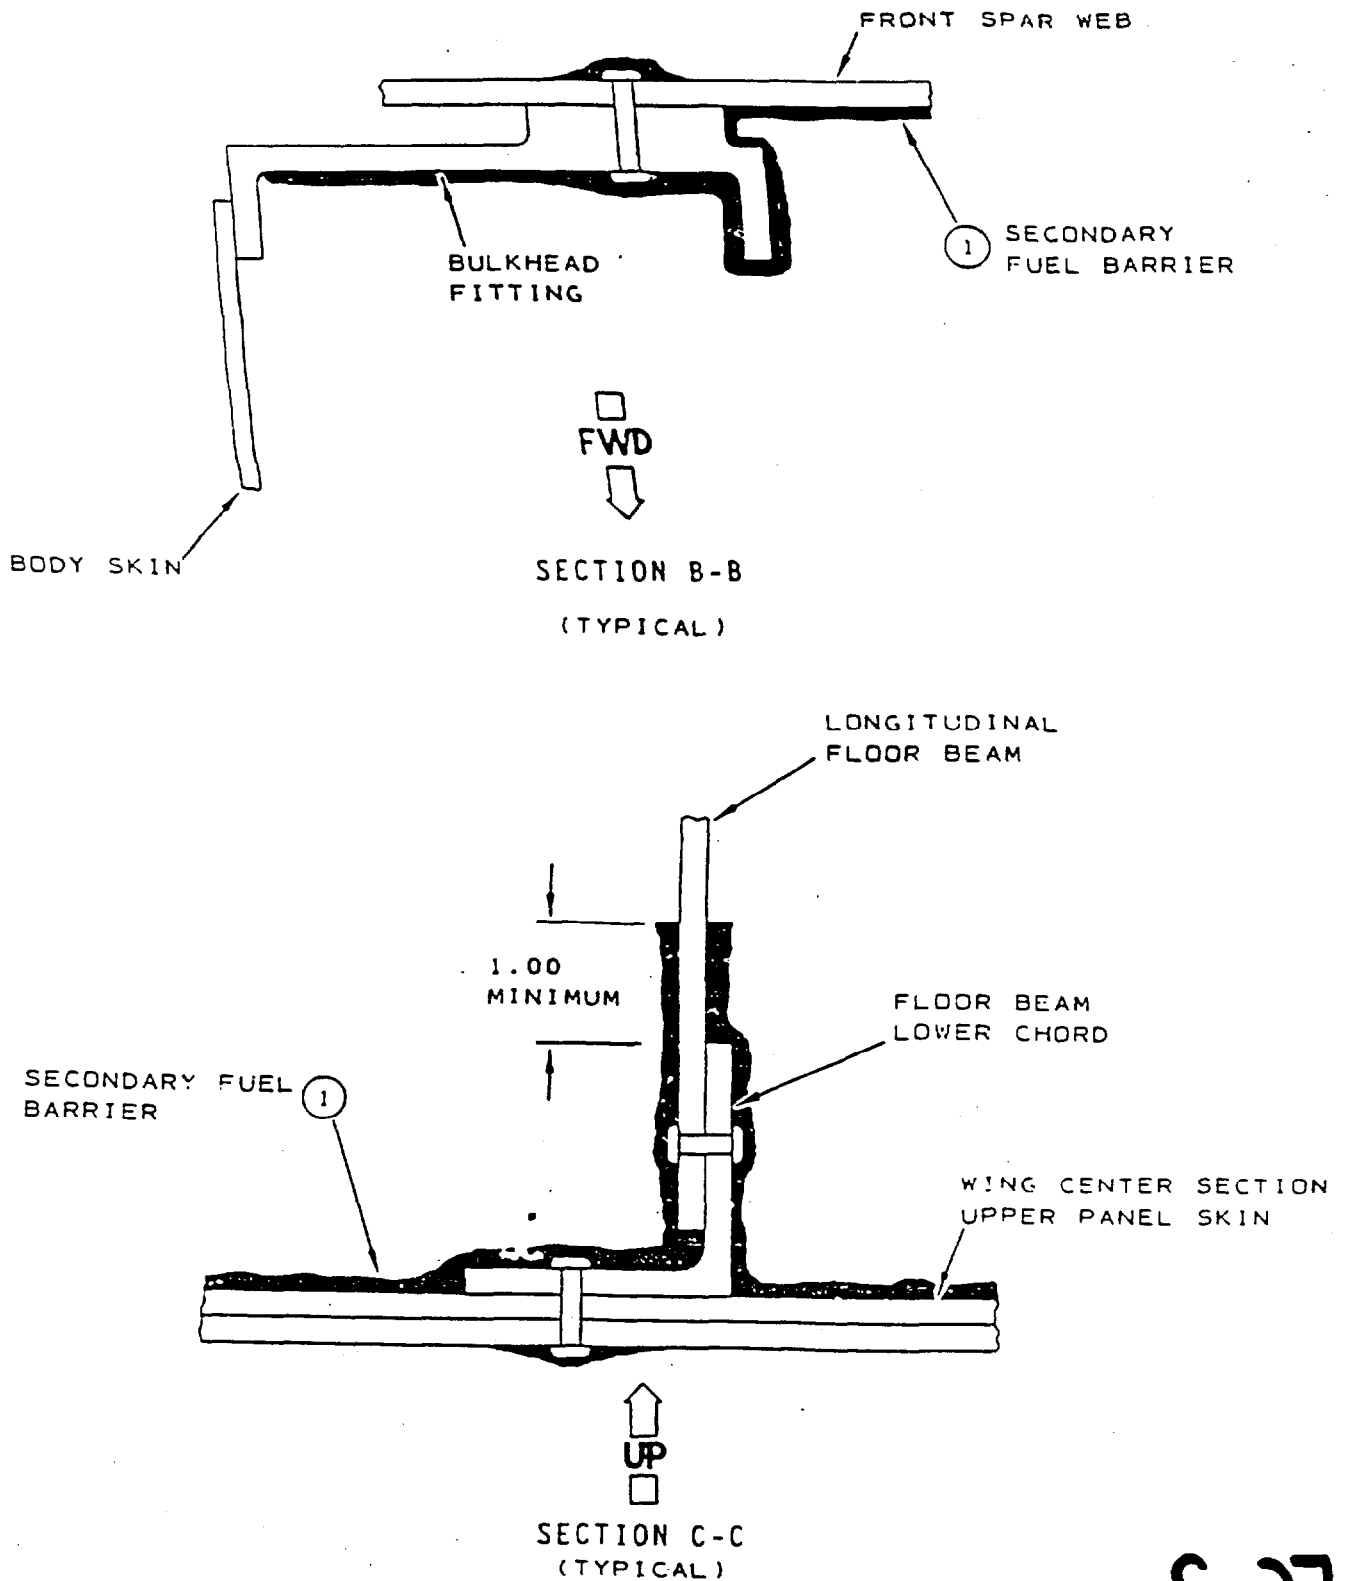
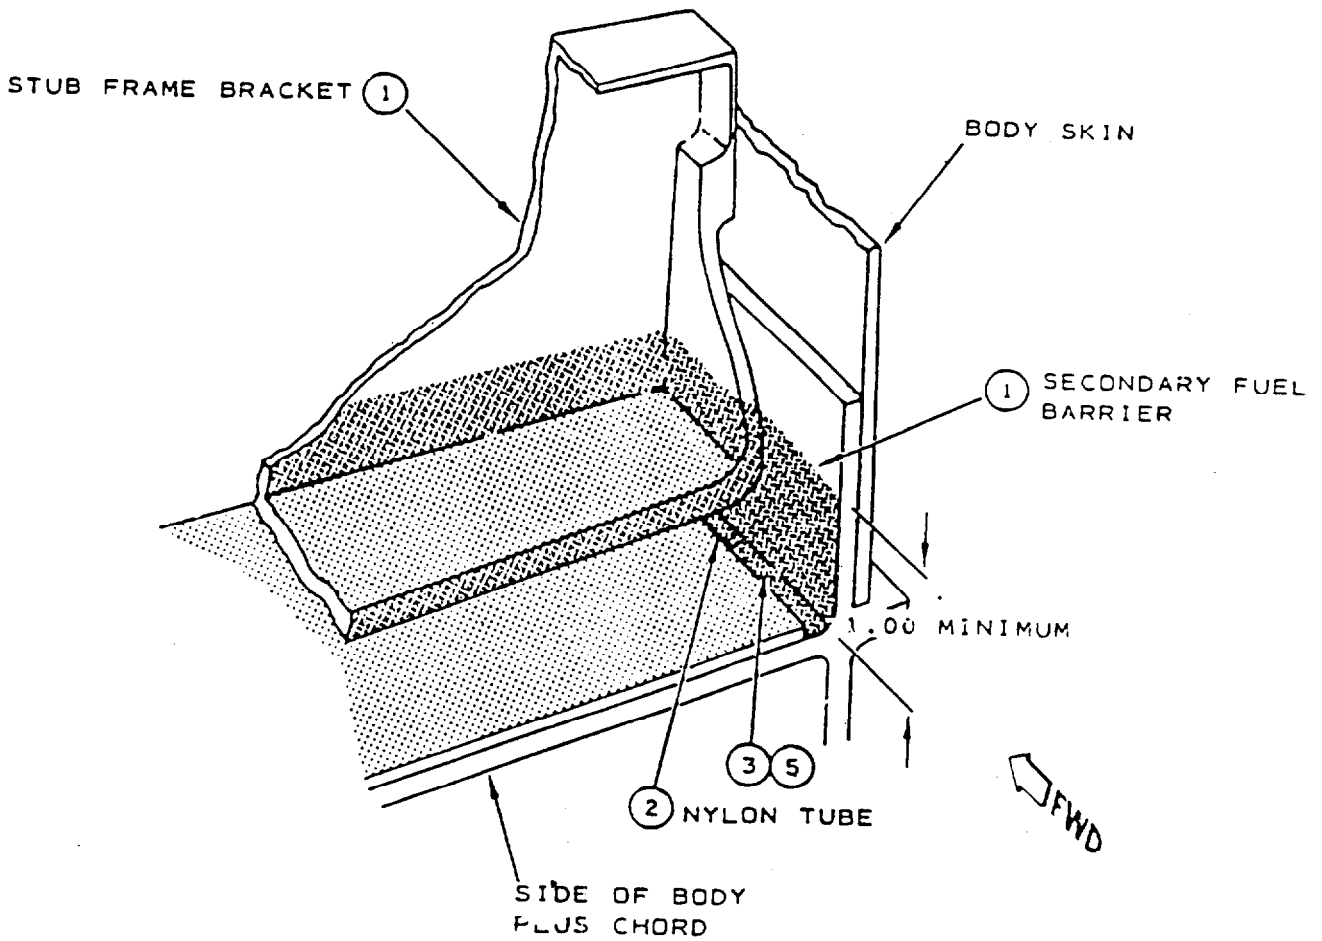
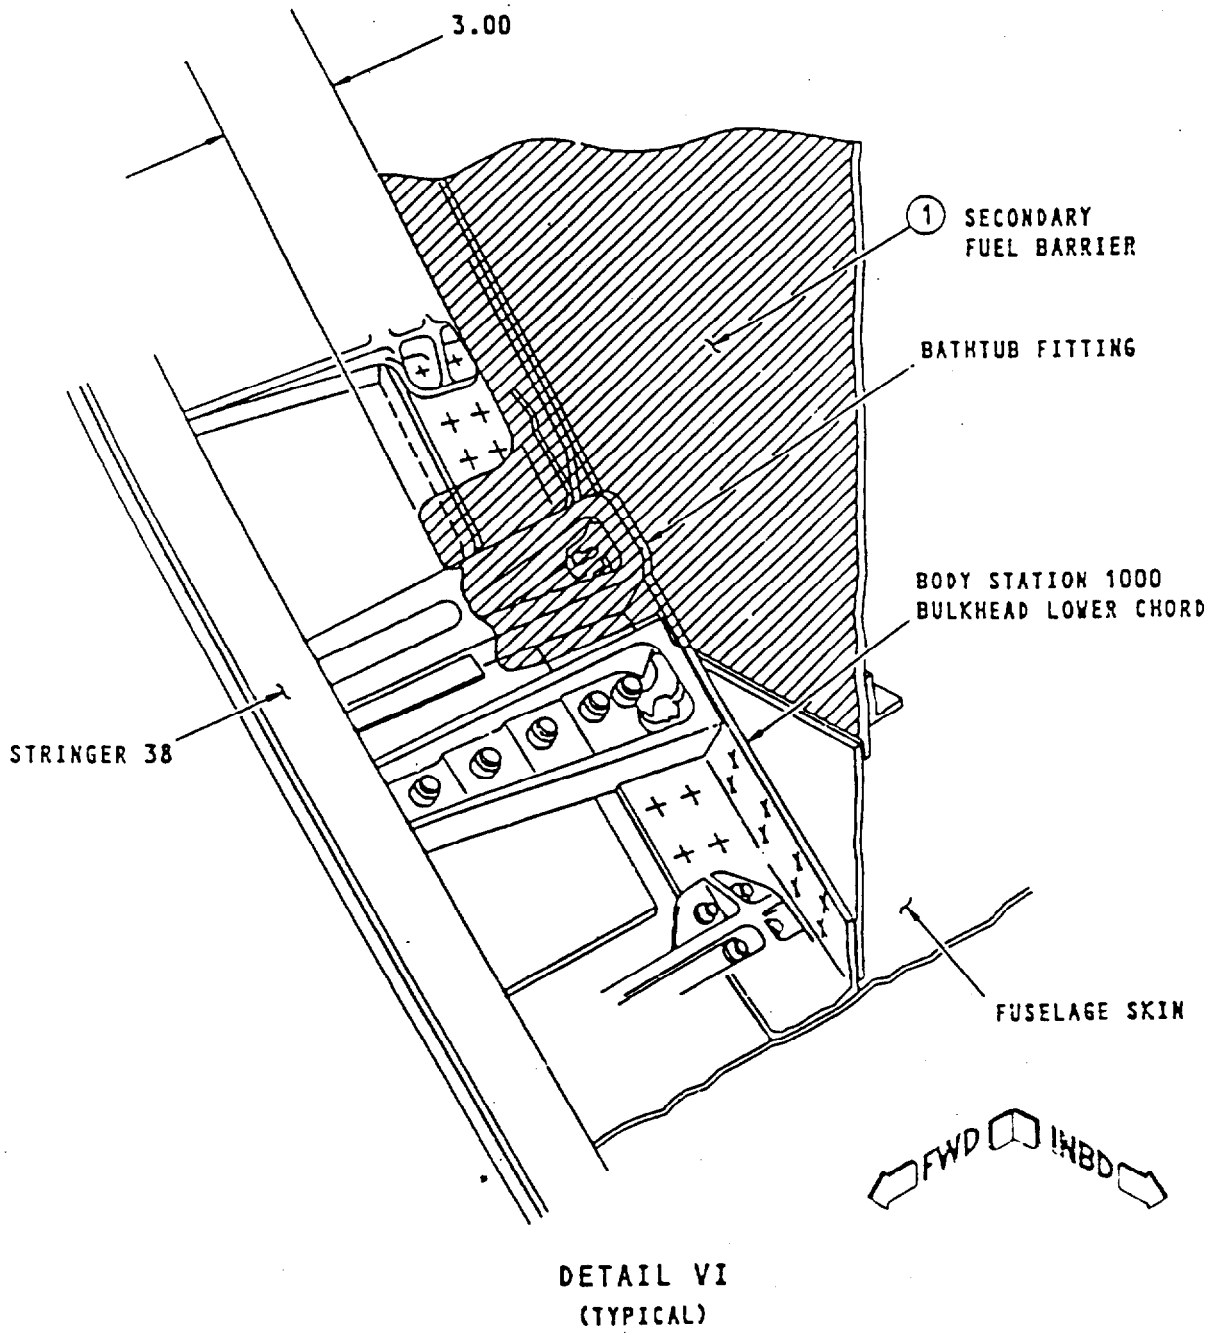
FIGURE 4. SECONDARY FUEL BARRIER INSPECTION AND REPAIR - GROUP 1 AND 3 AIRPLANES

- ① Perform a close visual inspection of the exterior surface of the wing center section front spar and upper surface to determine whether the secondary fuel barrier (sealant BMS 5-81) meets the following requirements:

NOTES: 1. The secondary fuel barrier may be identified by it's glossy finish, clear to brownish hue, and rubber like texture.

2. Particular attention should be paid to areas around fasteners, brackets, and structural joints.
- a. The secondary fuel barrier should have complete coverage (with no breaks or openings) of all structure on the front spar and upper surface which is in contact or directly adjacent to the wing center section fuel.

- b. On the front spar, the secondary fuel barrier should extend a minimum of one inch forward of front spar of stiffeners, fittings, chords and brackets.

- c. On the front spar, the secondary fuel barrier should cover the web flange of the Body Station (BS) 1000 bulkhead lower chord (see Detail II).
 - d. On the front spar, the secondary fuel barrier should cover the bulkhead fitting at BS 1000 up to the outboard flange at fillet (see Detail III).

- e. On the wing center section upper surface, the barrier should extend a minimum of one inch above the longitudinal floor beam lower chord (see Section C-C).

- f. On the wing center section upper surface, the coating should extend a minimum of one inch onto the wheel well canted bulkhead.
 - g. On the wing center section upper surface, the barrier should extend a minimum of one inch above the horizontal flange of the side of body plus chord and stub frame brackets (see Detail V).

- h. On Group 3 airplanes, the secondary fuel barrier should extend at least 3.0 inches forward of the front spar at the bathtub fitting at Stringer S-38 (see Detail VI).

Repair areas where secondary fuel barrier is missing or damaged with sealant BMS 5-81 per Process Data pages or operator's comparable procedure.

NOTE: Use of a borescope is recommended for areas which are covered by tubing, ducting, insulation blankets or wire bundles. However, if additional access is needed for inspection or repair, accomplish the following as needed:

- a. Disconnect wire bundle supports and move wiring out of the way.
- b. Locally remove and reinstall insulation blankets per operator's standard procedure (Ref 747 Maintenance Manual Subject 25-52-04).
- c. Remove air conditioning ducts and plenum chamber per operator's standard procedure.
- d. Remove water tanks per 747 Maintenance Manual Subject 38-11-04 or operator's comparable procedure.
- e. Remove fire extinguishers per 747 Maintenance Manual Subject 26-23-01 or operator's comparable procedure.
- f. Remove supplemental air fans per 747 Maintenance Manual Subject 21-25-07 or operator's comparable procedure.
- g. Remove insulation from trim air mufflers and ducts per 747 Maintenance Manual Subject 21-13-02 or operator's comparable procedure.

- ② Optional - Insert 3/8 inch outside diameter nylon tube under stub frame, leaving 0.50-0.75 inch length of tube extending beyond each side of the fitting. Temporarily plug the tube during sealant injection.
- ③ Clean area per Process Data pages and inject sealant BMS 5-26 under all stub fittings (stub frame) and fair into fillet seal. Provide a ramp to allow water to drain around fitting.
- ④ Clean area per Process Data pages and inject sealant BMS 5-26 under forward three stub frame fittings on each side of airplanes and fair into fillet seal.
- ⑤ Apply secondary fuel barrier sealant BMS 5-81 and overlap at least one inch onto existing barrier per Process Data pages or operator's comparable procedure.

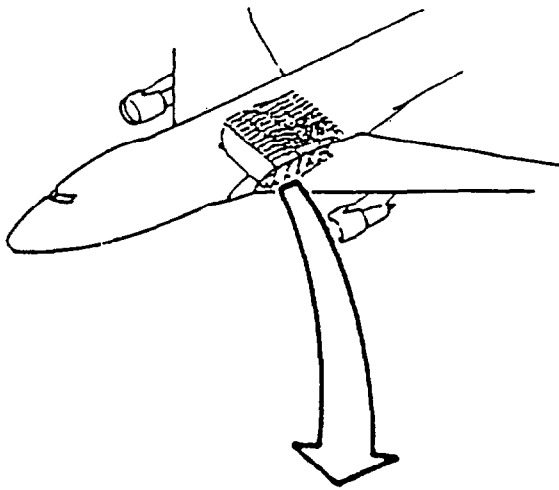
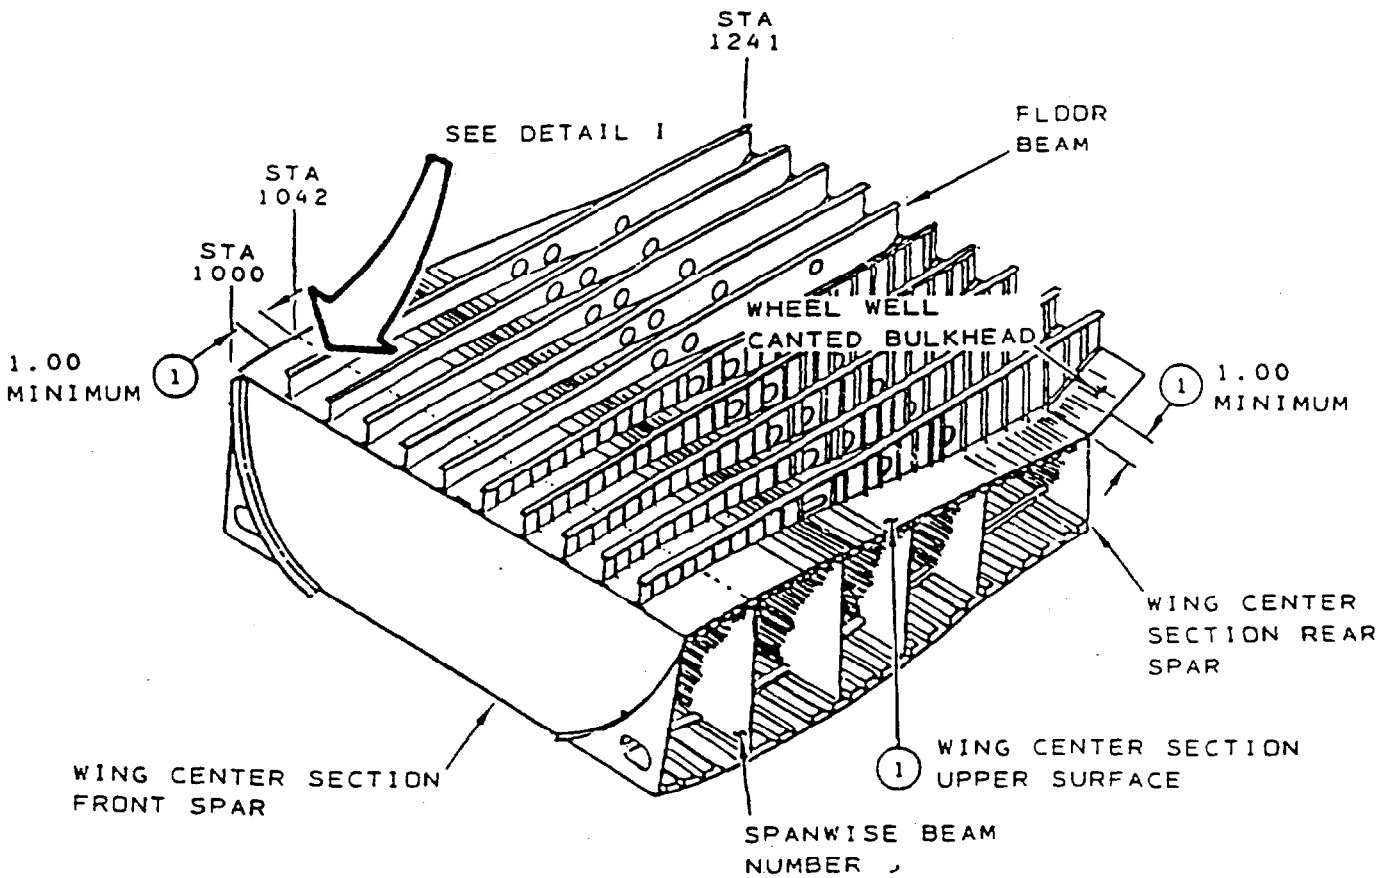
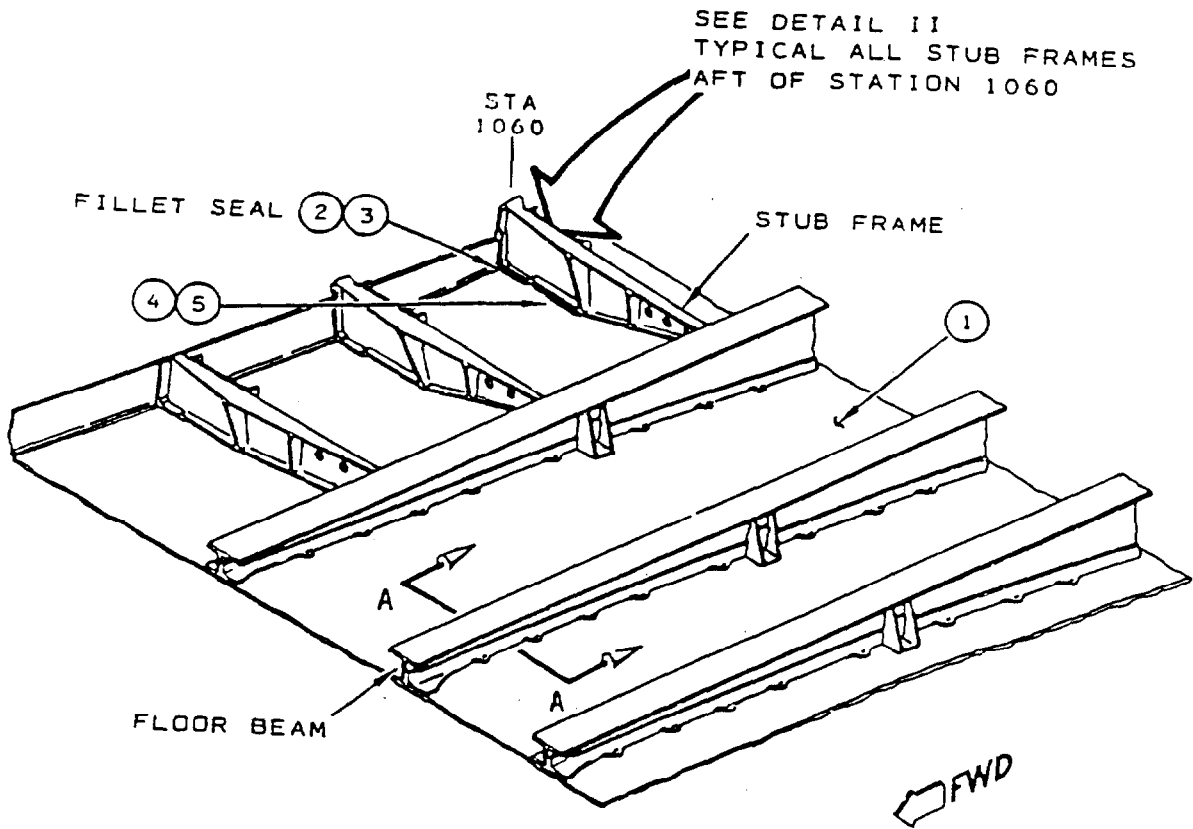
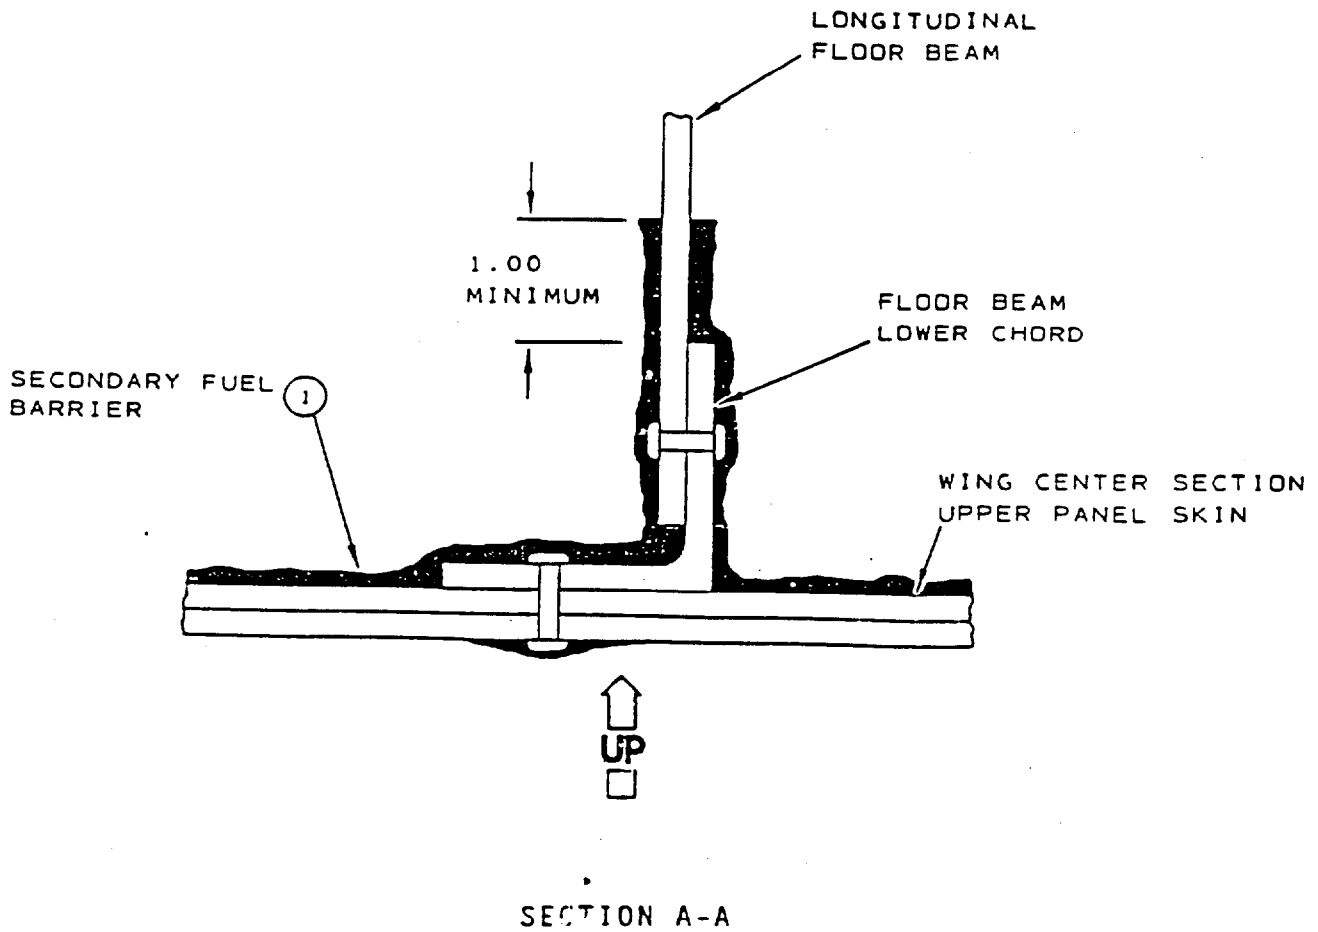
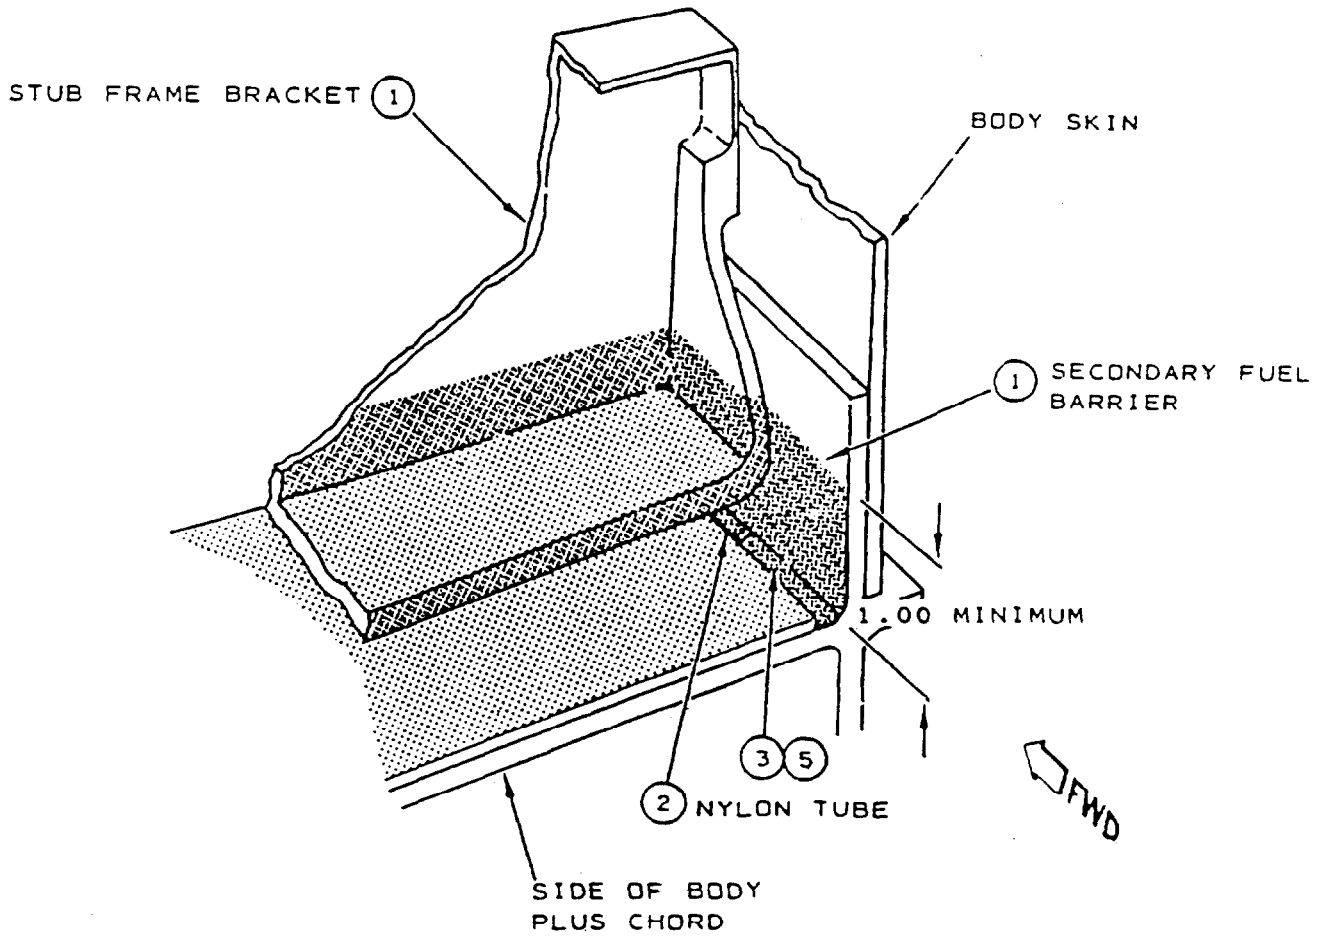
FIGURE 5. SECONDARY FUEL BARRIER INSPECTION AND REPAIR - GROUP 2 AIRPLANES

Perform a close visual inspection of the exterior surface of the wing center section upper surface to determine whether the secondary fuel barrier (sealant BMS 5-81) meets the following requirements:

NOTES: 1. The secondary fuel barrier may be identified by its glossy finish, clear to brownish hue, and rubber like texture.

2. Particular attention should be paid to areas around fasteners, brackets, and structural joints.

- a. The secondary fuel barrier should have complete coverage (with no breaks or openings) of all structure of the upper surface which is in contact or directly adjacent to the wing center section fuel.
- b. On the wing center section upper surface, the barrier should extend a minimum of one inch above the longitudinal floor beam lower chord (see Section A-A).
- c. On the wing center section upper surface, the coating should extend a minimum of one inch onto the wheel well canted bulkhead.
- d. On the wing center section upper surface, the barrier should extend a minimum of one inch above the horizontal flange of the side of body plus chord and stub frame brackets (see Detail II).
- e. On the wing center section upper surface, the coating should extend a minimum of one inch forward of spanwise beam number 3.

Repair areas where secondary fuel barrier is missing or damaged with sealant BMS 5-81 per Process Data pages or operator's comparable procedure.

NOTE: Use of a borescope is recommended for areas which are covered by tubing, ducting, insulation blankets or wire bundles. However, if additional access is needed for inspection or repair, accomplish the following as needed:

- a. Disconnect wire bundle supports and move wiring out of the way.
- b. Remove air conditioning ducts and plenum chamber per operator's standard procedure.
- c. Remove supplemental air fans per 747 Maintenance Manual Subject 21-25-07 or operator's comparable procedure.
- d. Remove insulation from trim air mufflers and ducts per 747 Maintenance Manual Subject 21-13-02 or operator's comparable procedure.

- ② Optional - Insert 3/8 inch outside diameter nylon tube under stub frame, leaving 0.50-0.75 inch length of tube extending beyond each side of the fitting. Temporarily plug the tube during sealant injection.
- ③ Clean area per Process Data pages and inject sealant BMS 5-26 under the stub fitting (stub frame) and fair into fillet seal. Provide a ramp to allow water to drain around fitting.
- ④ Clean area per Process Data pages and inject sealant BMS 5-26 under the aft stub frame fitting on each side of airplane and fair into fillet seal.
- ⑤ Apply secondary fuel barrier sealant BMS 5-81 and overlap at least one inch onto existing barrier per Process Data pages or operator's comparable procedure.
