# EXHIBITS

## EXHIBIT 1 - FUEL QUANTITIES AND WHAT THEY TELL US

By Captain Howard T. Mann

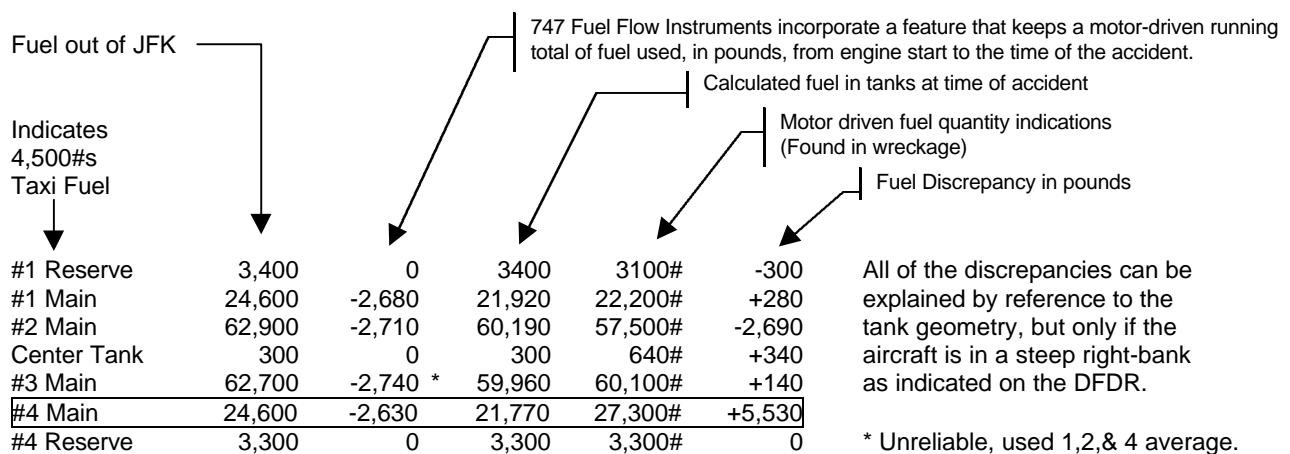
We were told at the Public Hearing in Baltimore that FL800 was making a normal climb-out with wings level when the center tank exploded. On other occasions, we were told something happened to the aircraft and that 20 seconds later the center fuel tank blew up. Reference to the Flight Data Recorder indicates the aircraft went through some violent maneuvers before the loss of electrical power. The 20:31:12 second line of the FL800 Flight Data Recording indicated the aircraft was rolling to the right and was in a steep bank. The purpose of this document is to support the FDR information by reference to a totally different system. I refer to the Fuel Quantity Indicating System (FQIS). The quantities indicated below are from official NTSB documents.

- Fuel quantity indications are valid in the wreckage because the indicators are motor driven and do not move when electrical power is removed.

The obvious discrepancy in the fuel figures for the #4 main tank tell us this aircraft was in a steep right bank just as the Flight Data last second line indicated when electrical power was lost. To understand what happened with the fuel quantity in the #4 main fuel tank takes some orientation about the tank itself and about the fuel quantity probes.
