**Interim Report
on the
Crash of TWA Flight 800
and the
Actions of the NTSB and the FBI**

Cmdr. William S. Donaldson, USN Ret.

Committee on Transportation & Infrastructure

July 17, 1998

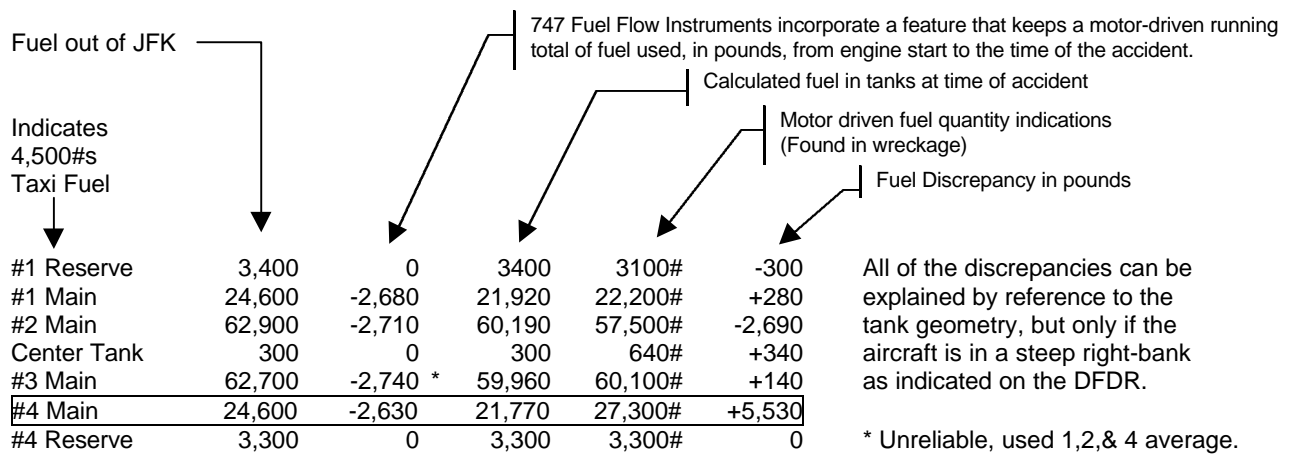
- Fuel quantity indications are valid in the wreckage because the indicators are motor driven and do not move when electrical power is removed.

The obvious discrepancy in the fuel figures for the #4 main tank tell us this aircraft was in a steep right bank just as the Flight Data last second line indicated when electrical power was lost. To understand what happened with the fuel quantity in the #4 main fuel tank takes some orientation about the tank itself and about the fuel quantity probes.

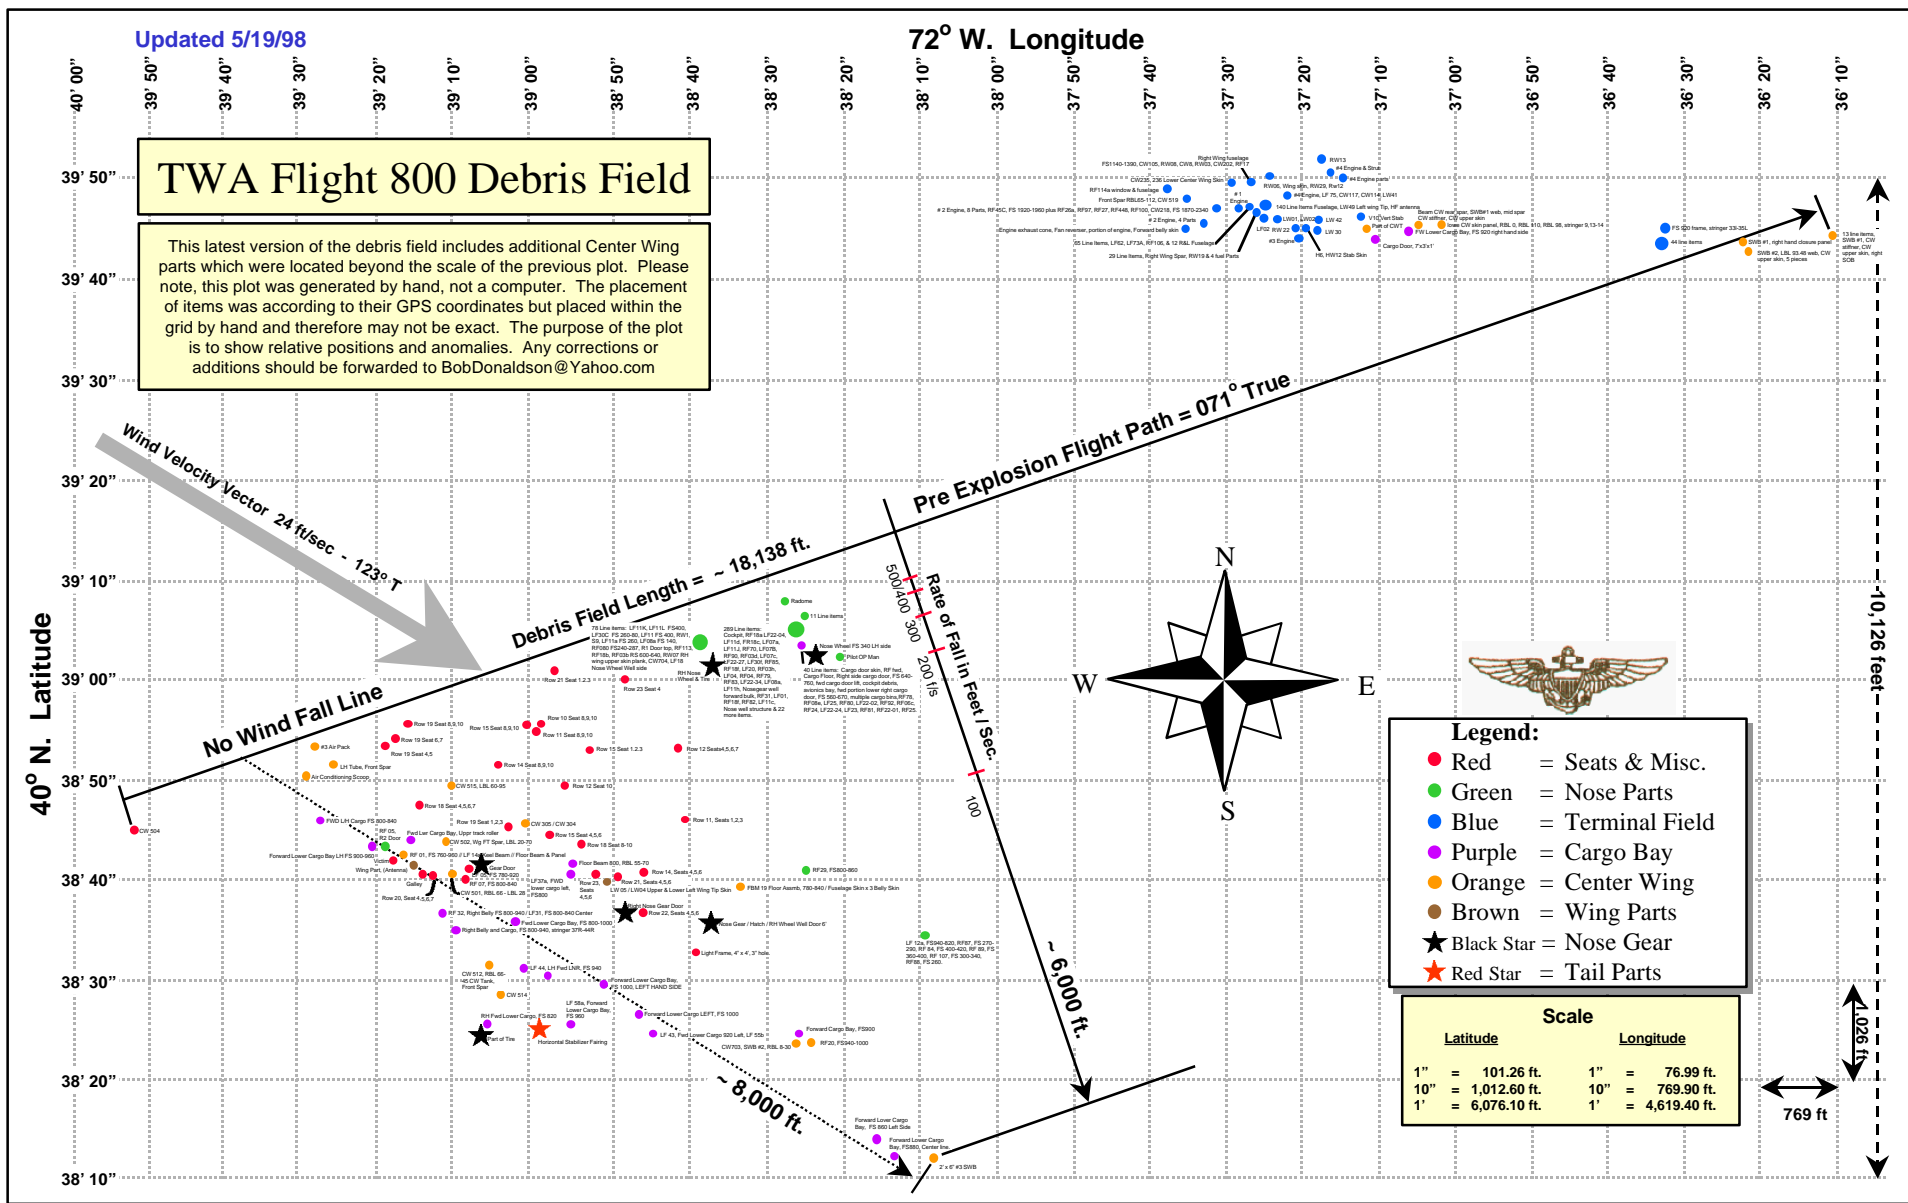
Exhibit 5 - TWA Flight 800 Debris Field

Fact: The majority of the actual center wing tank parts, that you would expect to be ejected in a tank explosion, were found 4,000 feet farther east than any other significant aircraft structure.

Comment: It appears the Debris Field database was not released to the public because the NTSB could not explain the wide separation of debris (18,000' long and 8,000' wide) and the amount of damage to the aircraft that is indicated by the distribution of debris. See Exhibit 5 on page 44.

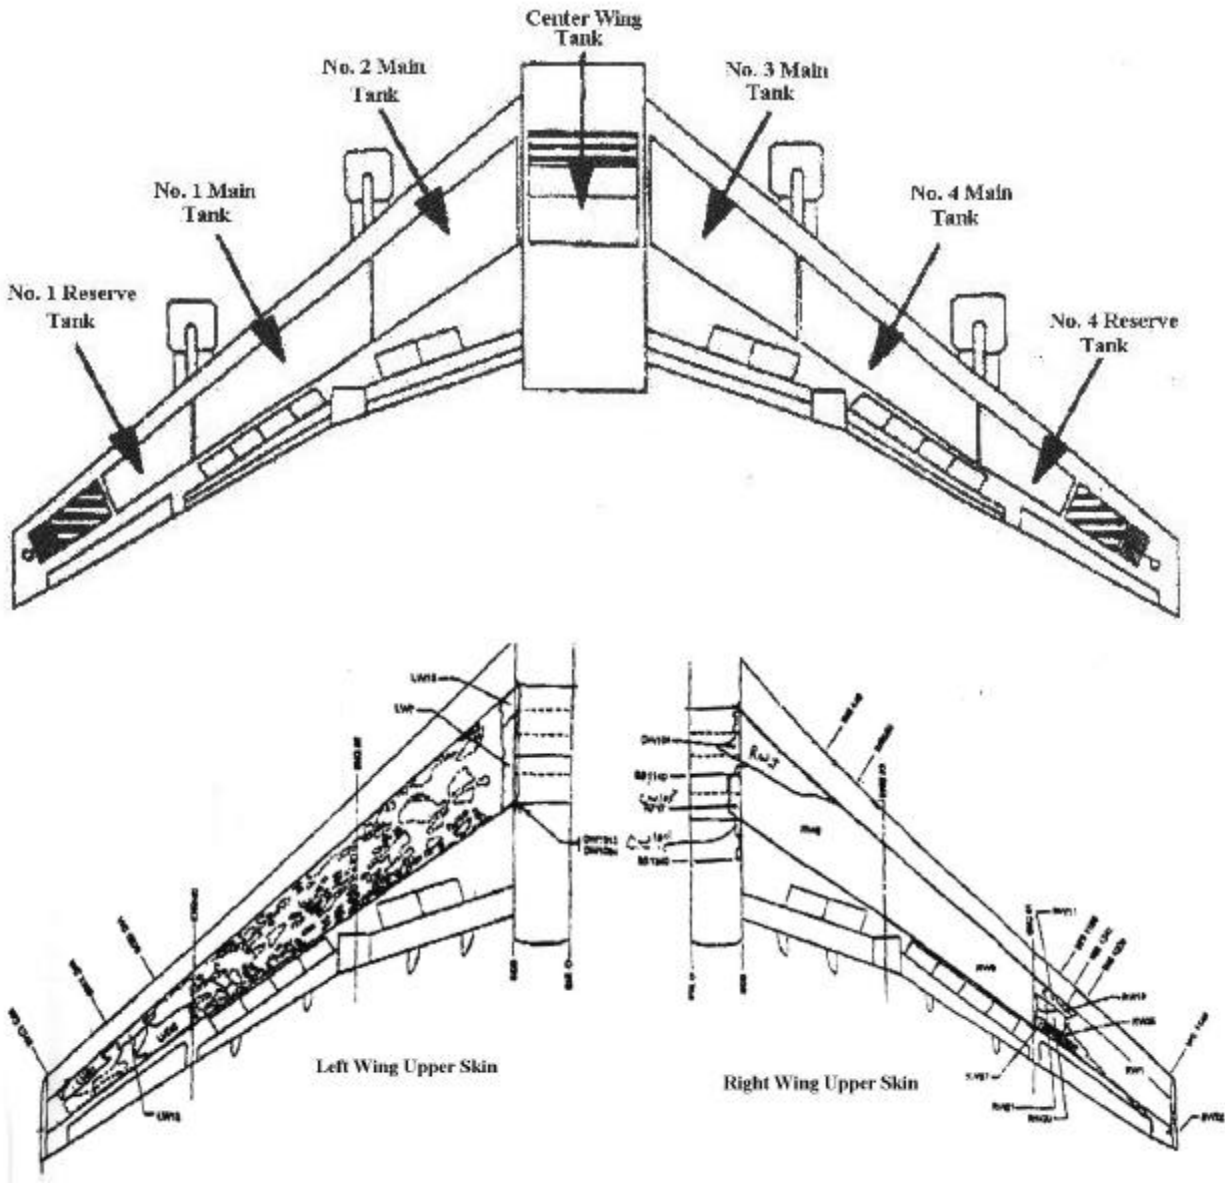
The first diagram shows a normal 747 wing with the location of the wing tanks and the second diagram shows the fragmentation of the upper skin of the left wing. This diagram was produced by analysts at the China Lake Naval Weapons Center. Only hydraulic RAM forces could produce this type of damage pattern.

1. Note the comparison of right and left upper wing skin damage. The bottom skins of both wings do not show this pattern.
2. Note the right wing is far less damaged despite a harder impact with the ocean. It was attached to the heavy fuselage at impact; the left wing was not.

3. The outer third of each wing separated early in the break-up sequence from high G overload.
4. Note extensive damage to left upper wing skin was confined to areas immediately over full or nearly full wing tanks. This implies the damage was a result of hydraulic RAM forces conveyed by fuel immediately under the skin.

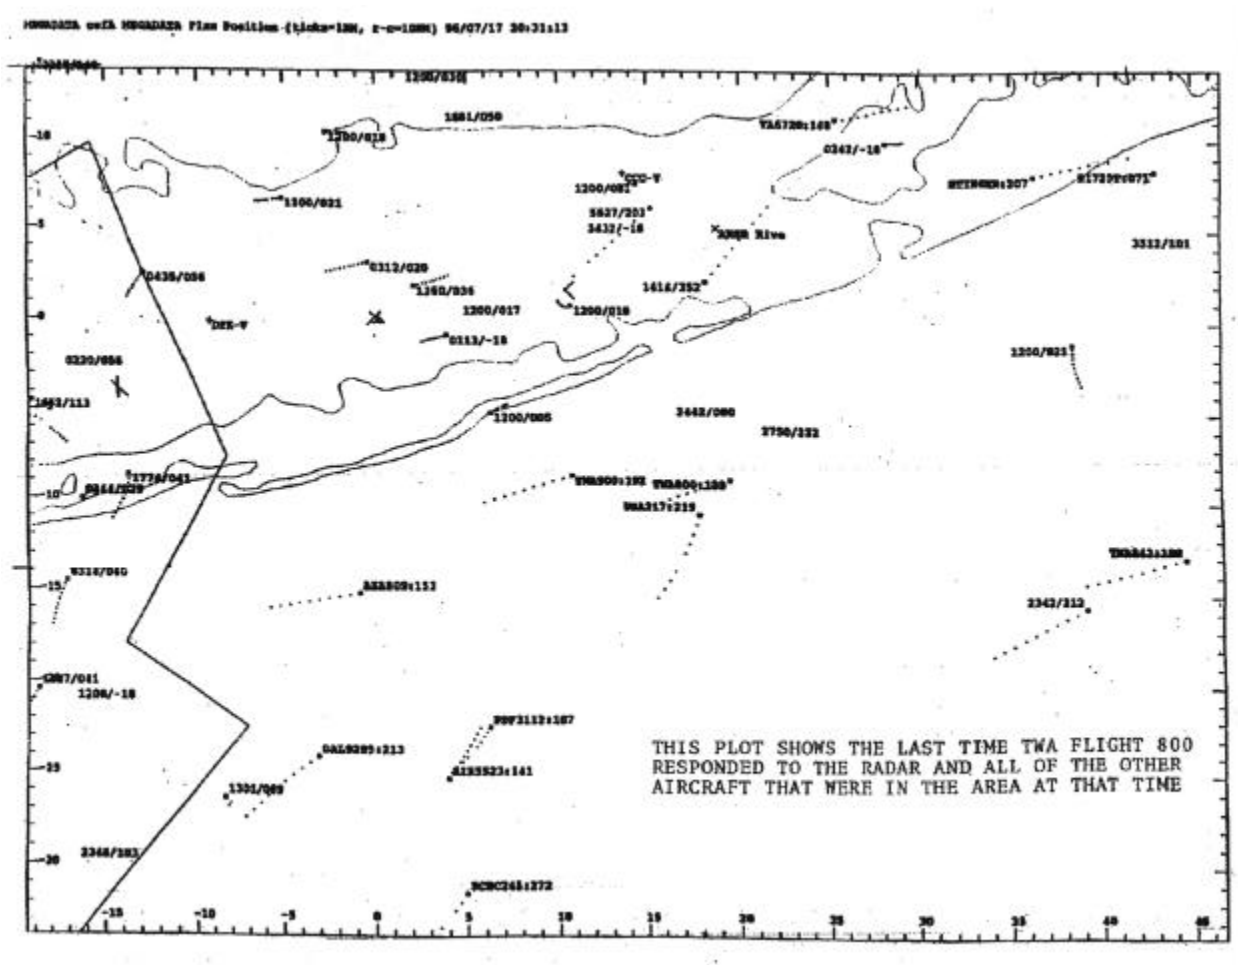
EXHIBIT 13 - MEGADATA SYSTEMS, INC. TRANSPONDER PLOT @ 20:31:13

This transponder plot shows TWA Flight 800's altitude as 13,800'. It was received at 20:31:13.

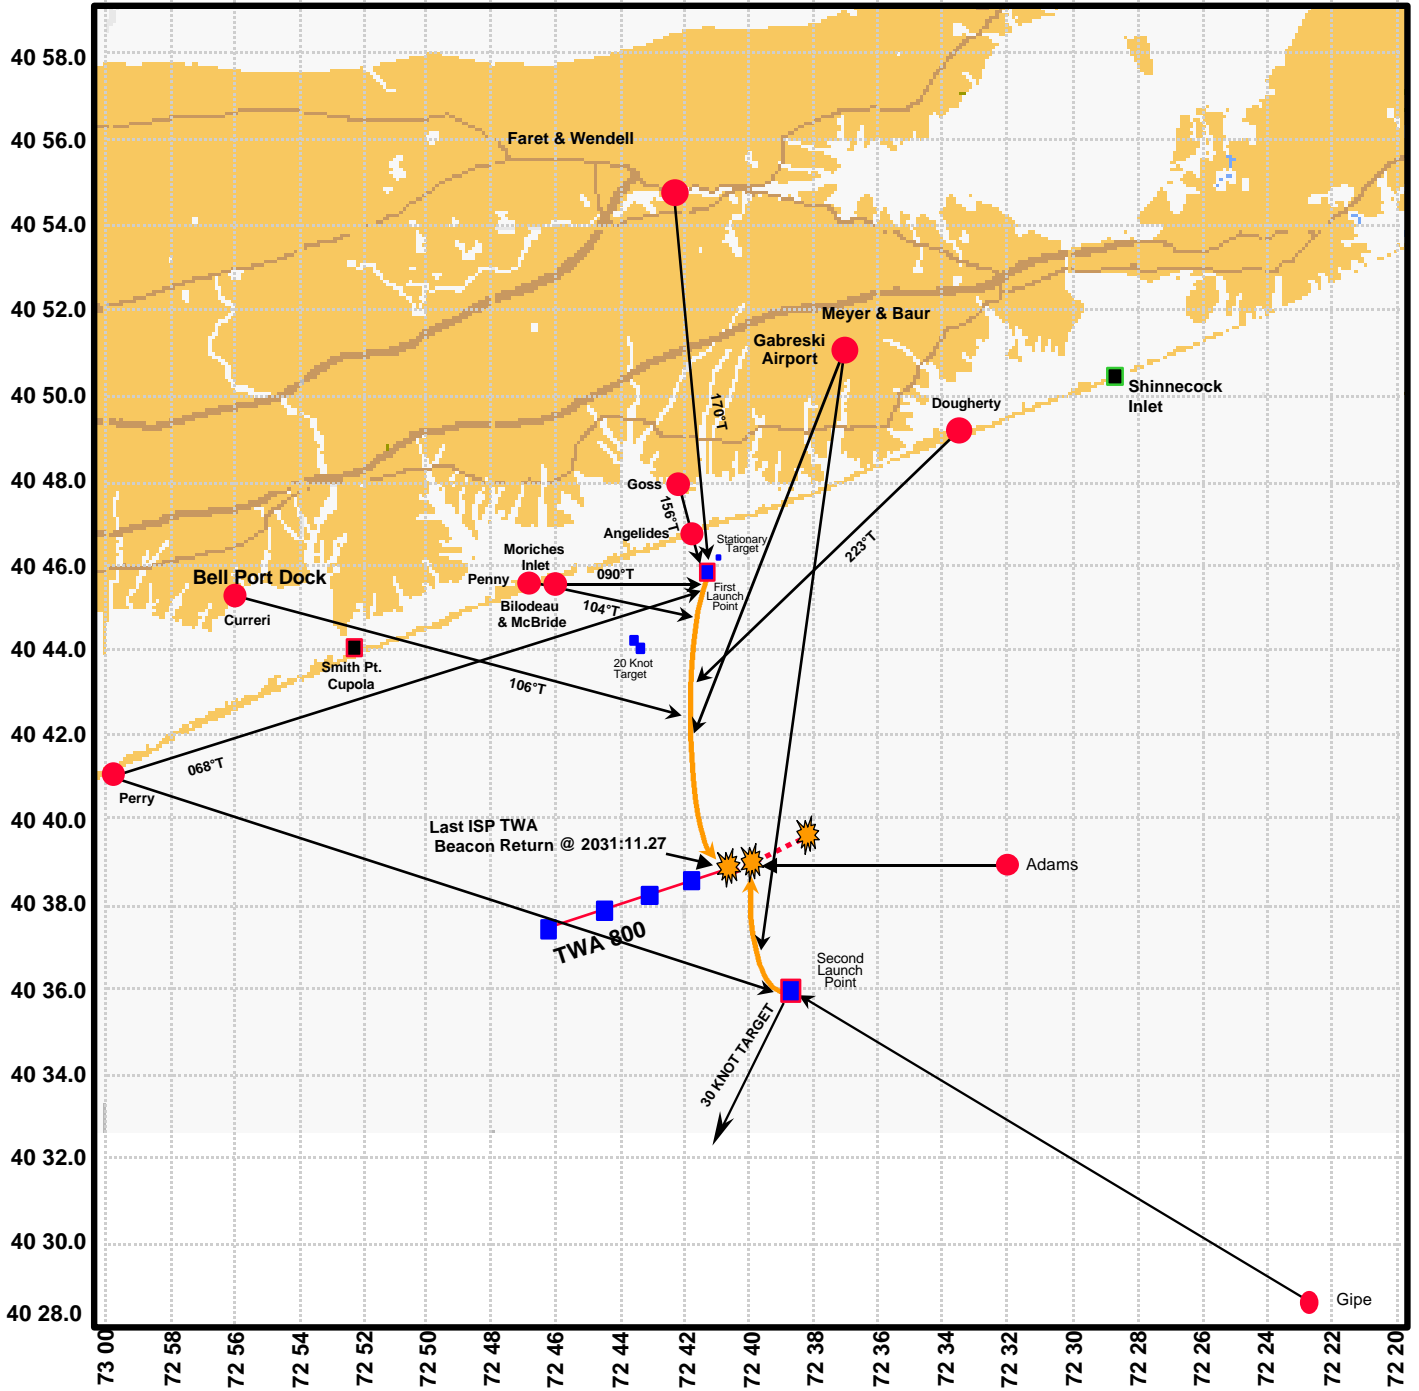
Exhibit 16 - Triangulation of Witness Bearing Line

The triangulation of witness observations was accomplished by thoroughly interviewing witnesses, and in many cases, going to the spot where the witness was located when they spotted the streak in the sky. A GPS position fix was used to document the location and the witness was asked to point to the spot where they first saw the streak. In many cases, there were reference objects, such as a house, pier or other fixed object which the witness could point to as a reference. A hand-bearing compass was then used to get the magnetic bearing. The witness was asked to describe the sequence of events, sights, sounds, vibrations, etc. In all but one case listed here, the witness first saw the object, then heard sounds sometime later. A number of witnesses took careful extemporaneous notes of their observations. These observations were then converted from Magnetic to True bearings and plotted on the above chart. The NTSB radar track of the last secondary return was then also plotted on the chart. Each of these witnesses saw the streak of light for a number of seconds, then saw one or more white explosions, followed some seconds later by a large orange fireball.

As you can see from the plot, the witnesses saw the streak from quite a few different angles and at different points in its flight. This explains the variability in witness statements as to direction of their observation and direction of travel with respect to them. Since none of them first heard the sounds, their observations cannot be explained away by the CIA video which was produced to suggest that all the eyewitnesses saw the crippled, headless aircraft climbing 3,000 ft. trailing burning fuel.

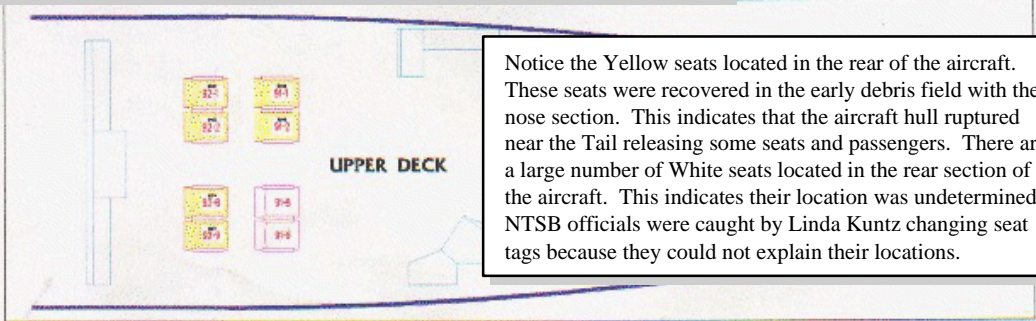
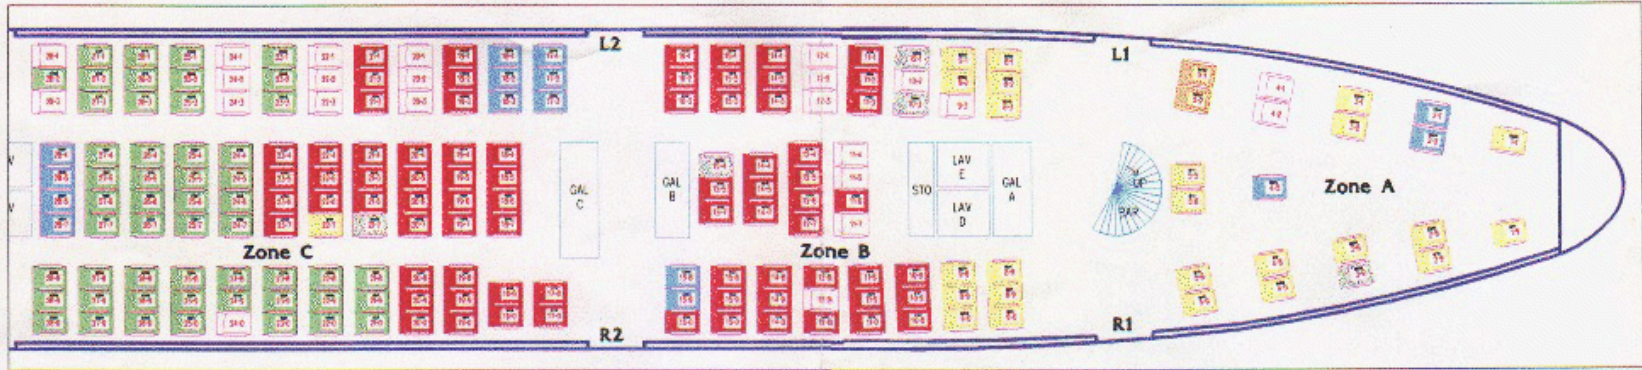
Exhibit 21 - Locations of Recovered Seats in the Debris Field

Notice the Yellow seats located in the rear of the aircraft. These seats were recovered in the early debris field with the nose section. This indicates that the aircraft hull ruptured near the Tail releasing some seats and passengers. There are a large number of White seats located in the rear section of the aircraft. This indicates their location was undetermined. NTSB officials were caught by Linda Kuntz changing seat tags because they could not explain their locations.

Seats marked with Grey were seats that previously had colored tags and were changed to "Indeterminate". A number of these seats previously had yellow tags.

These last two seats in the rear of the aircraft were found with the Cockpit in the debris field. This could not have happened unless the hull ruptured near the tail section.

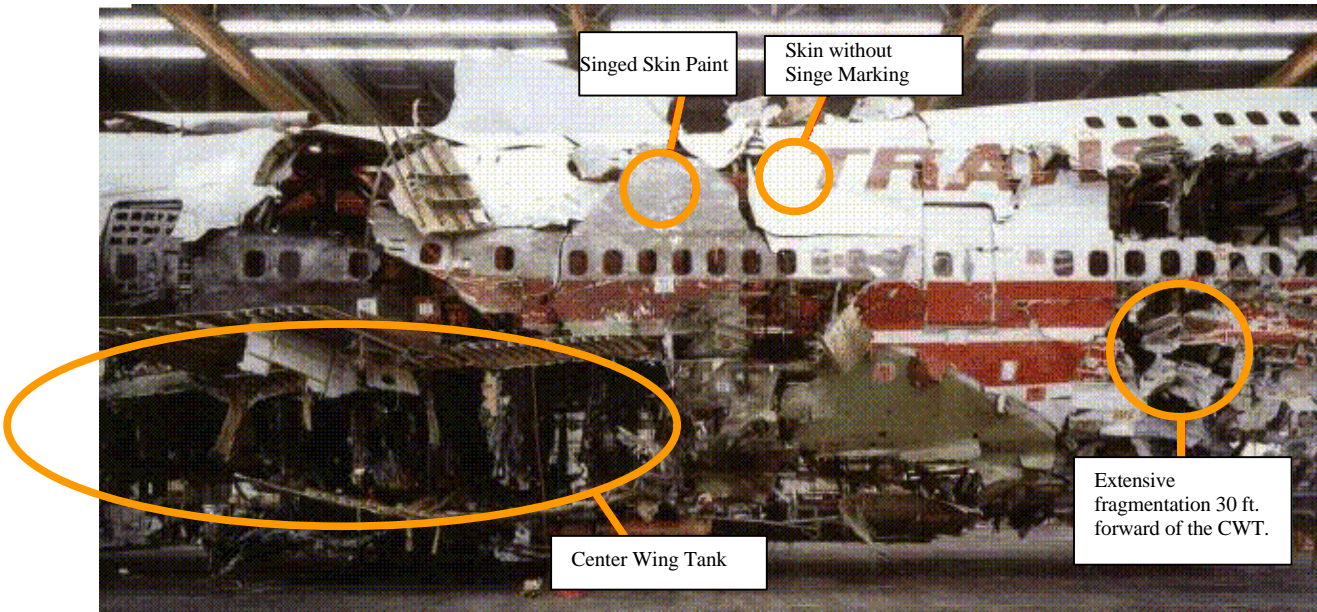
The photograph below shows the right side of the aircraft where the blast damage is

much greater and farther away from the Center Wing Tank. The metal is petaled outward as if a high velocity fragment transited the aircraft from left to right.

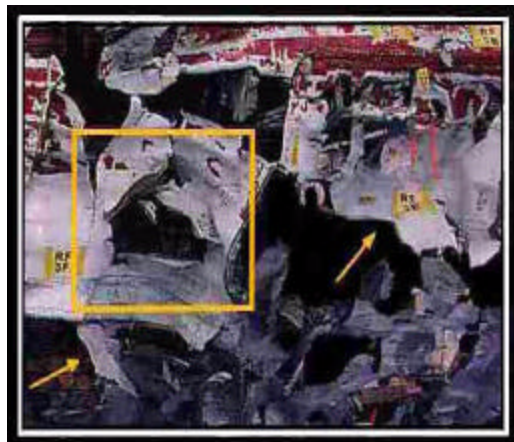
The close up at the right shows the extreme fragmentation on the right side. Notice the metal is petaled outward.

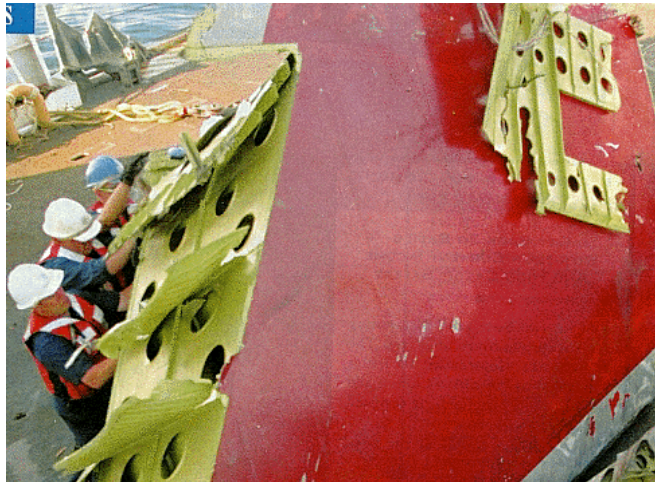
The photograph to the left is part of the tail section vertical stabilizer. Notice the clean, unsooted condition of this large section of the tail. It was located floating by eyewitnesses at least 1 mile from the fuselage impact area. See Captain Adams statement on page 19.
