DOCKET NO. **SA- 516**

**NATIONAL TRANSPORTATION SAFETY BOARD
WASHINGTON, D.C.**

Contracted Laboratory Documentation

TWA 800 Switch Analysis
(Failure Analysis)

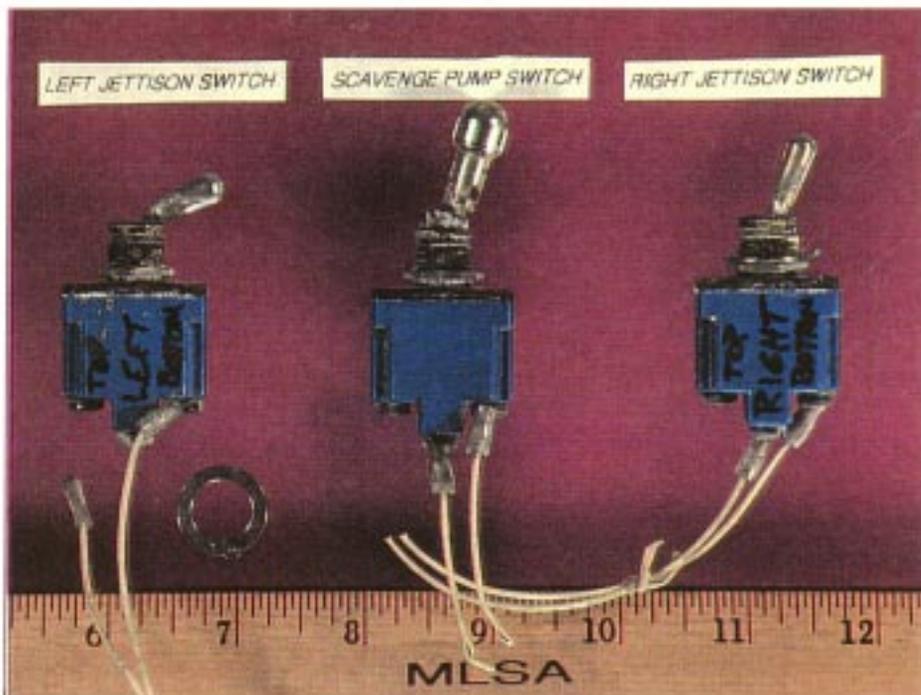
Figure 1. Side 1 of the three switches received for analysis.

The left jettison switch knob was bent towards the "off" position (bottom) 50 degrees beyond normal. The markings and the bent knob are shown in Figures 1 and 2. Corrosion was noted around the three contact screws (designated as top, left, and bottom) (Figure 5). The terminal wire was attached to the bottom screw terminal. The left screw terminal contact was in place but the wire had broken away at the lug terminal. There was no wire attached to the top terminal. There was green-colored corrosion around the terminal attachment. The exposed copper was also green colored. The copper was partly shiny on the broken solderless terminal connector (see arrow, Figure 5) . The top terminal appears to have been unused. Corrosion was noted on top of the switch and around the securing threads and inside the top one. There was a deep gouge in the securing thread. The case exhibited some corrosion and the blue colored case material was flaking off. The corrosion was primarily white in color with some green coloration- The metal surrounding the environmental seal had corrosion and salt water-like and sand deposits (Figure 6).

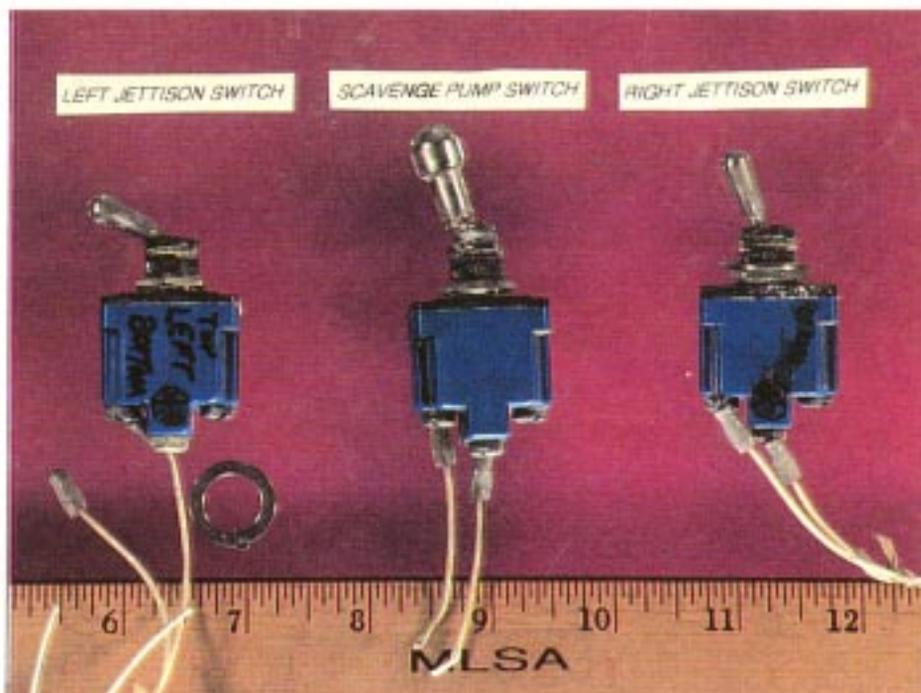
Figure 2. Side 2 of the three switches received for analysis.

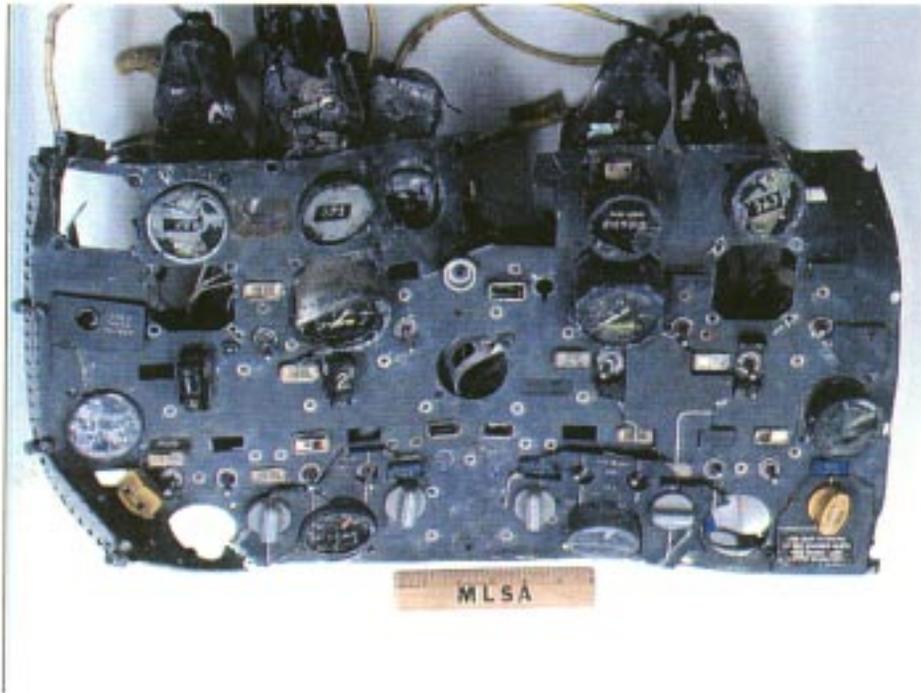
Figure 3. Face side of flight engineer's fuel control panel as received.

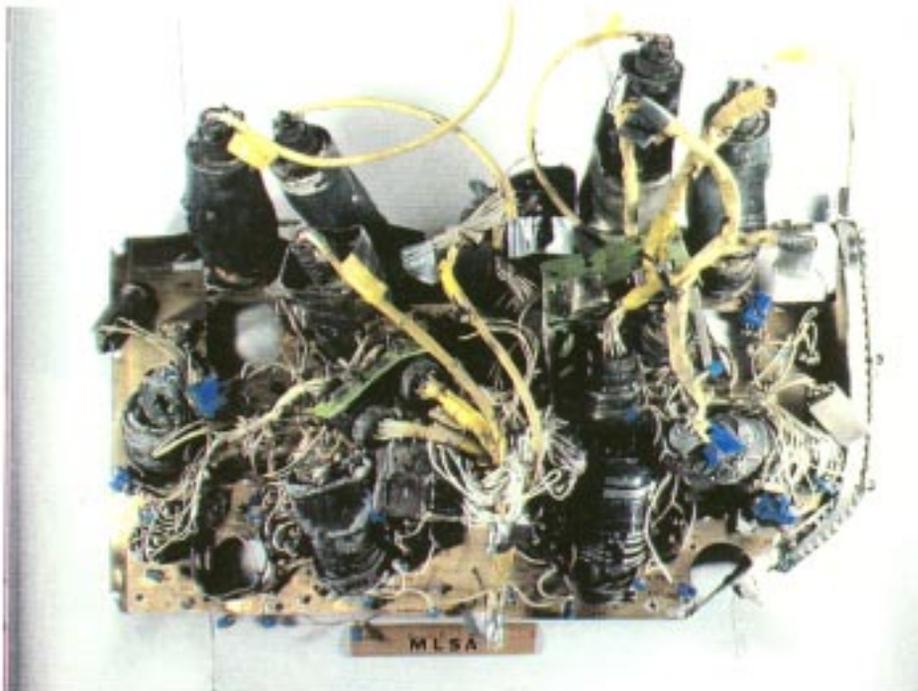
Figure 4. Back side of flight engineer's fuel control panel as received.

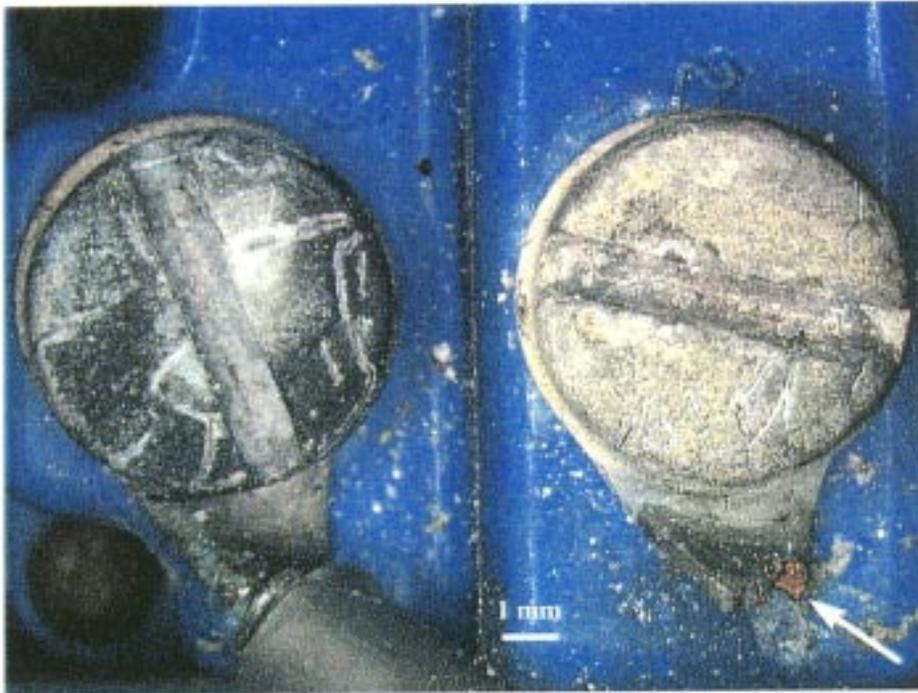
Figure 5. Left jettison switch screw terminals exhibiting corrosion from salt water exposure. Note the exposed copper from the solder lug (arrow).

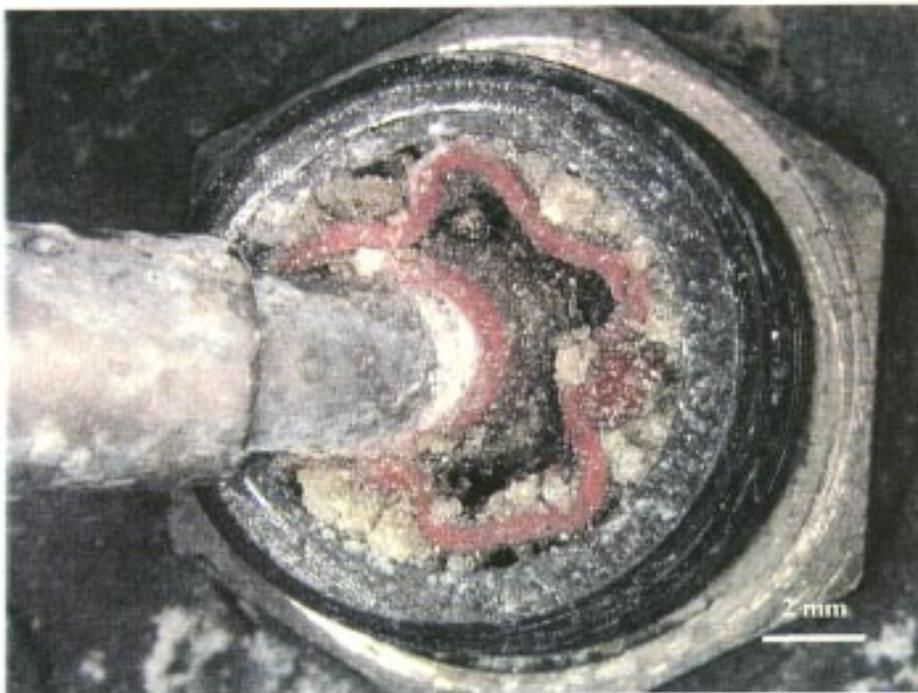
Figure 6. The environmental seal of the left jettison switch exhibiting corrosion and salt water-like deposits.

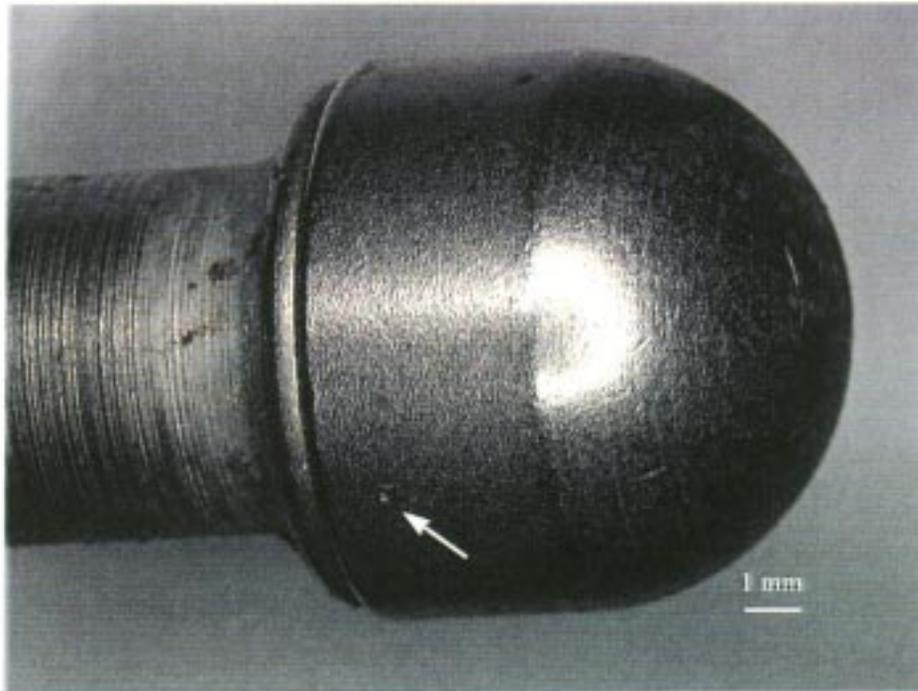
Figure 7. Gouge found on the left side of the scavenge pump switch knob 15 degrees forward of the knob center line.

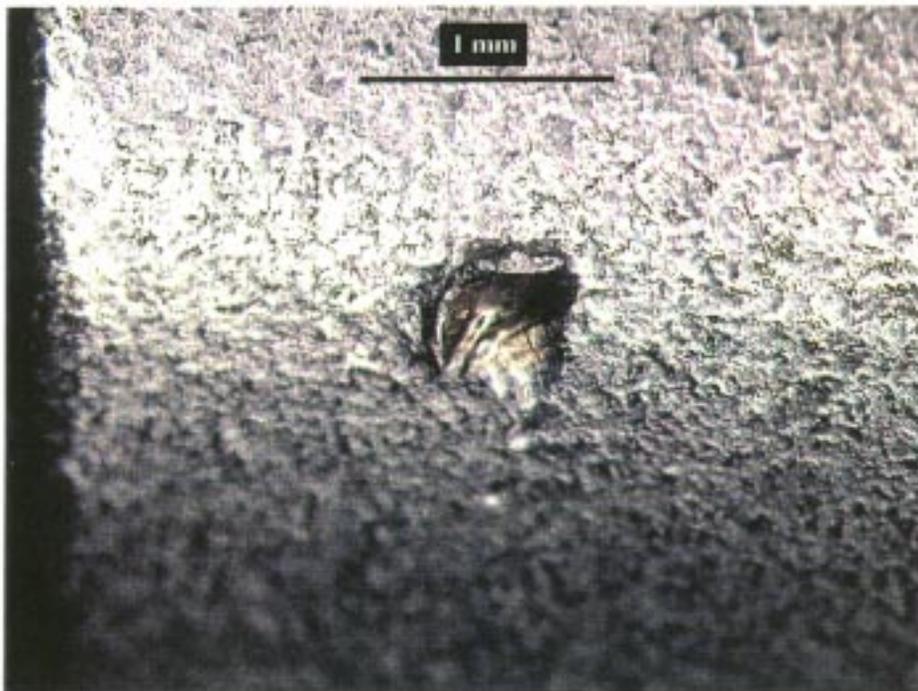
Figure 8. Close-up of the gouge. Note the metal displacement used to determine the gouge direction.

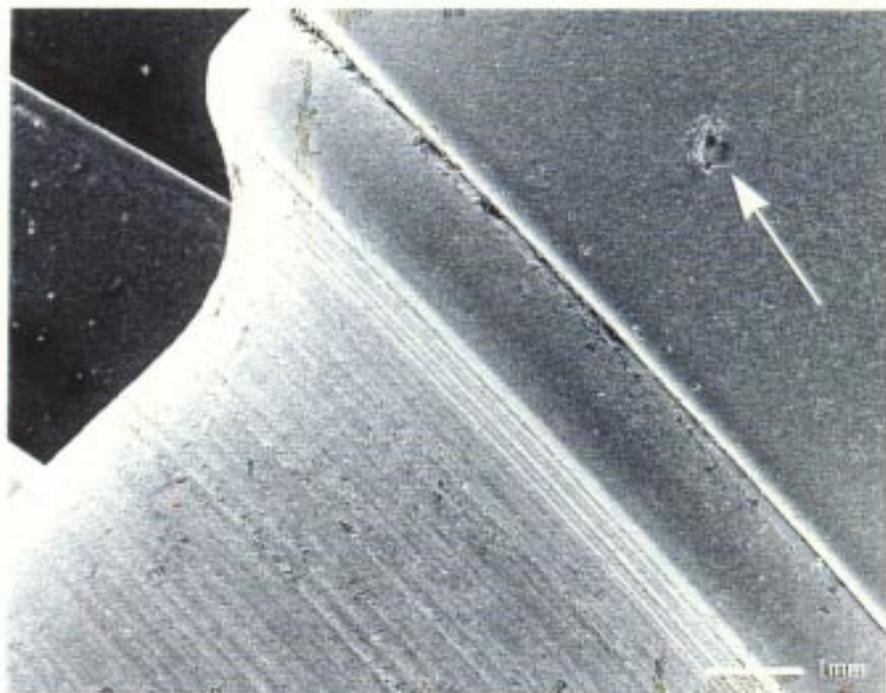
Figure 9. SEM view of the gouge found on the scavenge pump switch knob (arrow).

knob would be towards the "off" position. The EDS analysis was unable to determine the makeup of the material that caused the gouge. This was due to insufficient amount of material for analysis or because the impact object was constructed from the same material as the knob.

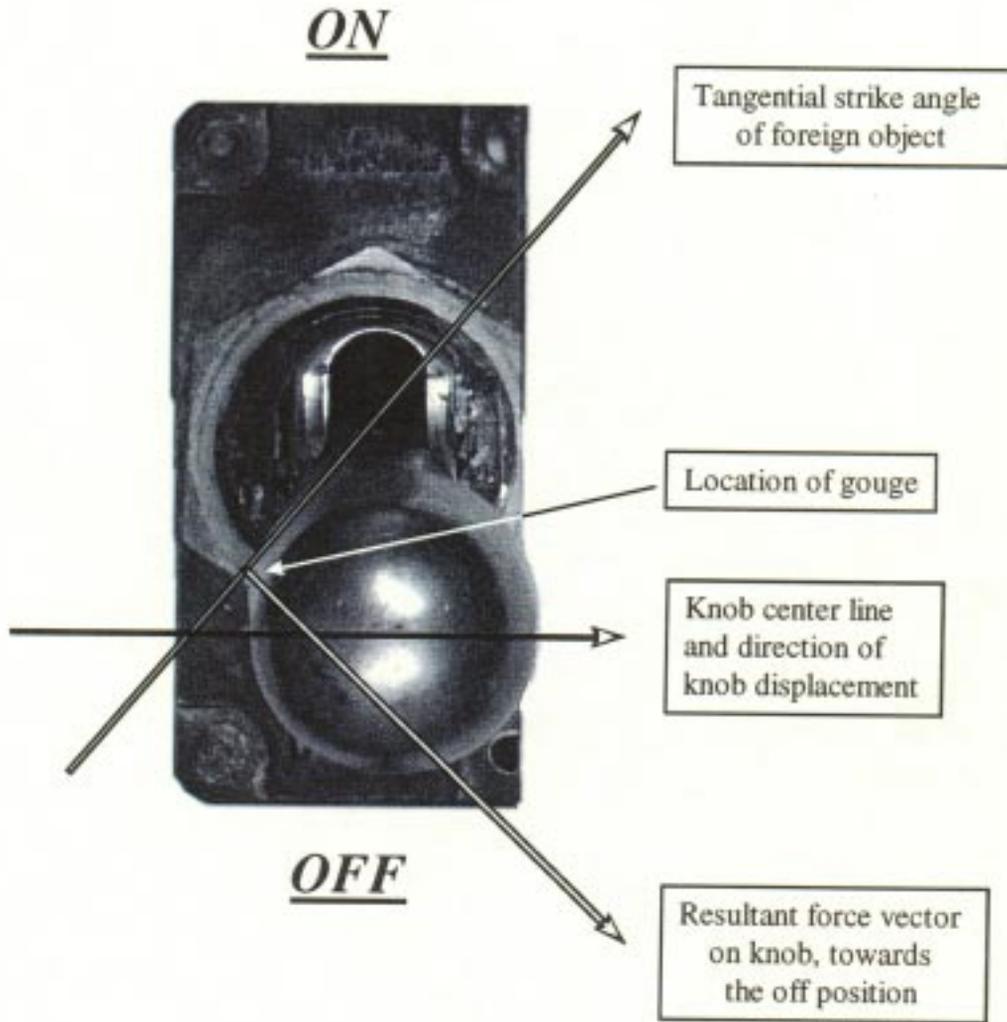
Figure 10. Overall view of scavenger pump switch knob showing the impact gouge (white arrow), the knob center line, the direction of the impact, and the displacement of the knob in the cam groove.

The metal displacement in the gouge found on the scavenge pump switch knob was consistent with an impact to the switch knob in the direction as diagramed in Figure 10. Since the impact was forward of the knob center line, the resultant force on the

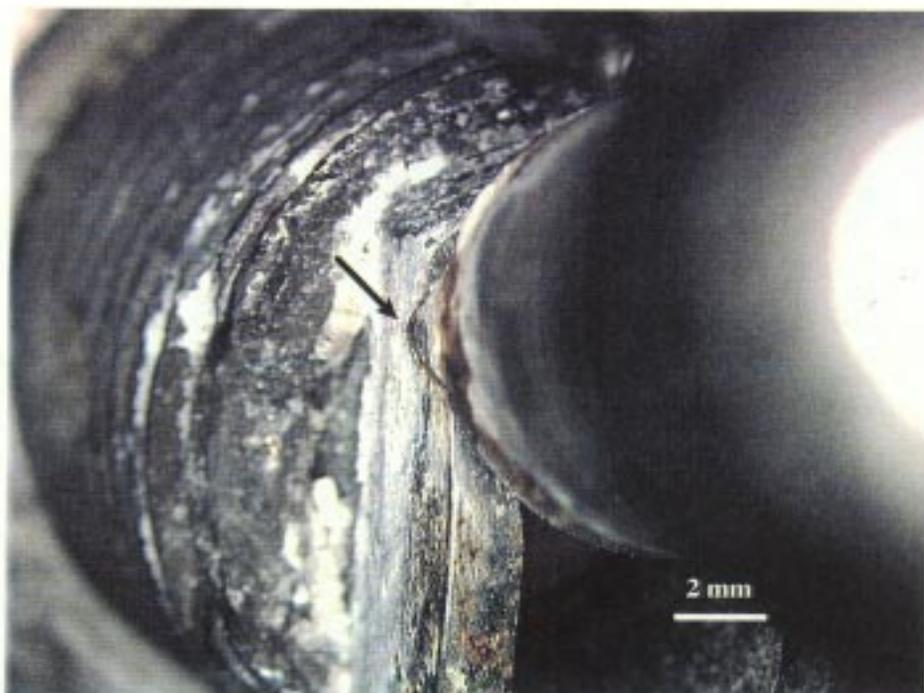
Figure 12. Scavenge pump knob exhibiting displacement towards the right side of the locking cam (left in the photograph).

toward the right side of the switch. Optical inspection also showed evidence the knob was displaced towards the right side of the locking cam (Figure 12) . The locking cam groove for the "off" position on the right side had metal displacement in the shape of a lip (Figures 13 and 14) . The environmental seal sleeve around the knob was stretched away from the knob towards the "on" position (Figure 15) . The locking cam surface was examined for any witness marks which would indicate a blow to the knob and none were found. The wear pattern appeared normal.

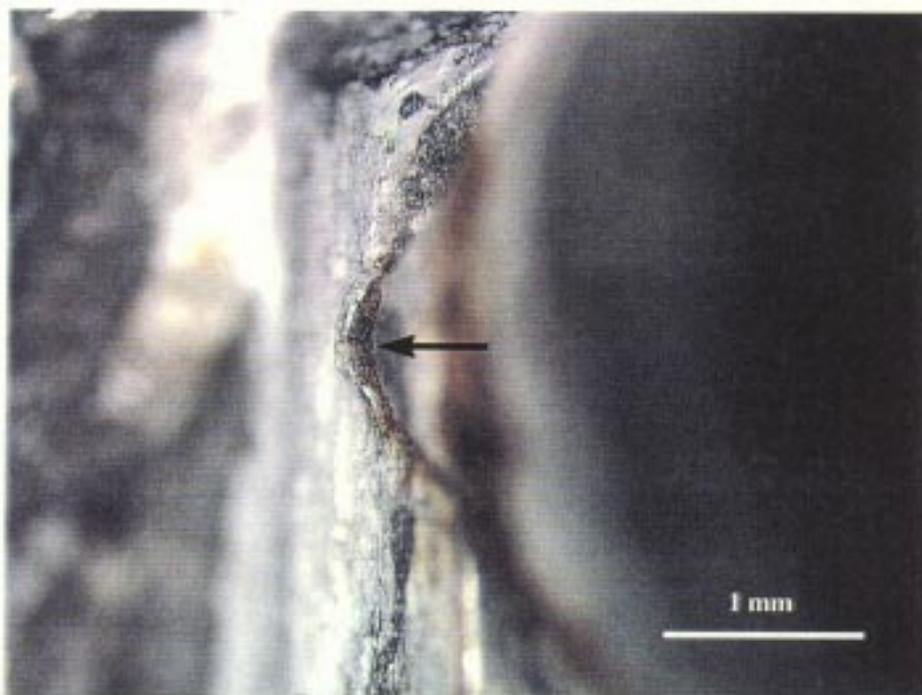
Figure 13. Close-up showing the lip shaped metal displacement of the locking cam (arrow).

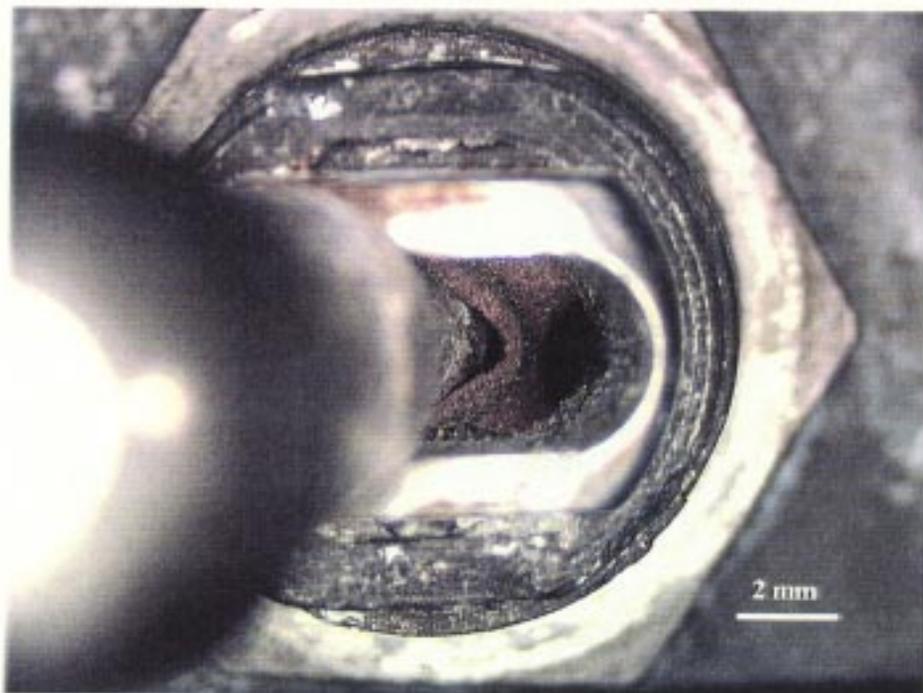
Figure 15. The environmental seal sleeve was displaced from the knob towards the "on" position.

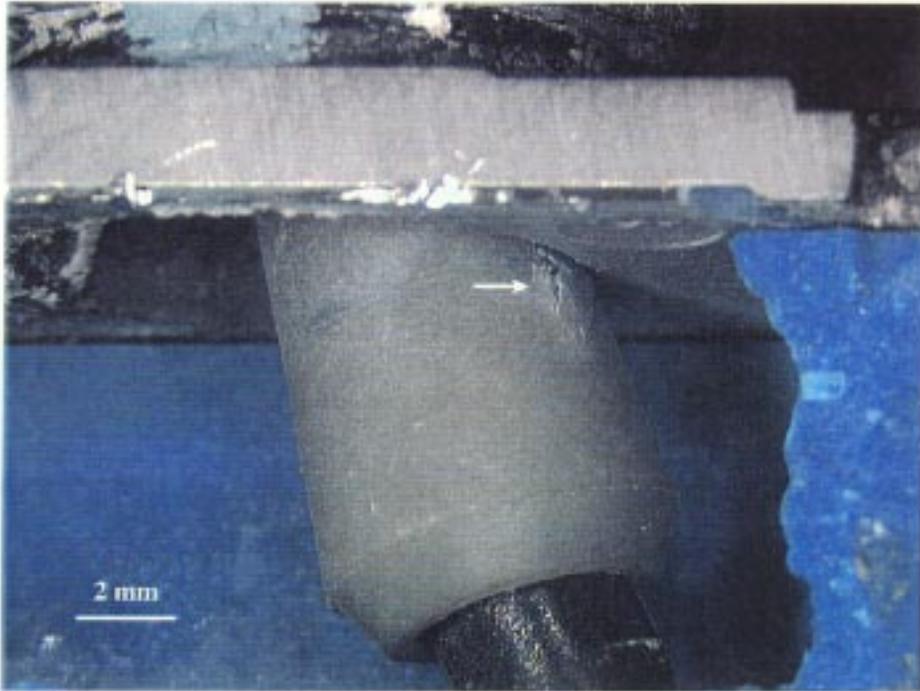
Figure 16. Scavenge pump switch plunger guide exhibiting surface cracks from the mold runner (arrow).

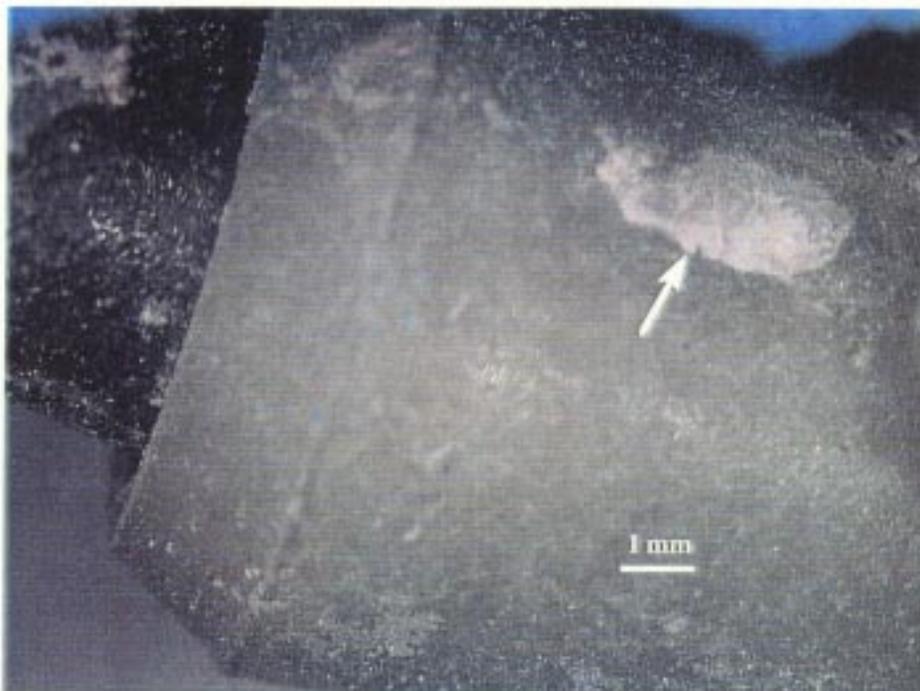
Figure 17. Right jettison switch plunger guide exhibiting typical mold runner marks (arrow).

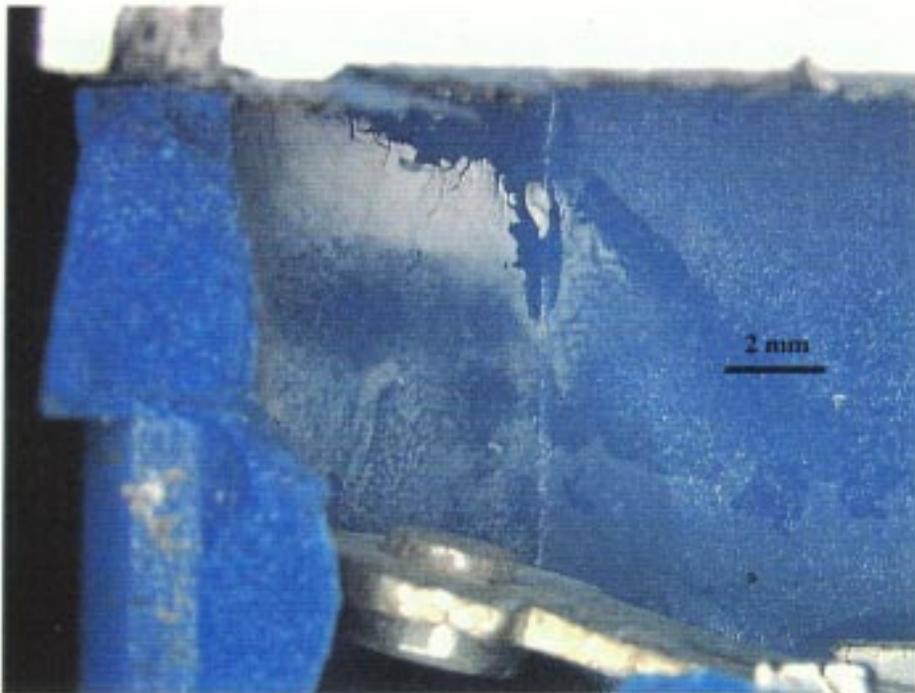
Figure 18. Evidence of internal salt water-like deposits on the scavenger pump switch case near the contact.

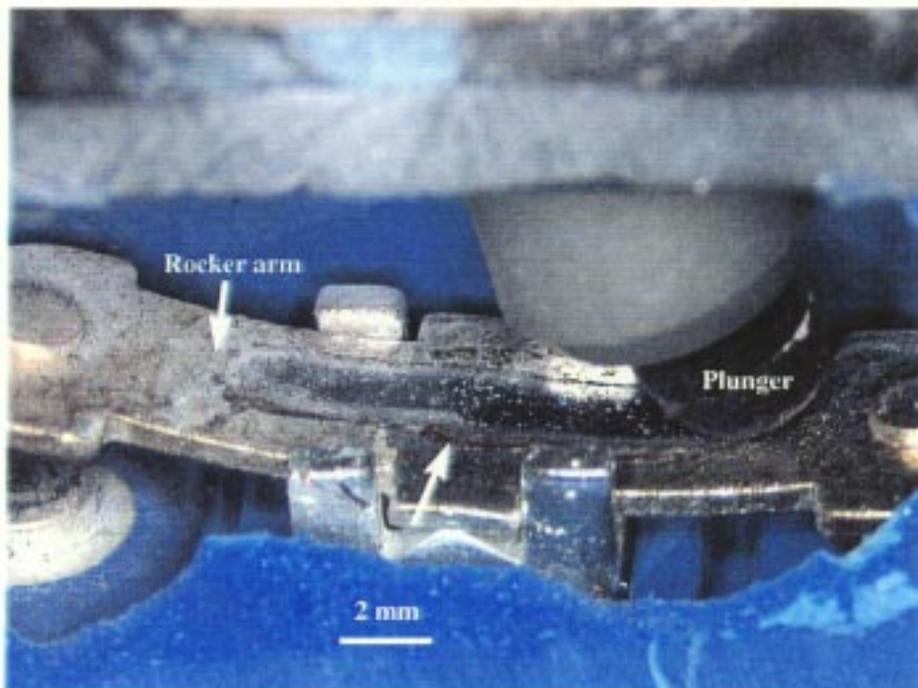
Figure 19. Internal view of the scavenger pump switch mechanism. The arrow indicates the lubricant material on the rocker arm which was chemically analyzed.

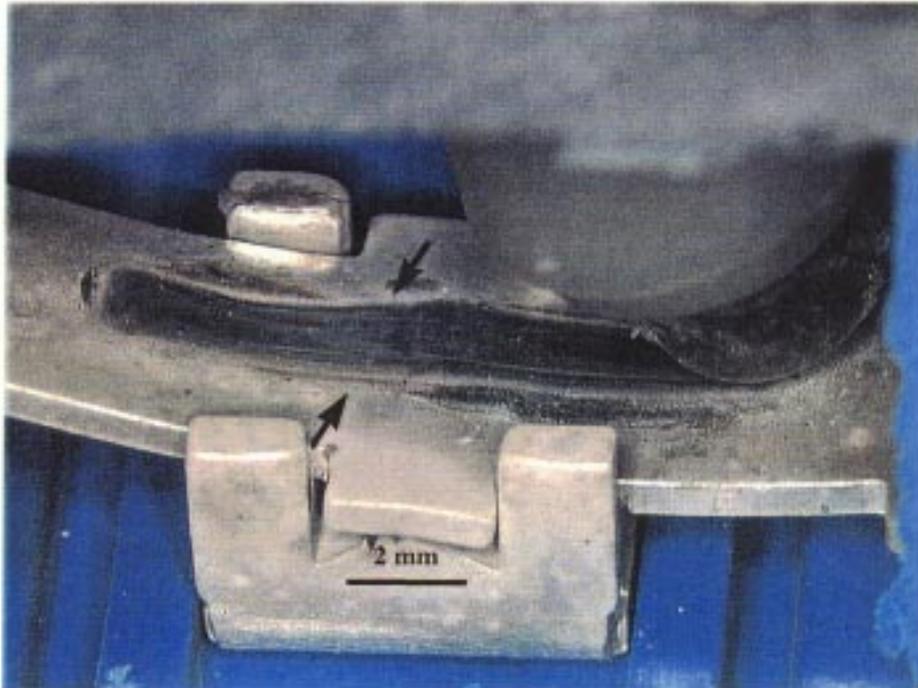
Figure 20. Internal view of the switch mechanism of the left jettison switch. The track is apparent as indicated between the arrows.

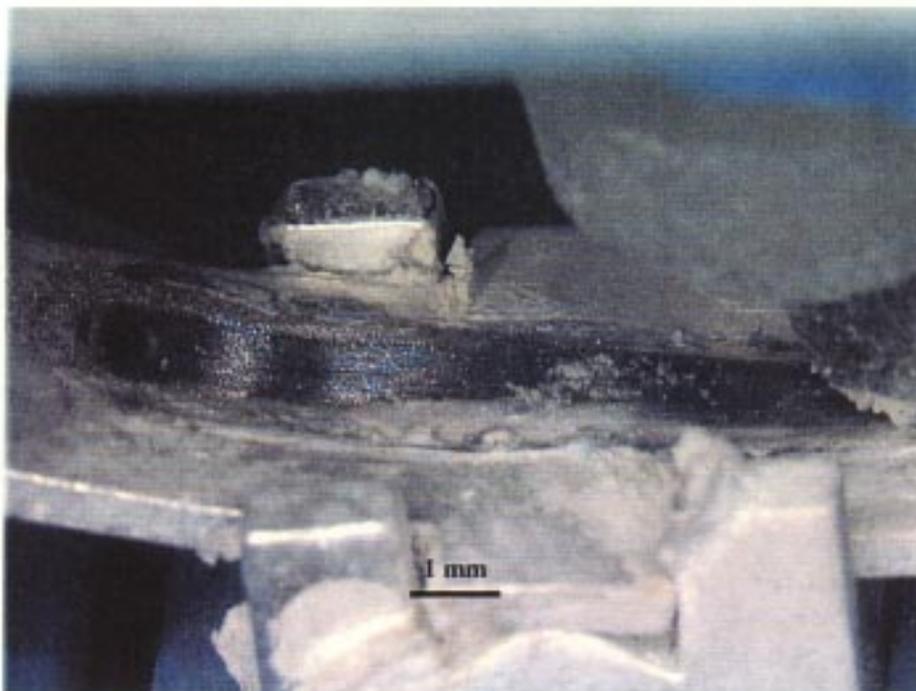
Figure 21. Internal view of the switch mechanism of the right jettison switch.

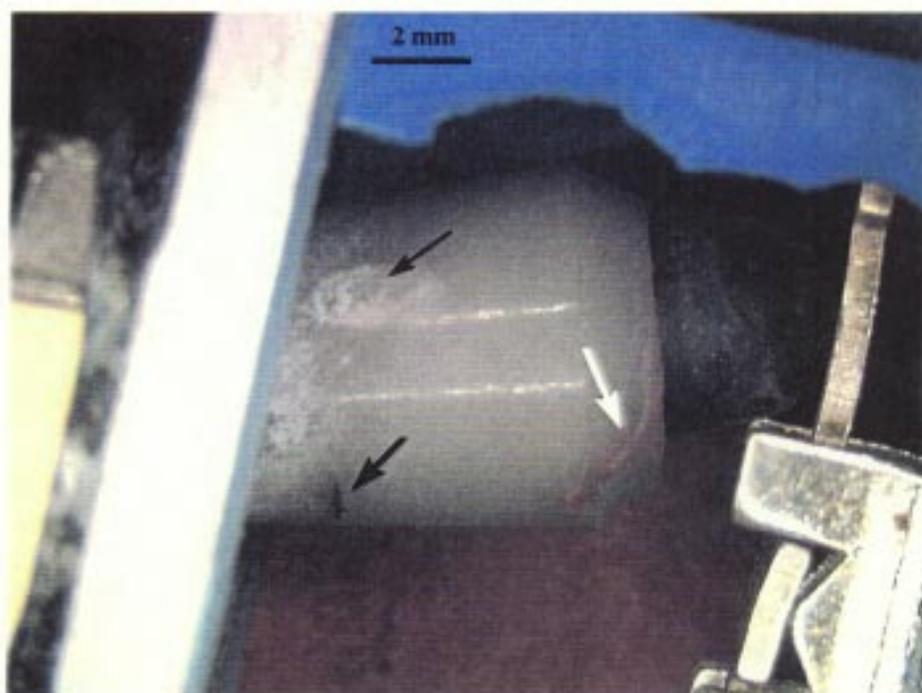
Figure 22. Internal view of the plunger and guide, red lubricant, (at white arrow, chemically analyzed) and rocker arm of switch S11. The mold runner mark on the plunger is apparent at the black arrow. The larger black arrow indicates the typical black marks on the plunger resulting from actuation impact with the plunger stop.

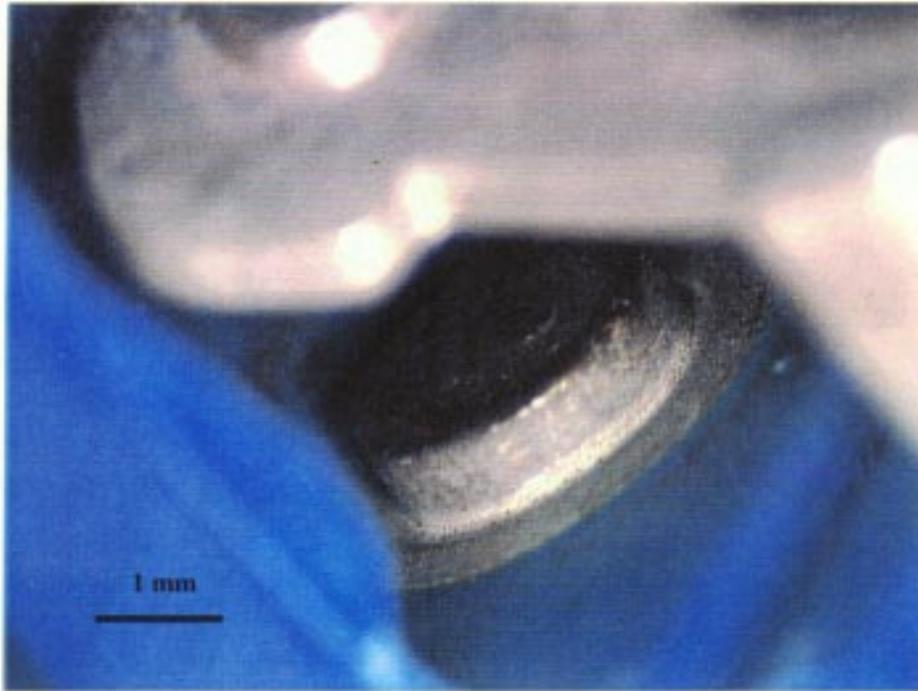
Figure 23. Normally open contact surface from the left jettison switch exhibiting typical wear.

The contact surfaces of all three switches were examined and only the normal wear pattern was found (Figure 23) . The normally open contact surfaces in right jettison pump switch were covered with salt water-like residues (Figure 24) . Contact resistance for the normally open contacts when actuated was 825 m Ω . The normally closed contact surfaces did not exhibit any salt water-like residues (Figure 25) . The contact resistance as expected was much lower at 2.7 m Ω . There appeared to be little or no salt water-like residues on the contact surfaces of the left jettison switch. The contact resistances for the normally open and normally closed were 17.3 m Ω and 20 m Ω , respectively. The normally closed contact surfaces of the scavenge pump switch were clean with a contact resistance reading of 3.8 m Ω . There were slight salt water-like residues on the normally open contact surfaces resulting in a 22.2 k Ω contact resistance (Figure 26) .

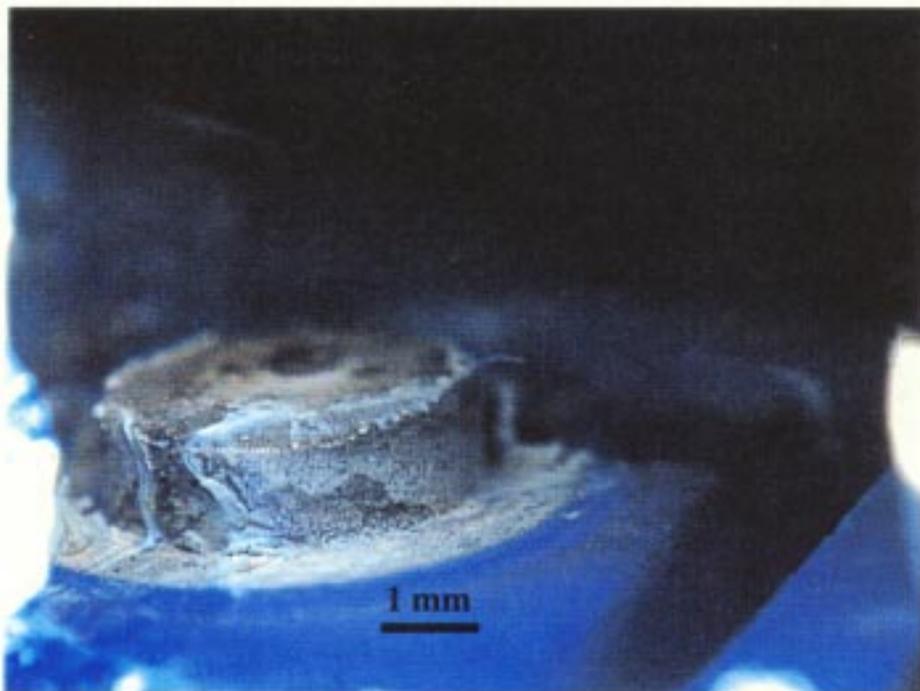
Figure 24. Normally open stationary contact surface of the right jettison switch exhibiting salt water-like residues.

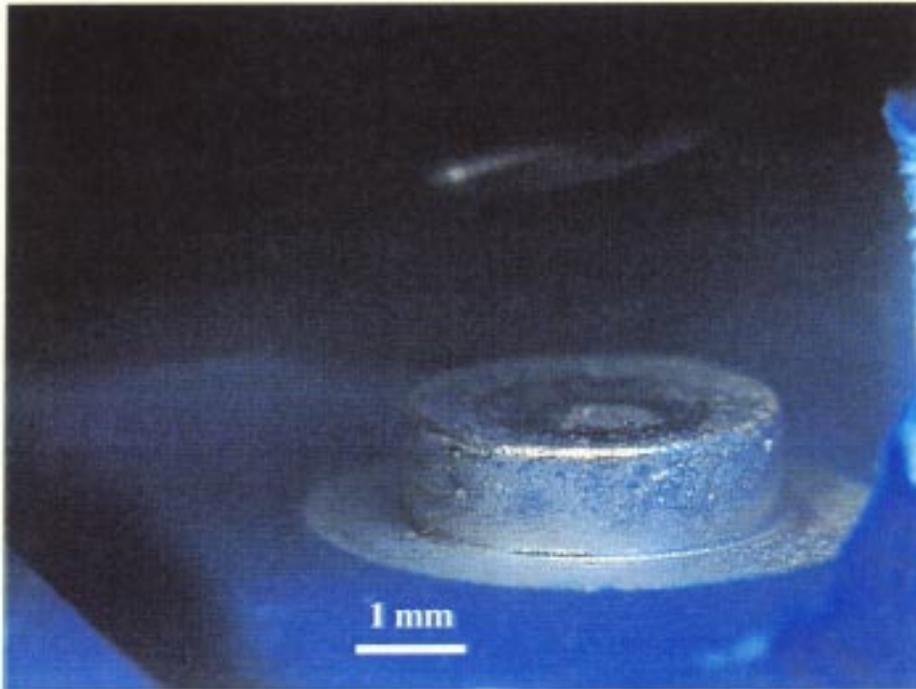
Figure 25. Normally closed stationary contact surface of the right jettison switch which exhibited little or no salt water-like residues.

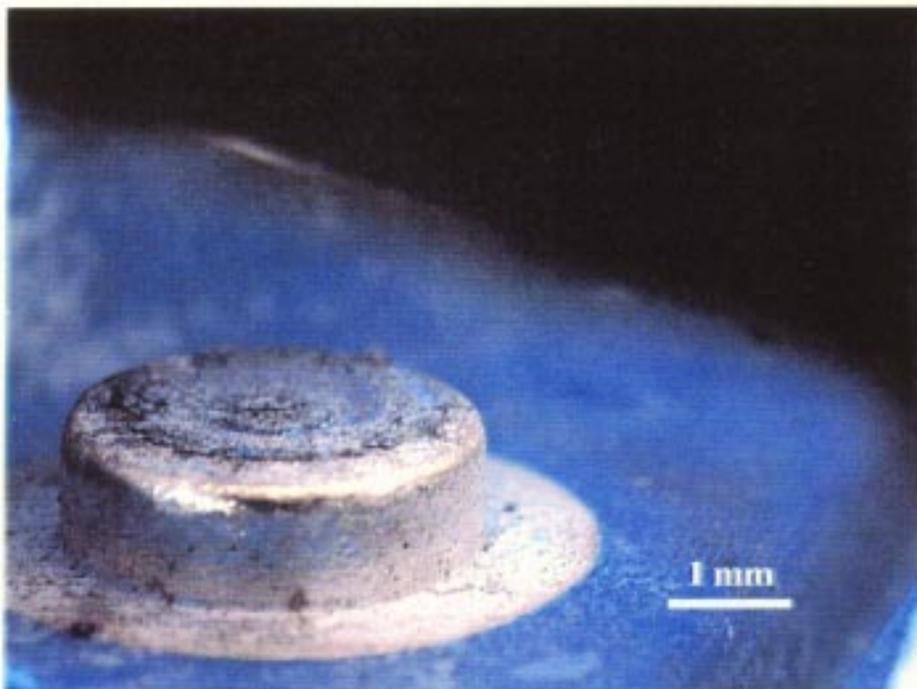
Figure 26. Normally open stationary contact surface of the scavenge pump exhibiting some salt water-like residues.

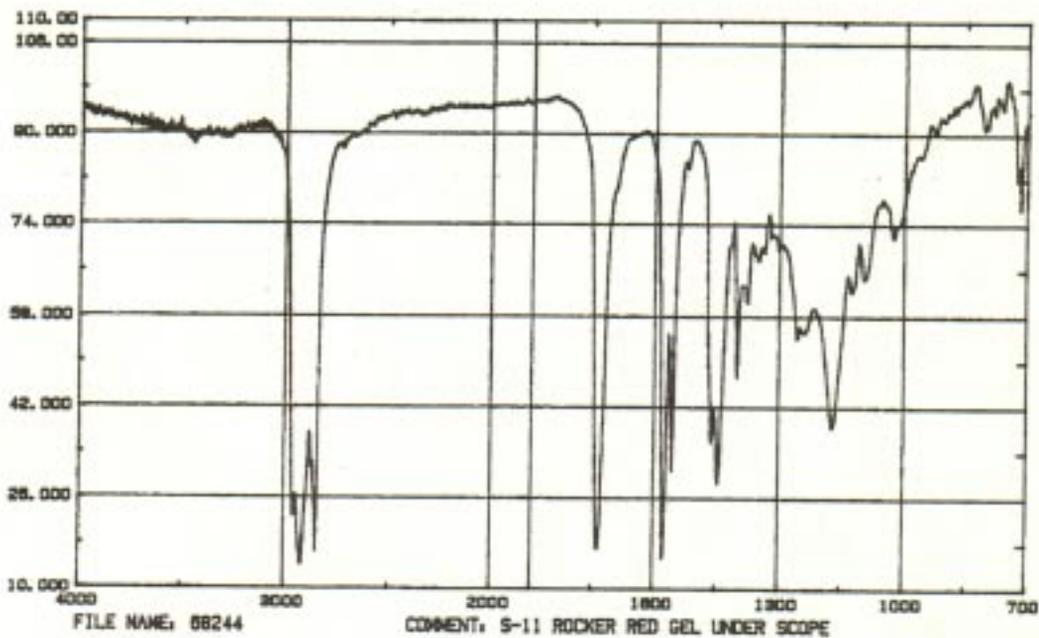
Figure 28. FTIR spectrum of the red lubricant in S-11 switch which was similar to the reference spectrum of ester-based lithium stearate.

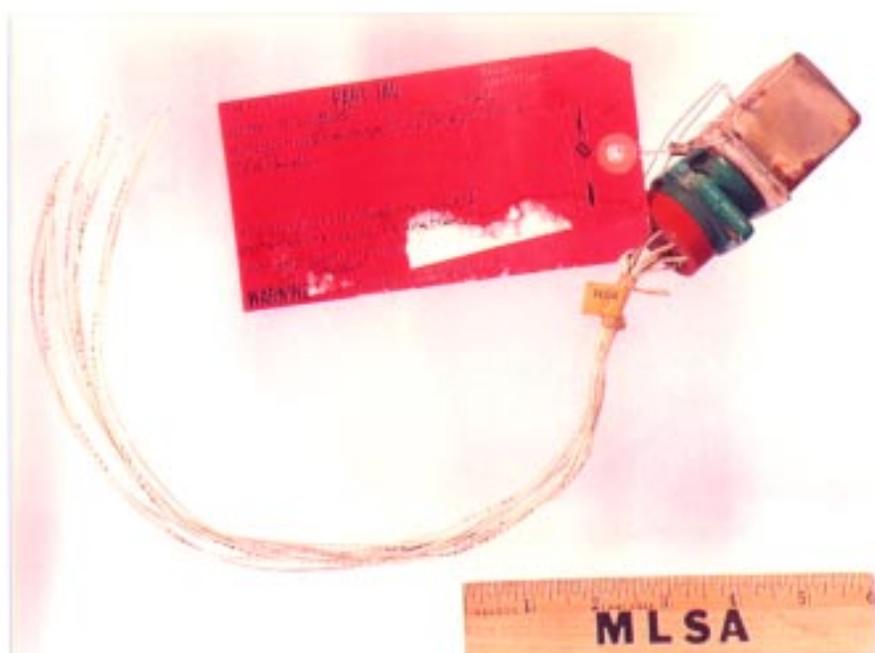
Figure 1. Scavenge pump relay, as received.

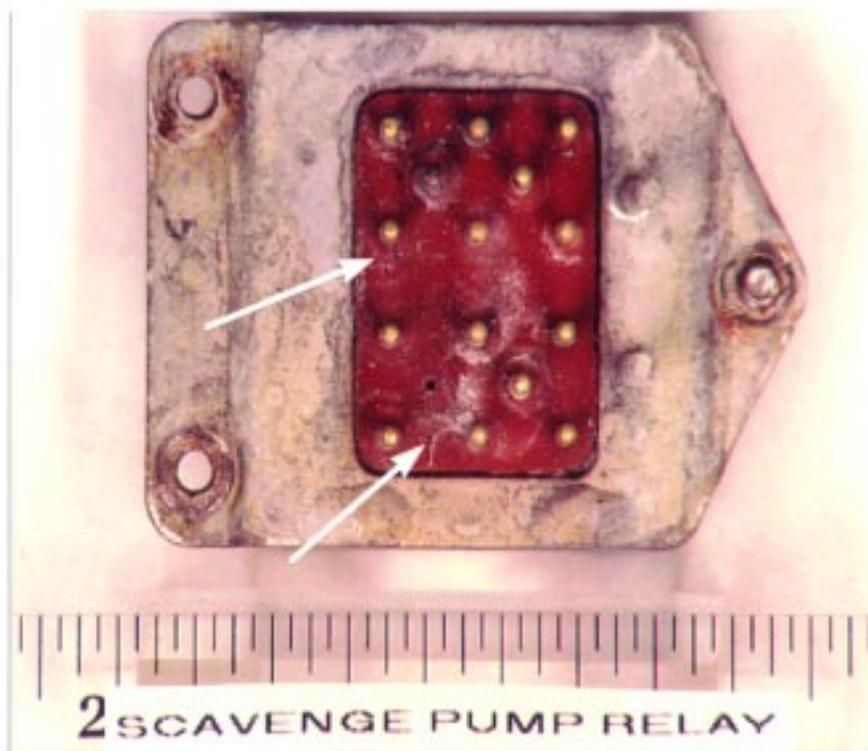
Figure 7. Electrical connector pins of the relay. Arrows indicate a brown and white residue on the mating surface.

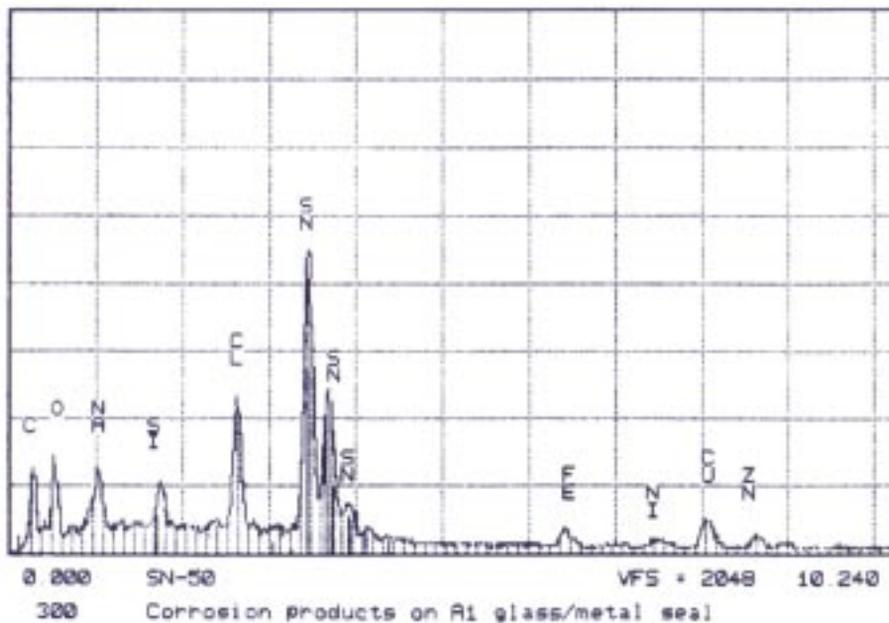
Figure 9. Corrosion products on glass to metal seal of N.O. contact A1.

except for the area surrounding N.O. contact A1. The area surrounding its glass to metal seal had a white residue (Figure 8). Analysis in the SEM by energy dispersive spectroscopy (EDS) suggests the area is composed primarily of the elements sodium, chlorine, and tin. Minor amounts of iron, nickel, copper, and zinc are also present (Figure 9). The glass to metal seal of A1 had a red, yellow, white, and green residue surrounding approximately one-third of the seal (Figure 8). Analysis of the area in the SEM found it to consist of the elements sodium, chlorine, tin, iron, nickel, copper, and zinc (Figure 10).

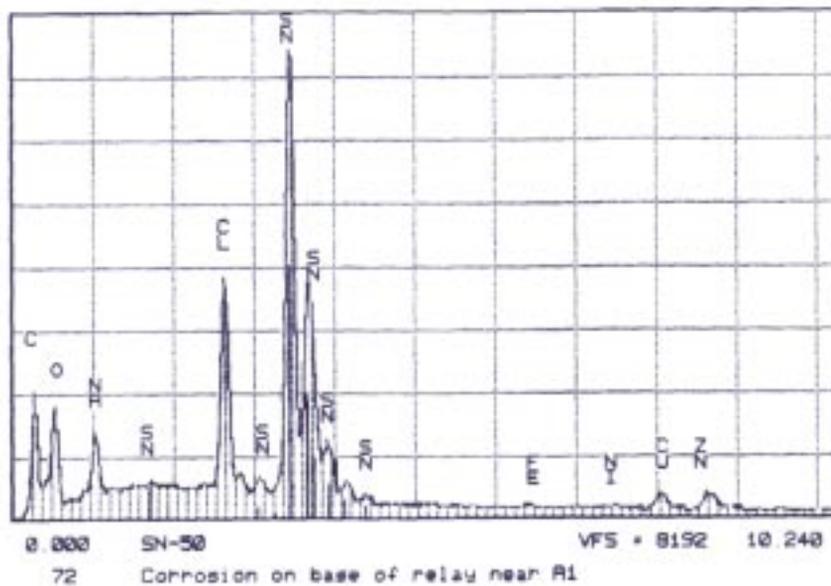
Figure 10. Corrosion products on base of relay near A1.

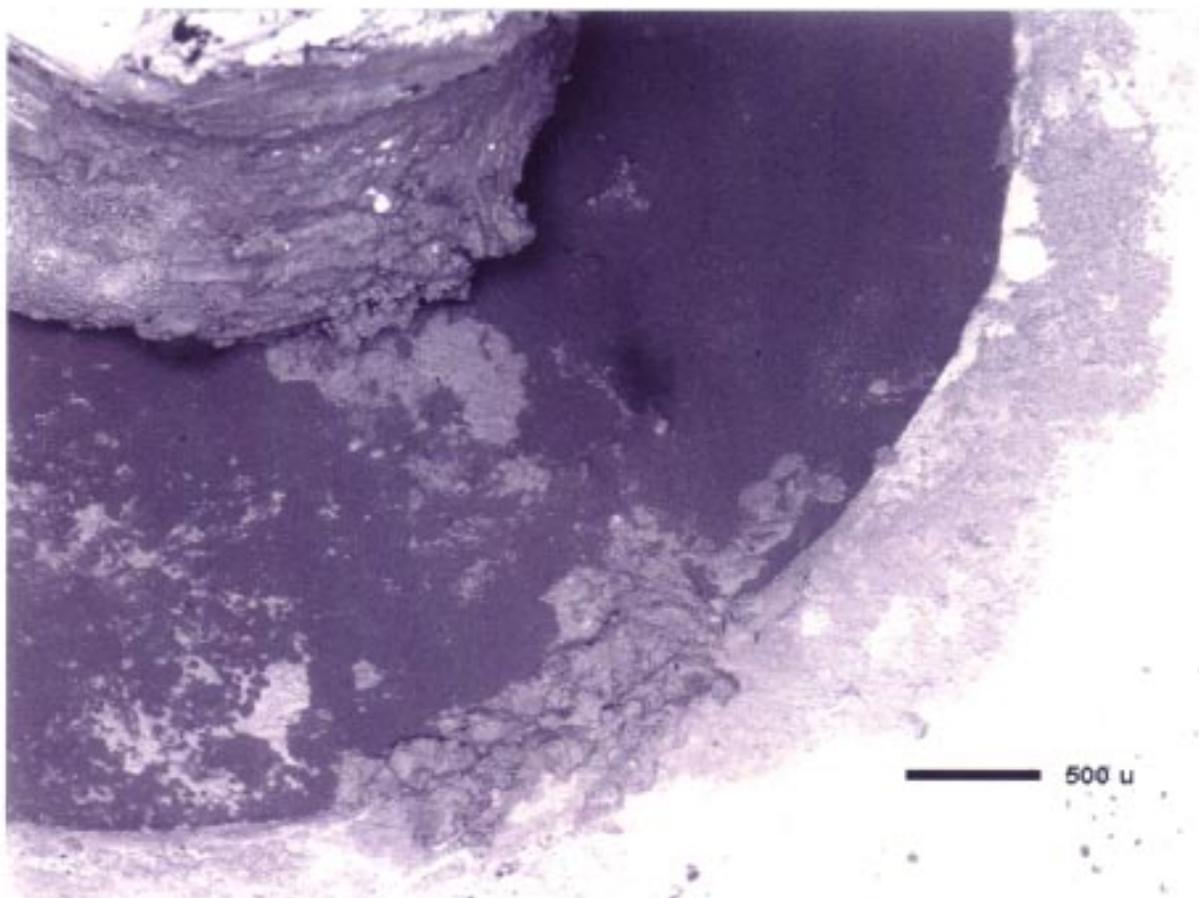
Figure 11. The glass to metal seal area of N.O. contact A1 after the residue was brushed away.

Electrical measurements were made again between the N.O. contact A1 and the case of the relay. The resistance was as before. The residue was removed and the electrical resistance measurement was repeated. The resistance increased and A1 to the case of the relay could now be considered as electrically open (greater than 20 M ohms). The area between the pin of A1 and the case of the relay was examined in the SEM for evidence an electrical short could have existed before the area had become corroded. The evidence would consist of melting of the pin or case material; no evidence of melting was found (Figures 11, 12, and 13).

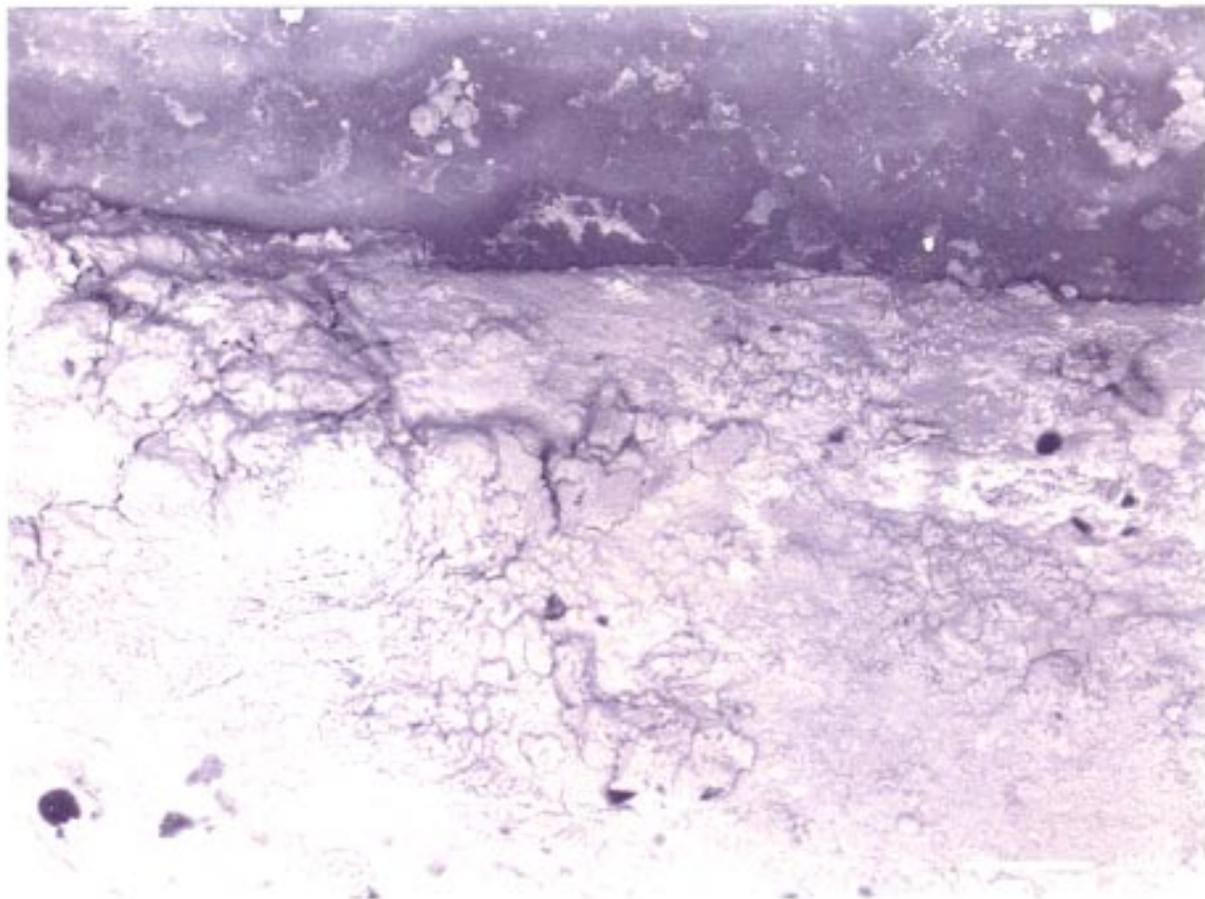
Figure 12. Base of the relay surrounding the glass to metal seal of N.O. contact A1.
