DOCKET NO. **SA- 516**

**NATIONAL TRANSPORTATION SAFETY BOARD
WASHINGTON, D.C.**

Contracted Laboratory Documentation

TWA 800 Switch Analysis
(Failure Analysis)

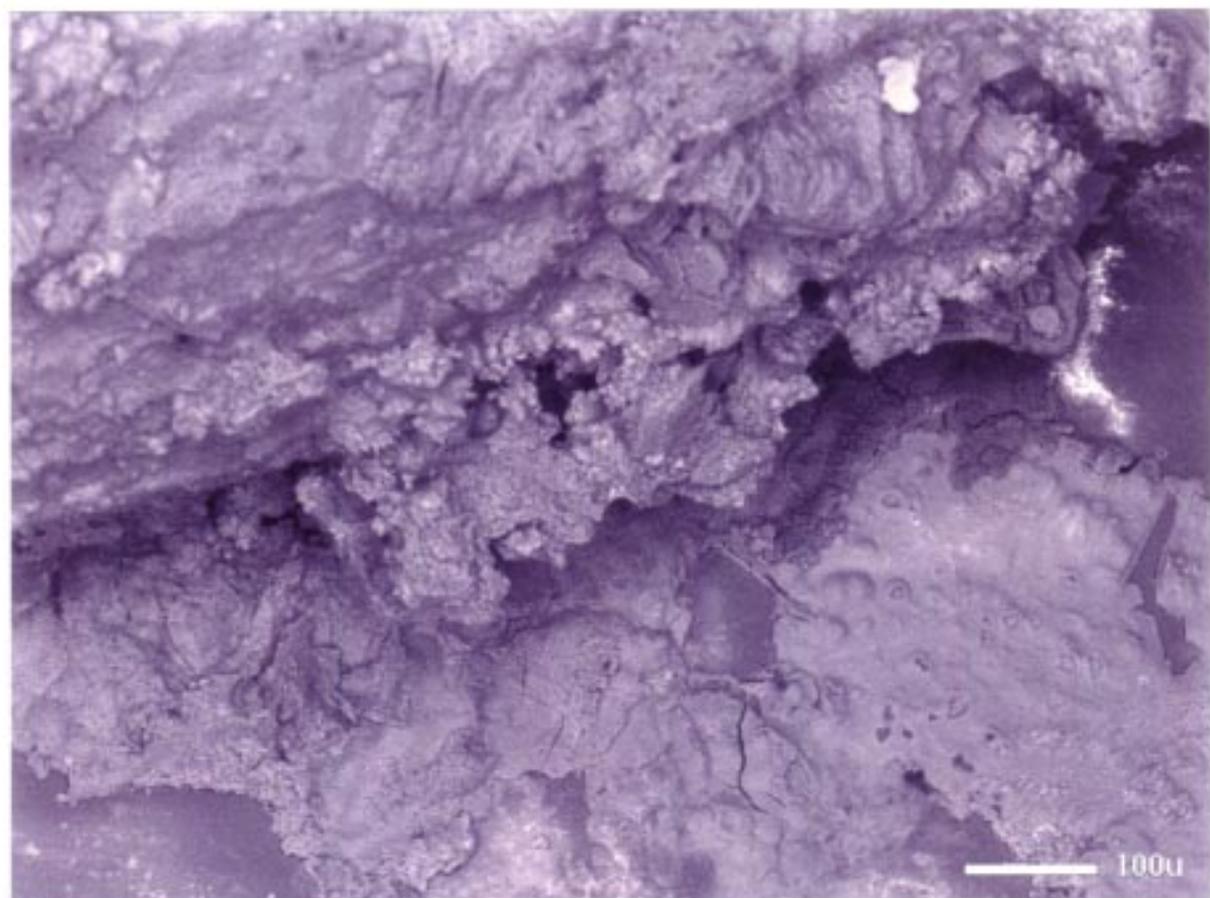
Figure 13. Base of the feedthrough pin and glass to metal seal of N.O. contact A1.

Electrical measurements were made again between the N.O. contact A1 and the case of the relay. The resistance was as before. The residue was removed and the electrical resistance measurement was repeated. The resistance increased and A1 to the case of the relay could now be considered as electrically open (greater than 20 M ohms). The area between the pin of A1 and the case of the relay was examined in the SEM for evidence an electrical short could have existed before the area had become corroded. The evidence would consist of melting of the pin or case material; no evidence of melting was found (Figures 11, 12, and 13).

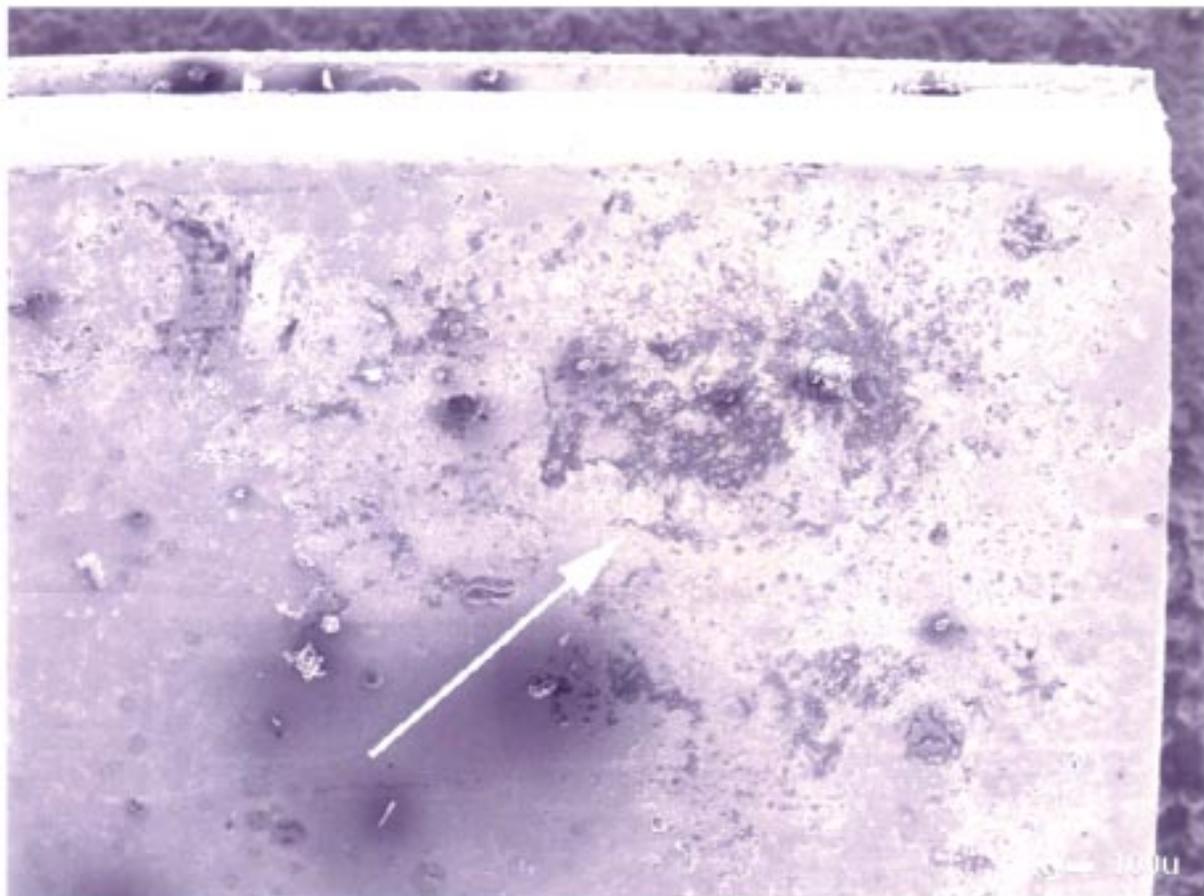
Figure 14. Mating surface of stationary contact A1. Arrow shows the residue covering the contact area.

The mating surfaces of the stationary and moving N.O. and N.C contacts were examined in the SEM, see Figures 14 and 15 for examples of A1 and A2. The mating surfaces of the contacts were generally free of residue except for the surface of stationary contact A1. Analysis in the SEM by EDS suggests the residue is composed primarily of the elements sodium, chlorine, and silver. The mating surfaces of the contacts did not exhibit arc erosion or excessive wear. The mating surfaces of the contacts did not exhibit signs of witness marks which could be distinguished from their normal making or breaking action.

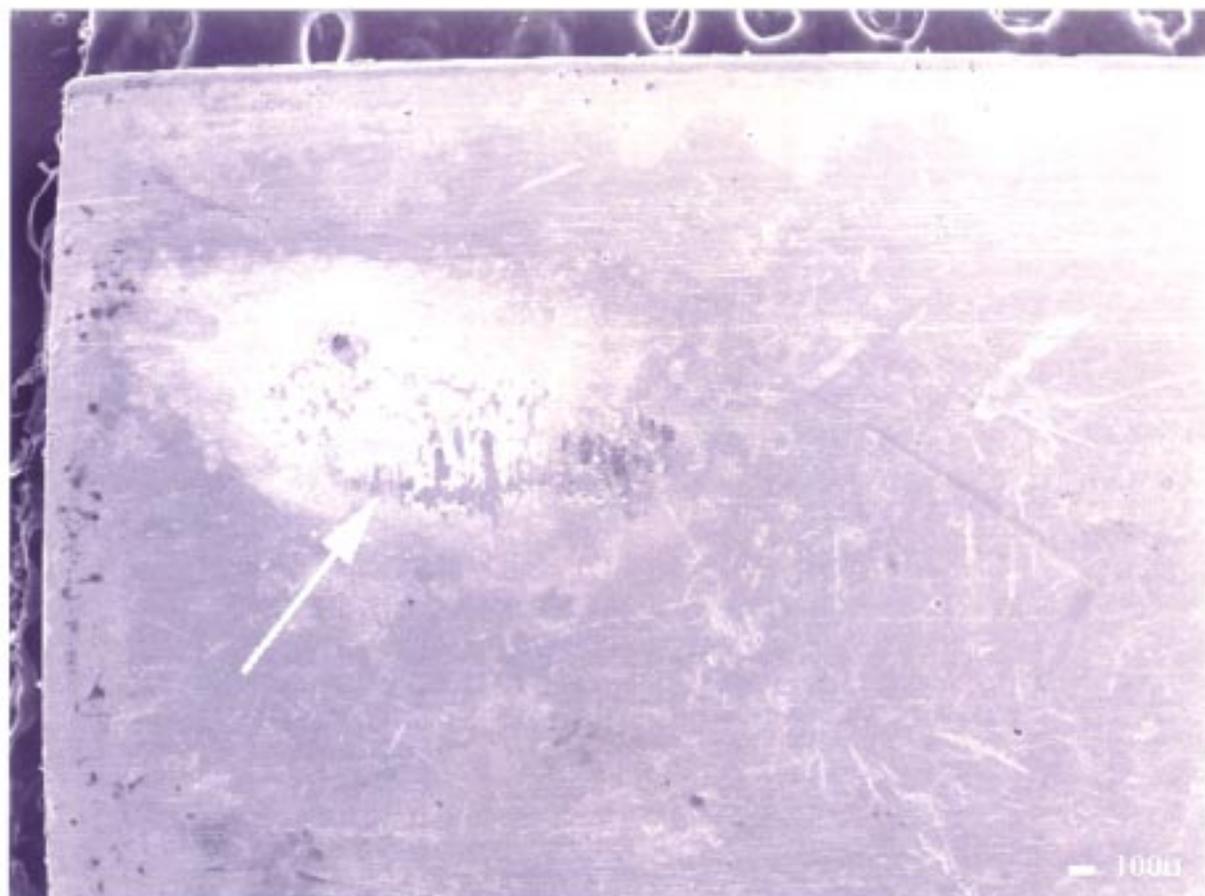
Figure 15. Mating surface of moving contact A2. Arrow shows the contact area.

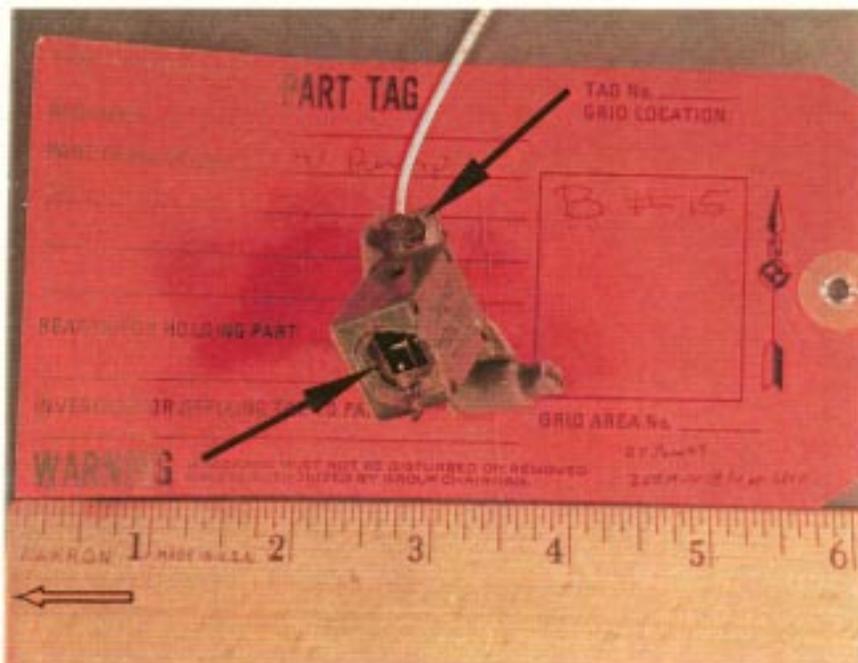
Figure 1. As received condition of the SPR circuit breaker. The upper arrow highlights the corroded terminal hardware. The lower arrow highlights the missing actuator stem and mounting bushing.

A visual examination of the circuit breaker revealed the actuator stem and mounting bushing of the circuit breaker were missing. The plastic housing of the breaker was cracked in several locations. The load and line terminal hardware were still intact, however, they were corroded.

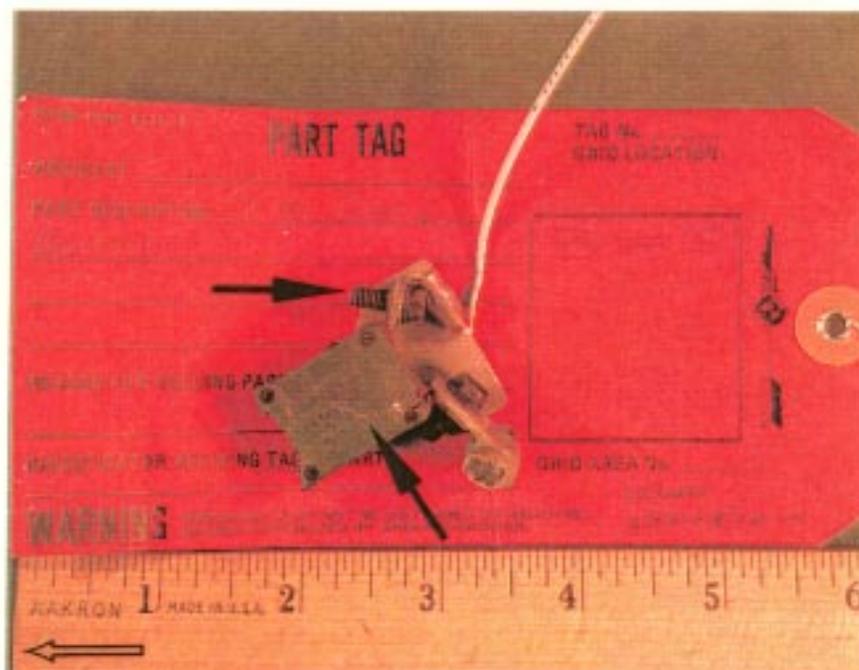
Figure 2. As received condition of the SPR circuit breaker. The upper arrow highlights the corroded terminal hardware. The lower arrow highlights the cracked housing.

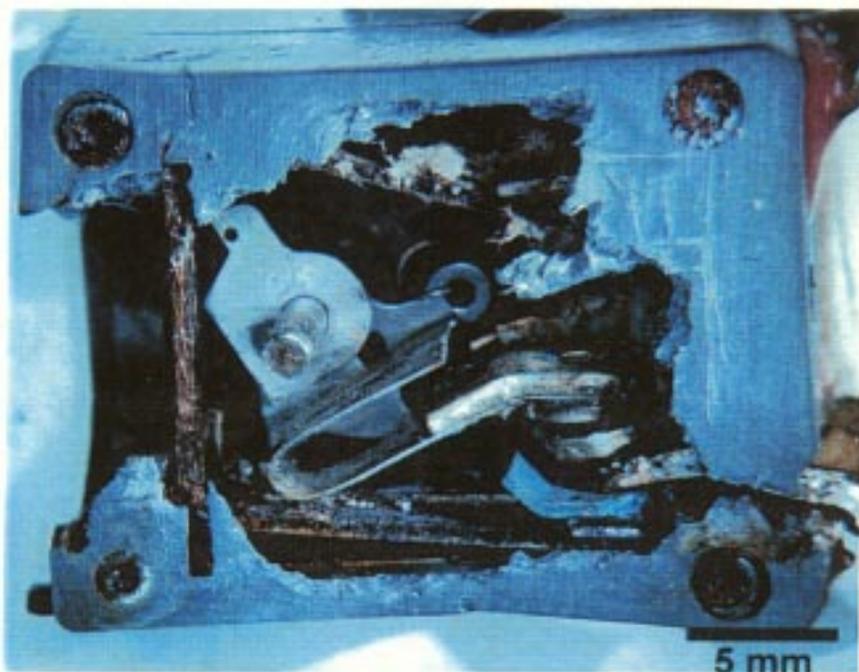
Figure 3. Various mechanical components of the SPR circuit breaker are corroded. The moving contacts are lying against the stationary contacts.

The Klixon side of the breaker was thinned by sanding through the wall of the plastic case. A knife was then used to carefully remove the remaining plastic to expose the interior of the breaker (Figure 3). An examination of the inside of the breaker revealed corrosion and a fibrous material. The thermal and compensator elements were observed to be corroded. The

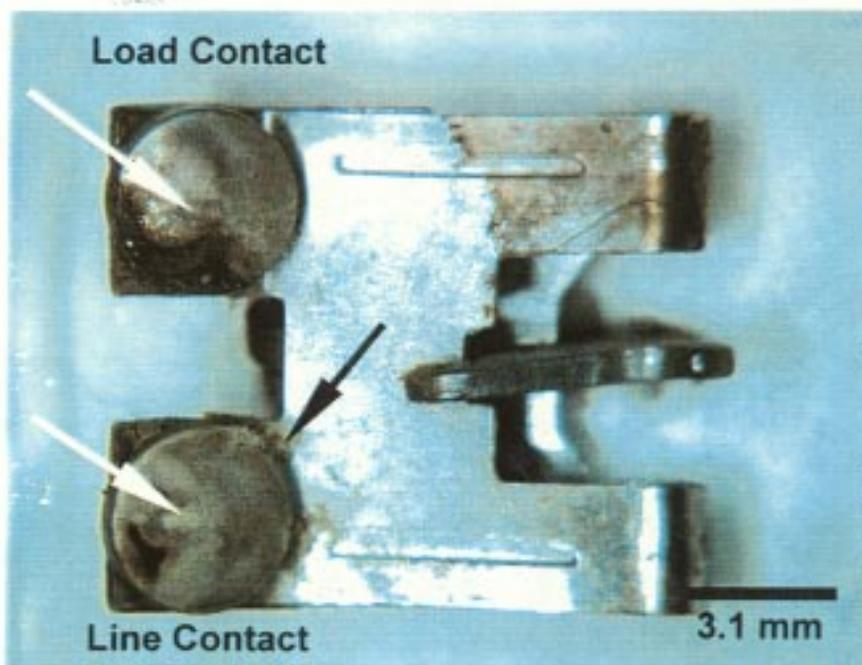
Figure 4. The moving contacts of the SPR circuit breaker have a tarnished appearance. White arrows highlight the mechanical wear from the making and breaking of the contacts. Black arrow highlights the fibrous residue.

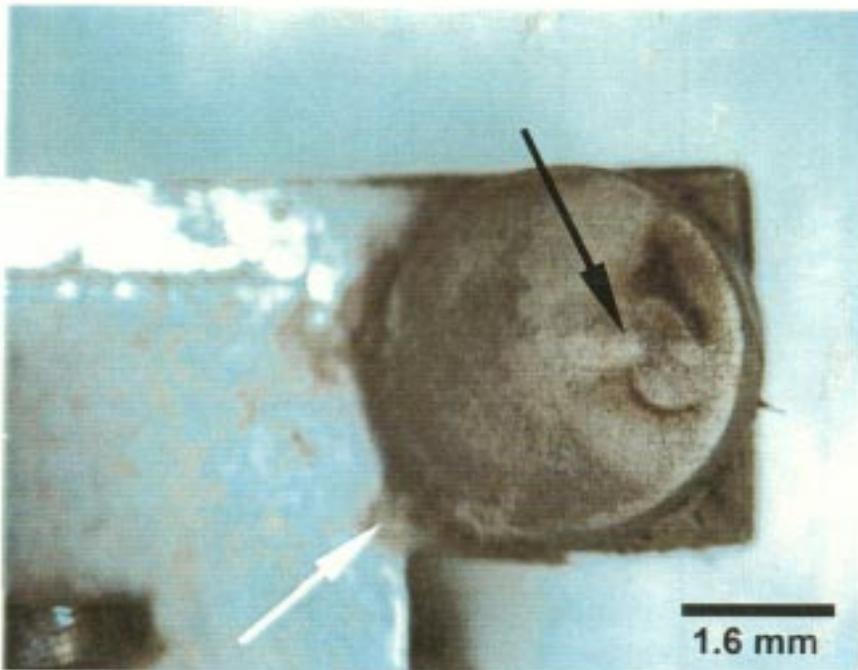
Figure 5. The moving line contact of the SPR circuit breaker has a tarnished appearance. Black arrow highlights the mechanical wear from the making and breaking of the contacts. The white arrow highlights the fibrous residue.

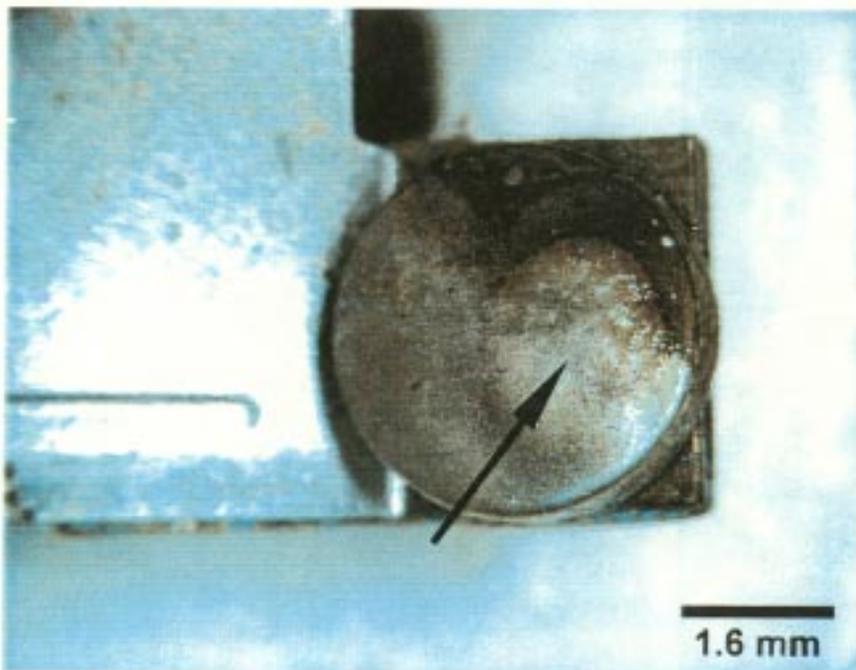
Figure 6. The moving load contact of the SPR circuit breaker has a tarnished appearance. The arrow highlights the mechanical wear from making and break of the contact.

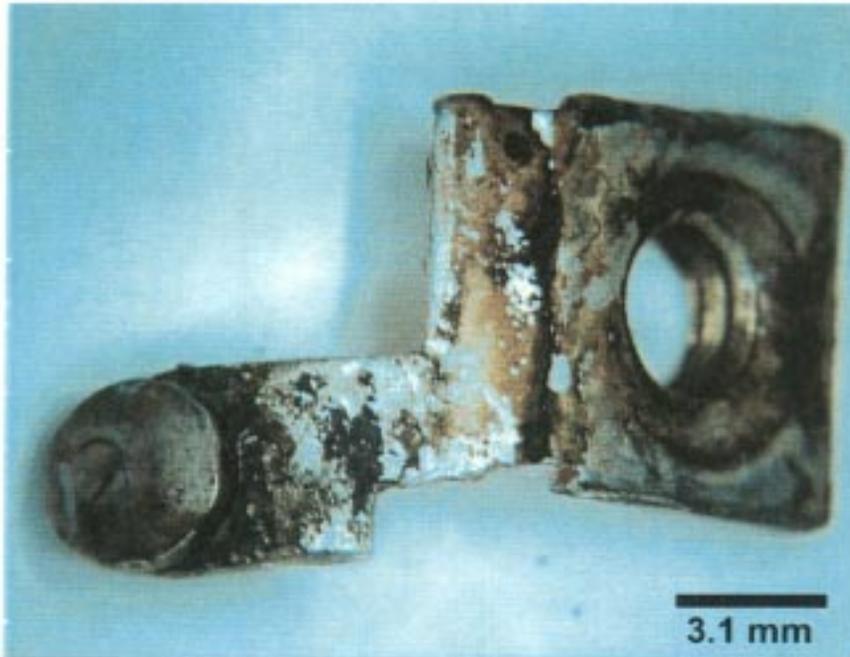
Figure 7. The stationary line terminal and contact of the SPR circuit breaker have a tarnished appearance.

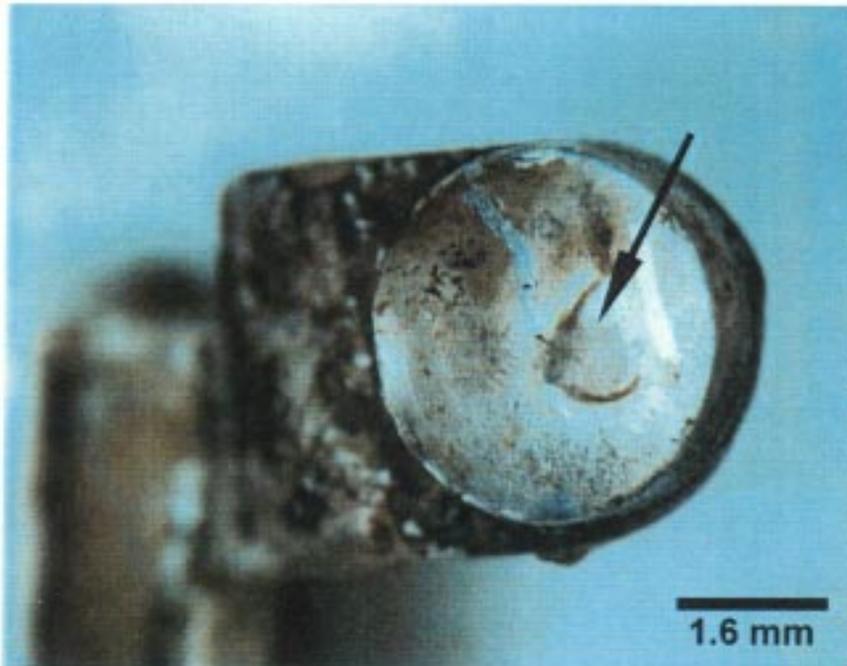
Figure 9. The stationary line contact of the SPR circuit breaker has a tarnished appearance. Arrow highlights the mechanical wear from the making and breaking of the contacts.

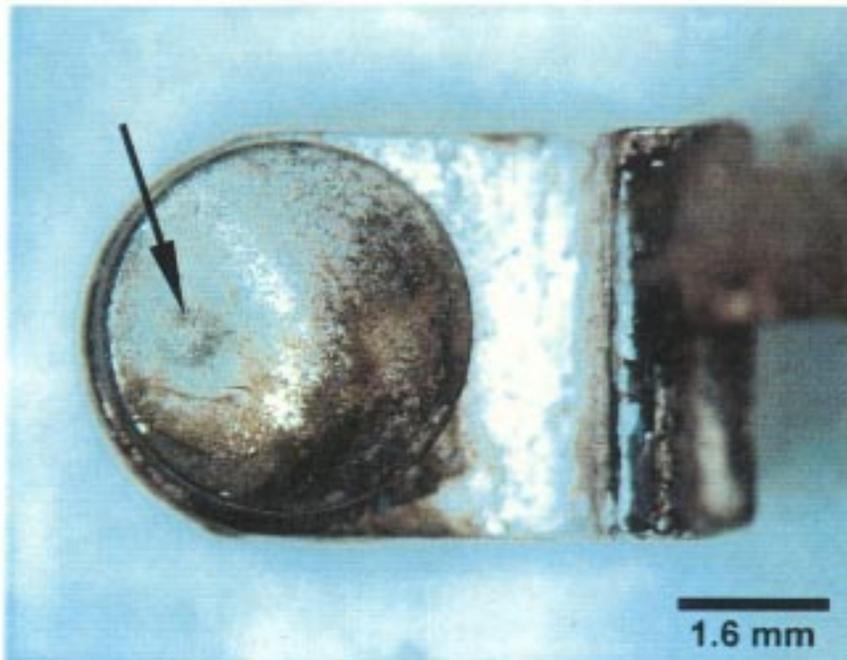
Figure 10. The stationary load contact of the SPR circuit breaker has a tarnished appearance. Arrow highlights the mechanical wear from the making and breaking of the contacts.

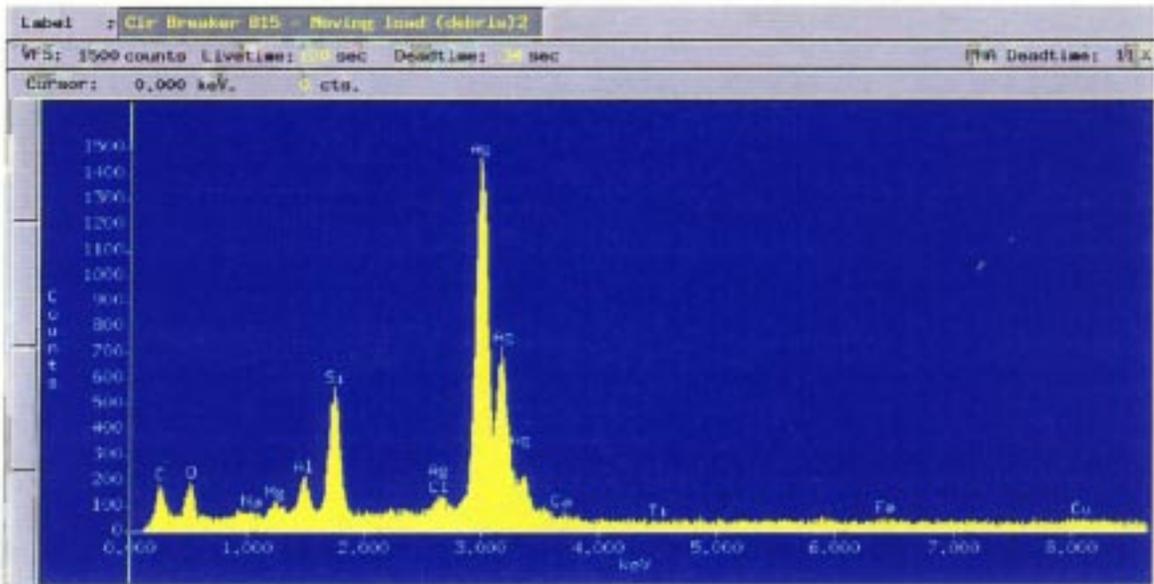
Figure 11. Energy Dispersive Spectrometry (EDS) spectrum of the fibrous material on the moving line contact of the SPR circuit breaker. The silver in both spectrums is primarily from the contact material.

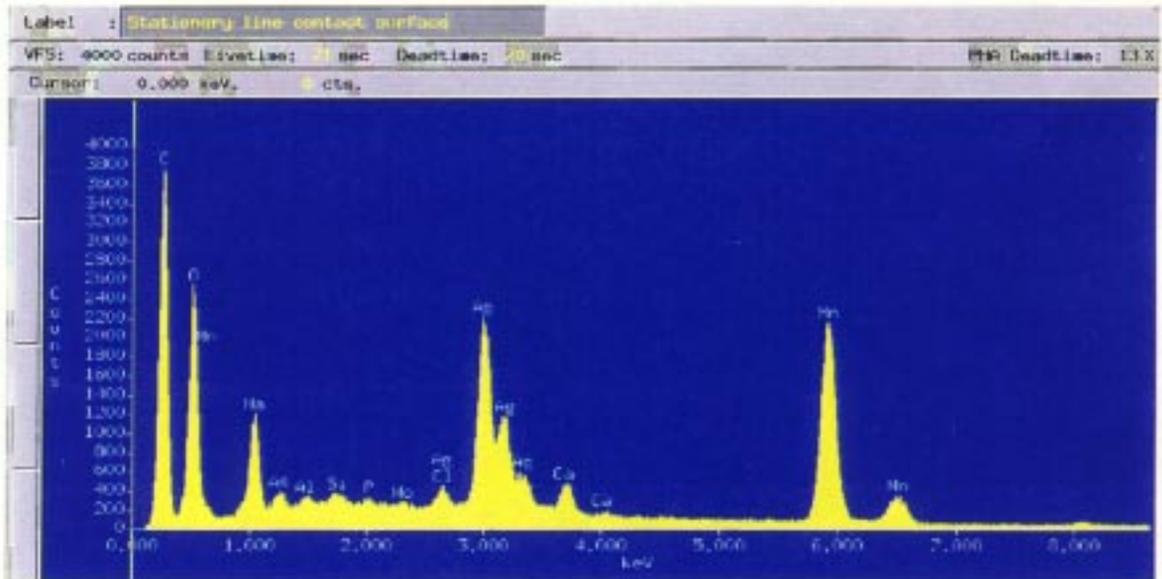
Figure 12. EDS spectrum of a area described as being tarnished on the stationary line contact of the SPR circuit breaker. The silver in both spectrums is primarily from the contact material.

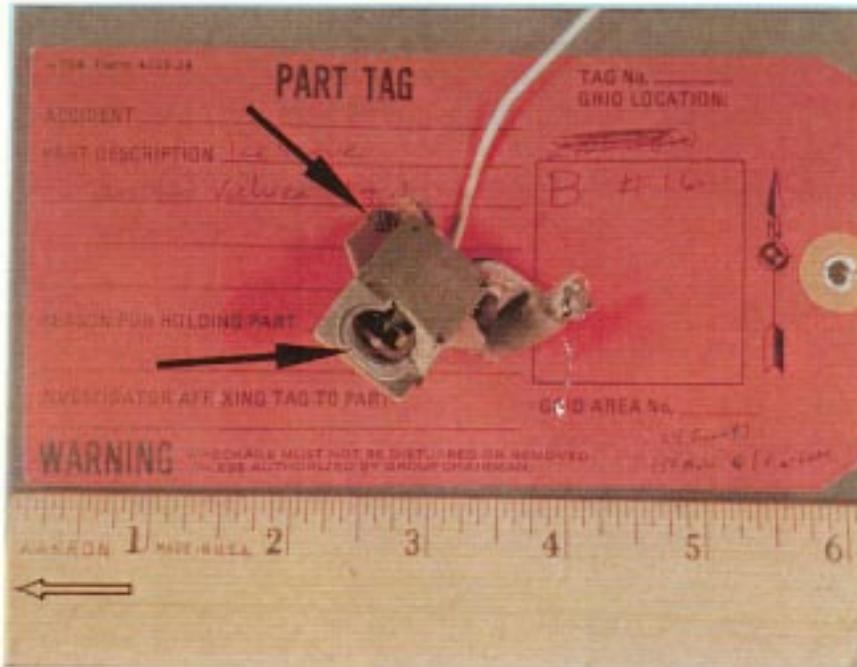
Figure 13. As received condition of the RTV circuit breaker. Upper arrow highlights the corroded terminal hardware. Lower arrow highlights the missing actuator stem and mounting bushing.

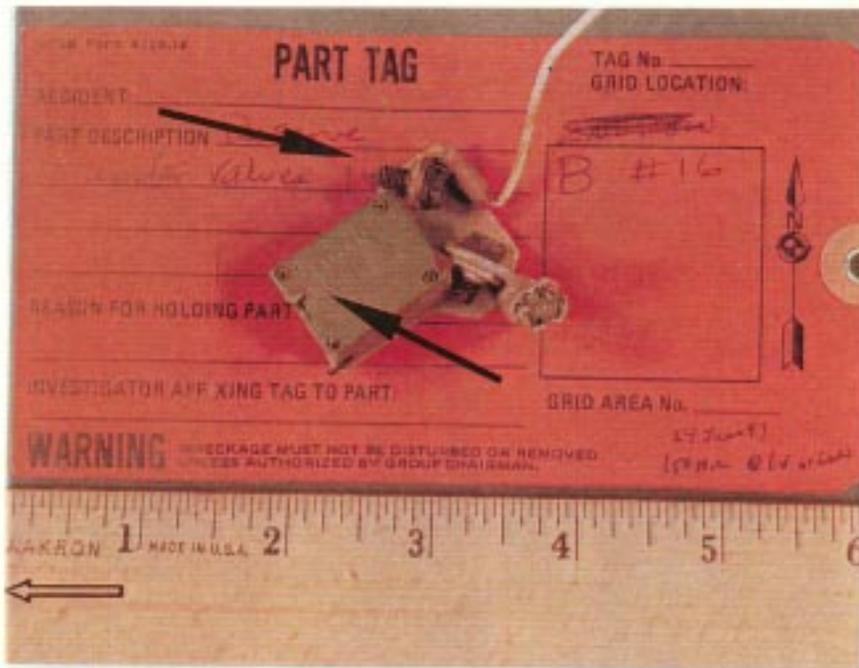
Figure 14. As received condition of the RTV circuit breaker. Upper arrow highlights the corroded terminal hardware. Lower arrow highlights the cracked housing.

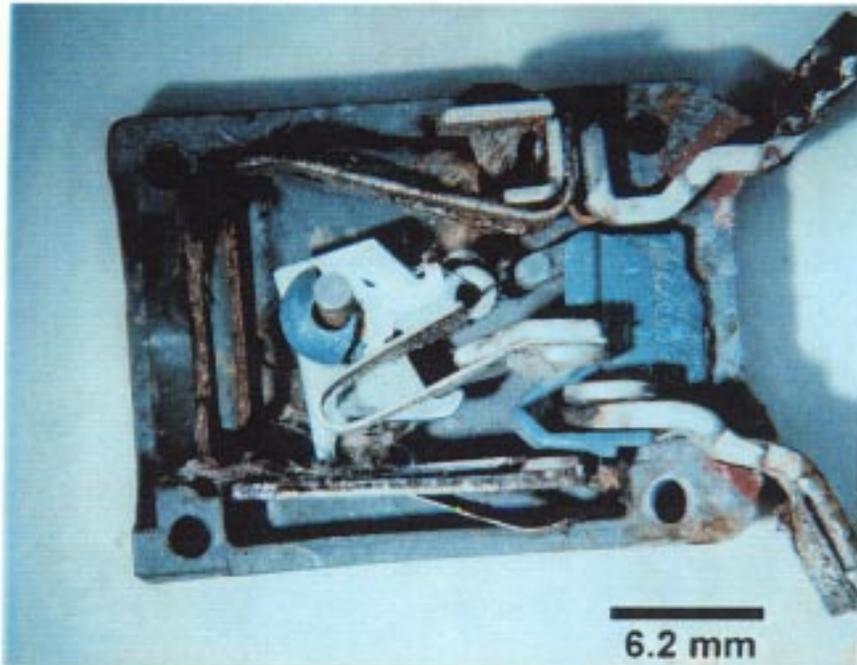
Figure 15. The various mechanical components of the RTV circuit breaker are corroded. The moving contacts are lying against the stationary contacts.

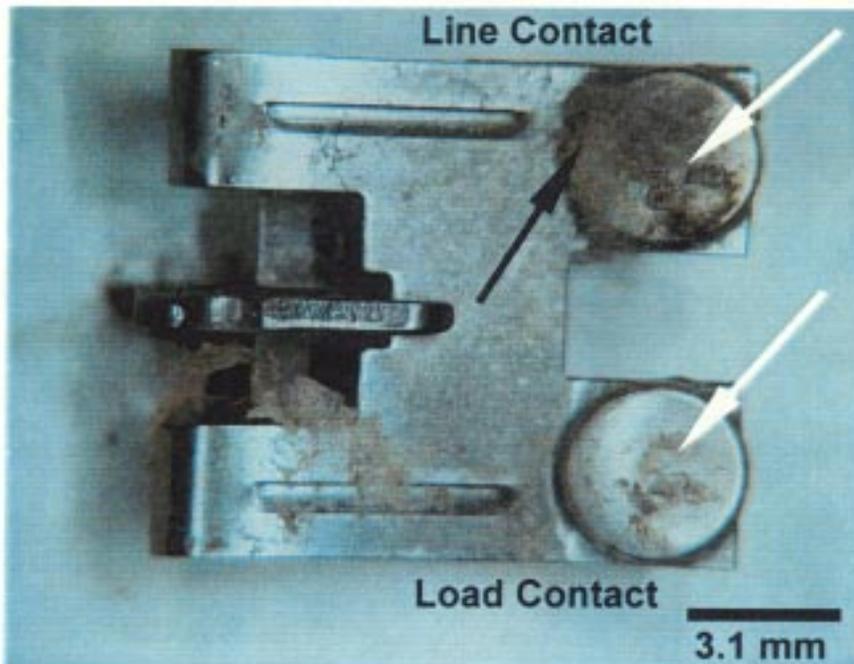
Figure 16. The moving contacts of the RTV circuit breaker have a tarnished appearance. White arrows highlight the mechanical wear from the making and breaking of the contacts. Black arrow highlights the fibrous residue.

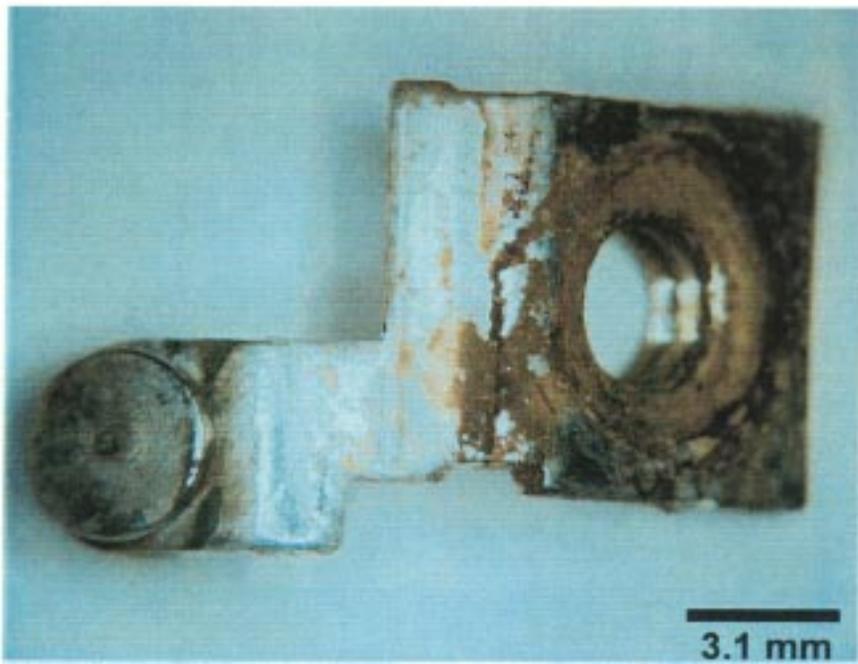
Figure 17. The stationary line terminal and contact of the RTV circuit breaker have a tarnished appearance.

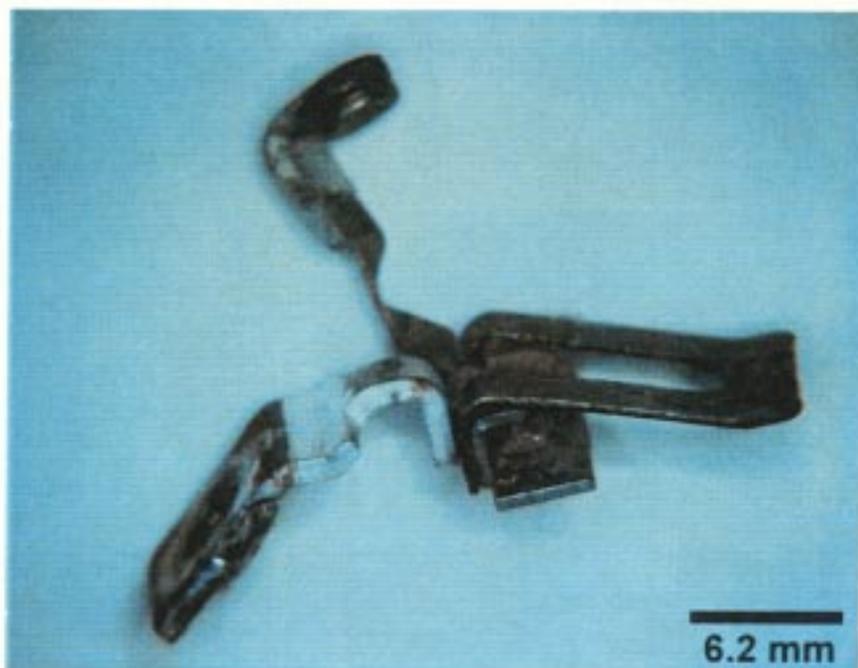
Figure 18. The stationary load terminal and contact of the RTV circuit breaker have a tarnished appearance.

The circuit breakers have impact damage as indicated by the missing actuator stems, mounting bushings, and cracked housings. The mounting hardware for the load and line terminals was corroded.

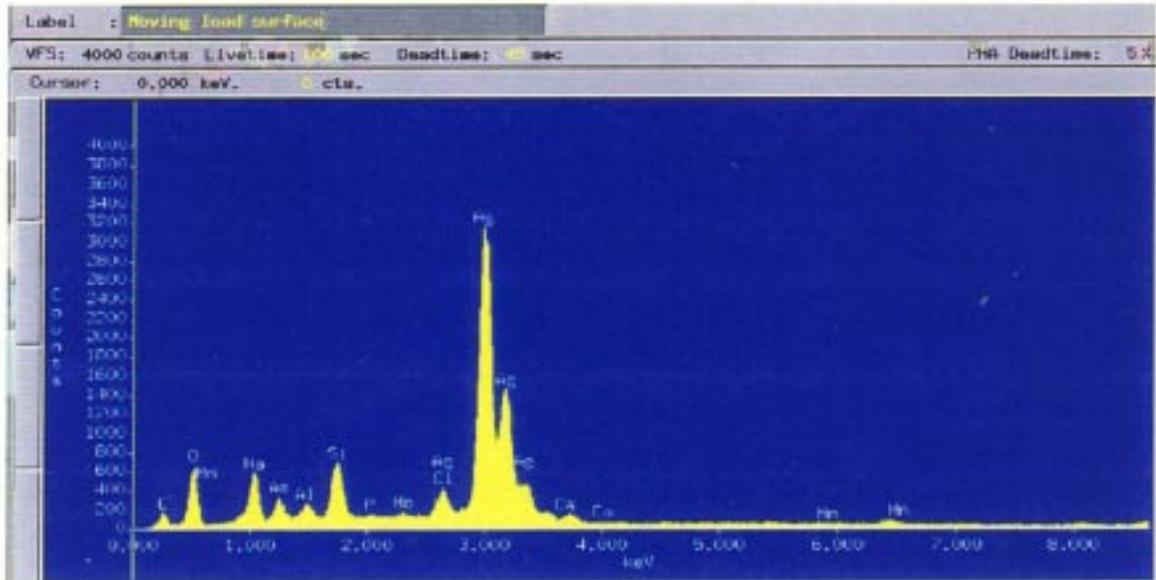
Figure 19. EDS spectrum of the moving load contact surface of the RTV circuit breaker. The silver in both spectrums is primarily from the contact material.

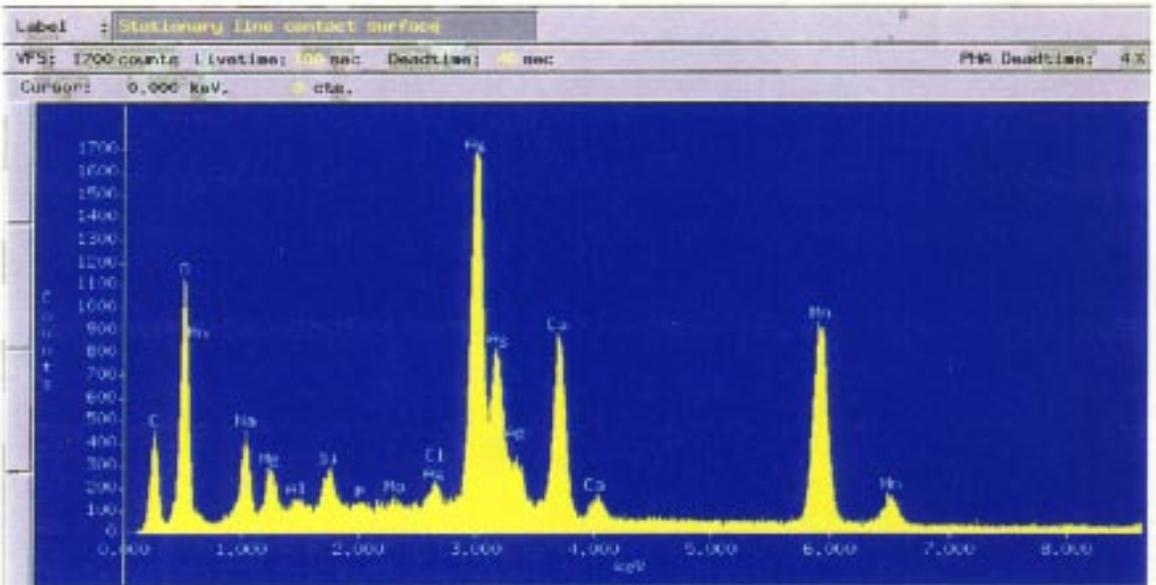
Figure 20. EDS spectrum of the stationary line contact surface of the RTV circuit breaker. The silver in both spectrums is primarily from the contact material.

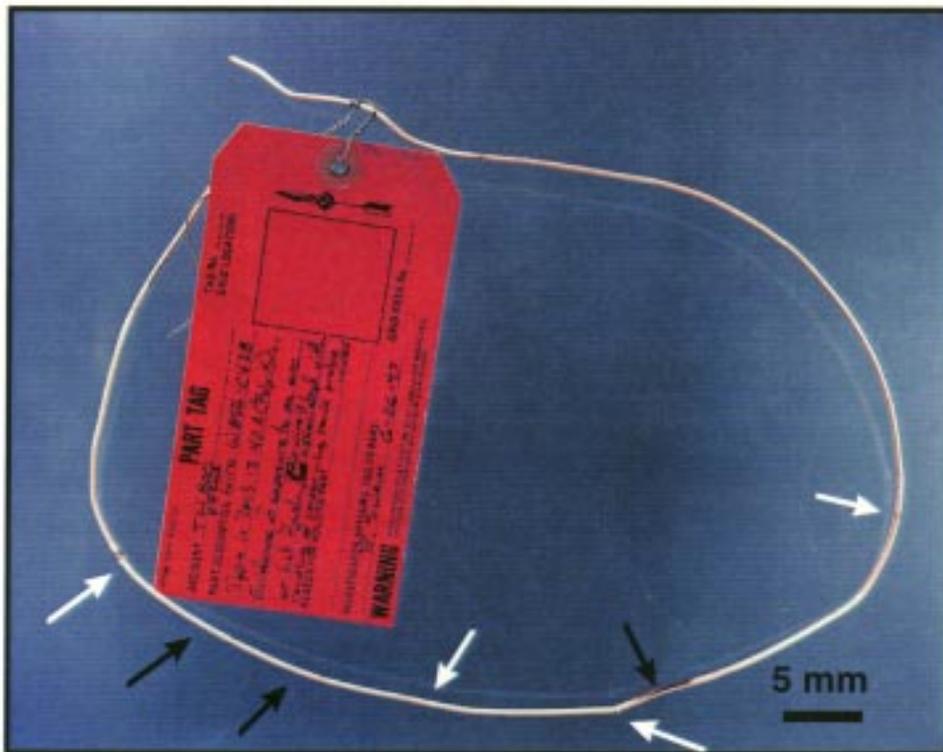
Figure 1. Wire sample submitted for analysis. The insulation exhibited blackened areas (black arrows) and mechanical damage (white arrows).

A 73 cm length of primary wire was submitted by the National Transportation Safety Board (NTSB) for analysis (Figure 1).

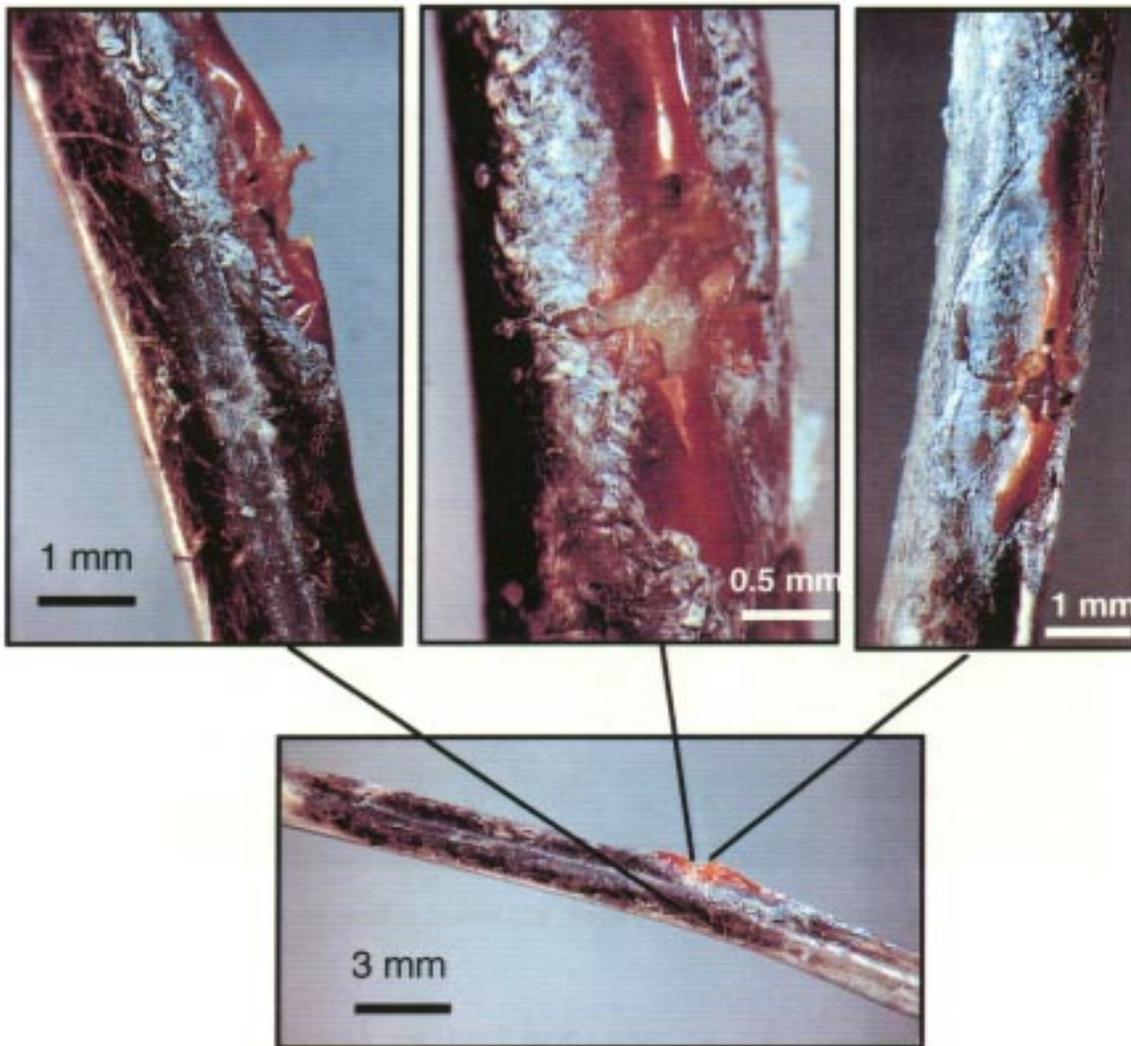
Figure 2. Multiple images of the largest blackened and thermally damaged area on the submitted wire.

The wire was removed from TWA 800 wreckage on 26 June 1997 and was reported to be a BMS 1342A (Poly-X) type wire that was associated with the routing of center wing tank probe wires. There were three blackened areas (black arrows, Figure 1) and at least four mechanically damaged areas (white arrows, Figure 1) on the wire insulation. The blackened areas were typically associated with thermal damage. Multiple orientation images of the largest blackened area are shown in Figure 2.

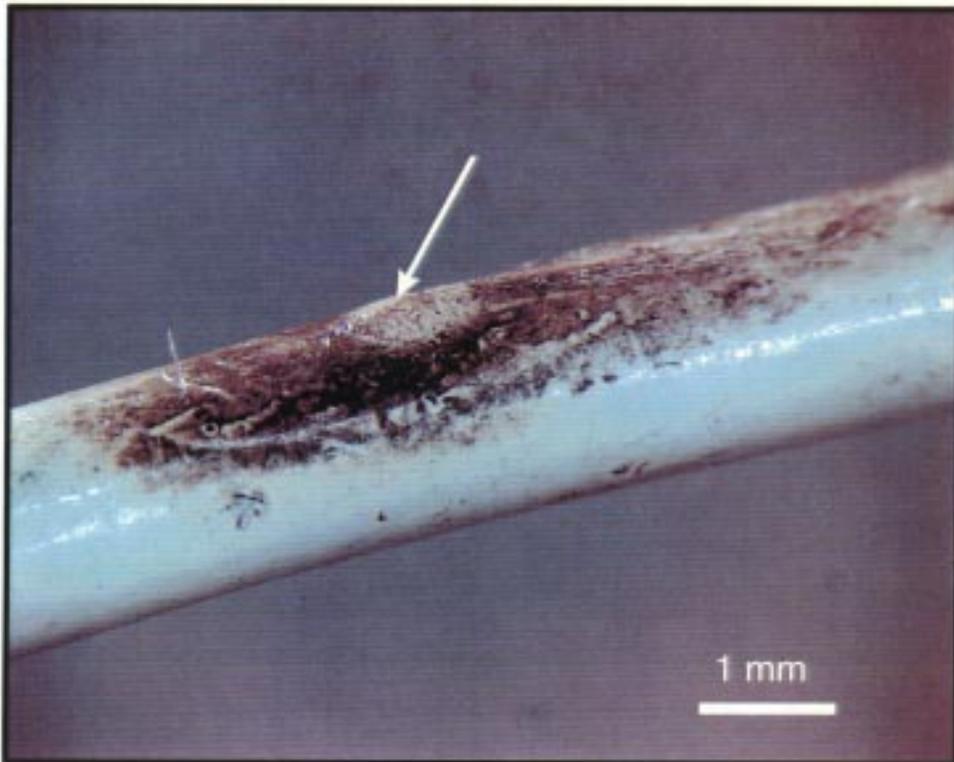
Figure 3. Blackened and thermally damaged area on wiring. Note raised area (arrow).

Note the crazed and melted appearance of the raised area. In all cases, the thermal damage progressed from the outside towards the conductor. A typical example of a mechanically damaged insulation area is shown in Figure 4.

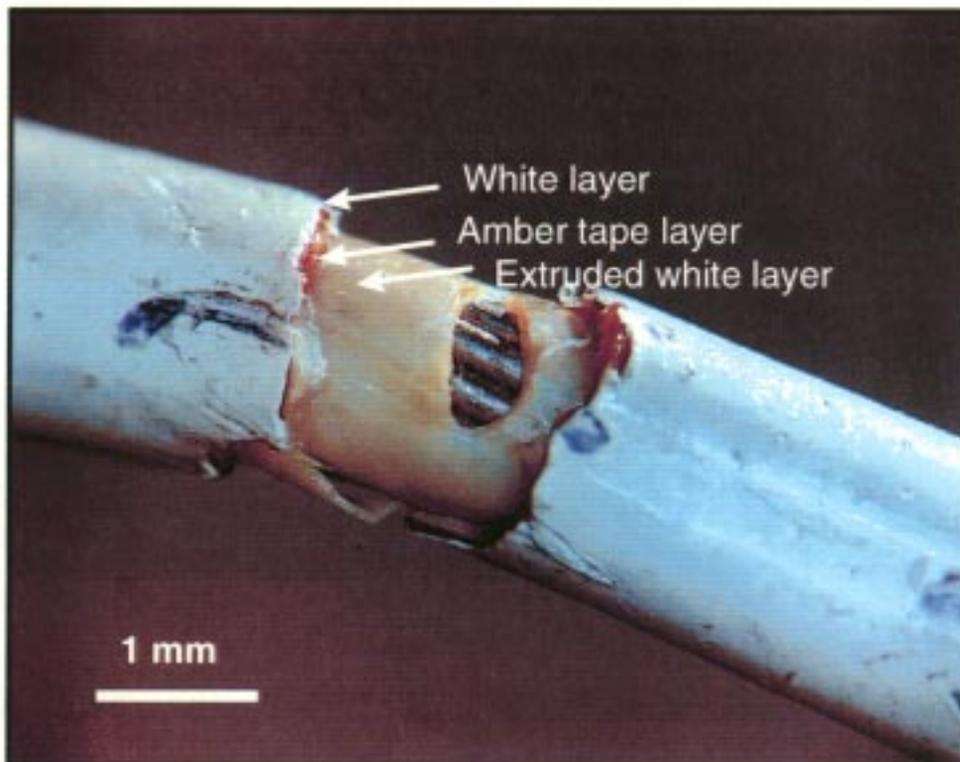
Figure 4. Typical mechanically damaged insulation area. Note the damage reveals the multiple layered insulation construction.

The insulation was flexible and bending of the insulation outside damaged areas did not produce cracks.

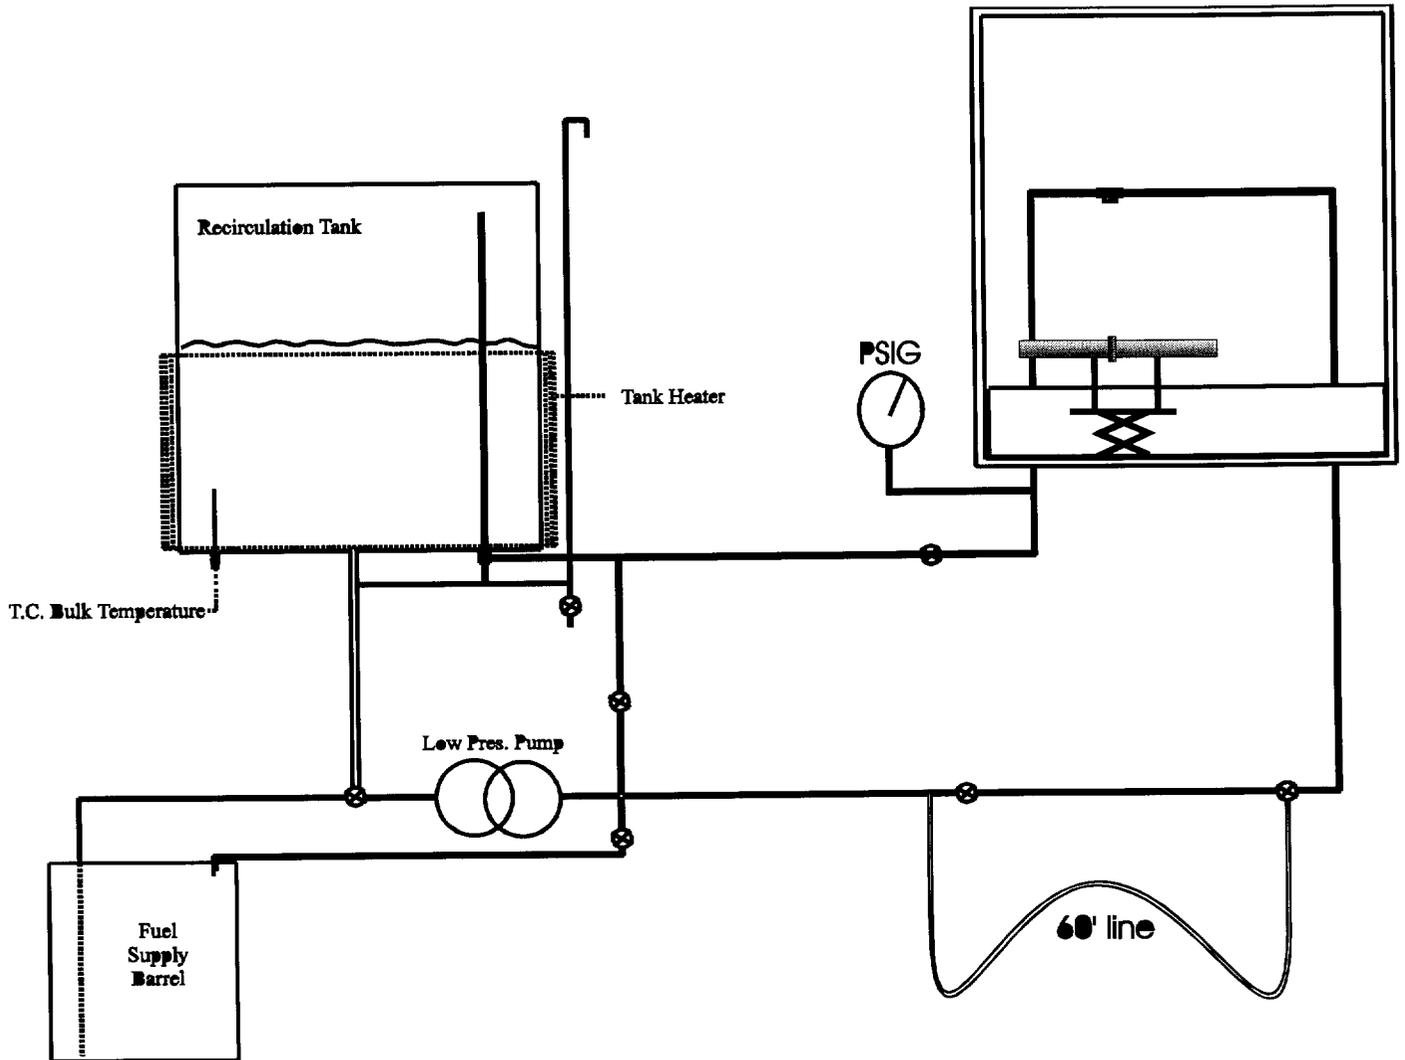
Figure 1. Test facility.

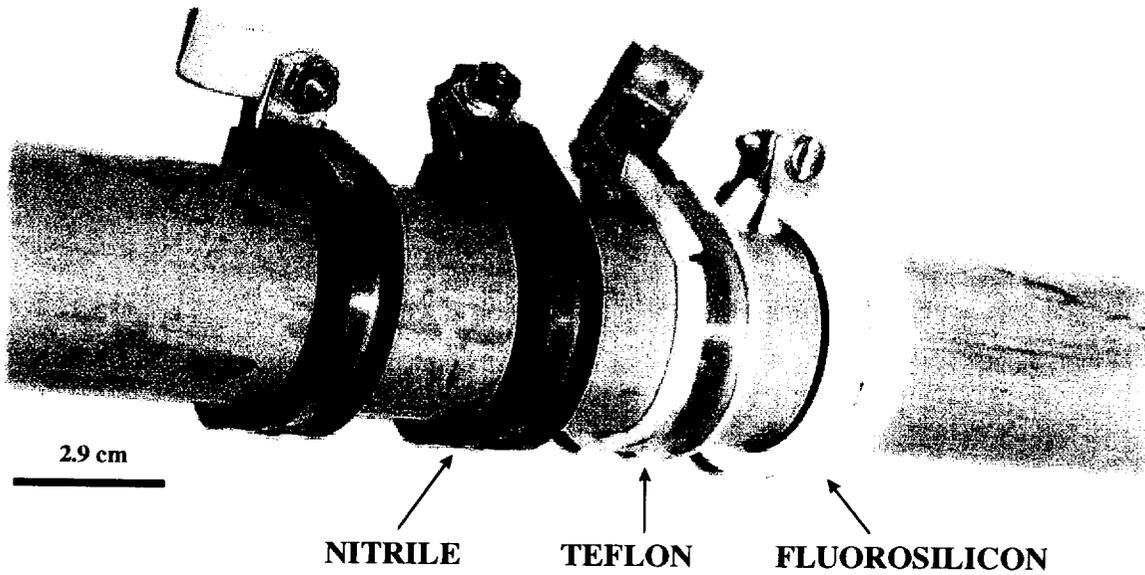
Figure 2. Cushioned loop clamps.
