DOCKET NO. **SA- 516**

**NATIONAL TRANSPORTATION SAFETY BOARD
WASHINGTON, D.C.**

Contracted Laboratory Documentation

TWA 800 Switch Analysis
(Failure Analysis)

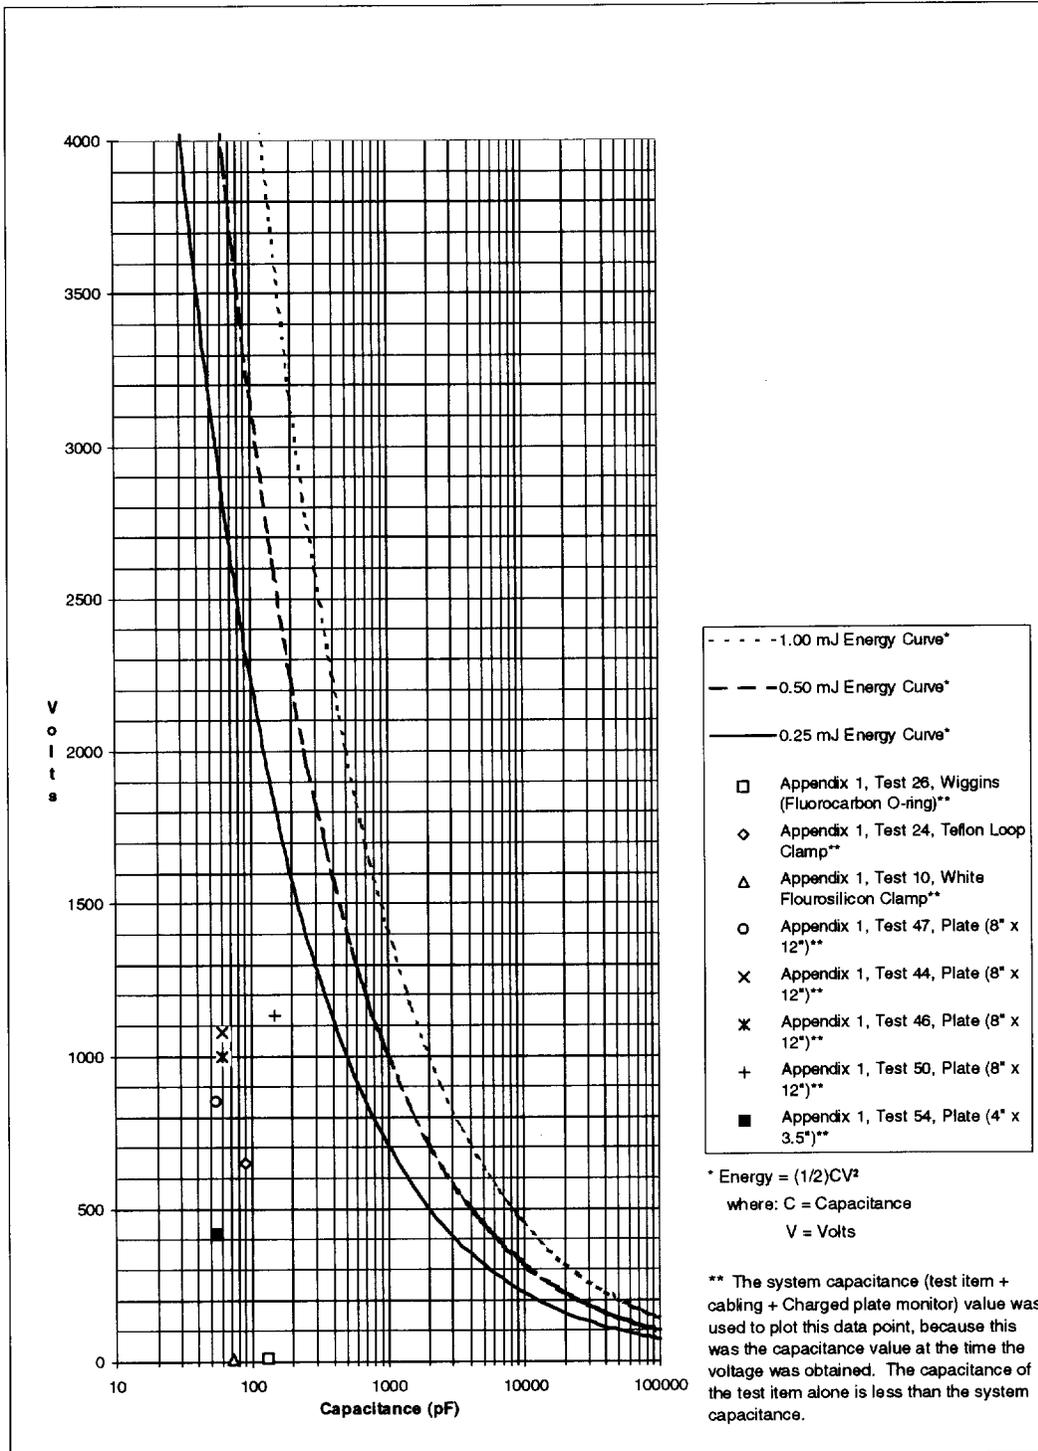
Figure 8. Minimum ignition energy curves and system test data points.

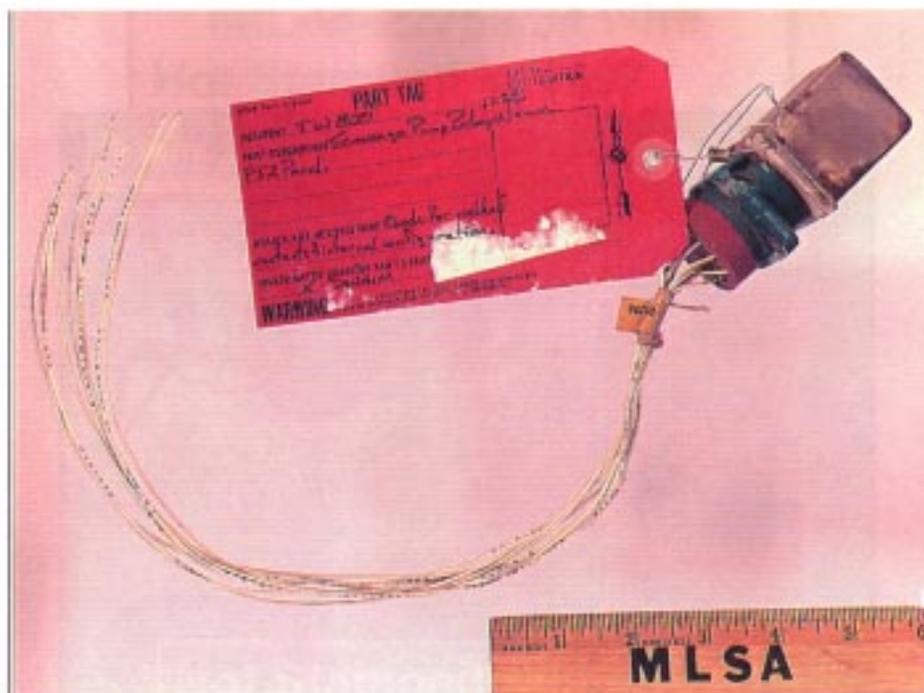
Figure 1. Scavenge pump relay with connector wiring attached.

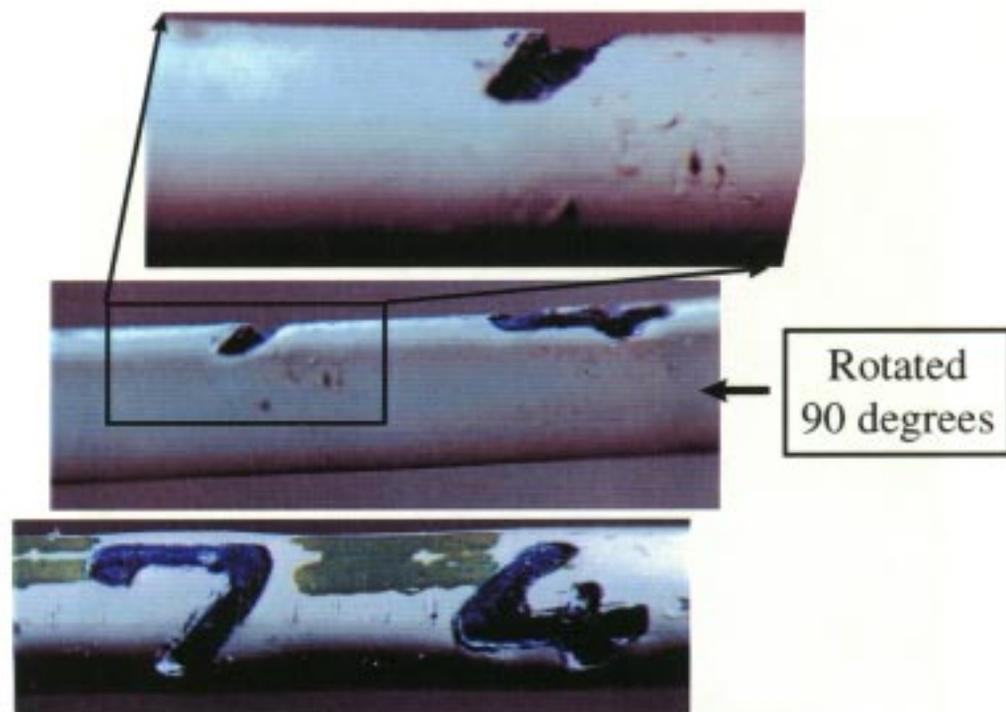
Figure 2. Typical example of hot stamp markings on relay connector wiring. Note depth penetration of the mark. A close-up of the seven mark is shown at the top.

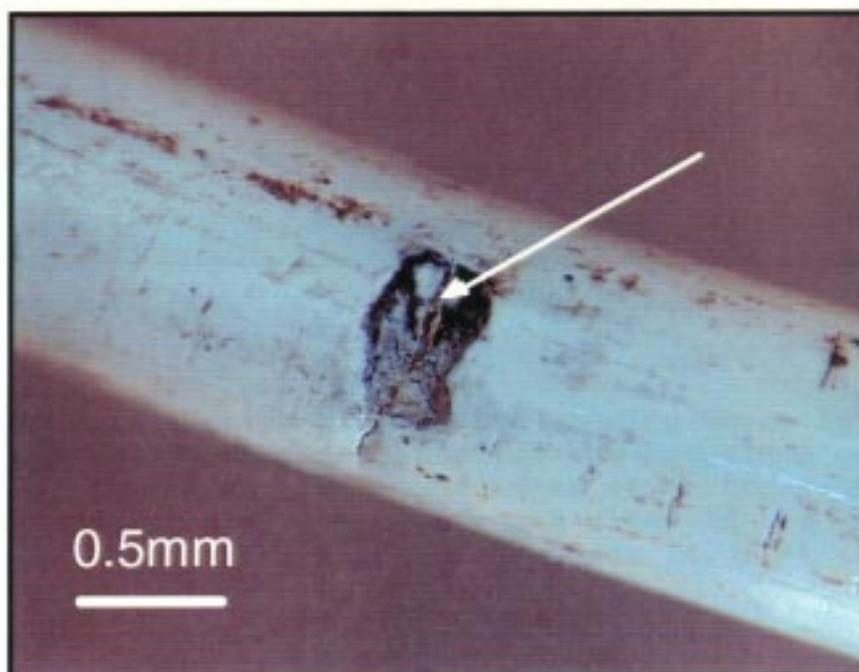
Figure 4. Crack found to propagate from a hot stamp mark. Optical inspection revealed the conductor was exposed.

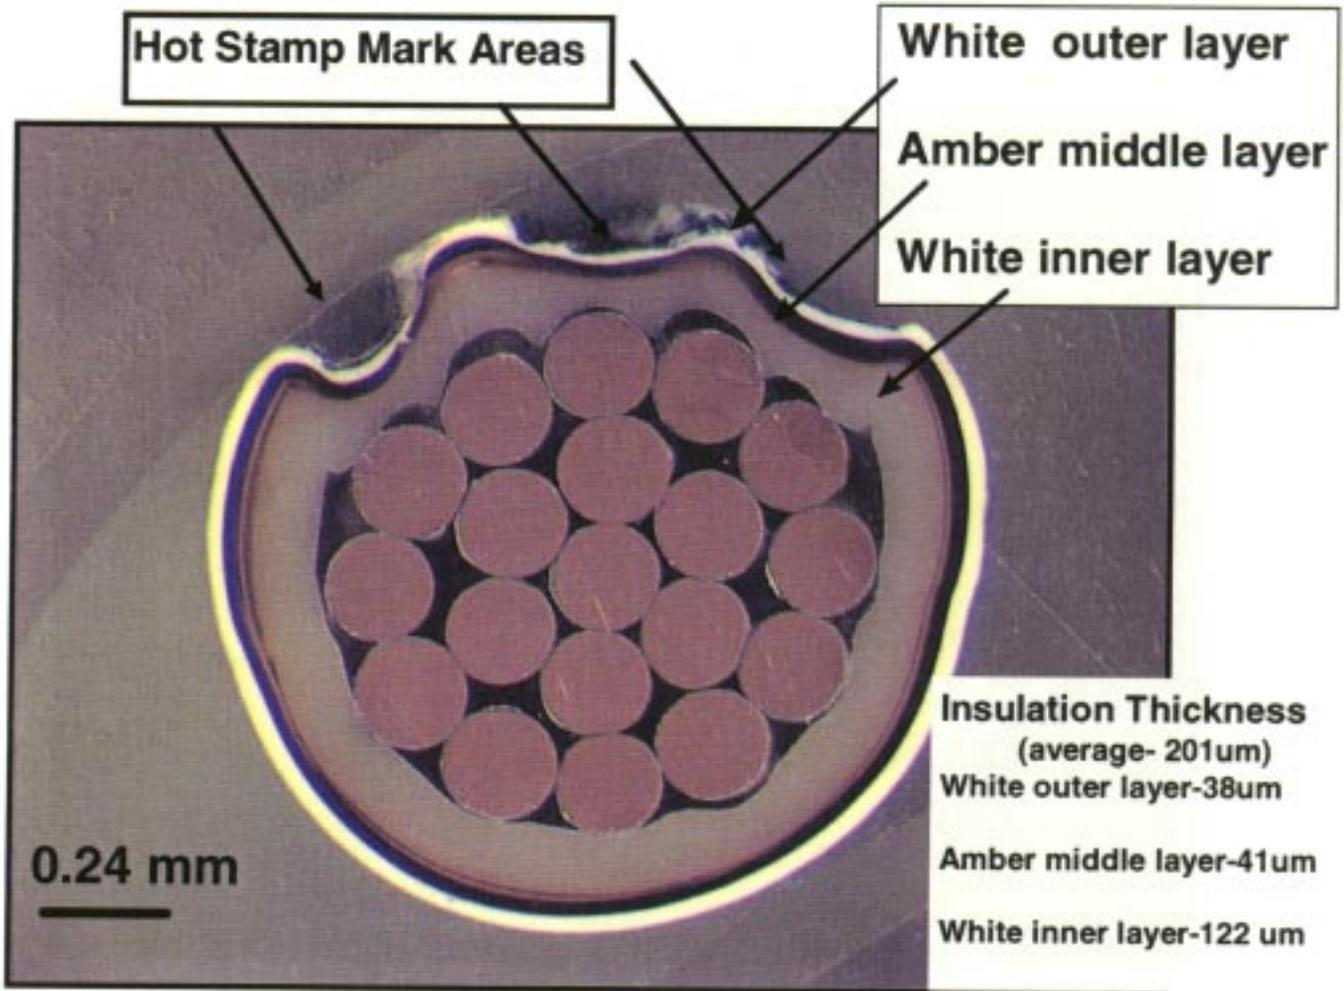
Figure 5. Cross section of the wire showing three layer construction and depth penetration of the hot stamp mark. Note thickness of layers and total thickness at bottom right. Considerable thickness variability was noted in the inner white layer. Also note deformation in the inner layer at the mark sites.

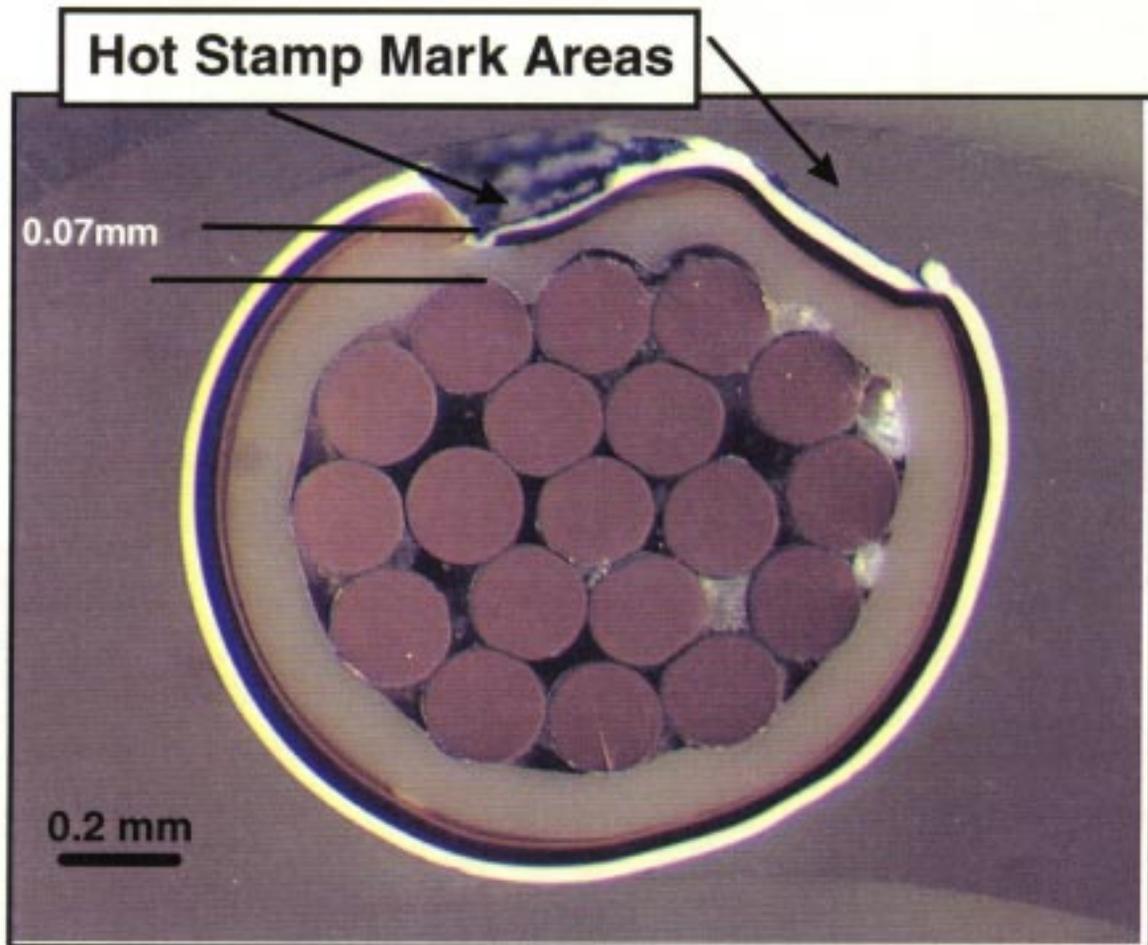
Figure 6. Perpendicular cross section showing depth penetration of the hot stamp marks. Note that all three insulation layers were penetrated (0.07 mm insulation was remaining at the mark site) and the inner white layer was deformed by the stamping process.

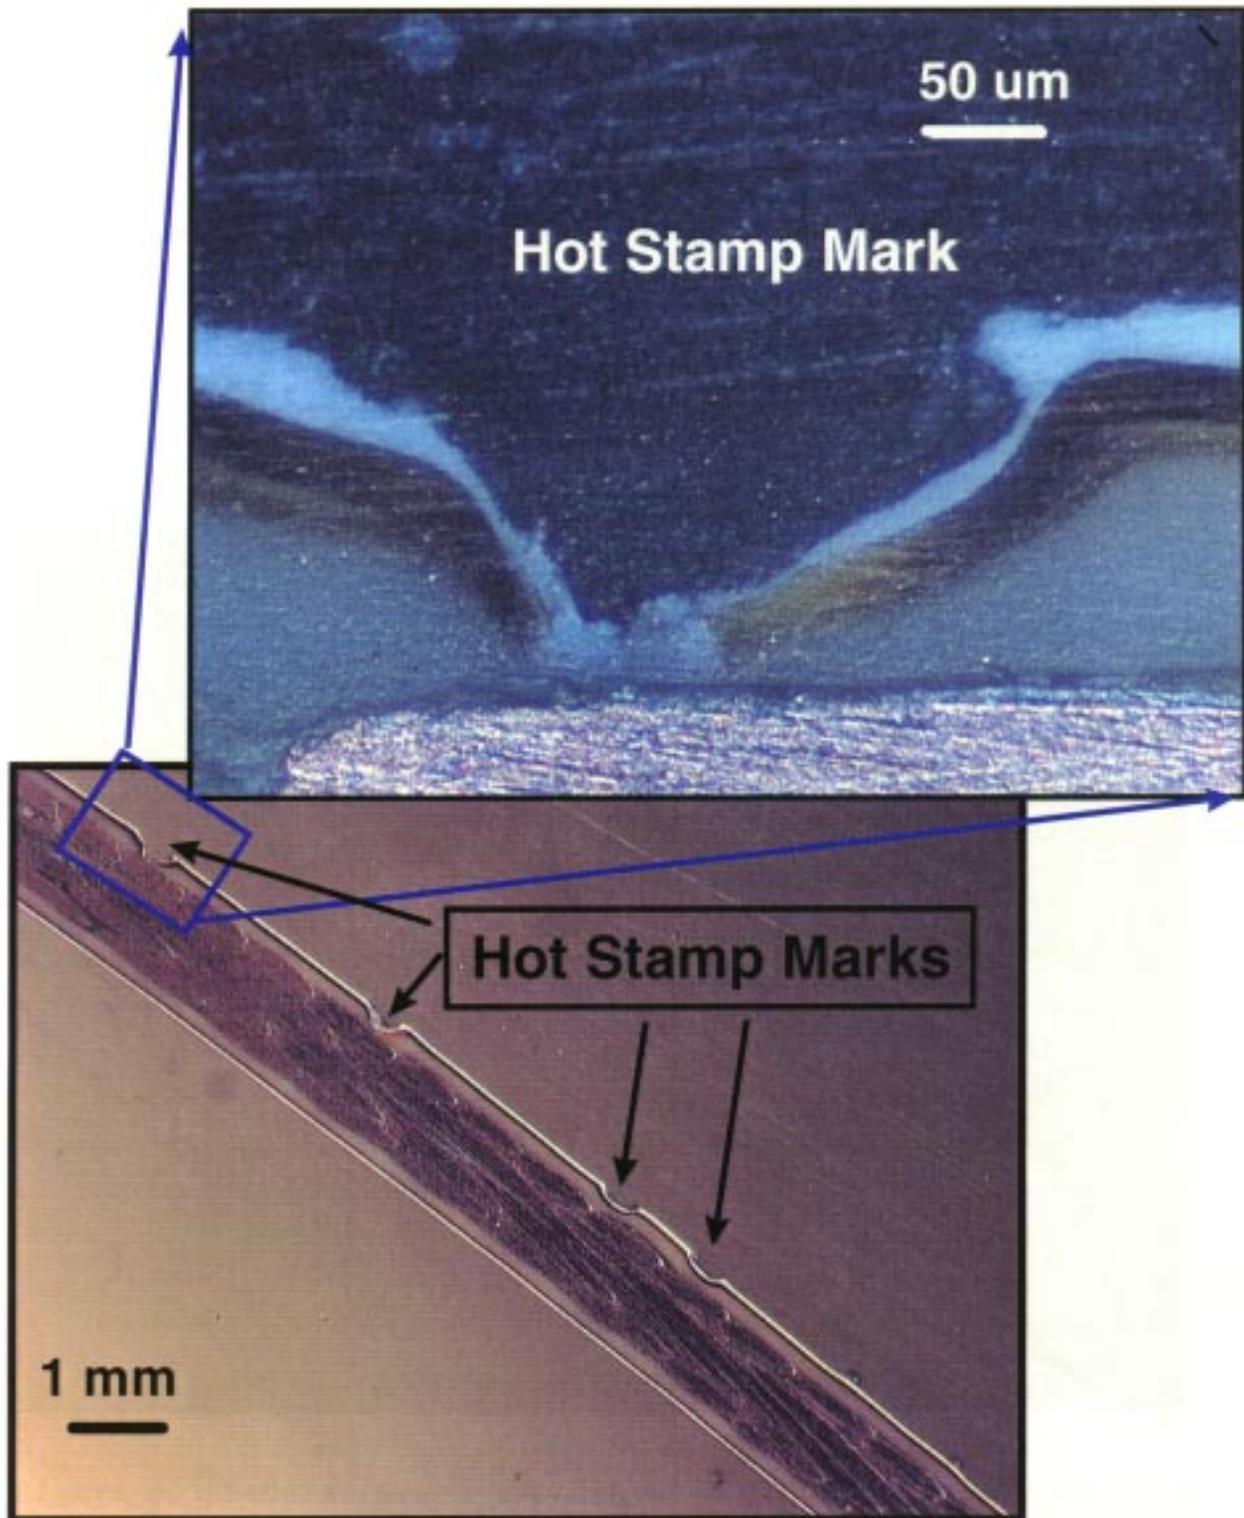
Figure 7. Lateral cross section showing multiple hot stamp sites. Note variability of depth penetration from right to left. Also note close-up of upper left mark showing that the mark penetrated all three insulation layers.

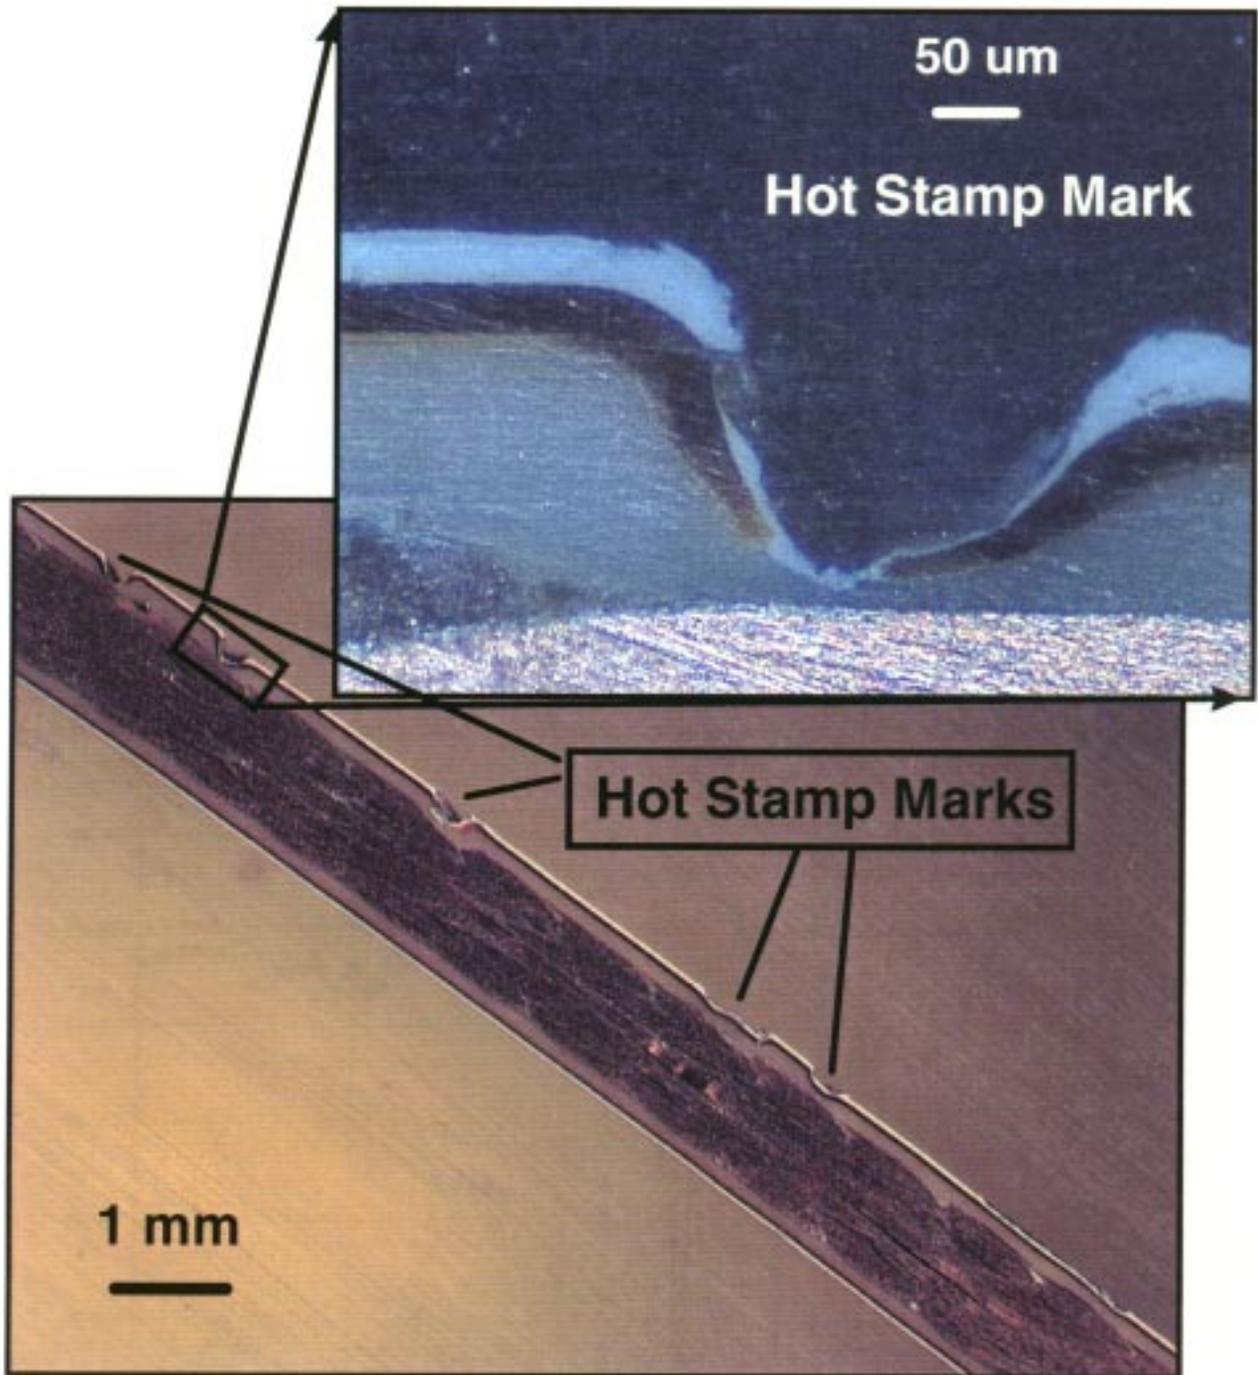
Figure 8. Lateral cross section of a different wire than from Figure 7. Again note depth variability of the mark from right to left. The inset image shows a close-up of a single mark site. Note all three insulation layers were again penetrated.

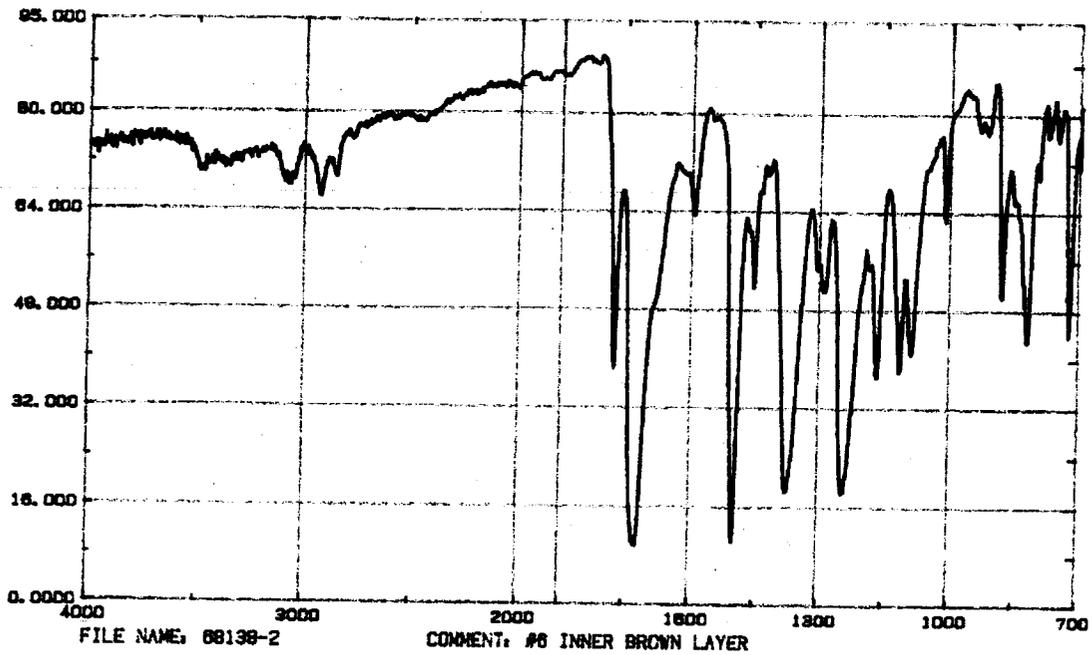
Figure 10. FTIR spectrum of the middle amber or brown insulation layer.

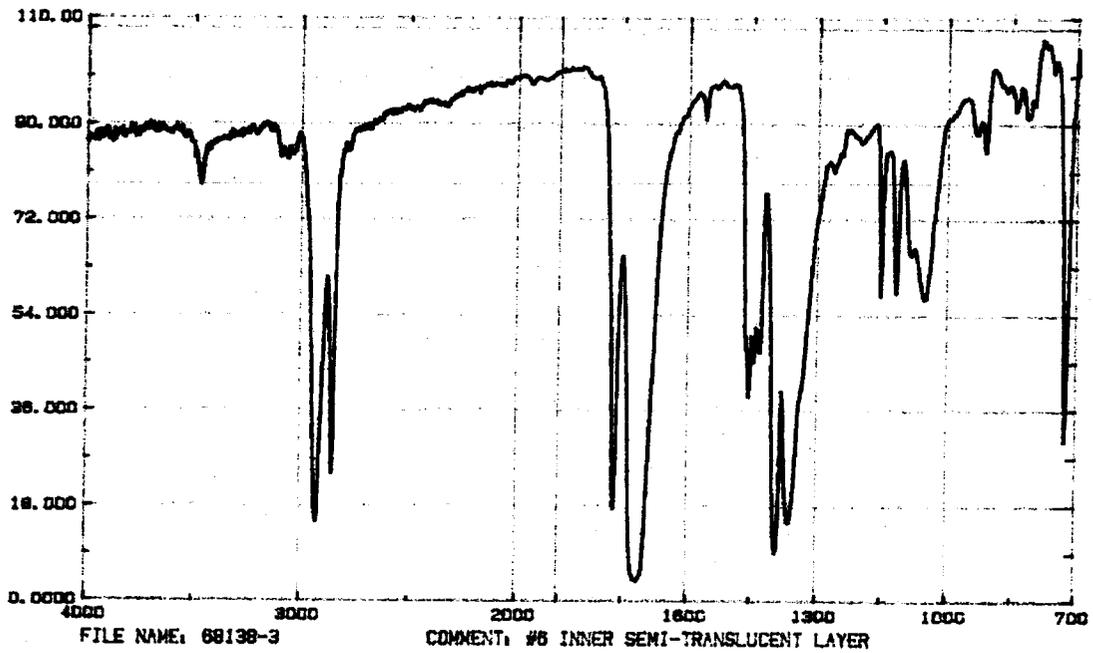
Figure 11. FTIR spectrum of the inner white insulation layer.
