DOCKET NO. **SA- 516**

EXHIBIT NO. **9E**

**NATIONAL TRANSPORTATION SAFETY BOARD
WASHINGTON, D.C.**

PHOTOGRAPHS (10 Pages)

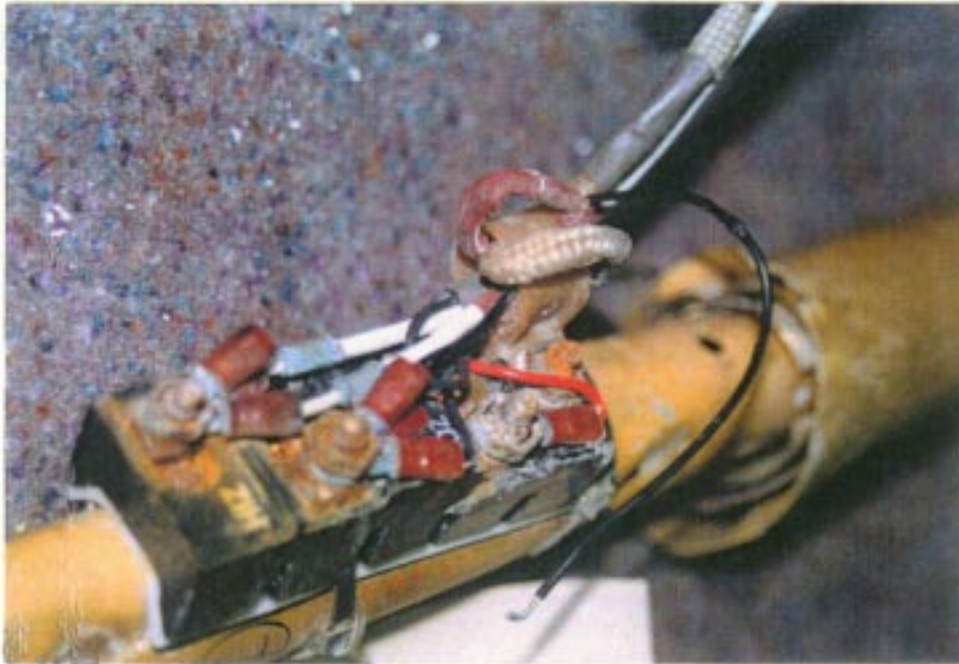
Photo 1: FQIS fragment #36 with large strain relief clamp

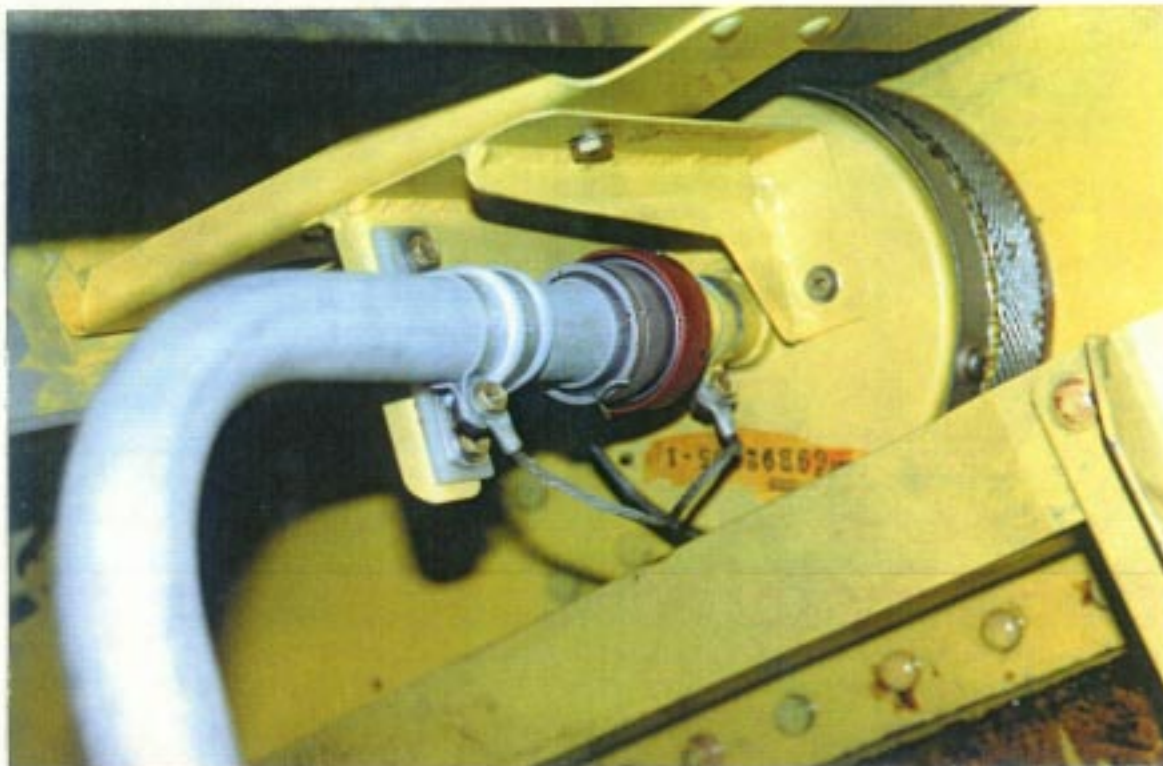
Photo 5: Scavenge pick-up

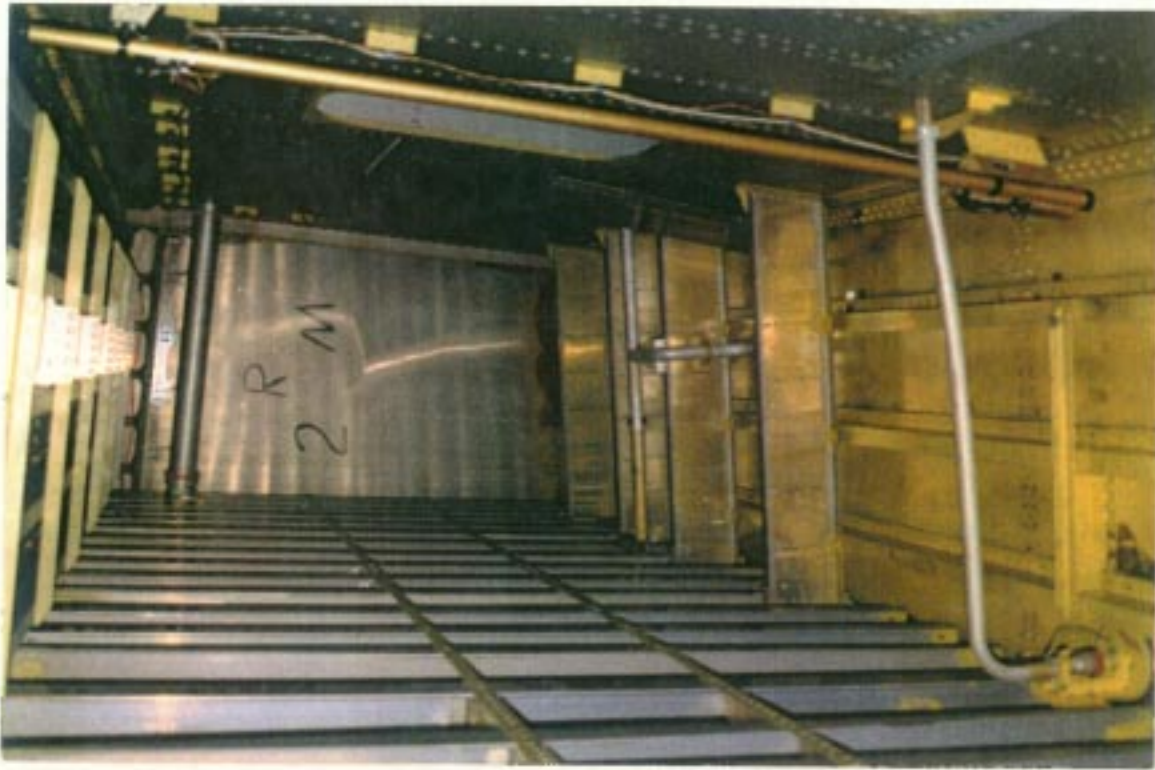
Photo 7: In CWT, looking across between spanwise 2& mid-spar. Shows fuel probe, compensator, & scavenge pick-up

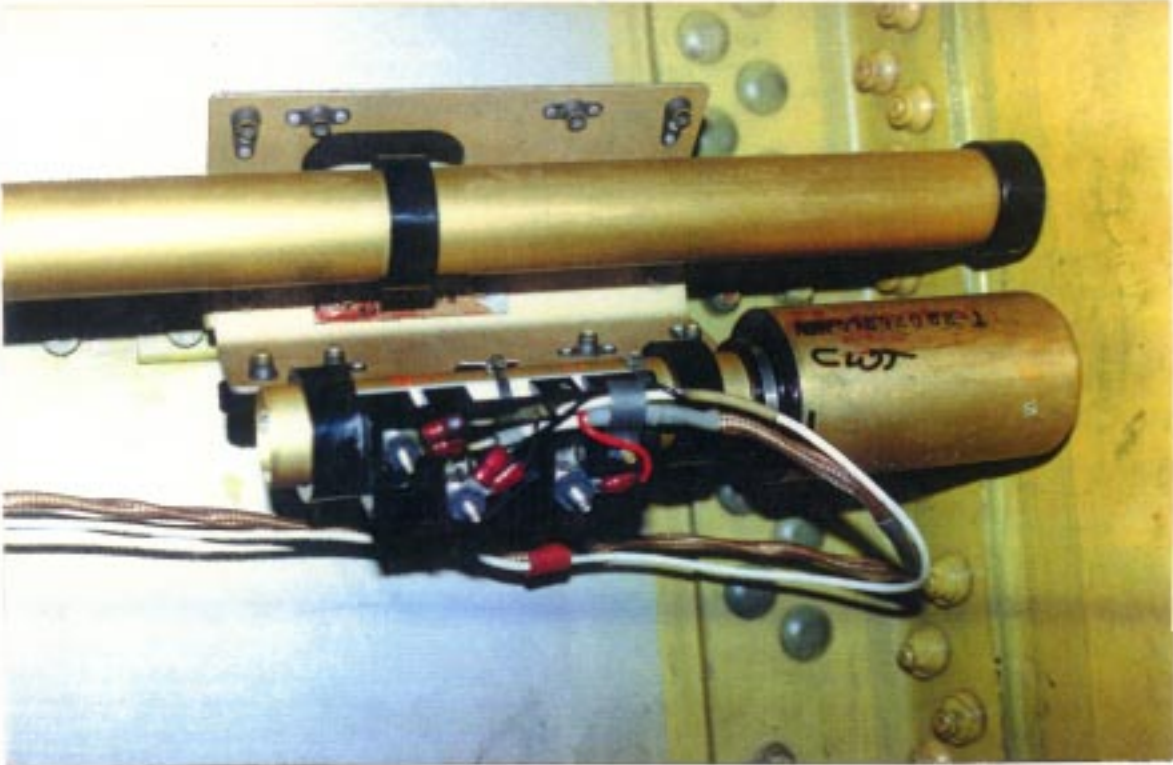
Photo 14. CWT fuel compensator & lower portion of fuel quantity probe
