**NATIONAL TRANSPORTATION SAFETY BOARD  
WASHINGTON, D.C**

**GROUP CHAIRMAN'S FACTUAL  
REPORT OF INVESTIGATION  
SOUND SPECTRUM STUDY**

Cockpit Voice Recorder

Aircraft: Trans World Airlines Inc.  
Boeing 747-131 N93119

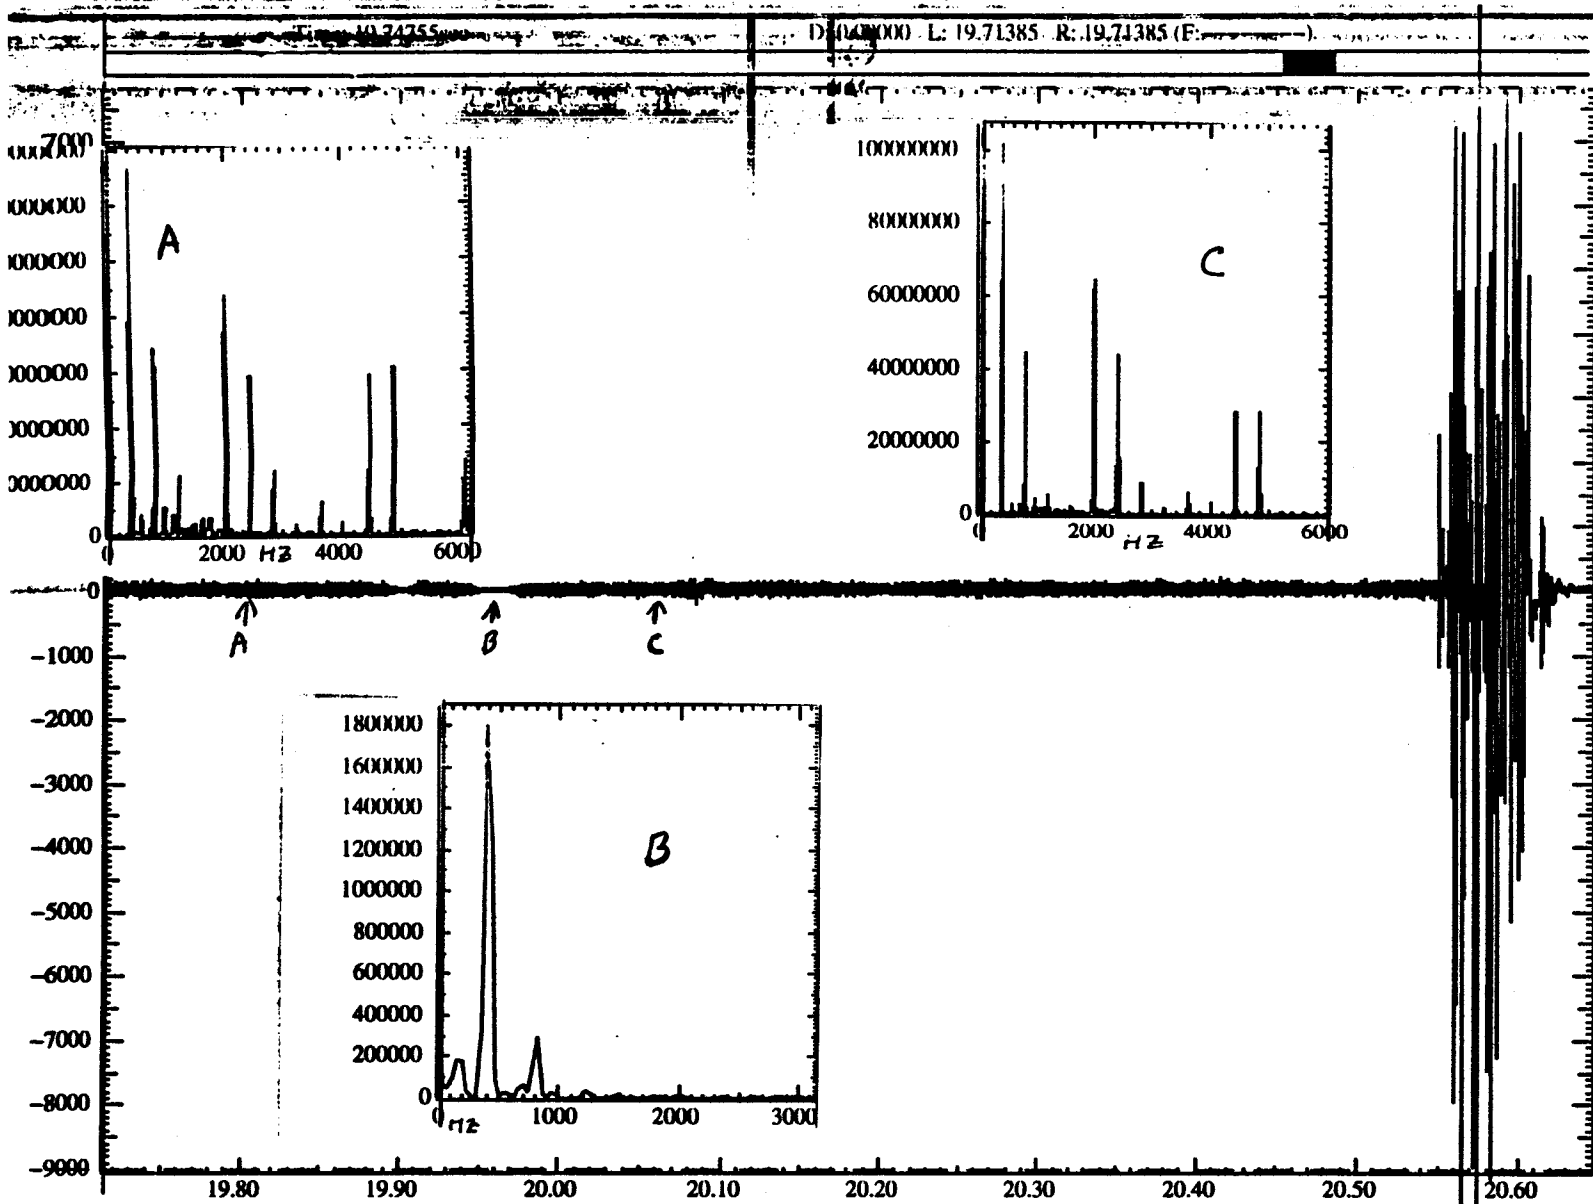
At time 0.73 seconds before the end of the recording and again at 0.68 seconds before the end, the normal 400 Hz signal with its associated harmonics changed. Chart 1 depicts this change in the background signal as observed on the Captain's radio channel. This change consists primarily of a lack of the upper harmonics of the 400 Hz. During these two different areas the signal contains only the 400 Hz component, no added harmonics. Chart 2 depicts the Captain's radio channel and the frequency plots for the regions prior, during and after the disturbance. Chart 3 depicts all of the 3 radio channels in this same area. It can be seen that the disturbance is identifiable only on the Captain's radio track of the CVR.
