**NATIONAL TRANSPORTATION SAFETY BOARD
WASHINGTON, DC.**

**METALLURGY/STRUCTURAL GROUP CHAIRMAN
FACTUAL REPORT
SEQUENCING STUDY
(57 pages)**

METALLURGY / STRUCTURES SEQUENCING STUDY

Place : East Moriches, New York
Date : July 17, 1996
Airplane : Boeing 747-131, N93119
NTSB No. : DCA96-M-A070

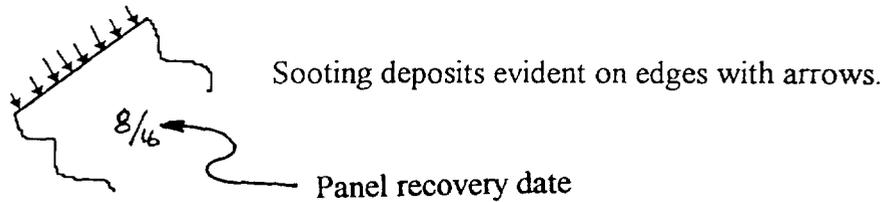
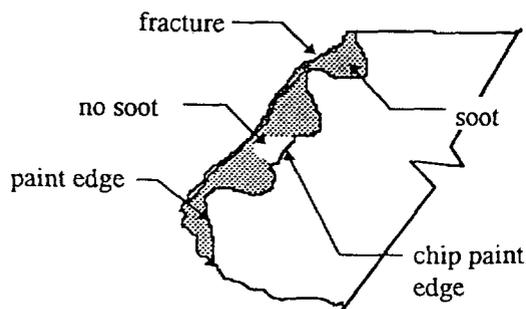
FIGURE 10-1

It can be seen from both the external and internal sooting patterns (figures 10-1 through 10-6) that there is a clear distinction between structure that departed with the left wing and the remainder of the right wing and aft fuselage. Lack of soot accumulation on the large fuselage piece (LF38) above the wing and fuselage pieces along the crown (RF34, RF41, and LF69) indicate that these pieces separated with the left wing. Soot accumulation on the remaining right

Surveyed panels are all recovered from the Green debris field and are located from approximately STA 910 to STA 1600.

Aft of STA 1600, no sooting is evident internally. On the exterior, there is light to moderate sooting extending aft along the entire length of the fuselage from approximately the main deck window belt on the RHS to approximately S-8 on the LHS

Determination primarily made by examining external paint failures near the fracture edge. Soot deposits remain on underlying paint when the top layer peels near fracture.

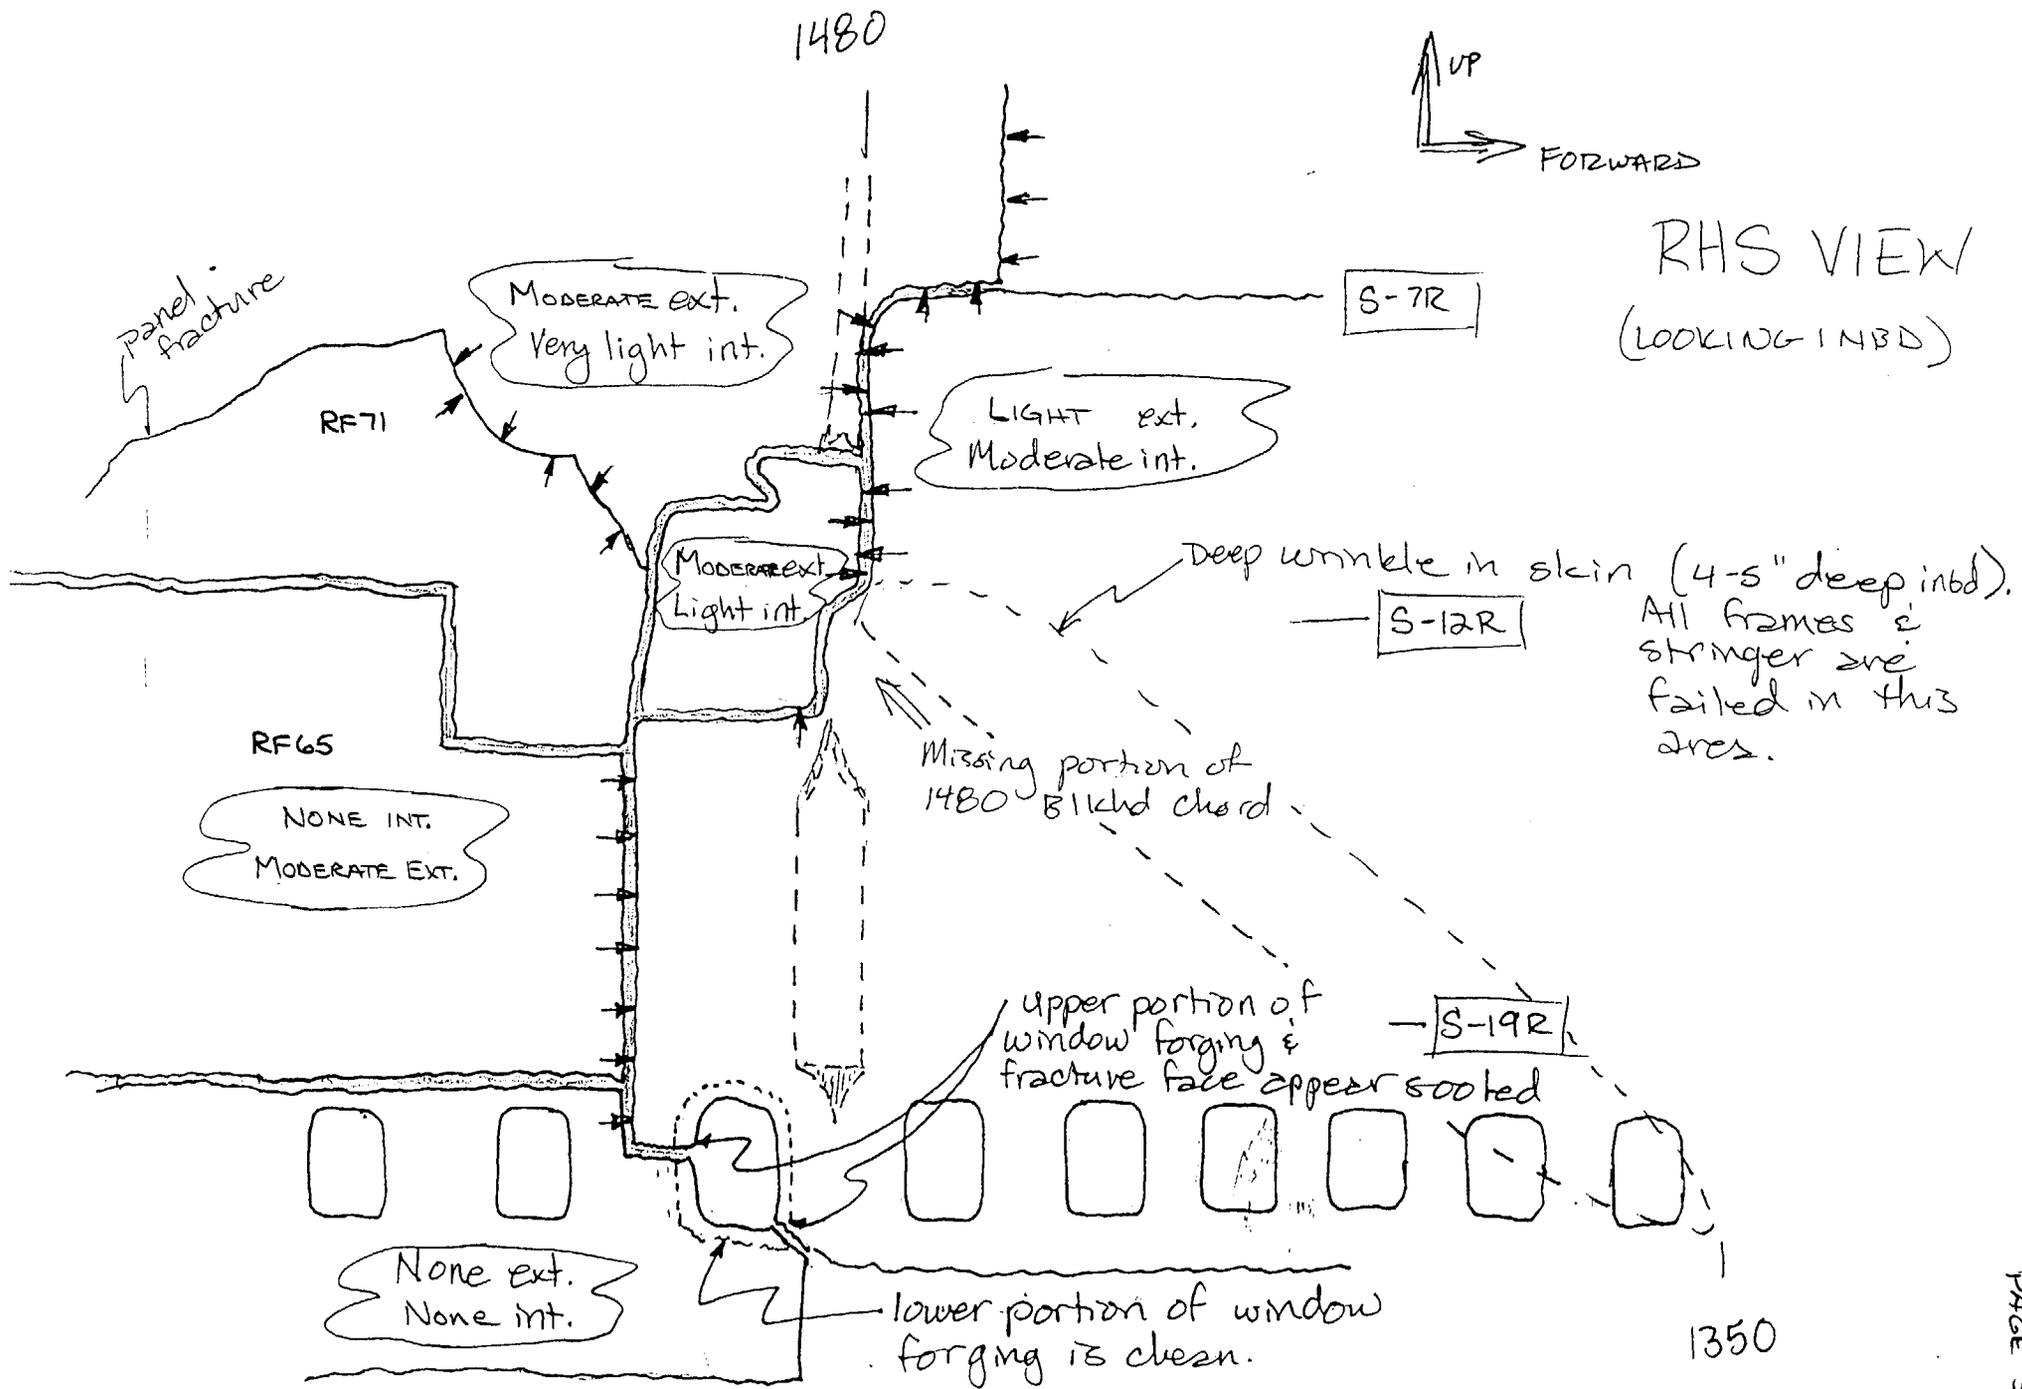
FIGURE 10-6

Following loss of the aft fuselage, some fuselage pieces (including major pieces LF39A, RF42, RF23) and some wheel well structure (including a portion of the keel beam and the STA 1350 bulkhead right of LBL 75 along with the right landing gear beam) remained with the right wing for a period of time and accumulated additional soot from a fire source on the right wing. See figure 10-7 for a diagram of the sooting patterns on the lower body structure between STA 1241 and STA 1480. These pieces subsequently separated before exposure to the major fire associated with the right wing. The right landing gear beam separated from the right wing at the outboard attach point liberating the right wing gear. Heavy soot accumulation and fire damage on pieces RF14 and RF37 indicated that they remained attached to the right wing for some period of time during the major fire. Fuselage piece RF17 was recovered attached to the right wing structure and was severely burned.
