**NATIONAL TRANSPORTATION SAFETY BOARD  
WASHINGTON, D.C.**

**SUPPORTING DOCUMENTATION FOR OVERALL  
BREAKUP SEQUENCE**

# **Metallurgy / Structures Sequencing Group Report**

## **Appendix B: Detailed Rationale**

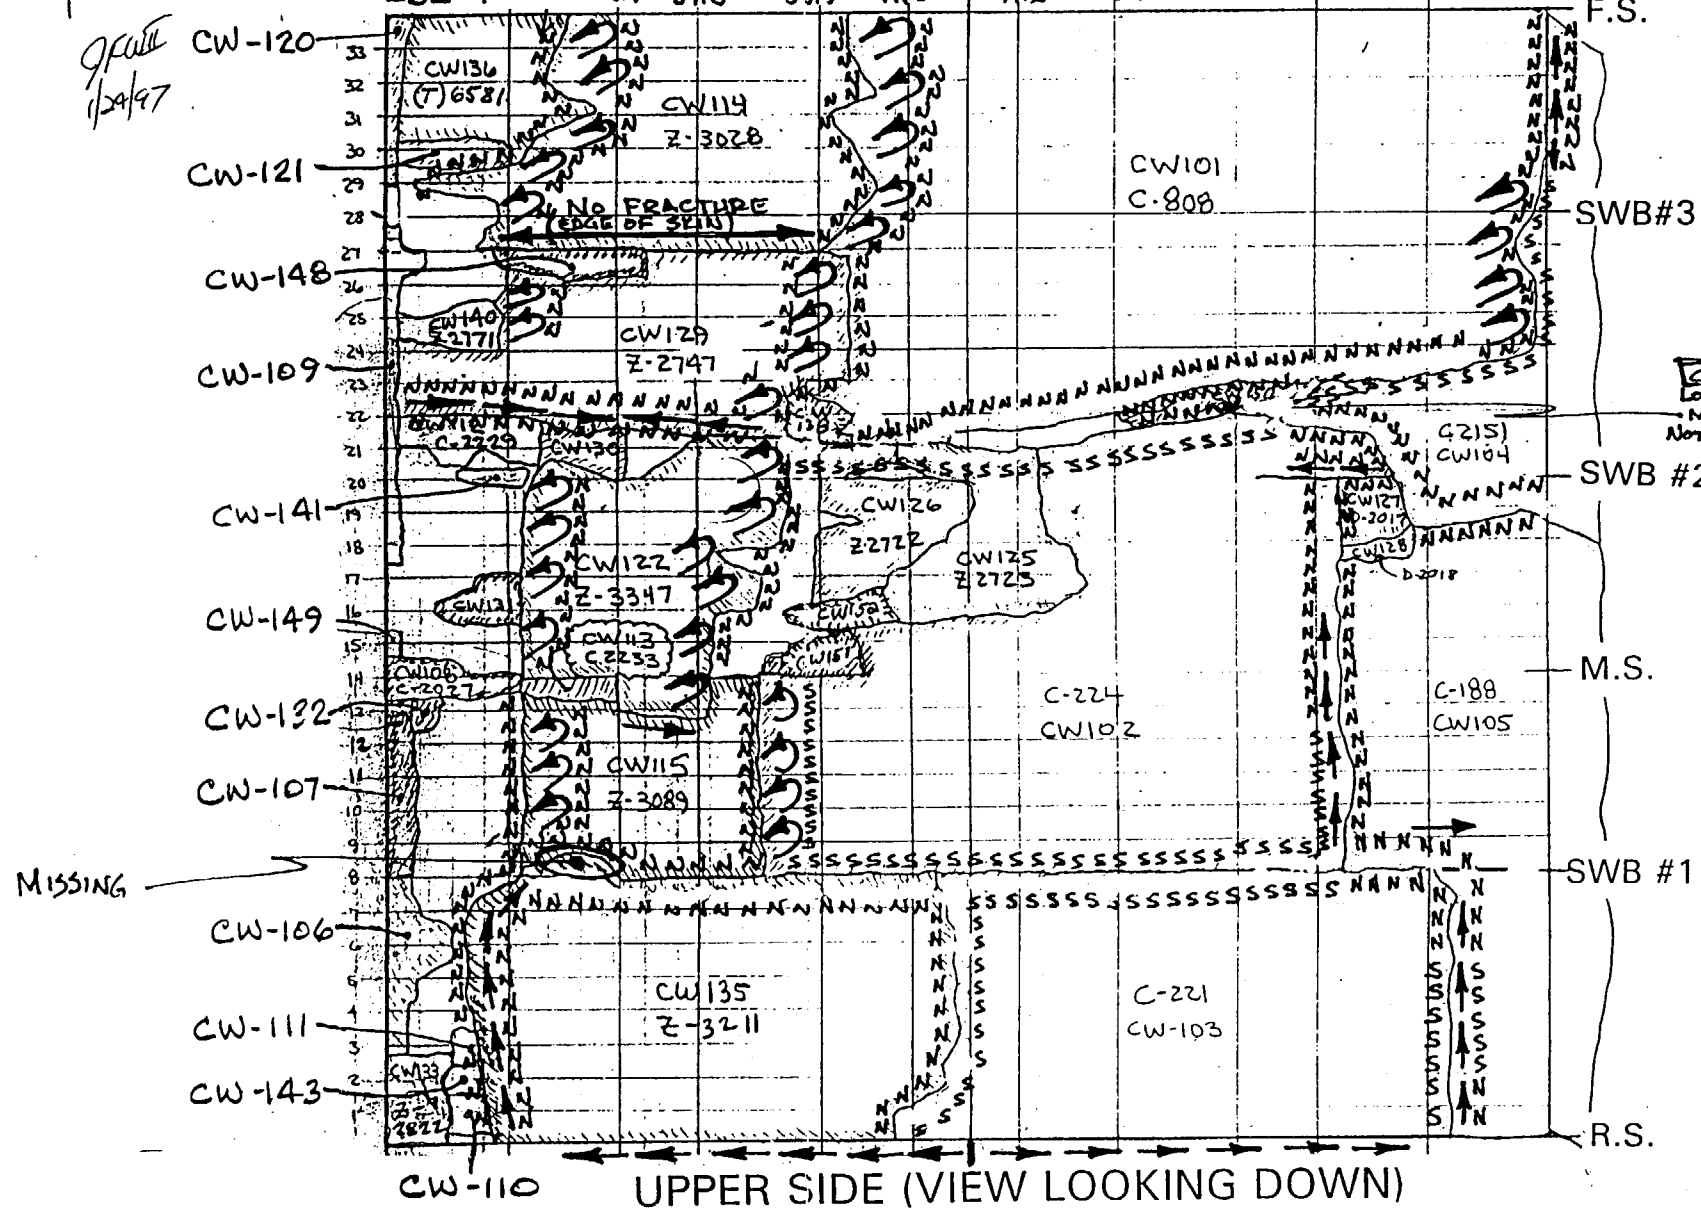
CW-110      UPPER SIDE (VIEW LOOKING DOWN)

**CW150**  
LOCATION OF MATING SURFACES NOT DRAWN CORRECTLY

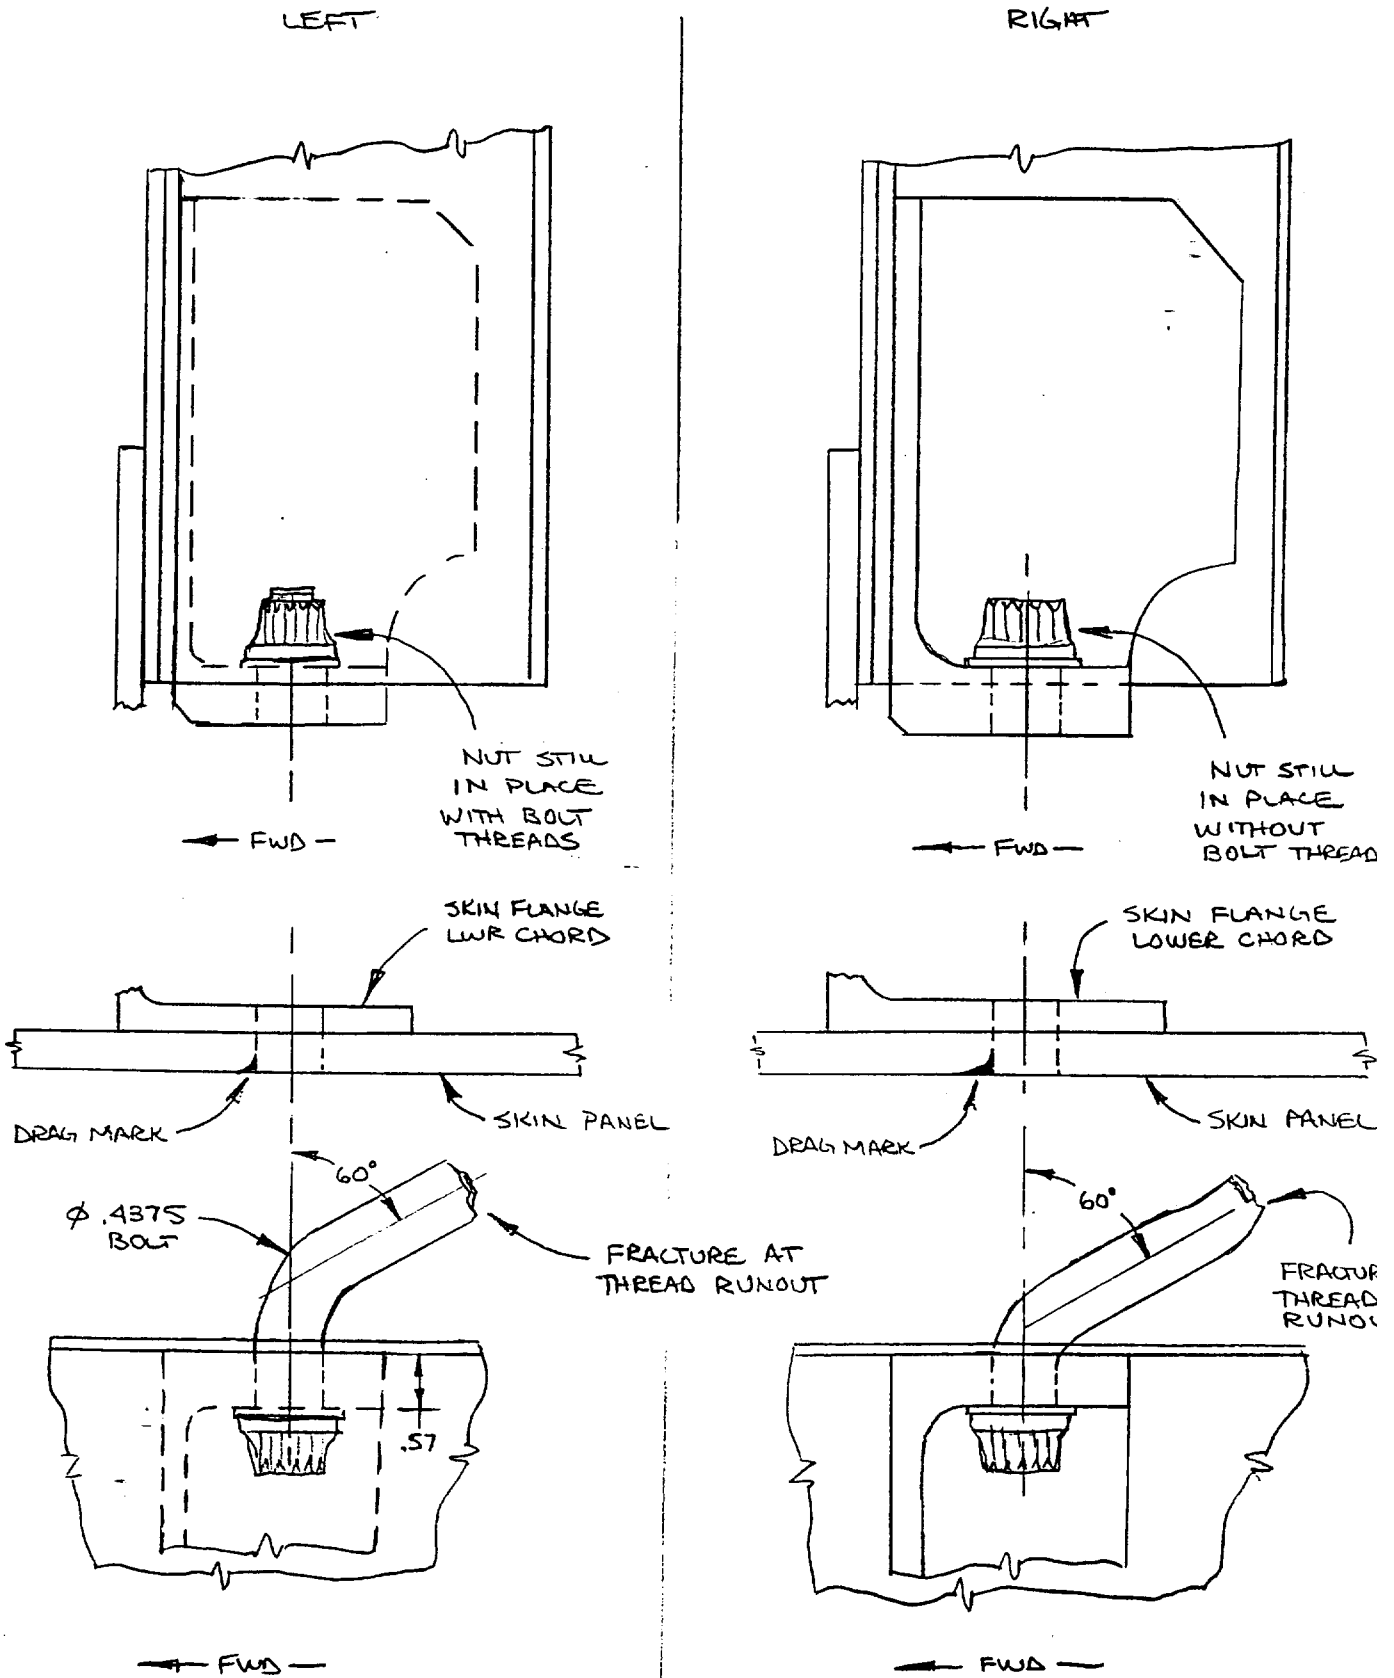
FIGURE R-2

DESCRIPTION OF POSSIBLE SEQUENCE	SUPPORTING OBSERVATIONS	NON-SUPPORTING OBSERVATIONS	Confidence Level
During the keel beam separation, the tension fasteners common to the keel beam fracture and the downward motion of the keel beam produces the residual bending of the keel beam tension bolts as shown in figure B-3.	1. Tension fasteners are bent aft 60 degrees as shown in figure B-1. 2. Drag mark exists on forward side of the tension fastener hole in the lower skin panel.		Medium

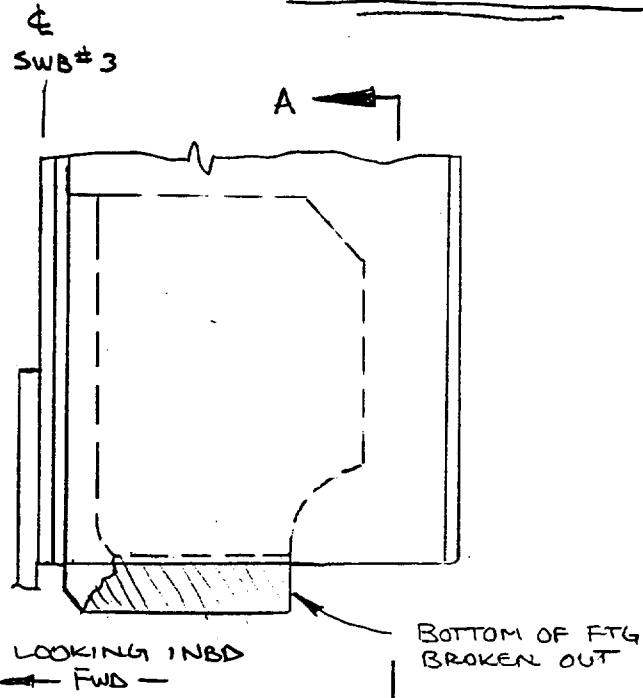
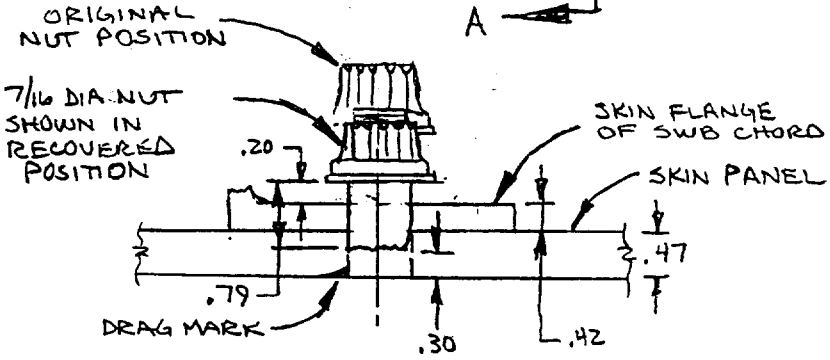
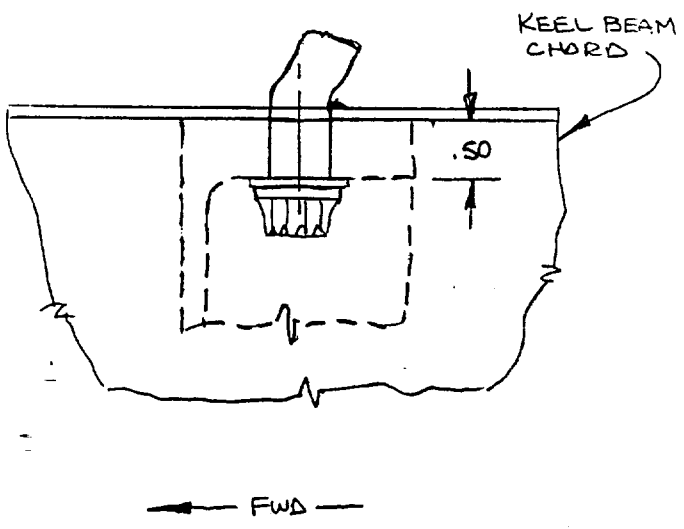
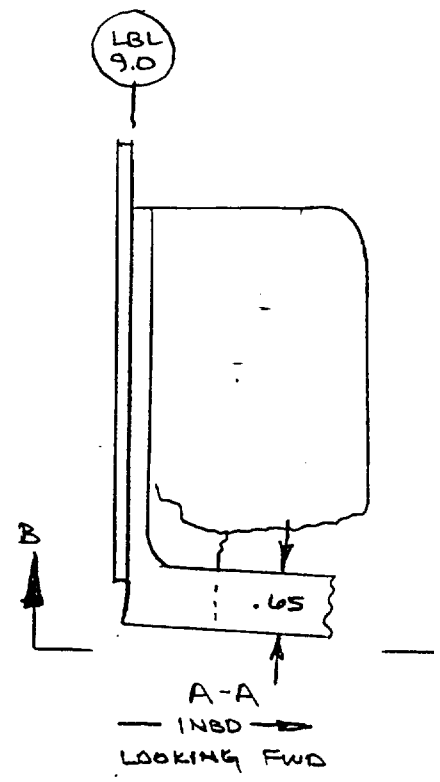
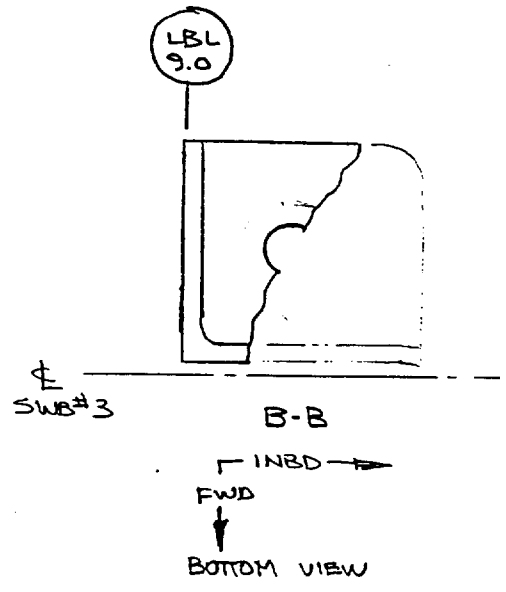
SWB #3 - LEFT FTG.

DESCRIPTION OF POSSIBLE SEQUENCE	SUPPORTING OBSERVATIONS	NON-SUPPORTING OBSERVATIONS	Confidence Level
<p>The right portions of the spanwise beam which are heavily fire damaged may remain with the right wing. The sections of spanwise beam may not have remained attached to the upper panel during wing breakup but possibly remained in the cavity between the front spar and SWB#2.</p>	<ol style="list-style-type: none"><li>1. The fire damage is consistent with the level of soot accumulation and fire damage to the upper skin panel interior.</li><li>2. Both the stiffener that attaches the spanwise beam web to the side of body rib and the spanwise beam web are sooted on the interface whereas the stiffener to side of body rib interface is unsoted on both the stiffener and the S.O.B. web.</li></ol>		<p>Medium</p>

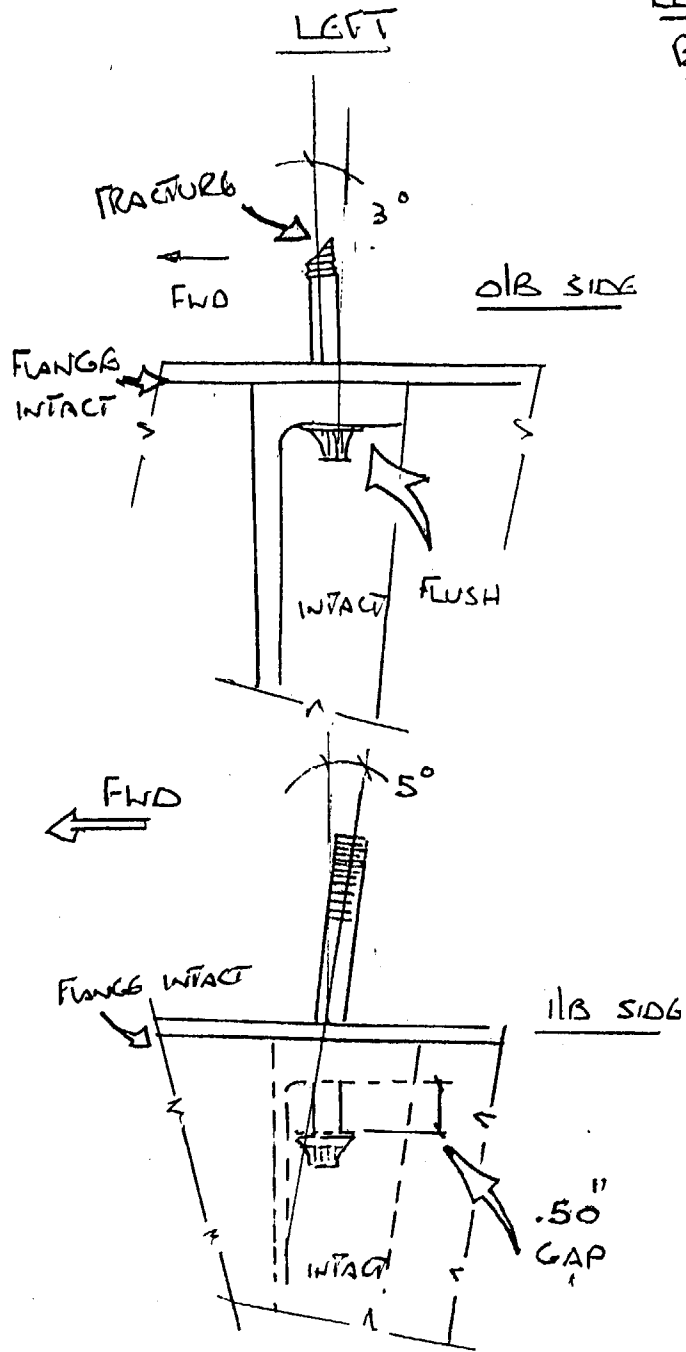
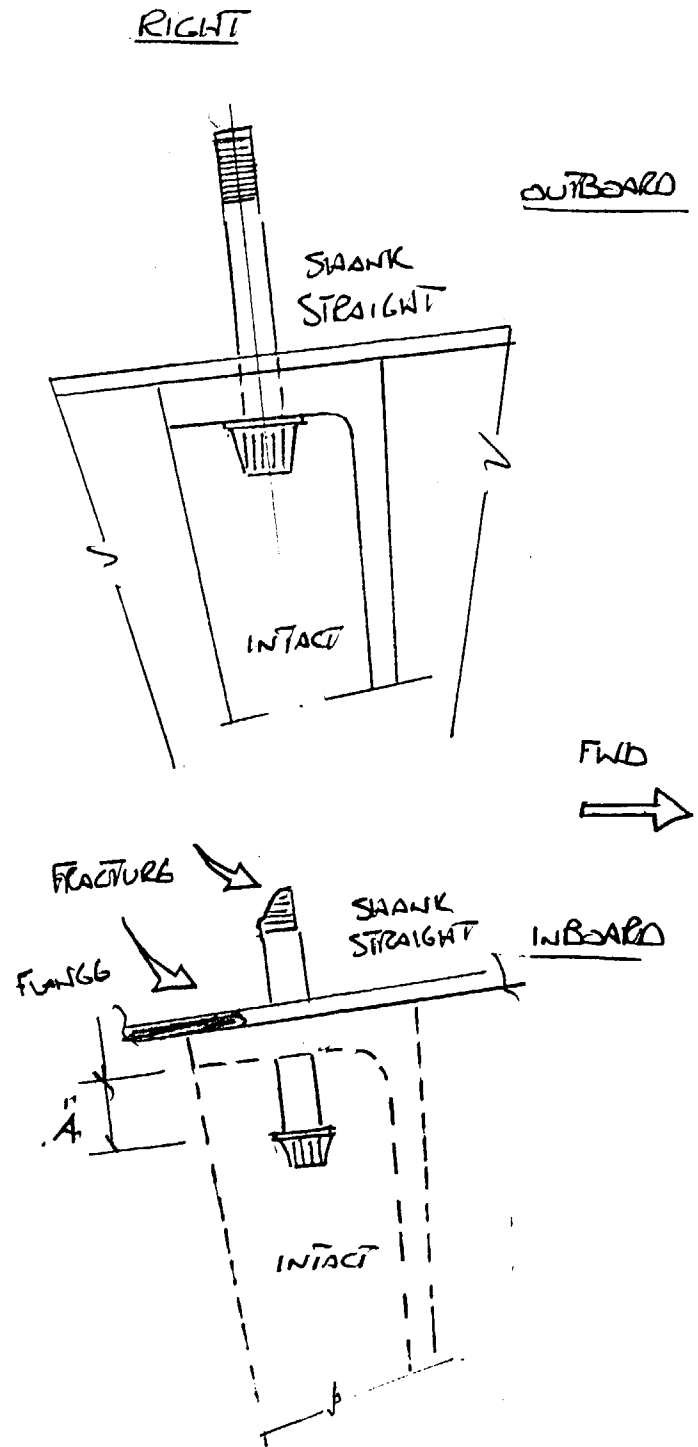
FIGURE B-9  
ROTATION REQUIRED BY SWB #3 AND FRONT SPAR IN ORDER TO PRODUCE DEEP SPLITS IN THE FRONT SPAR WEB AT RBL AND LBL 6.0 (ROTATION ABOUT LWR CHORD)

DESCRIPTION OF POSSIBLE SEQUENCE	SUPPORTING OBSERVATIONS	NON-SUPPORTING OBSERVATIONS	Confidence Level
<p>As a result of spanwise beam #3 rotating fwd, the upper chord of the spanwise beam impacts the aft side of the front spar stiffeners, This results in crushing of the aft side of the stiffeners at a location shown in figure B-8.</p>	<p>Impact marks and damage on the aft side of the front spar stiffeners at a distance of approx. 12" below the upper stiffener shear ties. The damage on the aft side of some of the stiffeners shows two distinct impact marks with 3" vertical separation that equals the chord height of the spanwise beam upper chord.</p>		High
<p>The applied impact force on the aft side of the stiffeners and local buckling of the stiffeners at the impact zone results in bending of the upper spar chord between the vertical and horizontal flange. Overpressure loads may also contribute, This bending moment results in a fracture in the fillet radius of the upper spar chord.</p>	<p>Multiple initiation sites of the upper spar chord fracture coincident with the floor beam locations at RBL 75 and 57.5, and LBL 11, 33, 75, and 98. These fractures are bending type fracture with the lower edge of the chord moving fwd relative to the skin flange of the chord. At all of these locations, the chord has a slight residual deformation indicative of an inbd/outbd bowing of the vertical flange of the chord. See figure B-13.</p>		High

<p>The one fracture in the upper spar chord fillet radius that originates at RBL 57.5 apparently progresses inbd from RBL 57.5 and propagates out of the fillet radius and down into the vertical flange near RBL 48.</p>	<p>Metallurgical review of fracture faces.</p>		High
<p>Once the upper chord of the front spar is separated from the upper skin, overpressure loads and the resulting downward loading of the forward end of the keel beam is reacted by shear loading of the front spar and lower pressure bulkhead.</p>			High

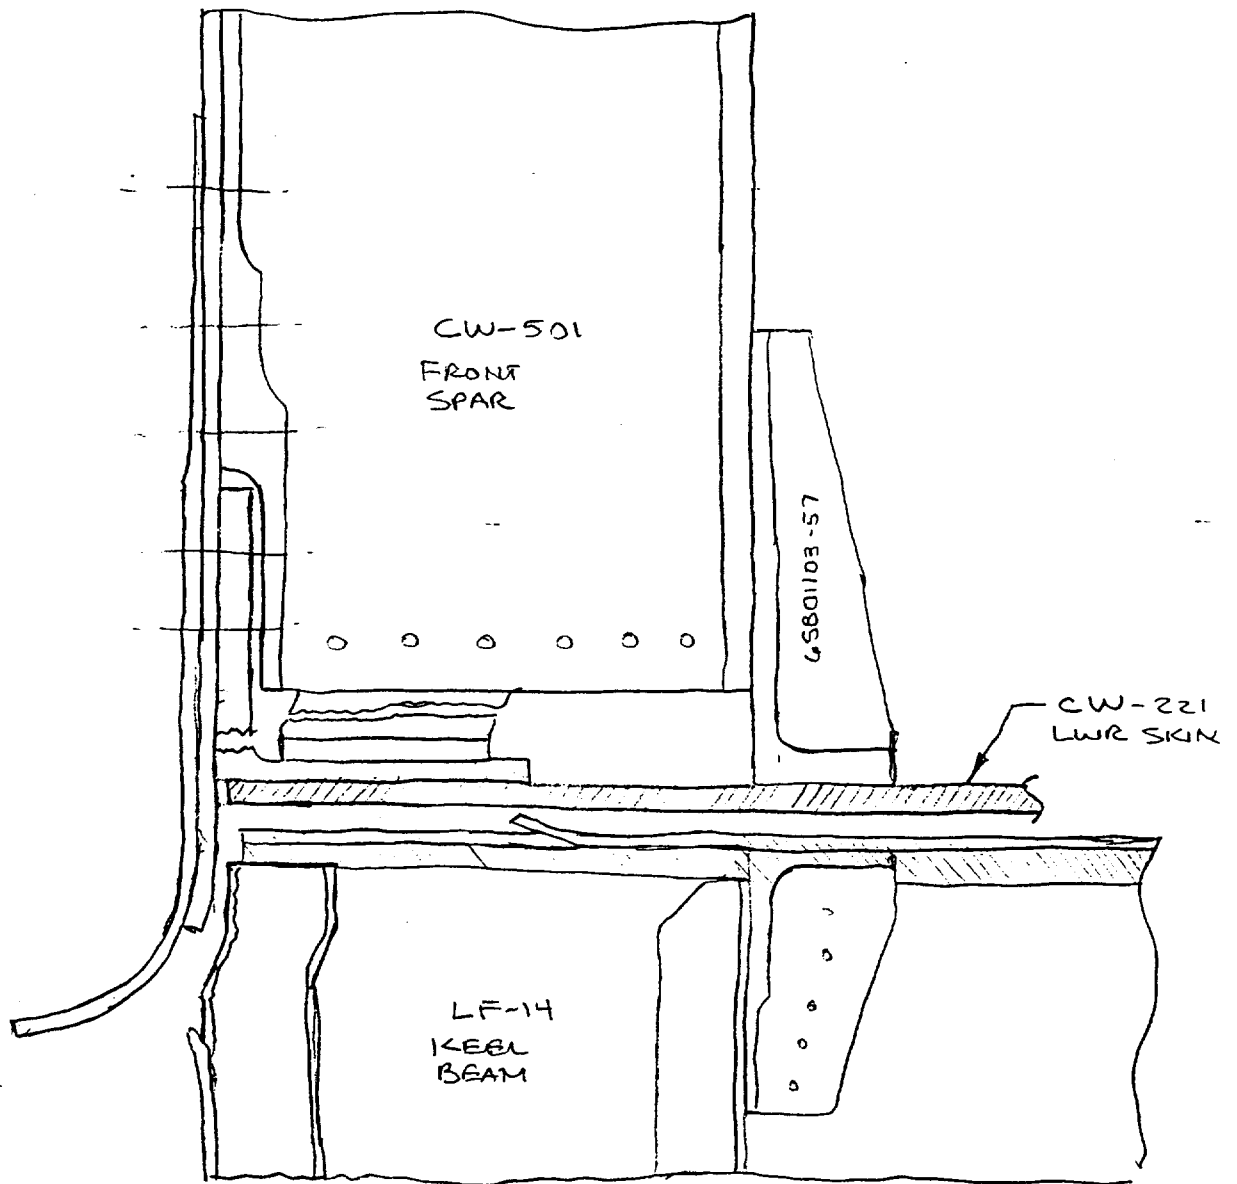
FIGURE B-11

DESCRIPTION OF POSSIBLE SEQUENCE	SUPPORTING OBSERVATIONS	NON-SUPPORTING OBSERVATIONS	Confidence Level
<p>With the front spar web separated at LBL 66 and RBL 66, the downward loads on the forward end of the keel beam result in a shear failure of the rivets connecting the lower pressure bulkhead web to the front spar web.</p>	<p>Web attachment fasteners common to the front spar web and lower pressure bulkhead web indicate a shear direction of approximately 45 degrees down and inward from LBL 33 to LBL 75 and from RBL 26 to RBL 75 (entire outboard portion of the web). See figure 4-10.</p>		<p>Medium</p>
<p>Continued downward loading on the forward portion of the keel beam results in vertical separation of the lower pressure bulkhead web at LBL 66 and RBL 66.</p>	<p>Downward progressing fractures through the lower pressure bulkhead web at LBL 66 and RBL 66 are at locations corresponding to early fractures in the front spar web. Fracture patterns are symmetric left to right. See figure 4-10.</p>		<p>Medium</p>

<p>Continued downward loading on the fwd portion of the keel beam is transmitted to the ring chord and fuselage skin just forward of the ring chord at LBL 66 and RBL 66.</p>	<p>Early fractures in the ring chord and fuselage at LBL 66 and RBL 66. See figure 4-11, 6-1, and 6-2.</p>		<p>Medium</p>
<p>Loss of cargo floor and fuselage structure forward of the front spar allows final liberation of the front spar red area pieces.</p>	<ol style="list-style-type: none"> <li>1. Minor damage to the front side of the potable water bottles mounted on the forward side of the front spar indicative of no impact between the bottles and cargo floor structure,</li> <li>2. Bending/buckling fracture of the stiffeners between the front spar and lower pressure bulkhead.</li> <li>3. Fracture of the front spar lower chord in the chord fillet radius, originating on each side near LBL 75 and RBL 75.</li> </ol>		<p>Medium</p>

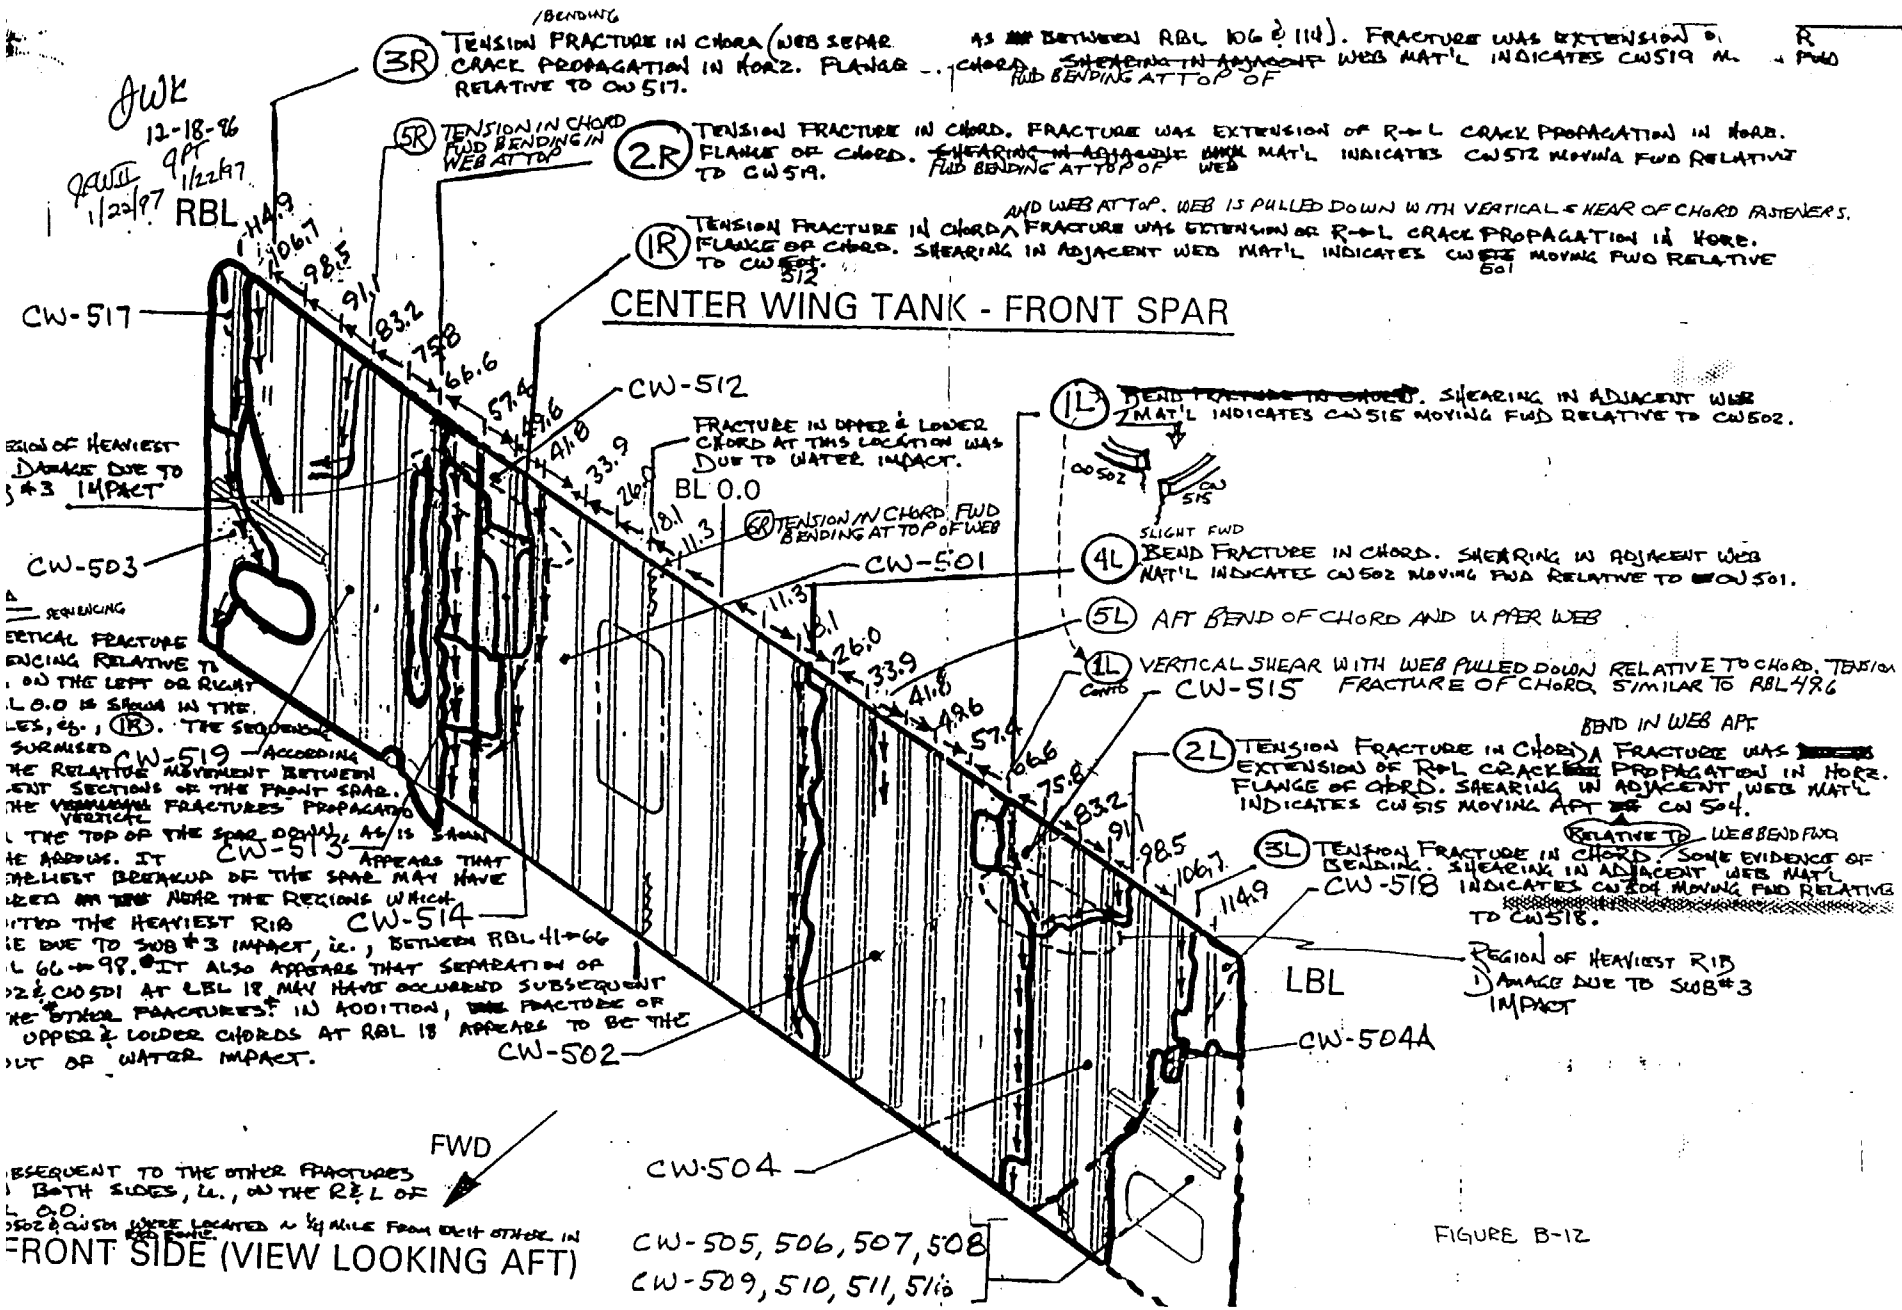
FIGURE B-12

SLIGHT BOWING & FWD NOTED AT ORIGIN SITES ASSOCIATED WITH FLOOR BEAMS AT RBL 98, RBL 75, RBL 57, LBL 11, LBL 33, LBL 57, LBL 75 AND LBL 98. INITIATION SITES IN UPPER CHORD CO-LOCATED AT FLOOR BEAM AT RBL 75, RBL 57, LBL 11, LBL 33, LBL 75, AND LBL 98. ONE ADD'L INITIATION SITE BETWEEN RBL 41 AND RBL 45 WAS ASSOCIATED WITH WHERE THE FRACTURE DROVE DOWN IN THE VERTICAL FLANGE OF FRONT SPAR UPPER CHORD.

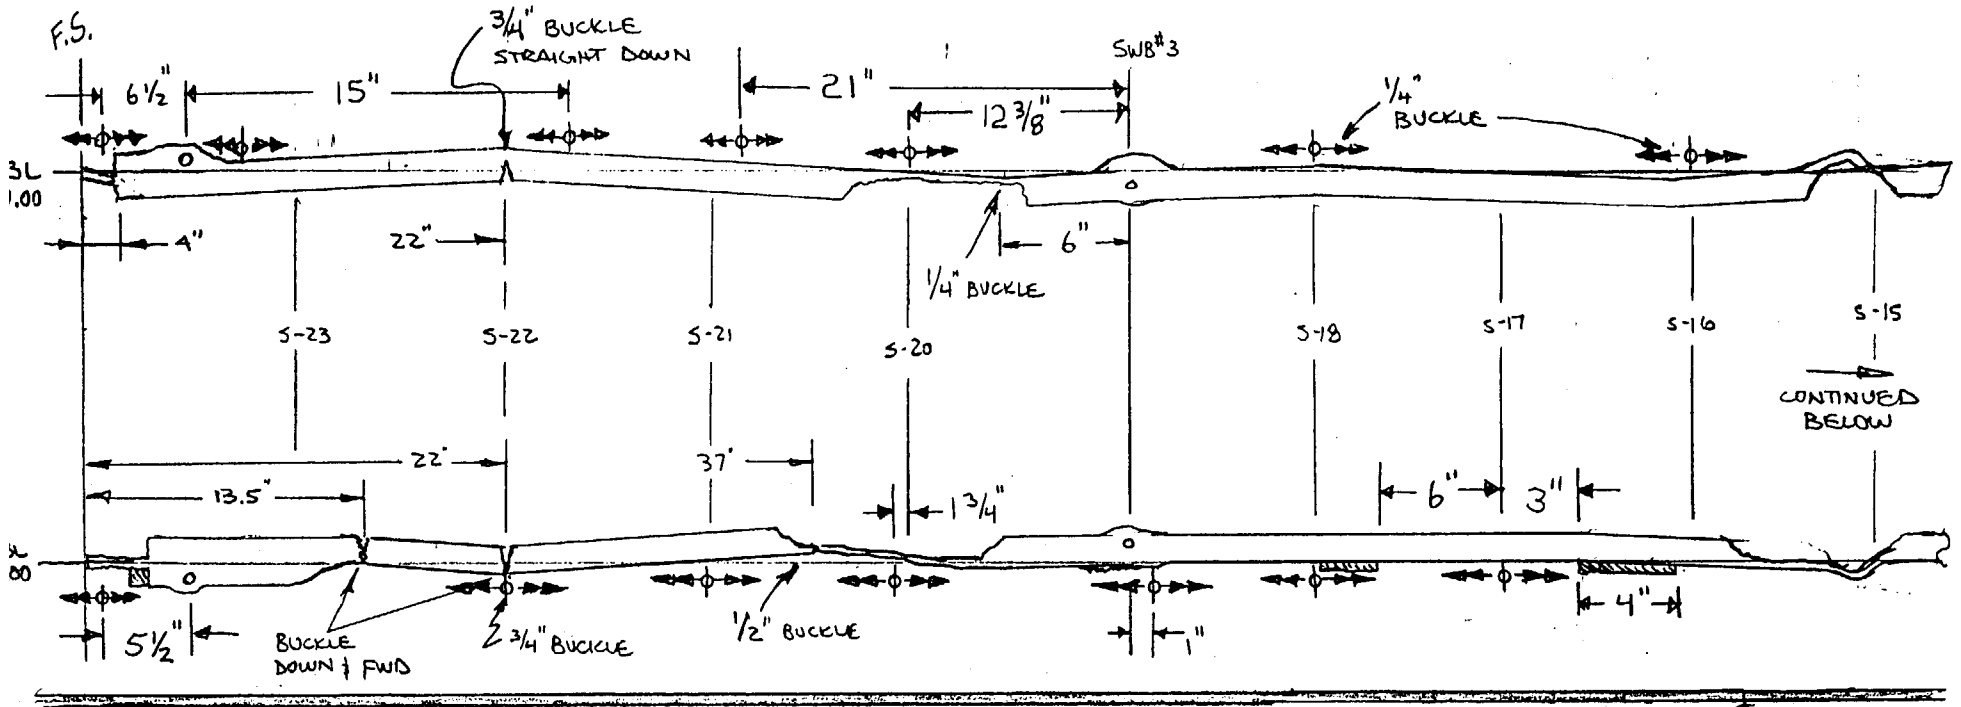
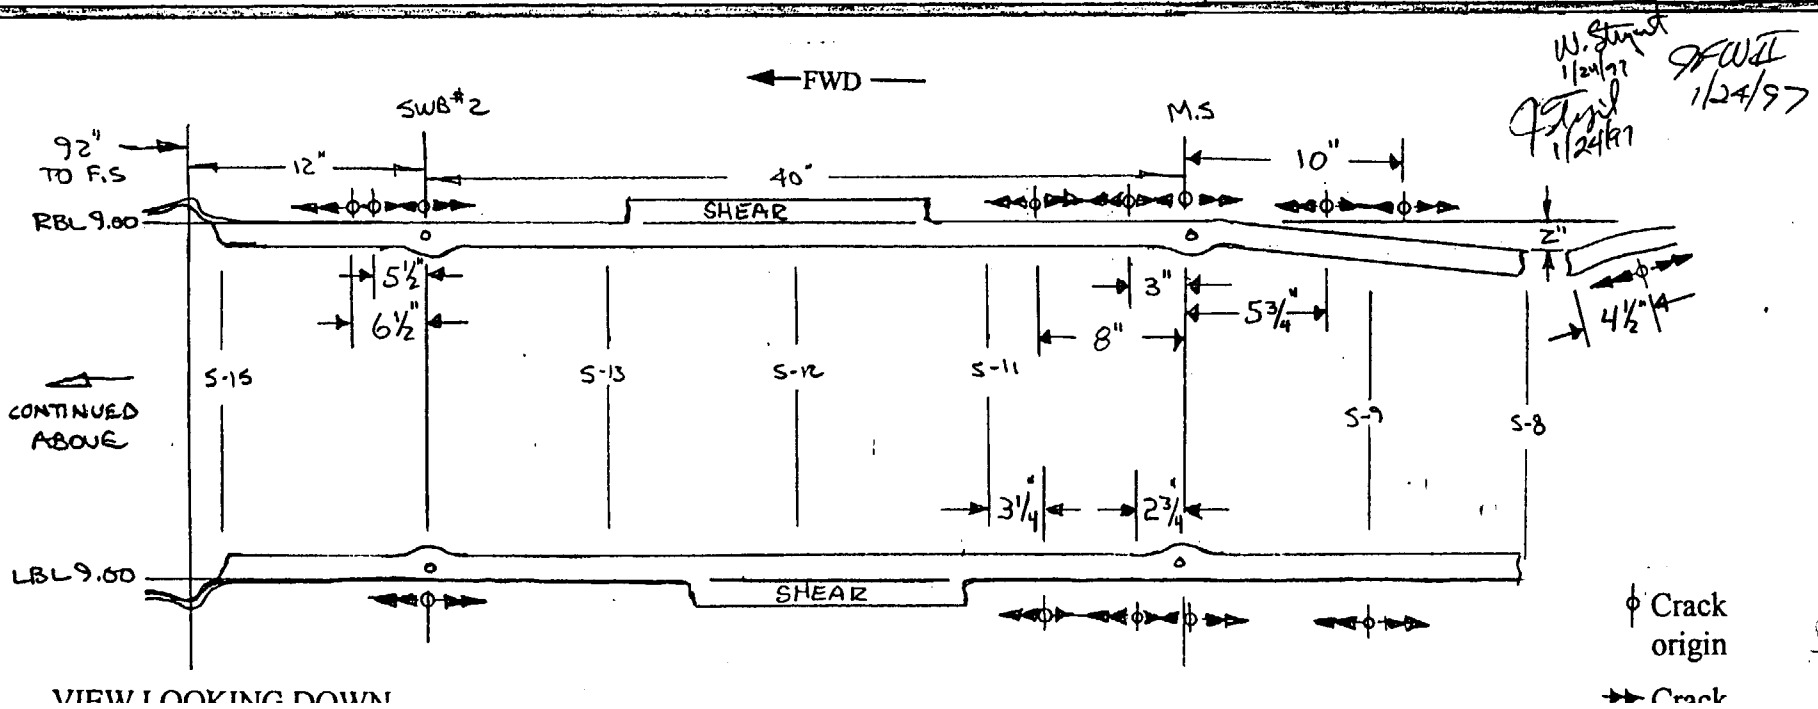
# UPPER CHC S OF KEEL BEAM

During the rotation of the keel beam and the separation from the lower skin panel, the motion results in aftward bending of the portion of the keel beam tension fasteners that are protruding from the top surface of the keel beam upper chord and also produces the drag marks in the lower skin panel holes common to the tension bolts.	See figures B-3, B-4, B-6, B-7 and B-10.		High
Compression buckling of forward keel beam web and upper chord occurs after the upper chord separation from the lower web skin, possibly just after separation.	Compression buckling of web and remaining portion of upper chord of forward portion of keel beam.		Medium
Continued downward movement of LF6A relative to the forward keel beam results in a bending fracture of the keel beam lower chord splice and also initiates bending fracture of the lower pressure bulkhead ring chord at LBL9.	<ol style="list-style-type: none"> <li>1. Downward bending fracture of the keel beam lower chord splice.</li> <li>2. Ring chord fracture initiates at LBL 9 and propagates left and right.</li> </ol>		Medium

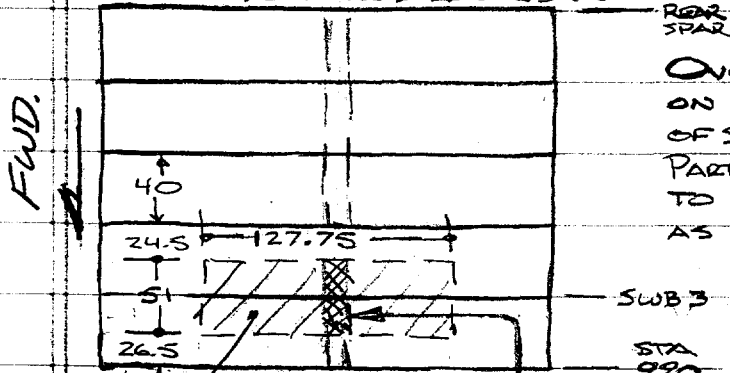
VIEW LOOKING DOWN WCS LOWER SKIN

OVERPRESSURE IN WCS TANK PUSHES DOWN ON LOWER SKIN & CAUSES TENS. SEPARATION OF SWB 3 LOWER CHORD FROM SKIN (SEE P. 11). PART OF THE UNSUPPORTED BAY LOAD IS DISTRIBUTED TO KEEL BEAM & IS DISTRIBUTED TO PRES. BLKD AS SHOWN ON P. 11 [  $V_{PRES, BLKD} = 63.6K$  ]

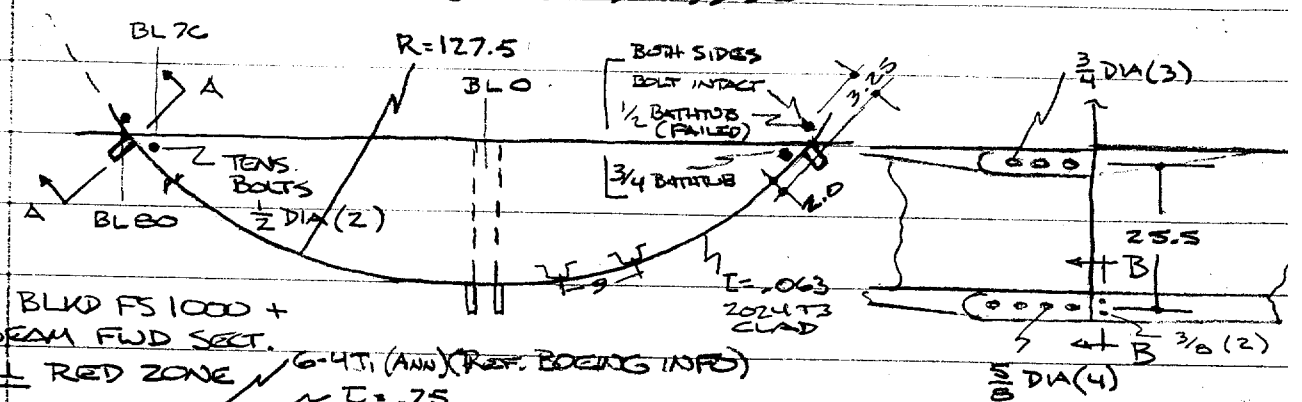
VIEW LOOKING AFT ~ LOWER BLKD FS 990

NOTE:  
LFGA, BLKD FS 1000 +  
KEEL BEAM FWD SECT.  
ARE ALL RED ZONE

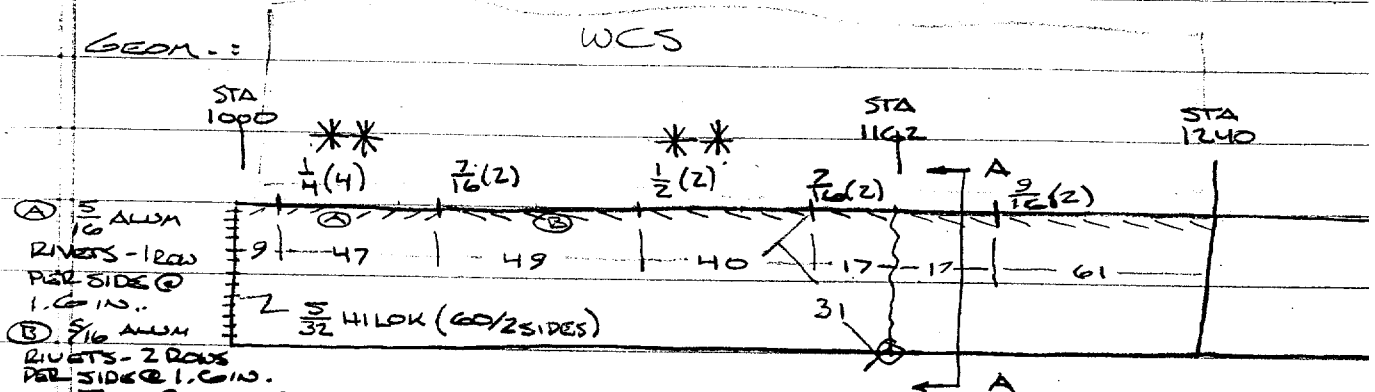
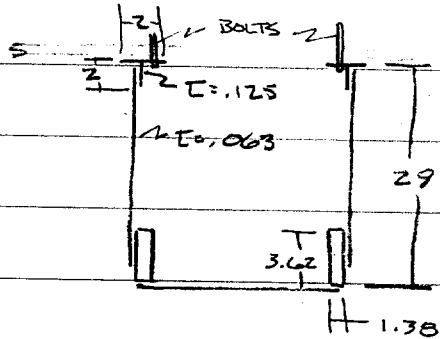
ANAL. OF KEEL BEAM FAILURE SEQUENCE:

THE RIVETS WILL UNZIP AT A LOAD SIGNIF. LESS THAN REQD TO FAIL BOLTS  $\leftarrow$   $\therefore$  THE RIVETS DO NOT CONTRIB. TO KEEL PEE-AWAY STRENGTH!

\*\*\* NUTS STRIPPED [2 OF 4 1/4" / 2 OF 2 1/2"]

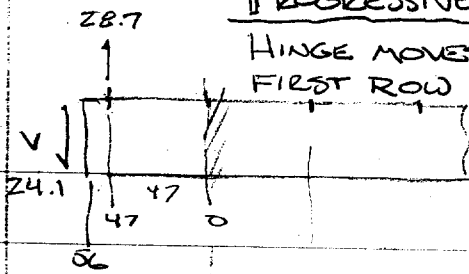
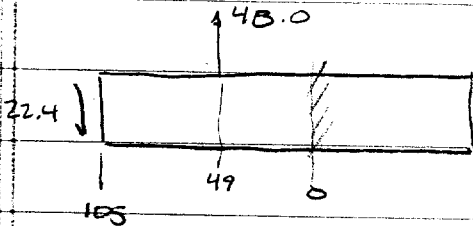
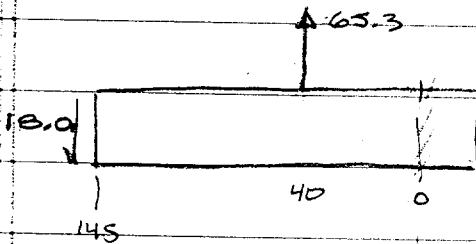
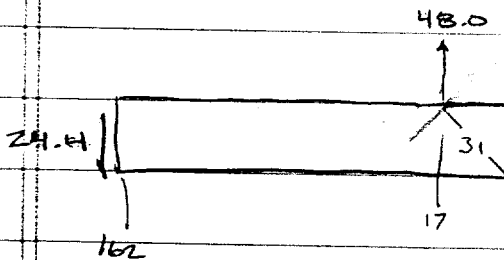
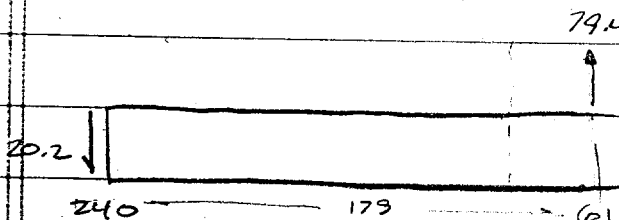
# PROGRESSIVE FAILURE OF TENS. BOLTS IN KEEL BEAM :

HINGE MOVES TO NEXT BOLT ROW AFTER FAILURE OF FIRST ROW ~ DOES KEEL BEAM SURVIVE ?

KEEL WILL FAIL BEFORE THIS BOLT GROUP FAILS!

THE FAILURE SEQUENCE BEGINS WITH LOAD BUILD-UP AT FRONT OF KEEL FROM "SMILEY-FACE" BKD. TO A LEVEL WHICH WILL INITIATE FAILURE OF 1ST ROW OF BOLTS (@ 24.1K). SUBSEQUENTLY, THE BOLTS WILL "UNZIP" ONE AFTER ANOTHER (BEC THE SUBSEQUENT FAILURE LOADS ARE LESS (THAN 26.4K) & YET THE KEEL BENDING STRENGTH IS NOT EXCEEDED AT ANY POINT UNTIL THE 4TH SET OF BOLTS (THE 7/16" BOLTS WHICH ARE GENERALLY 26" APT). WHEN THE 1ST THREE BOLT GROUPS HAVE FAILED & THE 4TH SET IS NEXT IN LINE, THE 3/8 BOLTS BEGIN TO ELONGATE & ALL ADDITIONAL LOAD IS TRANS. TO KEEL WEB WHICH THEN FAILS AT FS. 1162 ALONG WITH THE RAIL @ THIS POINT.

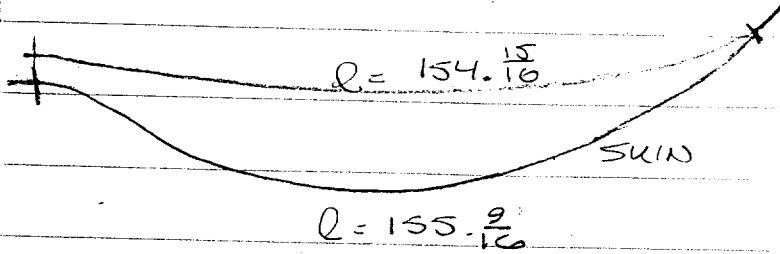
RHS LOWER SKIN/STRINGER DEFORMATION :

$\epsilon = \frac{.625}{155} \approx .004$   
 $f = 002(10^7)$

THE ABOVE OBSERVATIONS DESCRIBE THE EXPECTED CONDITION OF A BOLTED COMBINATION OF 2024 PLATE (SKIN) & 2024 ALUMINUM (STRINGER) AFTER EXPOSURE TO UNIFORM TENSION STRESS INTO THE PLASTIC RANGE WHILE RESTRAINED TO FORCE EQUAL STRAINS IN BOTH PARTS.

THE CONDITION FOUND @ THE RHS LOWER SKIN (WS 382 OF) WAS AS SHOWN ABOVE WITH THE STRINGER SEPARATED OVER A LENGTH OF 155 IN. THE SKIN ELEMENT WAS LONGER THAN THE STRINGER, INDICATING THAT THESE PARTS DID NOT ARRIVE AT THE OBSERVED STATE AS A RESULT OF UNIFORM TENSION INTO THE PLASTIC RANGE WHILE ACTING AS PART OF THE INTACT WING WITH APPLIED WING BENDING LOADS. [FOR THIS LOCATION]. OTHER LOCATIONS EXHIBIT DIFFERENT CONDITIONS OF THE SKIN/STRINGERS WHICH COULD SUPPORT THE BOEING VIEW THAT THE WING WAS HELDED BY BENDING INTO THE DIAGONAL POSITION.

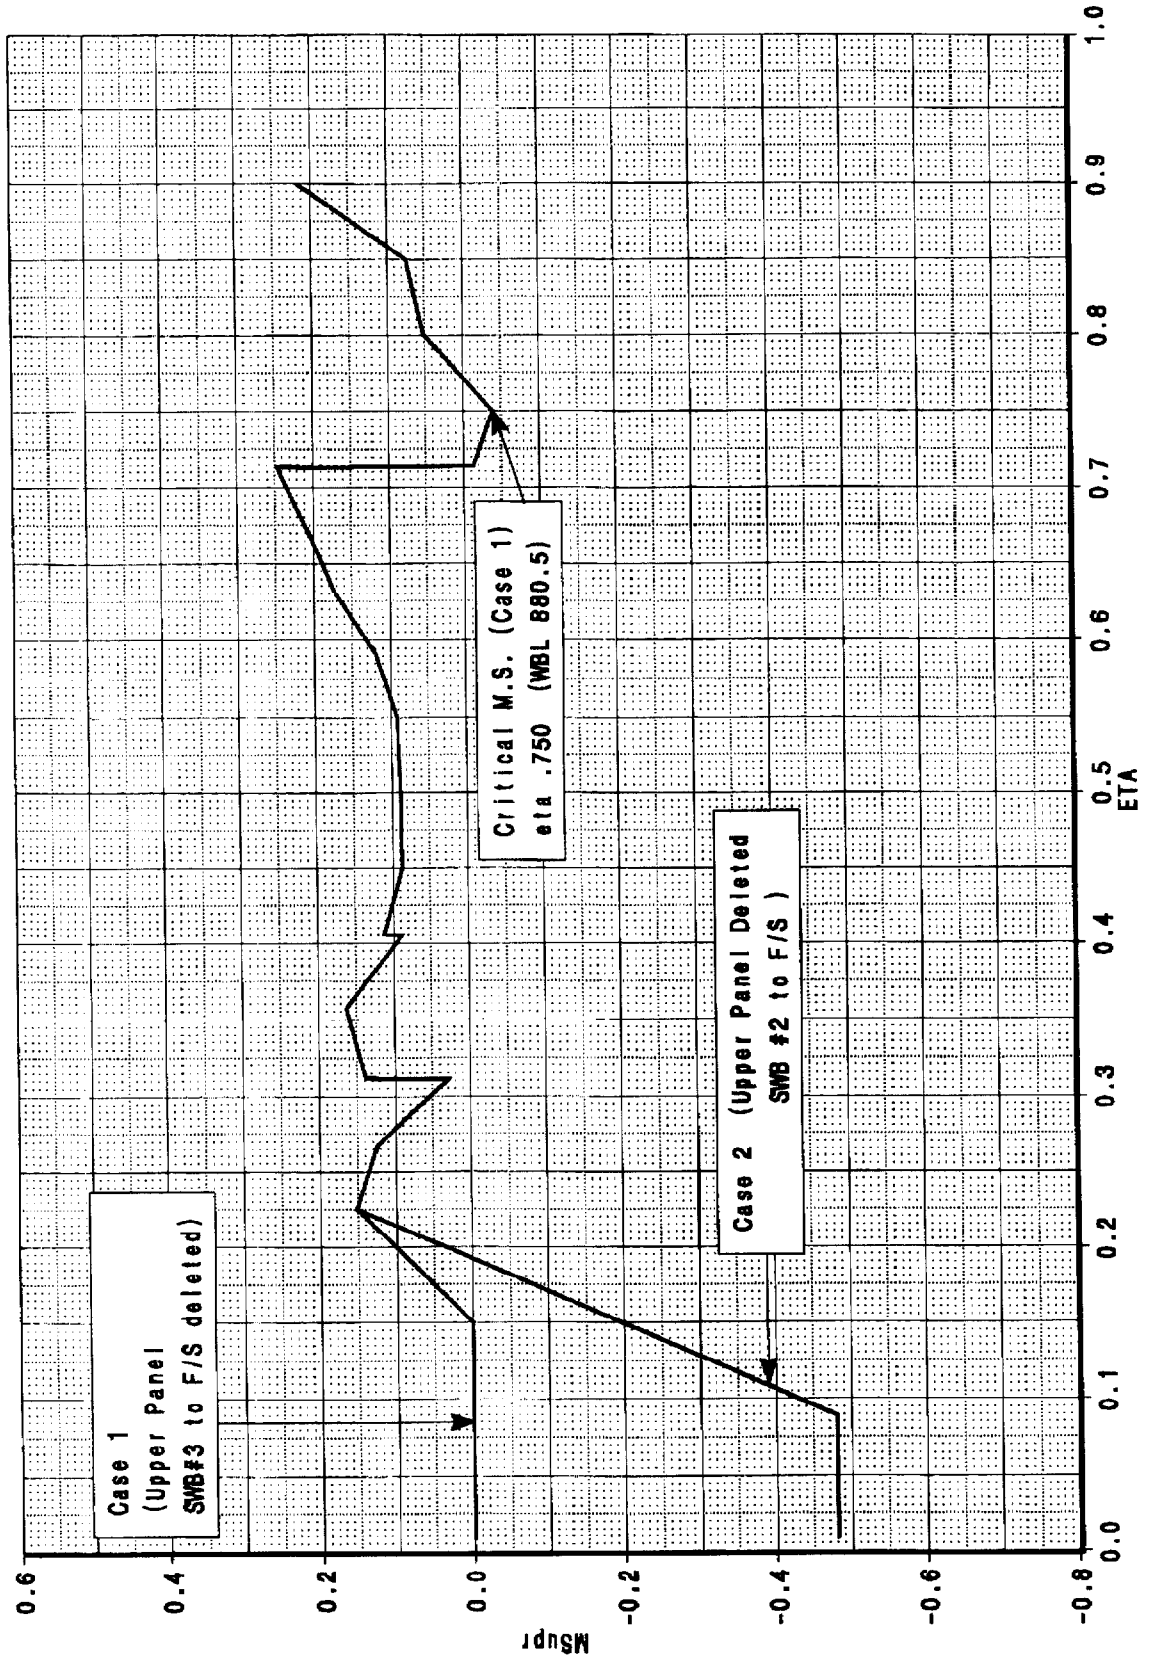
CALC	7Apr97	REVISED	DATE	747-100 Maximum Wing Load Tip On Margins of Safety - Upper Panel <b>BOEING</b>	PAGE FIG. E-2
CHECK					
APPD.					
APPD.

The analysis concluded that at a high angle of attack and approximately 5.5 to 6.0 “g” load factor the wing tips would fail while the wing center section with the lesser level of damage would continue to carry the predicted loads. Figure E -2 shows the margin of safety for the upper wing panel in compression (up bending) buckling versus wing percent span. As the figure shows, the margin of safety just outboard of the outboard engine is minus four percent.
