**NATIONAL TRANSPORTATION SAFETY BOARD  
WASHINGTON, D.C.**

**SUPPORTING DOCUMENTATION FOR OVERALL  
BREAKUP SEQUENCE**

# **Metallurgy / Structures Sequencing Group Report**

## **Appendix B: Detailed Rationale**

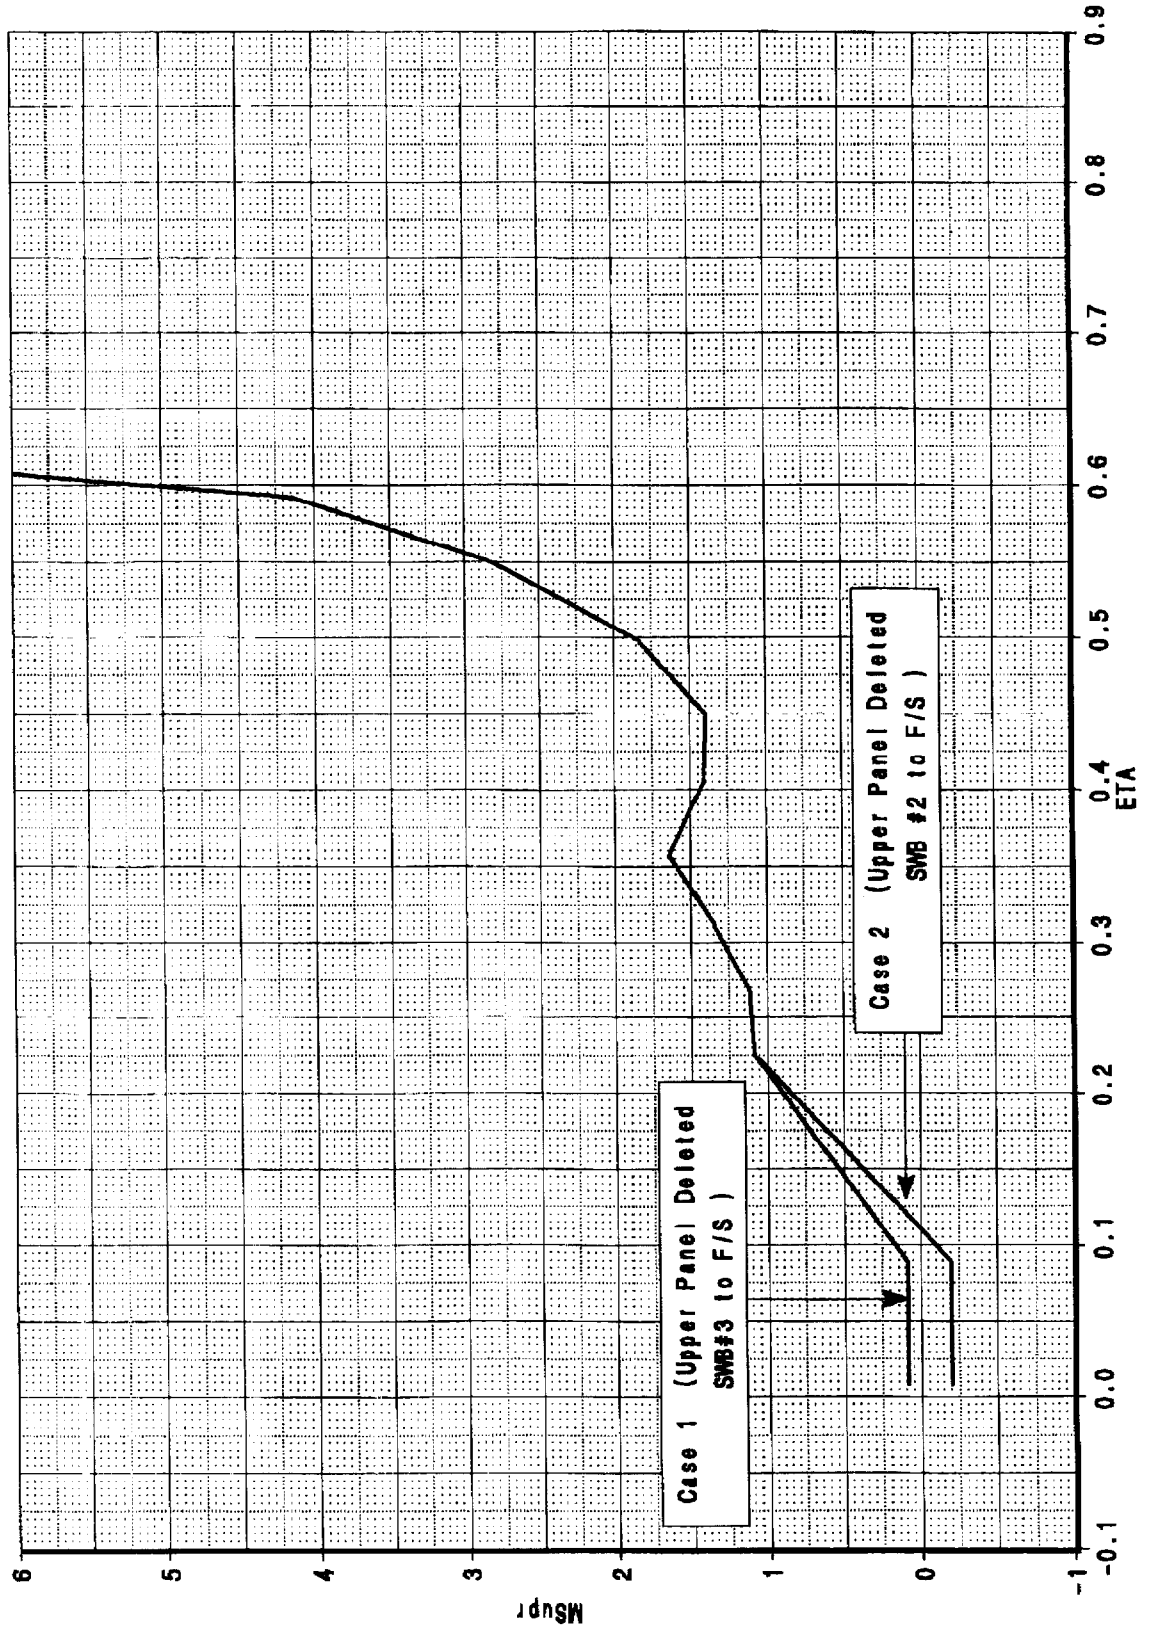
FIG E-3

With the aerodynamic loading assumptions modified to account for the wing tip removed the analysis was then rerun to determine if it is still rational to expect the center wing box to fail after the tip is gone. Figure E -3 shows the results of this analysis illustrating that the wing upper panel would buckle if the damage was somewhat more severe than the minimum level of “Case 1”. This loading case represented a further increase in load factor of approximately 1 “g” over and above the flight condition which resulted in the prior wing tip failure. The two wing bending analyses (tip on and tip off) do appear to support the premise that SWB #2 was still sufficiently intact to provide substantial support to the wing upper panel. This would be consistent with localized damage to only the mid-portion of the beam due to keel beam separation.

747-100  
 Maximum Wing Load Tip Off  
 Margins of Safety - Upper Panel
