**Interim Report
on the
Crash of TWA Flight 800
and the
Actions of the NTSB and the FBI**

Cmdr. William S. Donaldson, USN Ret.

Committee on Transportation & Infrastructure

July 17, 1998

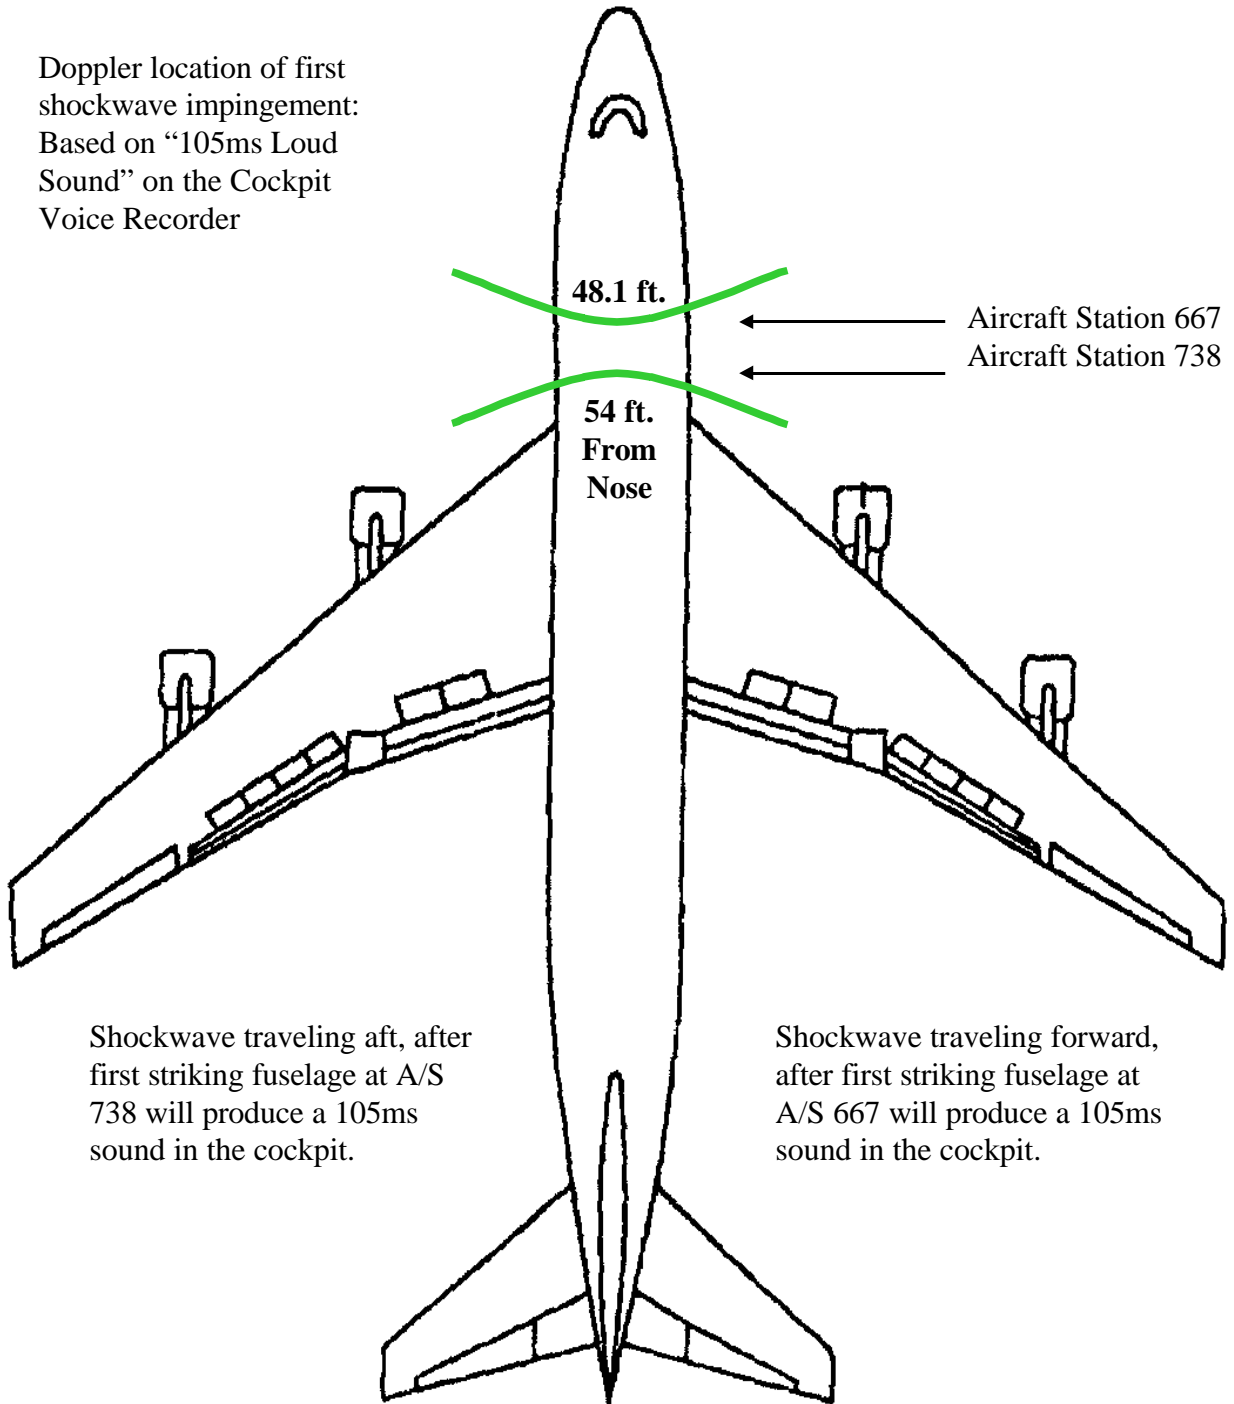
EXHIBIT 19 - DOPPLER LOCATION OF FIRST SHOCKWAVE

- d) 105 ms loud sound recorded on the CVR. It takes precisely 105ms for a weapon shock wave first impinging between airframe 667 and 740, to clear both the nose and the tail, and return to cockpit microphones through airframe aluminum. See Exhibit 8 on page 49. This is inconsistent with a CWT failure and consistent with an airburst anti-aircraft weapon.

Doppler location of first shockwave impingement:
Based on "105ms Loud Sound" on the Cockpit Voice Recorder

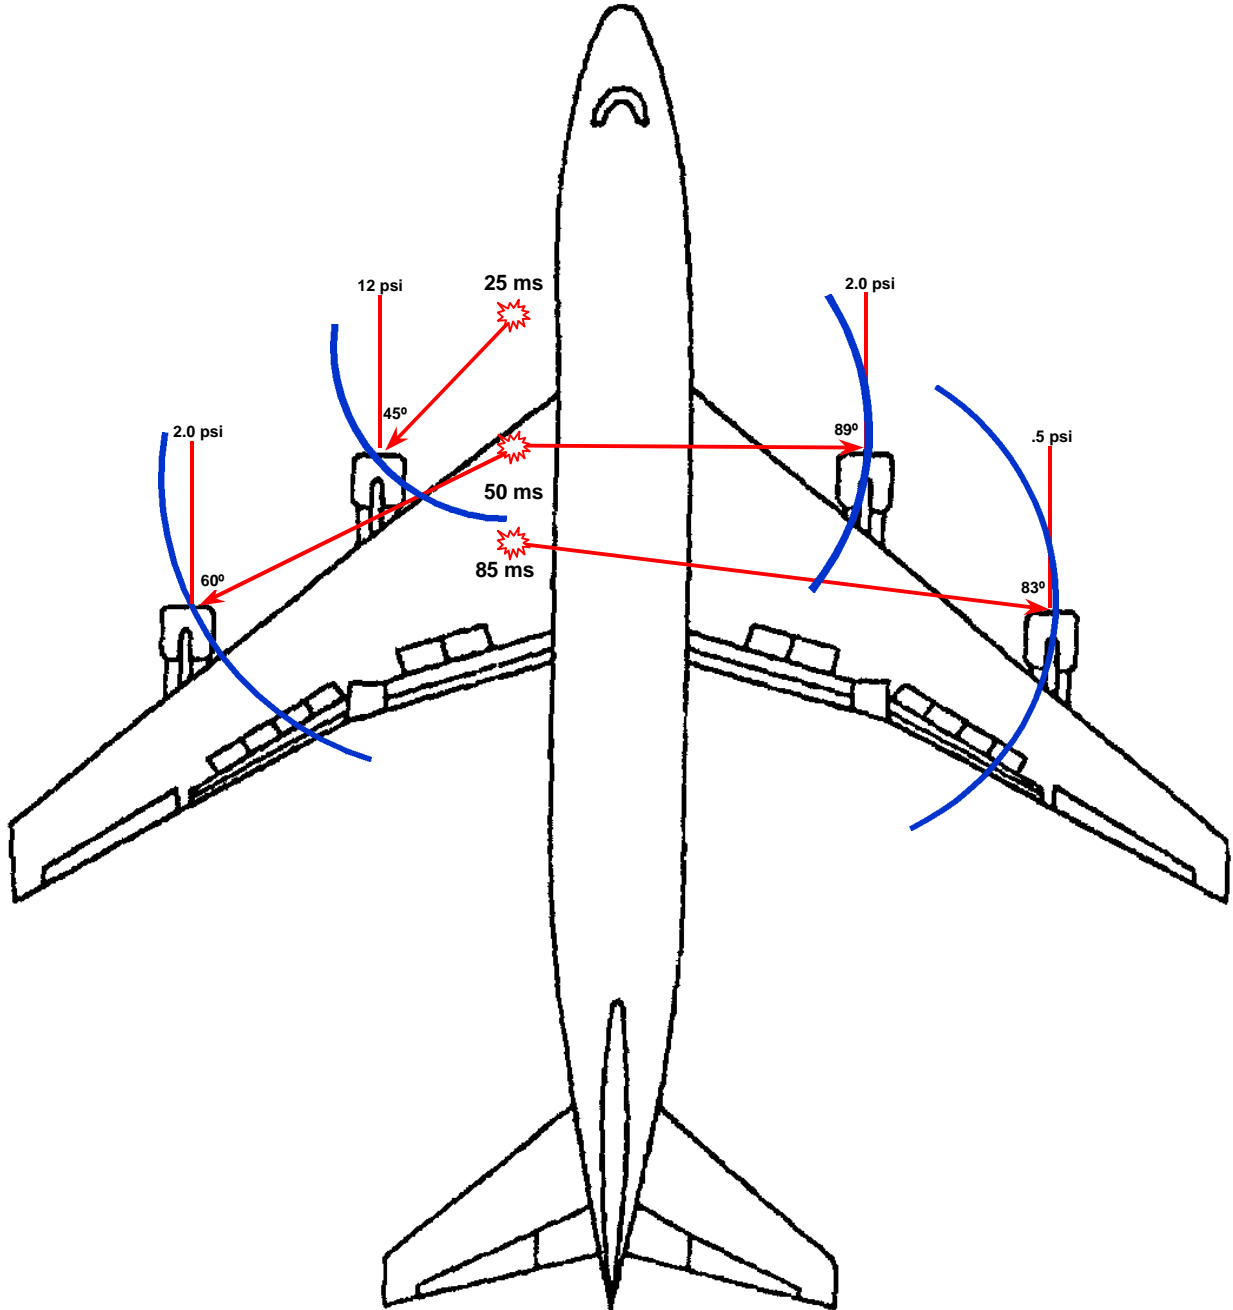
Airburst Shockwave impingement on wing and engines
